THERMAL IMAGING REPORT

LSHP Administration building

22.3.2018
Lapland UAS

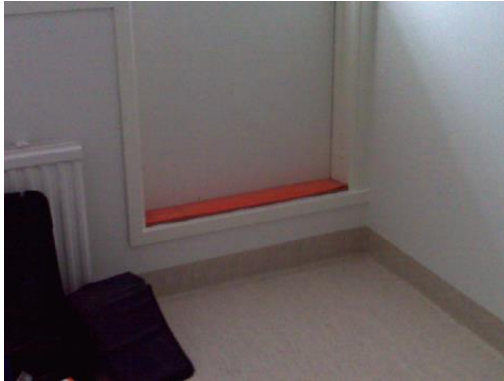
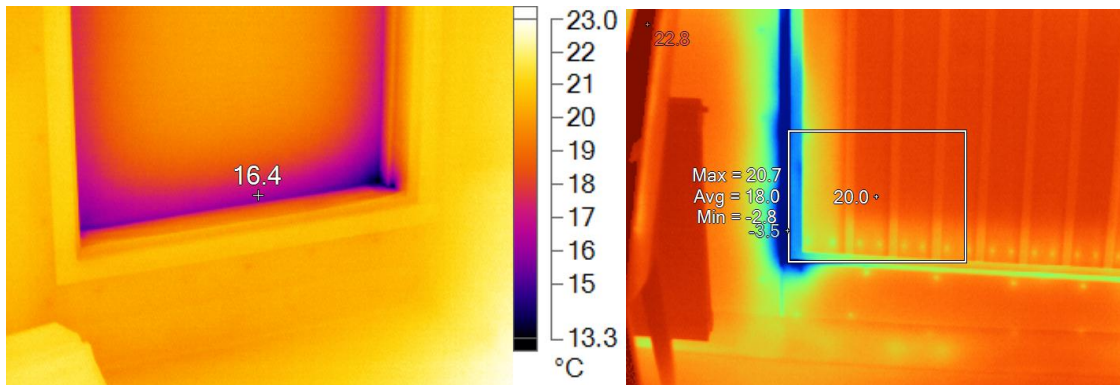
Room 138

Some changes in room structures has been made after 2011, but we were able to locate the same balcony entrance despite that. Door has been replaced and it has enormous, positive impact on thermal properties and comfort.

Thermal index of the lowest temperature recorded at current state is 70 % - Good.

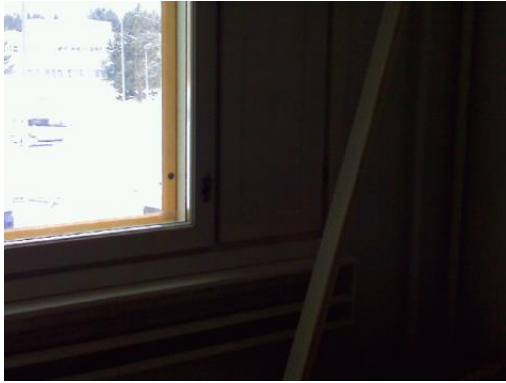
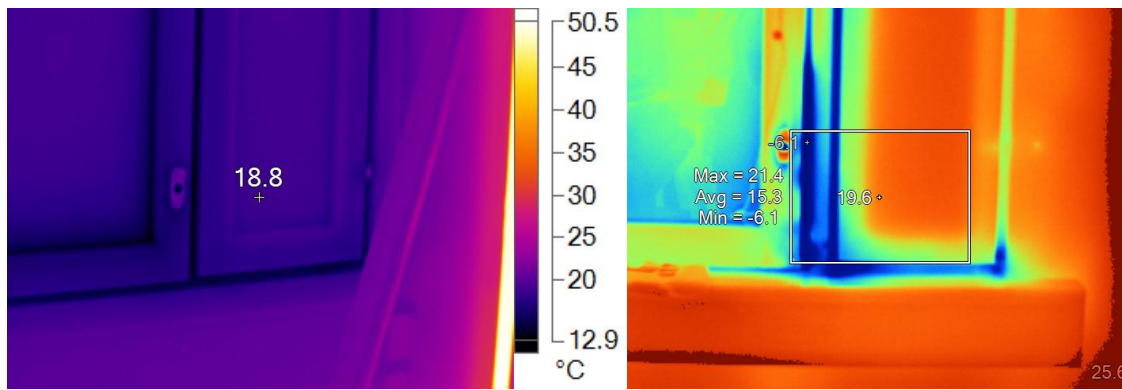
Room 145

Window has been replaced, which took care of great air leaks documented in 2011. Since air leaks are no longer present, surface temperatures are considerably higher now.

Thermal index of the lowest temperature recorded at current state is 73 % - Good.

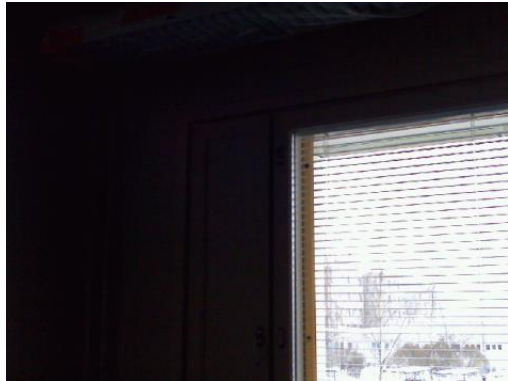
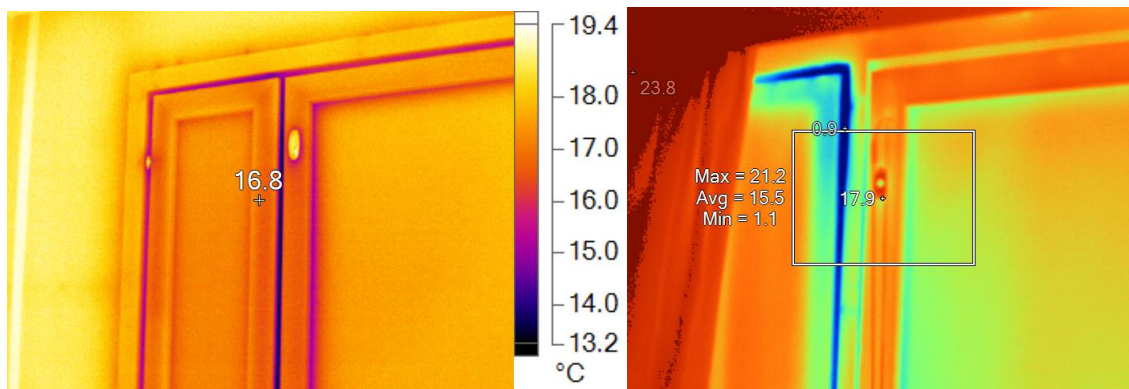
Room 163

Since the window has been replaced, air leaks are no longer present.

Thermal index of the lowest temperature recorded at current state is 75 % - Good.

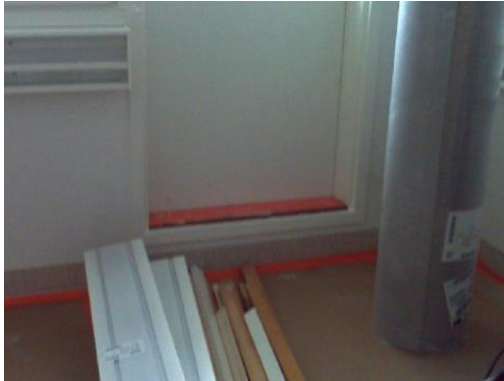
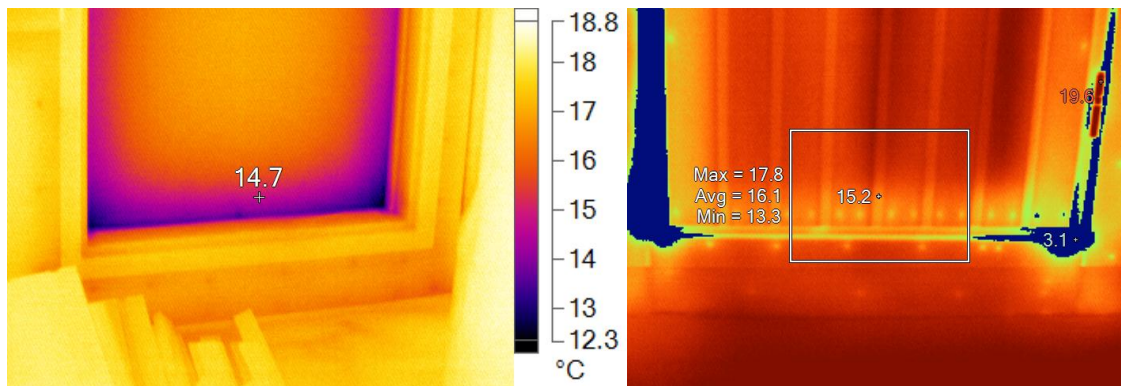
Room 163

Almost freezing temperatures measured in 2011 have been eliminated completely with new balcony door.

Thermal index of the lowest temperature recorded at current state is 70 % - Good.

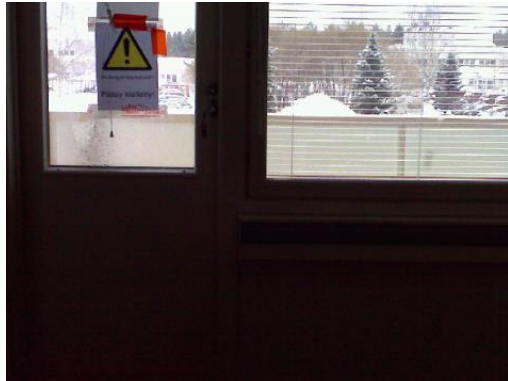
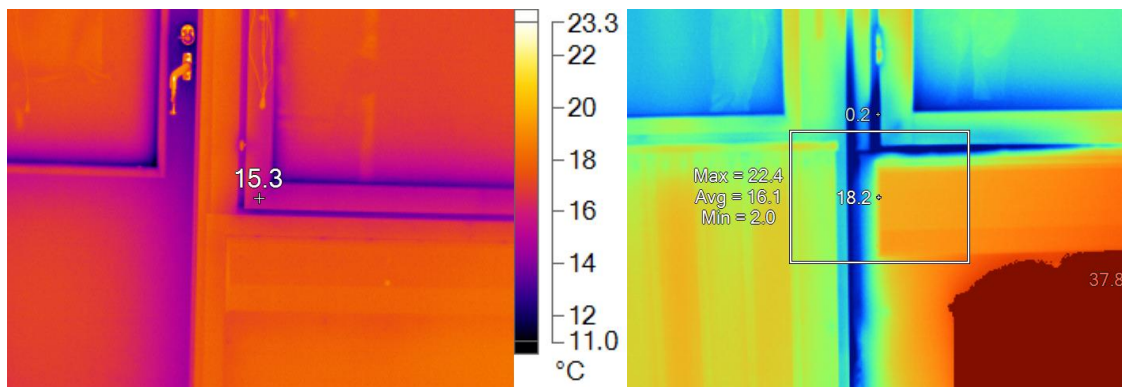
Room 165 was diagnosed with enormous air leaks between balcony door and window structure. At a current state, problem is no longer present and thermal properties are good.

Thermal index of the lowest temperature recorded at current state is 74 % - Good.

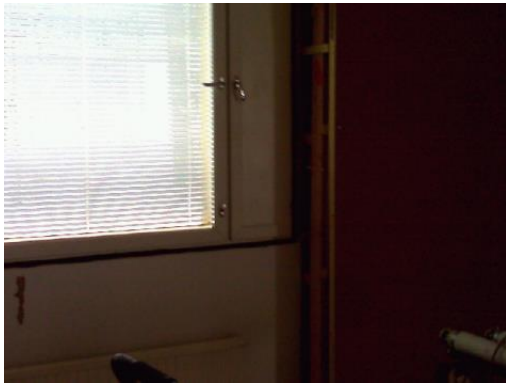
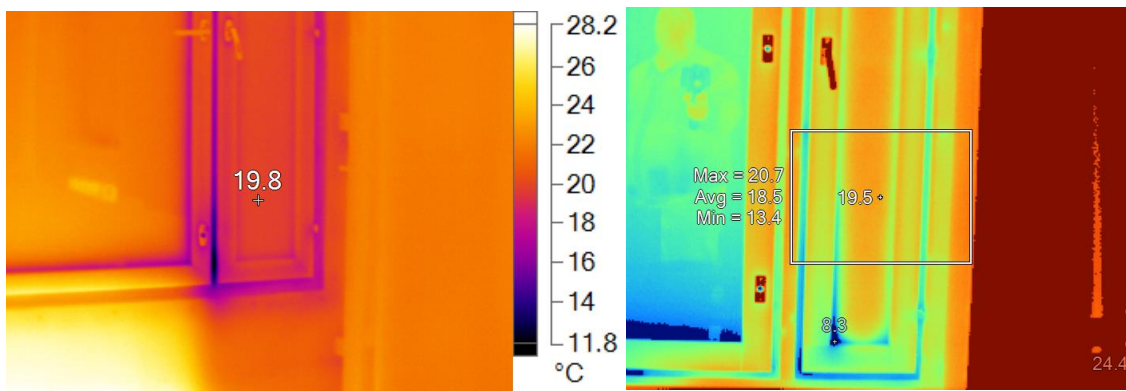
Room 173

Ventilation door in conference room still has a minor air leak at the bottom left corner. Although thermal impacts are clearly visible, the problem itself is likely easy to fix with a new seal.

Thermal index of the lowest temperature recorded at current state is 64 % - Decent.

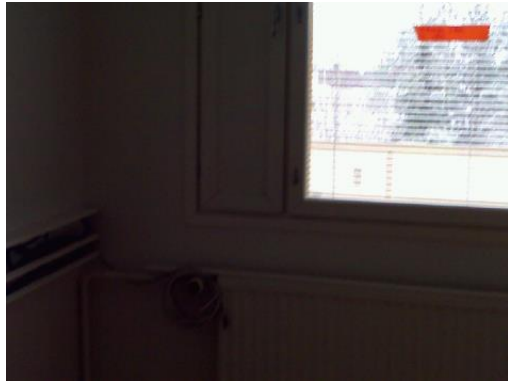
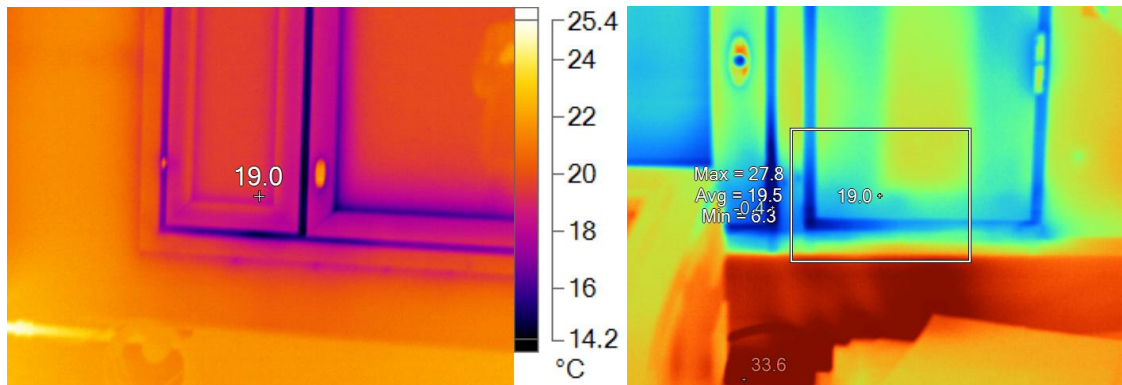
Room 201

In room 201, the ventilation window has been replaced and has switched from left to right during renovation. New window has no noticeable air leaks.

Thermal index of the lowest temperature recorded at current state is 76 % - Good.

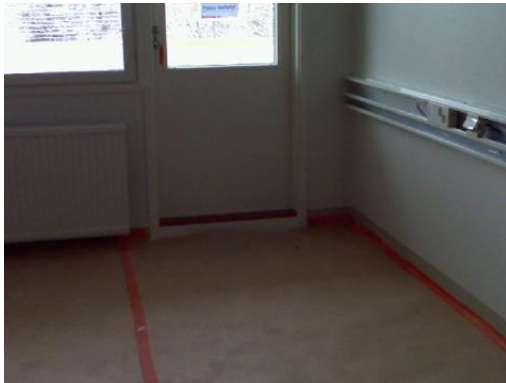
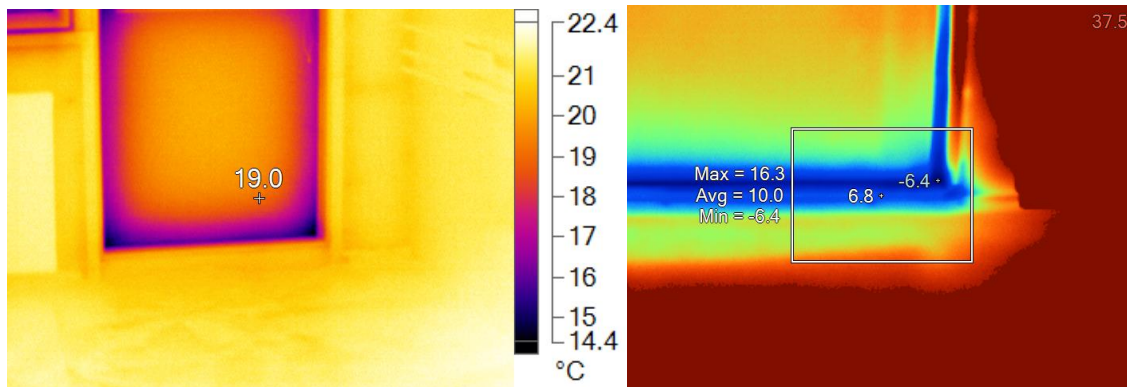
Room 201

Balcony door has been replaced and now has better air tightness, resulting in better thermal comfort.

Thermal index of the lowest temperature recorded at current state is 77 % - Good

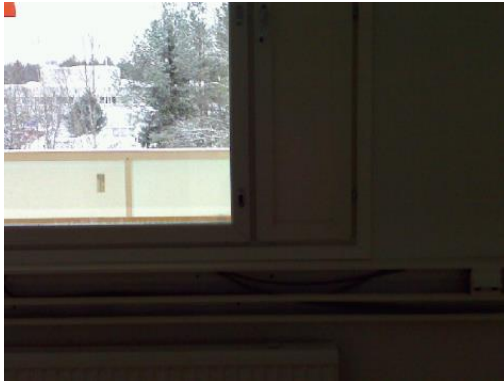
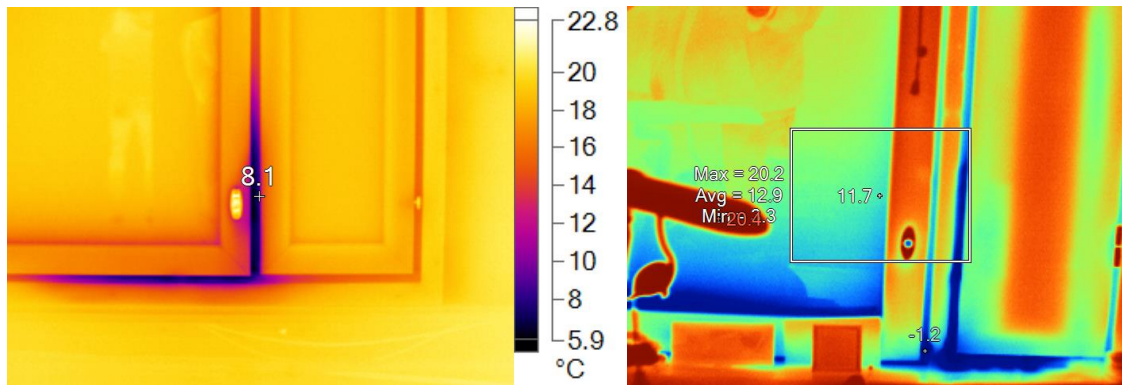
Room 204

In room 204, air leakage was present and almost identical to the one documented in 2011. Thermal index of window structure is very poor. Maintenance is required to avoid thermal discomfort and further structural damage.

Thermal index of the lowest temperature recorded at current state is 39 % - Requires maintenance.

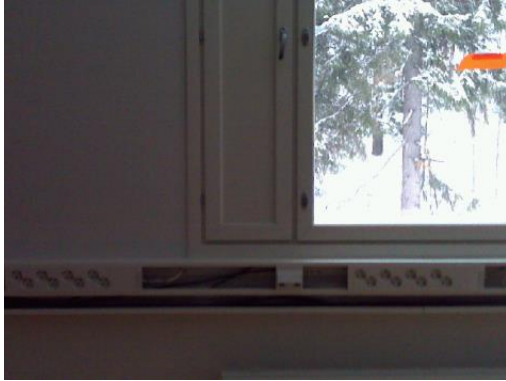
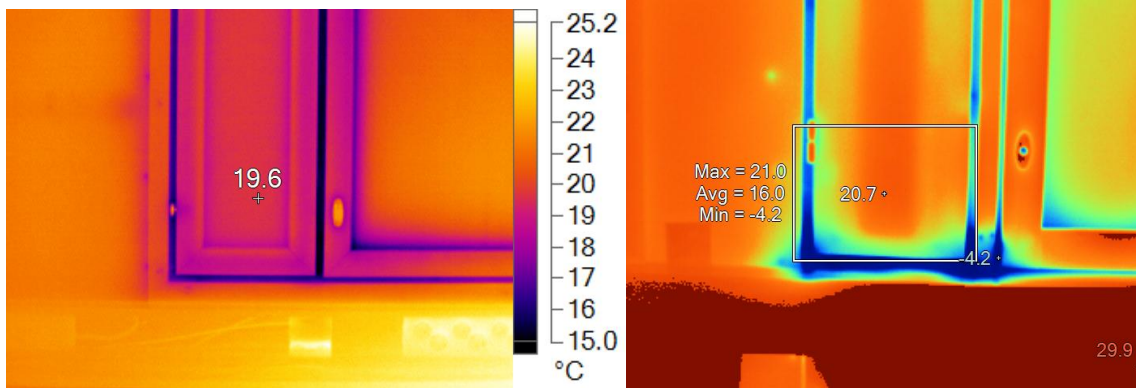
Room 208

Ventilation window has noticeably better air tightness when compared to the situation in 2011. There were no extremely low temperatures present in 2018.

Thermal index of the lowest temperature recorded at current state is 78 % - Good.

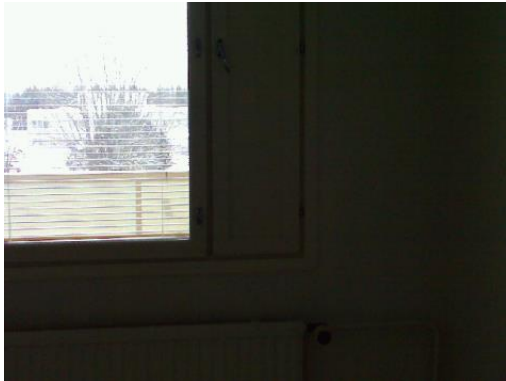
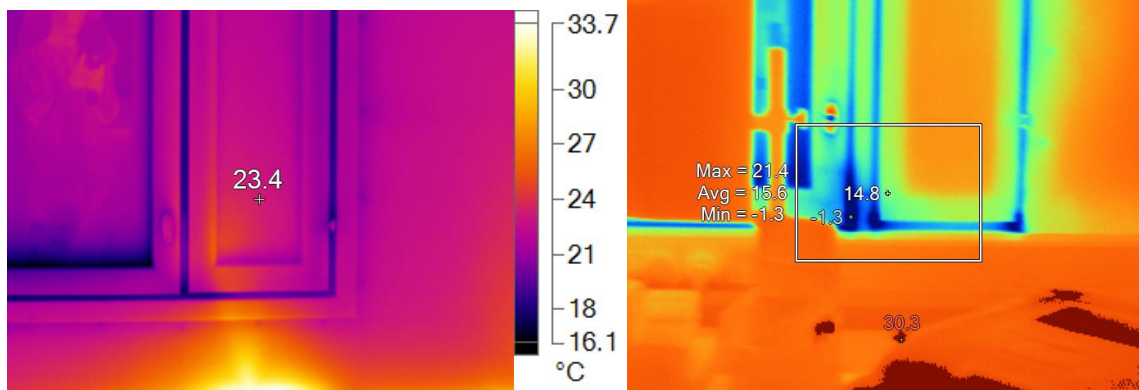
Room 225

Problematic air leak was solved by changing the window structure.

Thermal index of the lowest temperature recorded at current state is 84 % - Good.

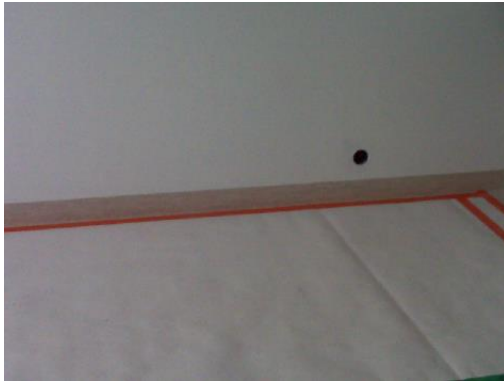
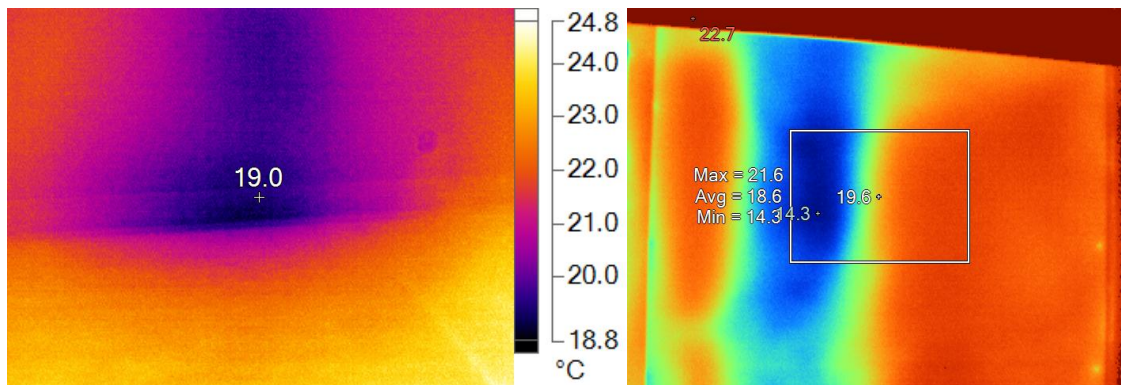
Room 228

Structural energy efficiency of wall structures was under the scope only in room 228, since report from 2011 did not mention that any other space would have deficiencies regarding thermal properties of walls, floors or roof structures. One, clearly visible thermal bridge was still present in room 228, but it does not affect the thermal comfort, thanks to added insulation layer on the wall. Thermal bridge is due to balcony structures. Balcony does not exist anymore, but some inconsistencies are still within the wall structure.

The remnants of an old balcony structure forms thermal bridge. In current state, added insulation keeps the wall temperature in good values, thanks to added insulation.

Thermal index of the lowest temperature recorded at current state is 94 % - Good.

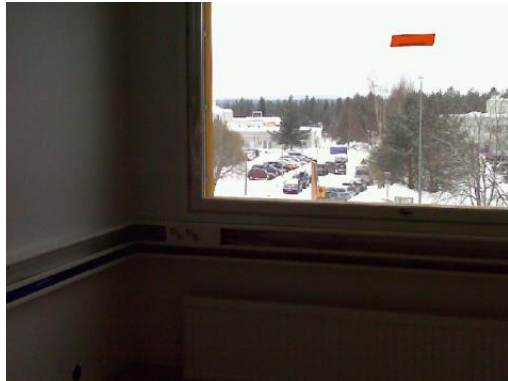
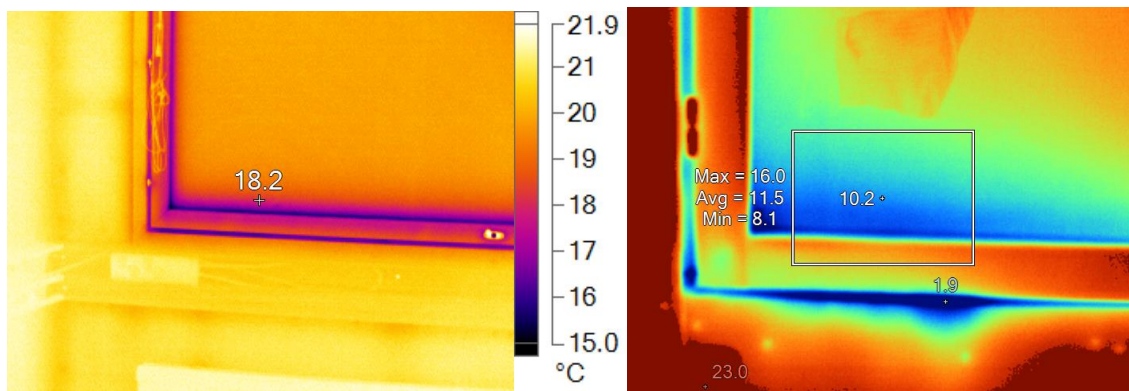
Room 238

Problem regarding the great air leakage thermally imaged in 2011 has been solved by changing the window structure.

Thermal index of the lowest temperature recorded at current state is 78 % - Good.

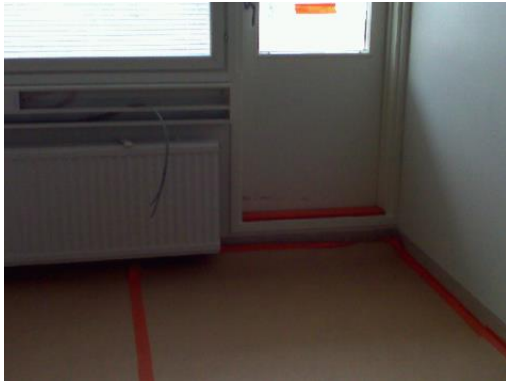
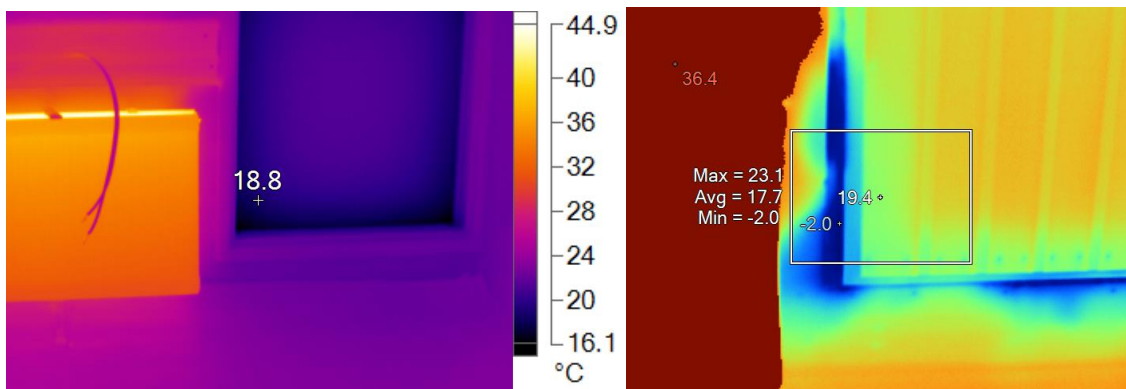
Room 255

Replaced balcony door has eliminated the strong air leakage.

Thermal index of the lowest temperature recorded at current state is 84 % - Good.

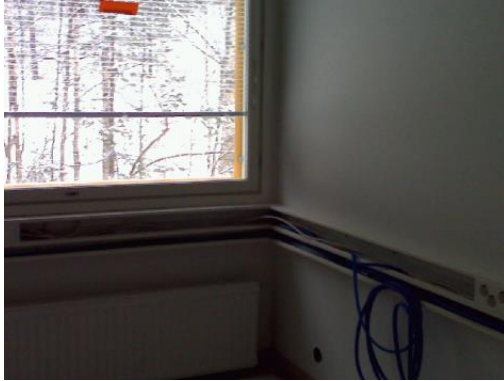
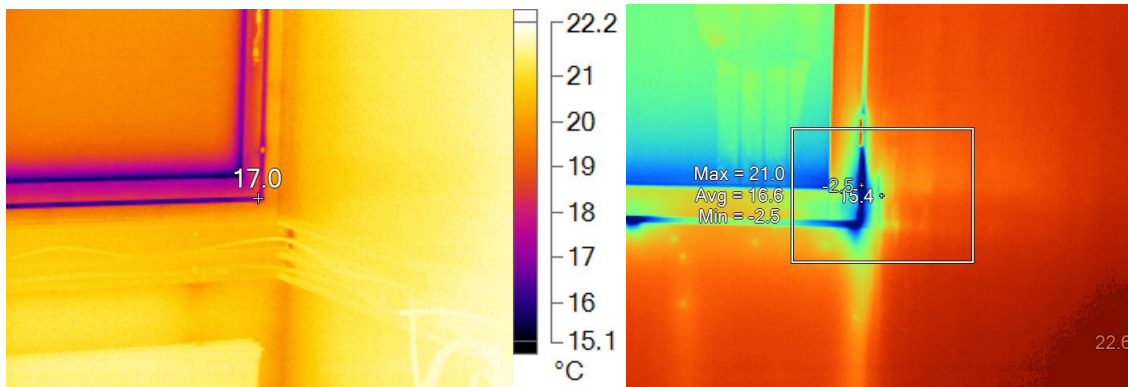
Room 260

Replaced window in room 260 has improved thermal comfort greatly. There was no air leaks to be found, and overall temperature in and around the window is higher than in 2011.

Thermal index of the lowest temperature recorded at current state is 80 % - Good

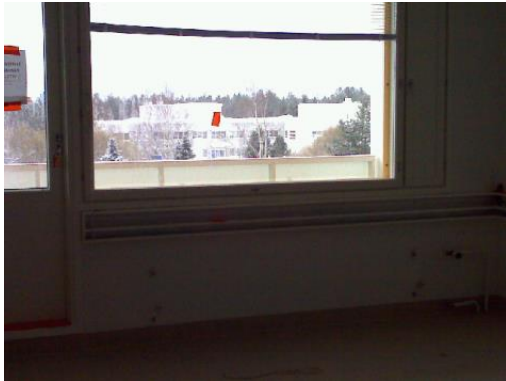
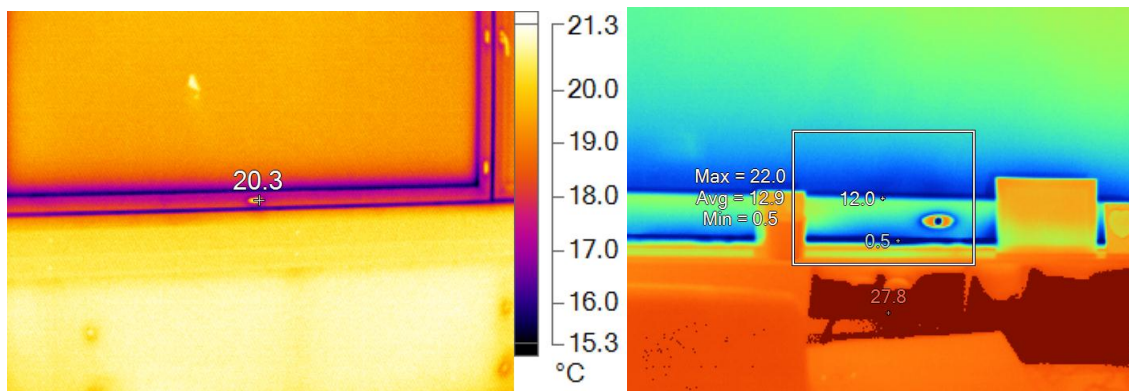
Room 274

Temperature of the window structure was warmer in current state, and no noticeable air leaks were found.

Thermal index of the lowest temperature recorded at current state is 79 % - Good.
