MORPHOLOGICAL DEVELOPMENT OF SECONDARY CHANNELS

BUILDING WITH NATURE – EXPLORATORY RESEARCH OF MORPHOLOGICAL DEVELOPMENT OF SECONDARY CHANNELS

Client: Rijkswaterstaat
Project number: RWS188
Report number: 2.0
Status: Definitive version
Date: 17 april 2020

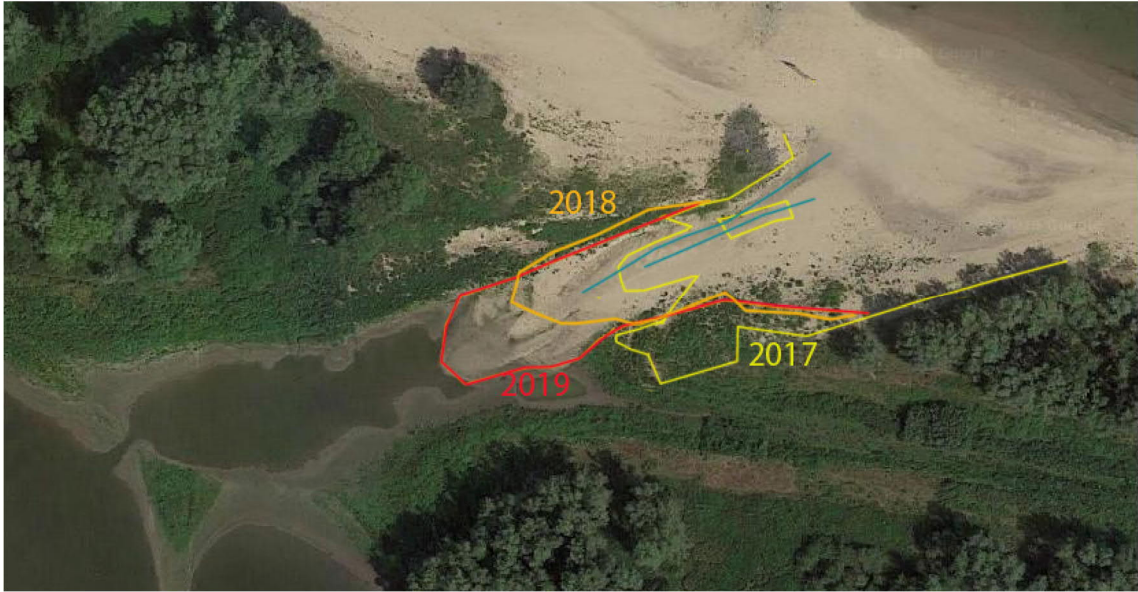
Figure 3.7 Detail of the situation in the western short-circuit channel over the period 2017 to 2019. The blue lines indicate the location of a shallow channel.

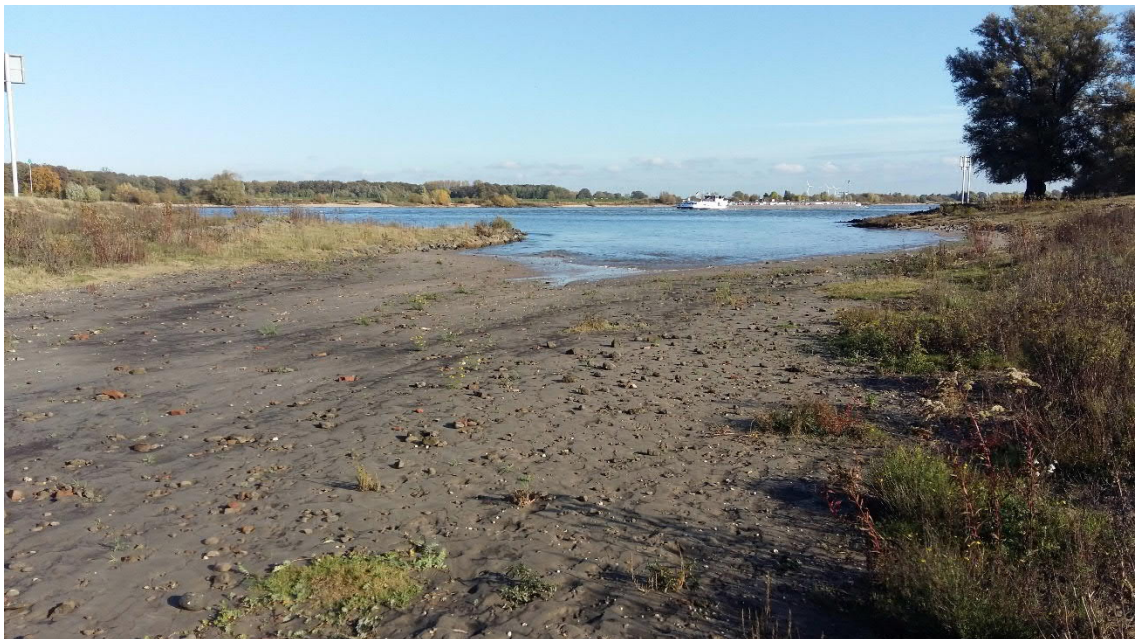
During a field visit at the end of 2019, it was observed at the sandbanks in the eastern channel that some of the fence posts there were partially buried in sand that was approximately 40 - 50 cm deep. In the years 2018 and 2019, the photos show that the sandbank gradually gets longer and fills the deeper part of the channel.

Figure 3.8 Inflow opening of the eastern channel (November 2019). The bottom is barren here because the area is lower than the median water level. Erosion takes place here, because the larger stones (which are too big to be moved) are exposed.

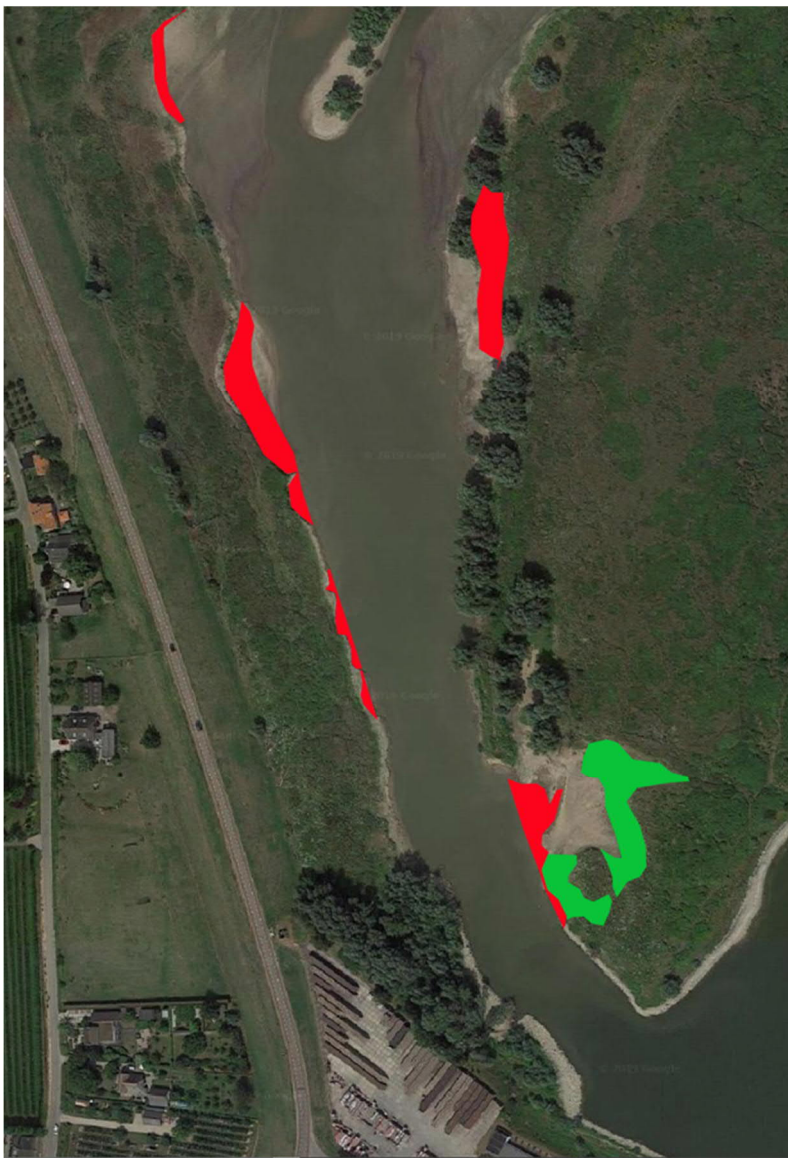
The cause of the bank eroding more in one place than in another is unclear; it is not due to the situation of the foreshore because low water situations (see Figure 3.20) show that the foreshore differs little in places that do and do not erode.

Figure 3.18 Bank erosion (red) and sedimentation (green) between 2005 and 2019.

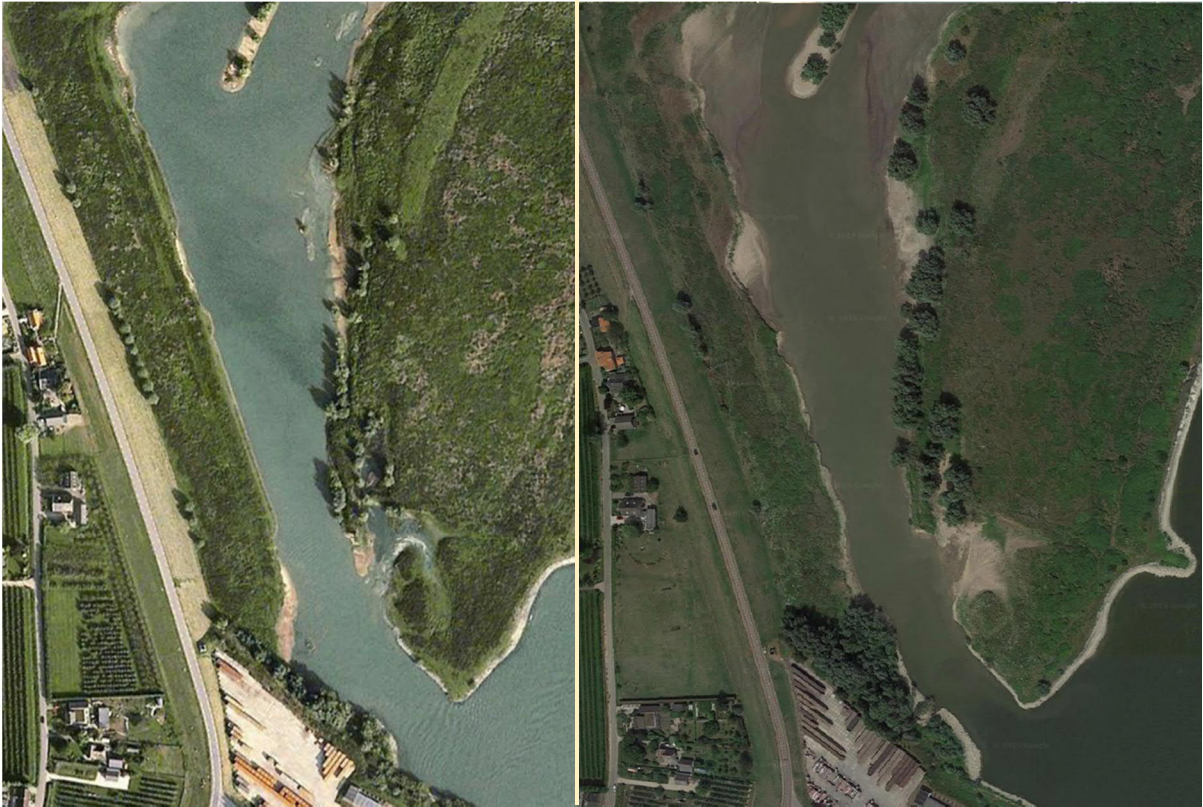
Figure 3.19 Changes in the bank of the side channel between 2005 (left) and 2019 (right).

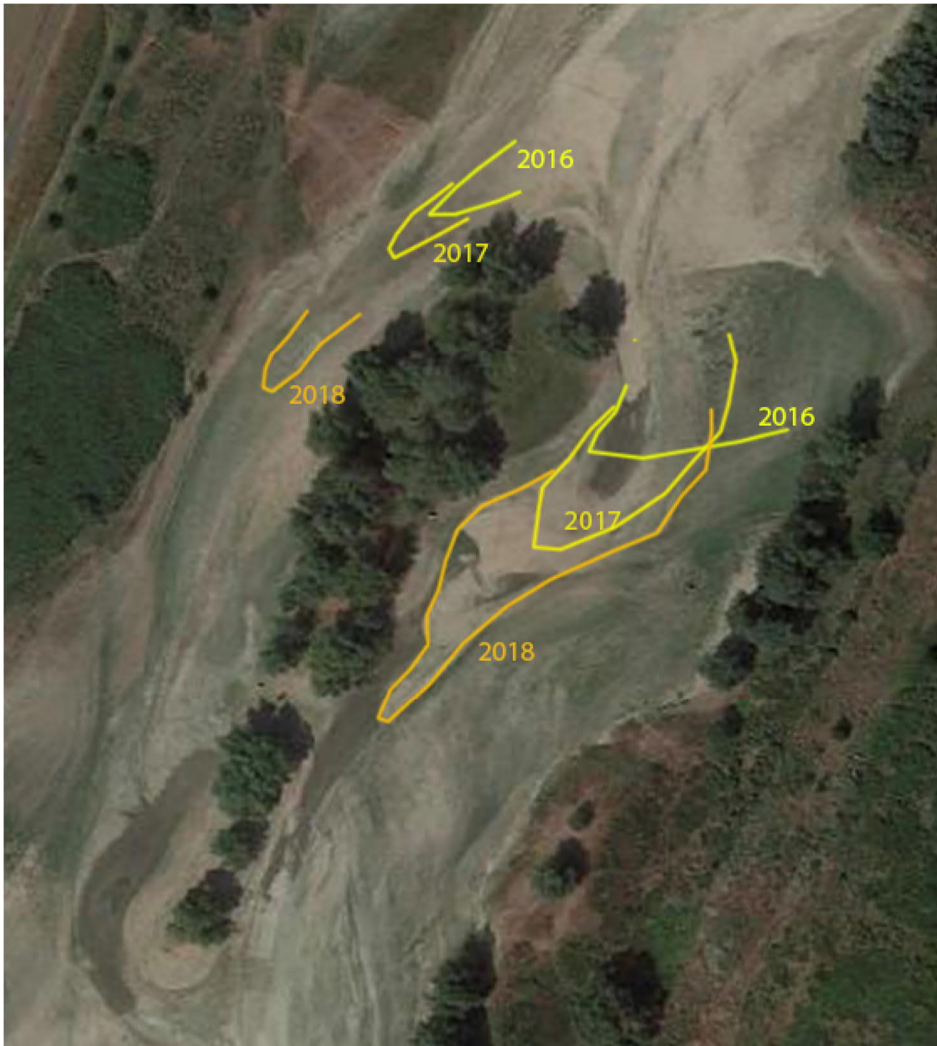
It is unlikely that this is sand from the river, because there is an even deeper section in the part of the channel that is situated before the narrow part (see elevation map in appendix B2) in which the sand brought in from the river will settle.

Figure 3.21 Changes in the contours of a sand lobe that has formed after 2016 (construction of inlet works) in the lower part of the secondary channel.

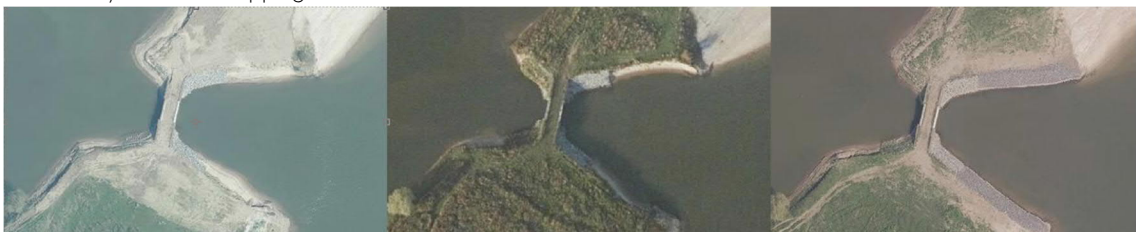
The wave action caused by shipping traffic can easily reach the channel banks exposed to the river. The erosion that is caused by this is clearly visible on the banks in front of the inlet of the co-flowing secondary channel. These were built quite steeply in 2016 (approx. 1: 3) and bank erosion took place right after the moment of construction of the inlet, so that the bank slowly started retreating. After about 2 years, this process was stopped by human intervention by completely fixating the bank area with quarry stone (see figure 4.12). The outflow can also be reached by waves of shipping traffic.

Figure 3.12 Inflow opening in 2016 (left), 2018 (center) and 2019 (right). Immediately after construction, a lot of erosion took place on the steep banks of the inflow, after which additional bank defenses were required after only a few years.

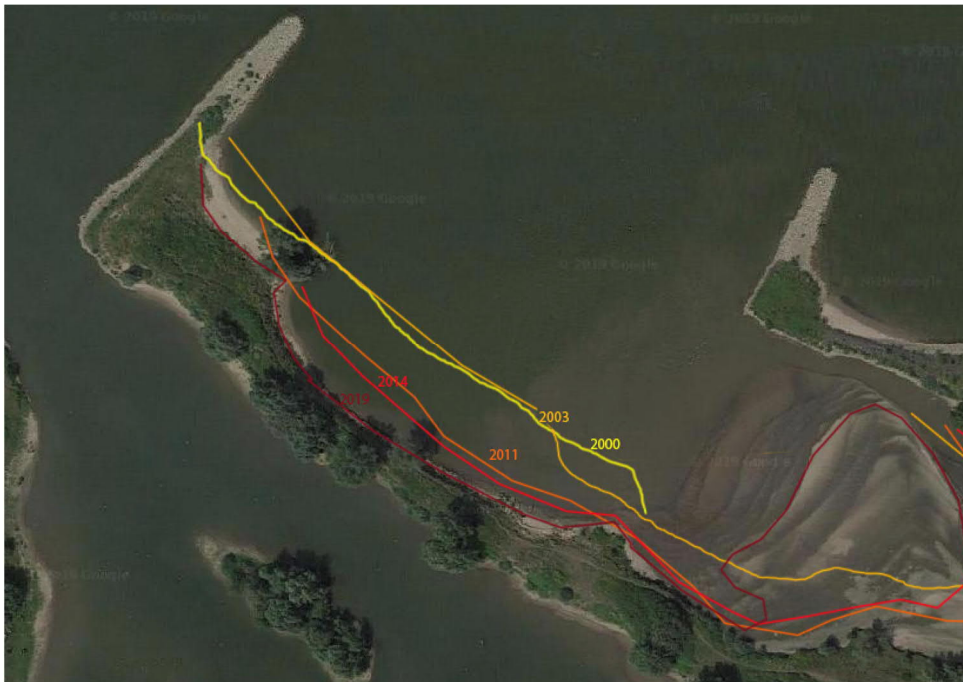
Figure 3.37 shows that quite a lot of erosion also occurs along the river bank. In most groyne sections, the sandy beach is smaller in 2019 than in 2000. Higher on the bank, the boundary between overgrown and bare has retreated. The large area of bare sand in the groyne sections directly after the outflow of the northeastern secondary channel, is a location that was covered with lowland riparian forest. After this forest was cut down in 2006, no vegetation has returned.

Figure 3.41 Contours of the bank in the outflow of the northwestern side channel over the period 2000 to 2019.

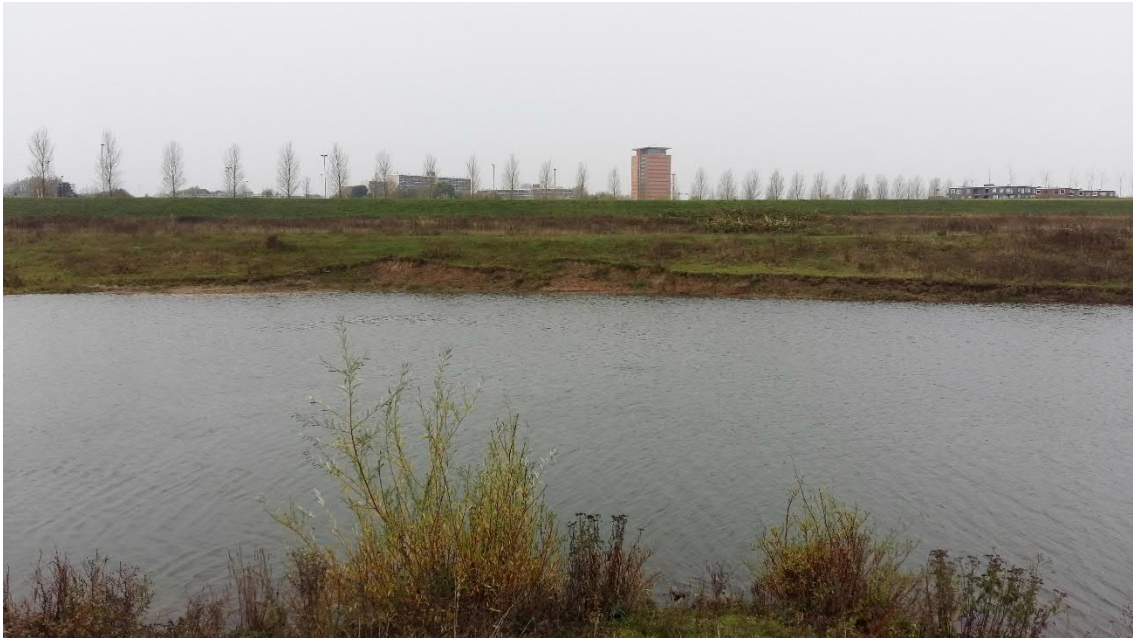
Generally erosion occurs along both banks, but the most erosion occurs along the eastern bank (see Figure 3.46). It concerns a limited retreat of the bank of up to 5 m, but usually no more than 2 to 3. During a field visit in 2019, it was also observed that there is a turning bank on many routes. In many places the bank was covered by vegetation, from which it can be concluded that the bank is not actively eroding.

Figure 3.46 Bakenhof: erosion on the eastern bank

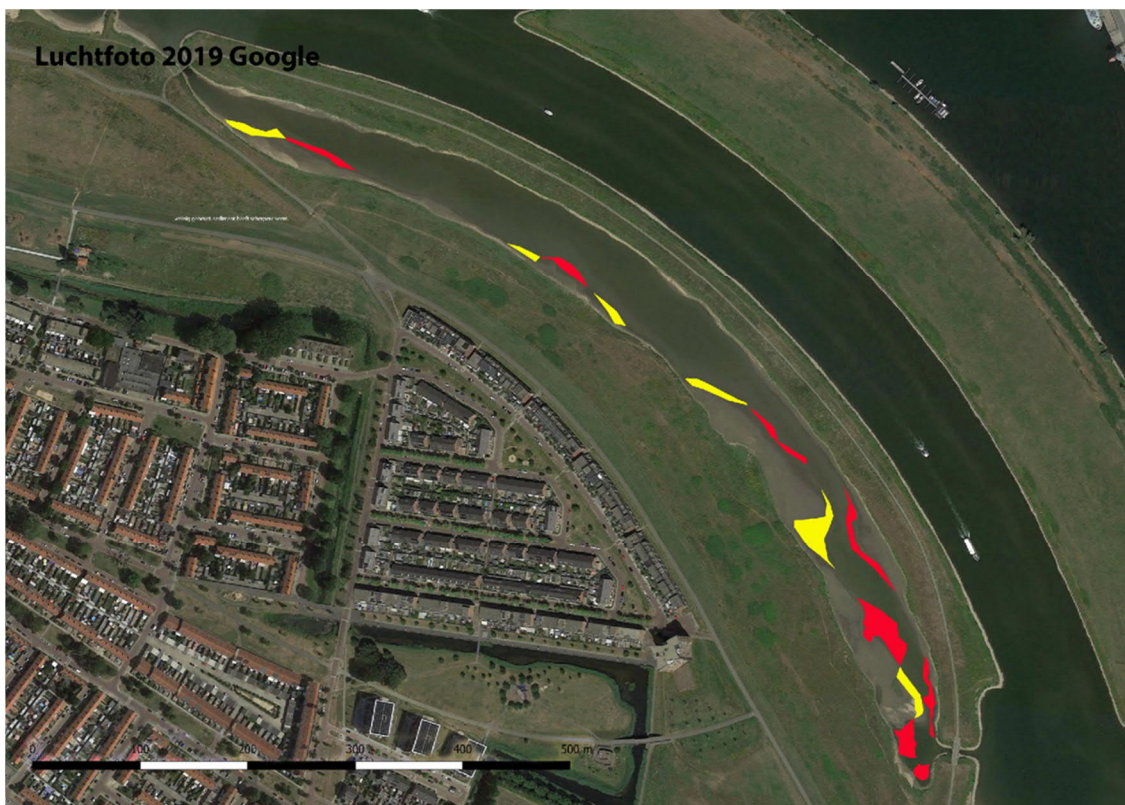
Figure 3.48 Changes in the bank line between 2005 and 2019 (NB The photo from 2003 was too unclear to deduce the bank line).

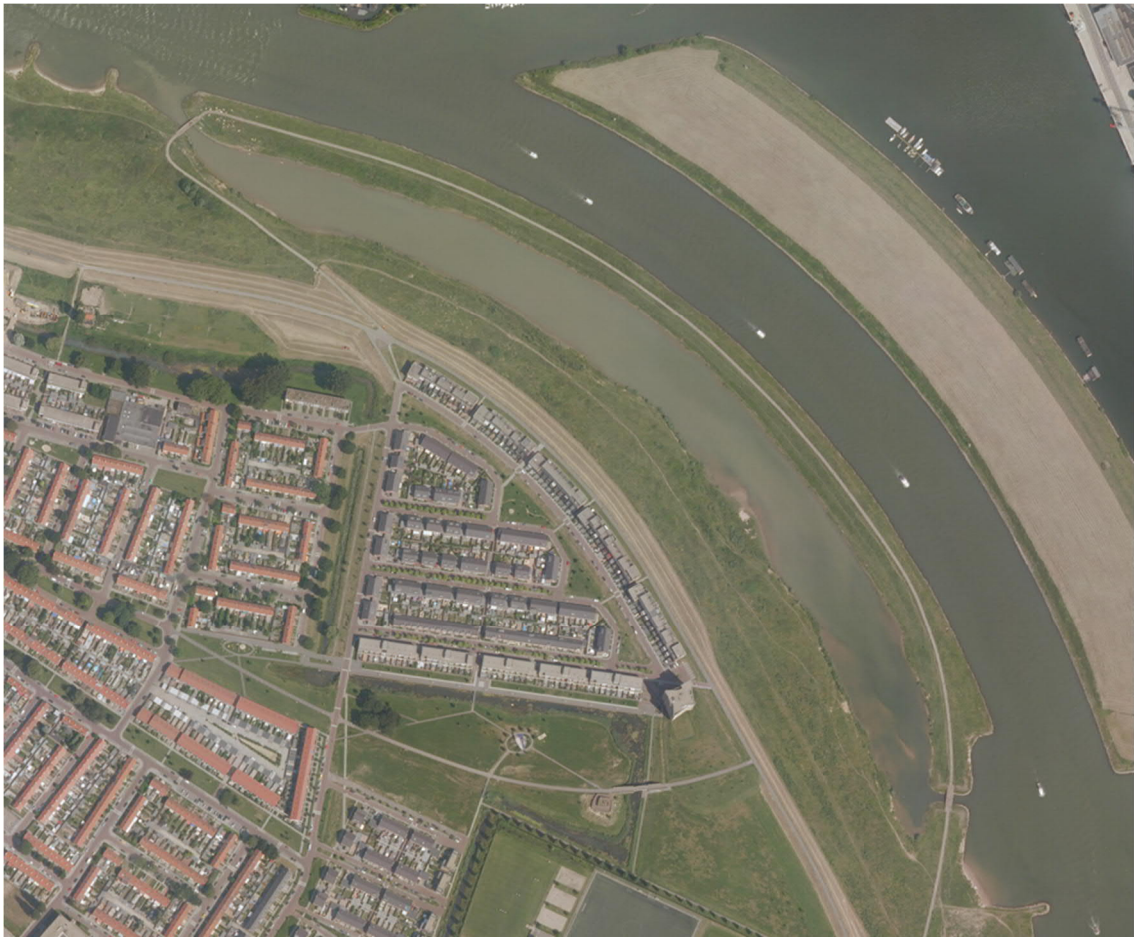
The aerial photos with a water level around the average, in which the sandbanks in the channel are under water, show that the water that flows through the channel picks up sludge and becomes more cloudy than the river water (see Figure 3.49). A sediment plume is then visible at the outflow. It is not known what happens during higher discharge levels because there are no photos available.

Figure 3.49 At approximately average water levels and associated water inflow, the water picks up sludge on the way; it enters the channel light on sludge and leaves it murkier. A small plume is visible downstream.

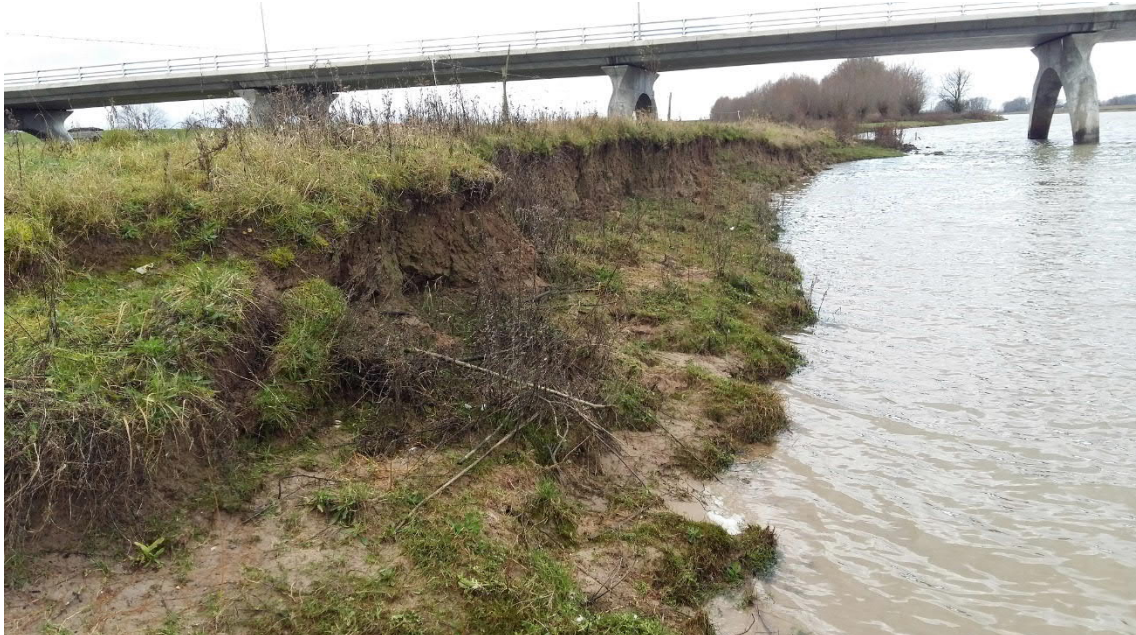
Figure 3.53 Lexkesveer: erosion on the south bank.

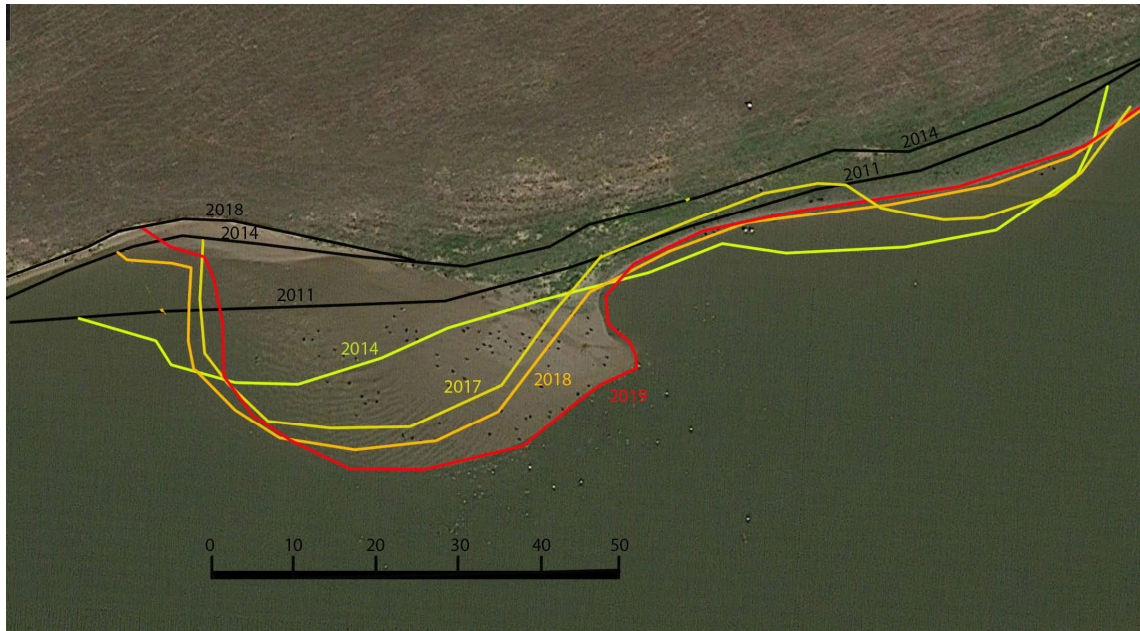
Locally, the erosion has resulted in bank deterioration; this occurs mainly along the south bank and on the west-exposed banks. To the east in the narrower parts of the secondary channel, there is also some local sedimentation and growth of the bank (green on map in Figure 3.54). The analysis of the entire photo series shows that most erosion already occurred in the early years, namely between 2011 and 2014. After that, the erosion speed has decreased and in the later photos the bank is stable. See also the bank line in Figure 3.55. The photo in Figure 3.51 also shows that the bank around the waterline has become vegetated. The erosion reduction may have been caused by the vegetation stabilizing the bank after it started growing. Another explanation is the change in the bank profile. It changed from a fairly steep slope over the entire profile, to a steep edge with a gently sloping beach in front of it. This means that the waves break on the gently sloping section and can no longer reach the deteriorating banks.

Figure 3.55 Contours of the development of a sandbank in front of the north bank. The bank retreated (black lines) between 2011 and 2014. From 2014 on, sandbanks are created in front of the bank, with the right sandbank disappearing again and being incorporated into the bank and the left sandbank growing further into the water.

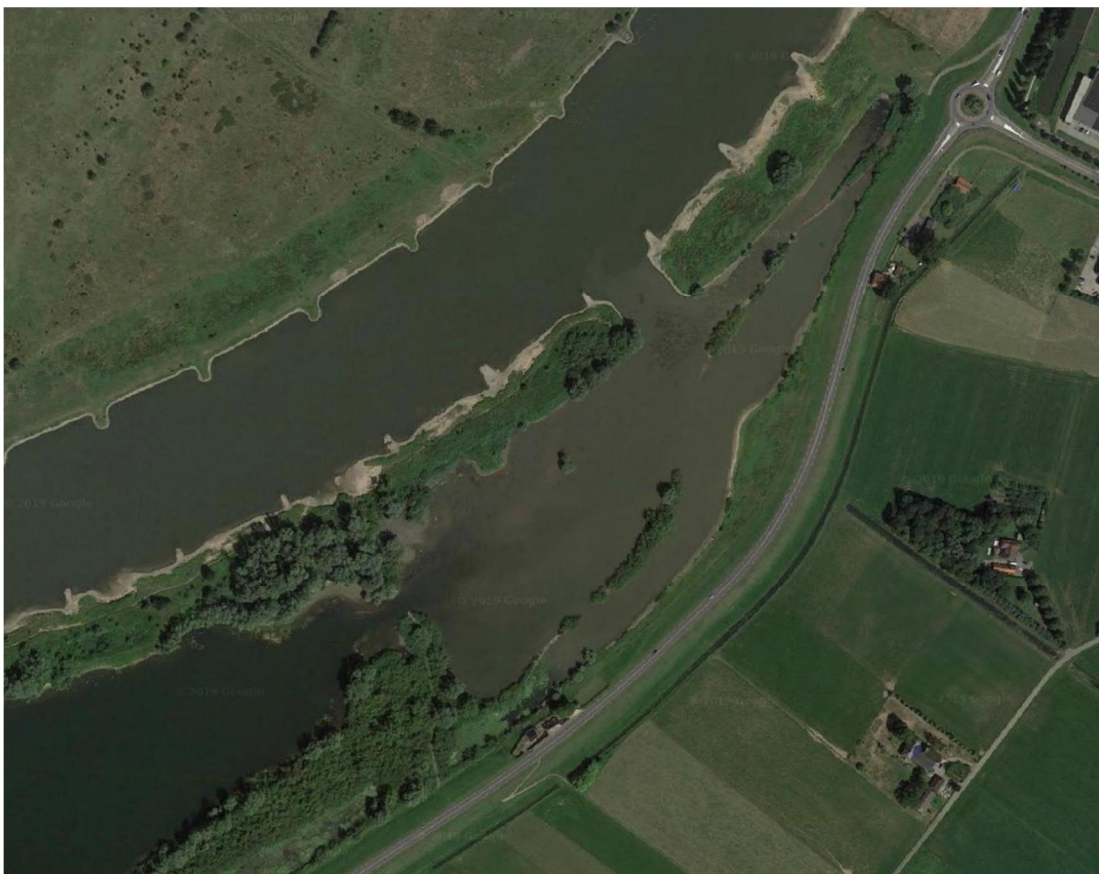
Figure 3.77 The northern lake is shallow and silt quickly swirls here. Part of this silt is then carried by outflowing water to the IJssel where a small plume is visible.
