**D.T1.3.3 – Estimation of heating losses from
thermal data / PA2**

A.T1.3 Estimation of PV potential and heating losses

In the following section the activities related to PA2 in Judenburg, Austria (JUD) are reported.

Acquisition date	28.2.2018
Time and ext. temperature	7:00 Outside temp. -20 °C Room temp. ca. 22°C
Type of building	Primary and Secondary School
Owner	Municipality of Judenburg
Materials of the facades	Concrete and bricks

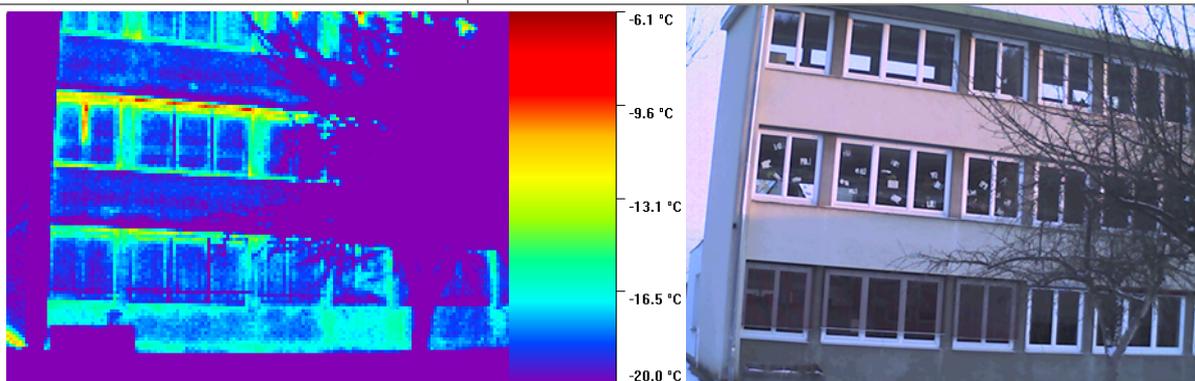
1. South side NMS:

New windows were installed in the last years. You can see a lot heat-bridges above the windows, and in the ground floor below the windows.

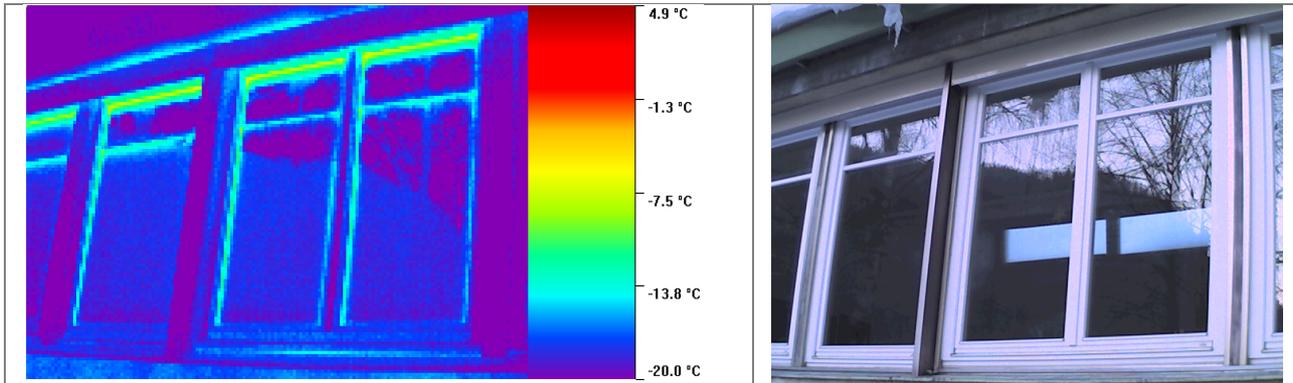
2. Window details:

The windows are basically in good condition, here you can clearly see the reflection over the stainless steel spacer.

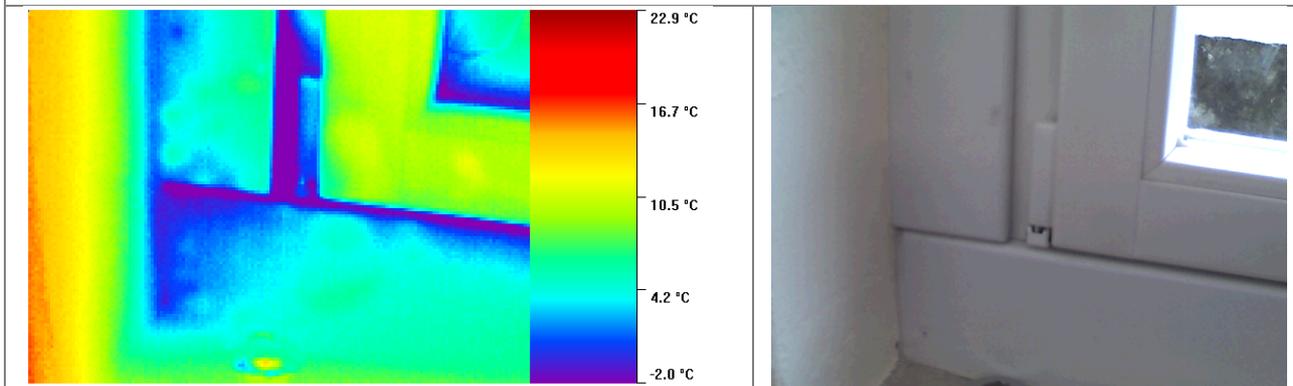
3. Window detail inside – wardrobe

The window connections in the elementary school were covered with frames on the inside. There are clear leaks here, in some cases the temperature drops to -2°. By removing the frames and applying special window sealing tapes, a significant improvement could be achieved.

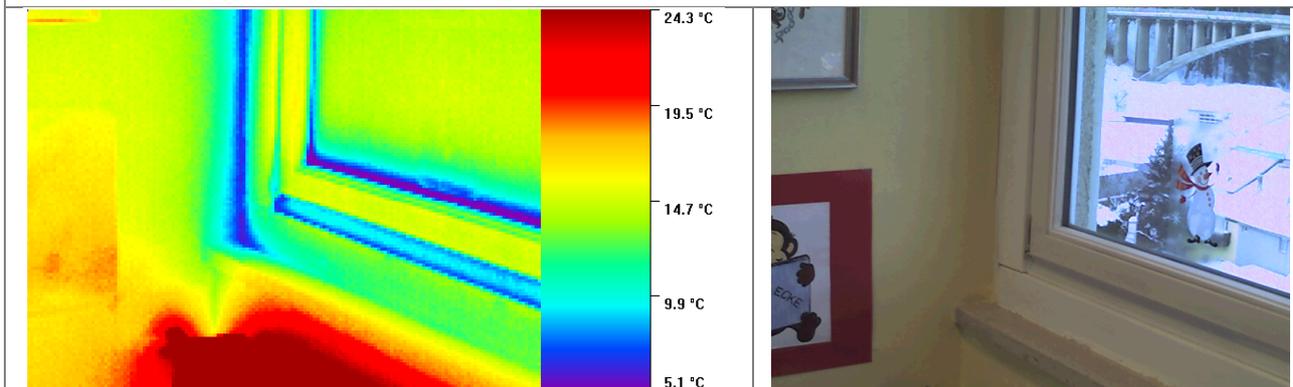
4. Window detail – class room NW

Here, too, the clear leakage in the area of the window connection can be seen. In spite of the radiator mounted under the window, a very large drop in temperature is visible.

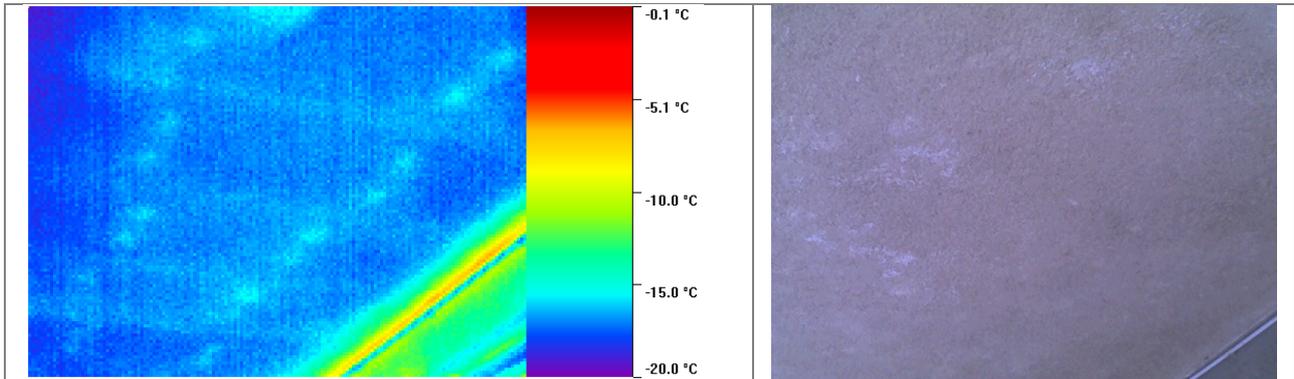
5. Underside cantilever NW, VS

Here you can see the underside of the cantilevered ceiling, this is insulated with EPS insulation boards. The boards and the fixing dowels are clearly visible. A narrow thermal bridge is visible when connected to the brickwork.

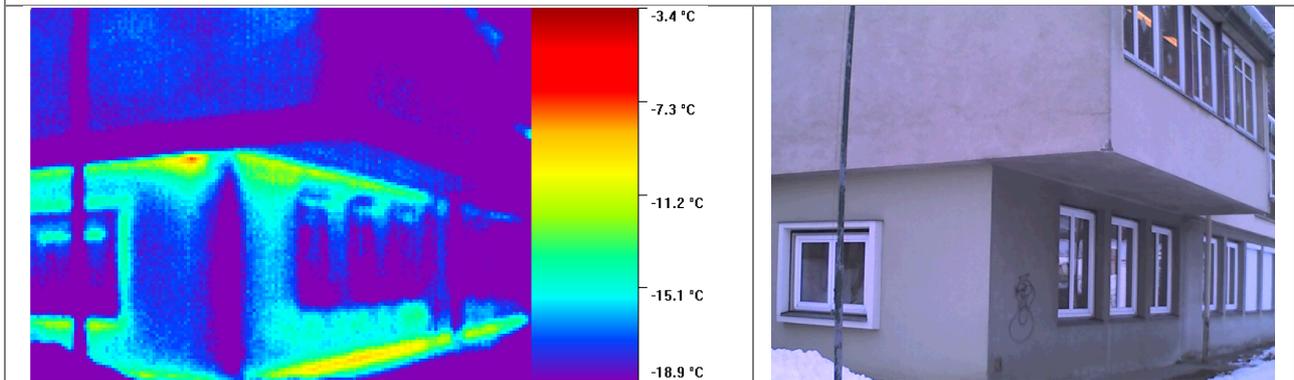
6. View NW, VS

Here you can see the area of the cantilevered ground floor. At the connection joints of the ceiling to the brickwork, slight thermal bridges can be seen, also at the base area a thermal bridge is visible.

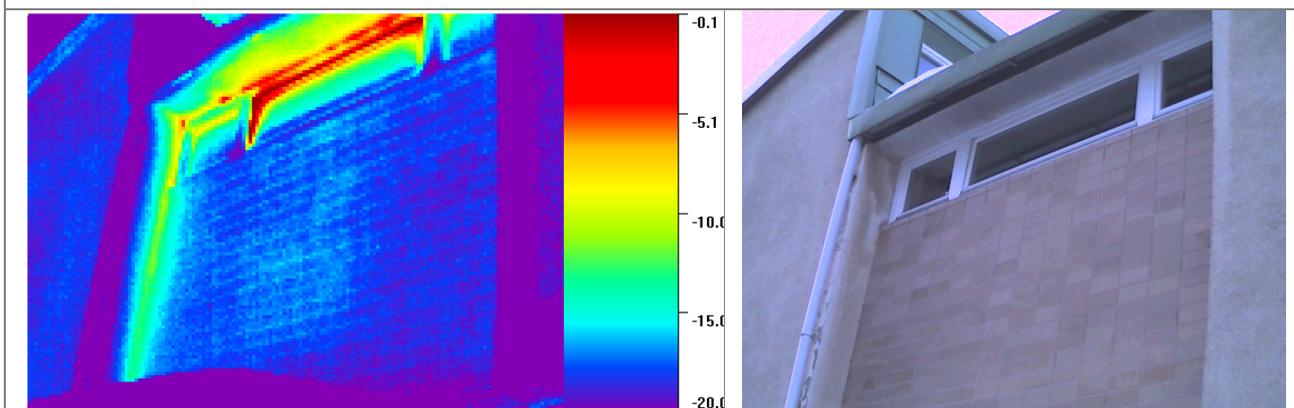
7. Window north, WC OG VS

Here you can see the outer wall of the WC on the upper floor behind it. The facade is covered with tiles, the joints are clearly visible. The middle window is obviously not completely closed, so that a large heat flow is visible here. The closing mechanism and the seals of the window should be checked.

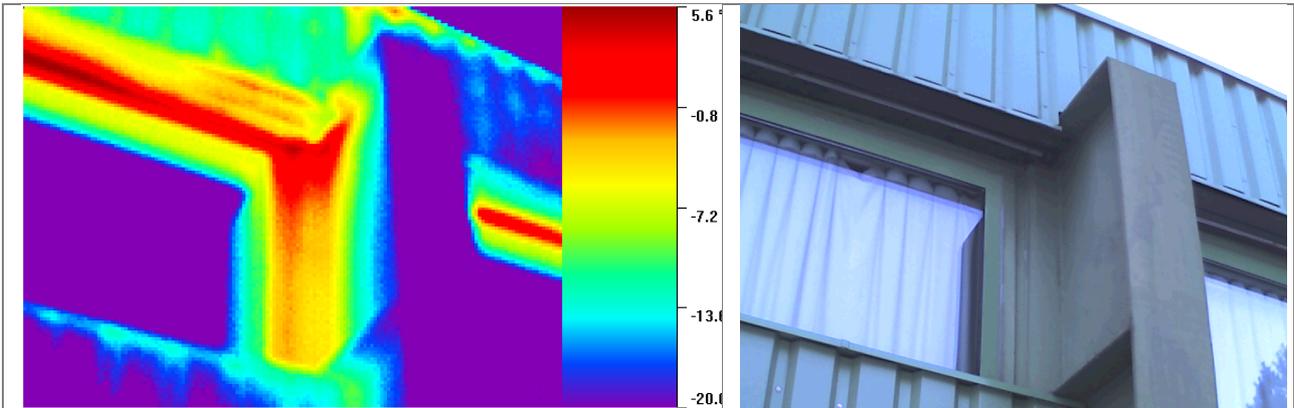
8. Window connection steel girder, Lindfeld gym-hall

The supporting structure of the gymnasium consists of solid steel girders, which are not insulated on the outside. One can clearly see the thermal bridges at the window connection to the girder and the roof construction. The girder should be insulated in the course of a facade renovation.

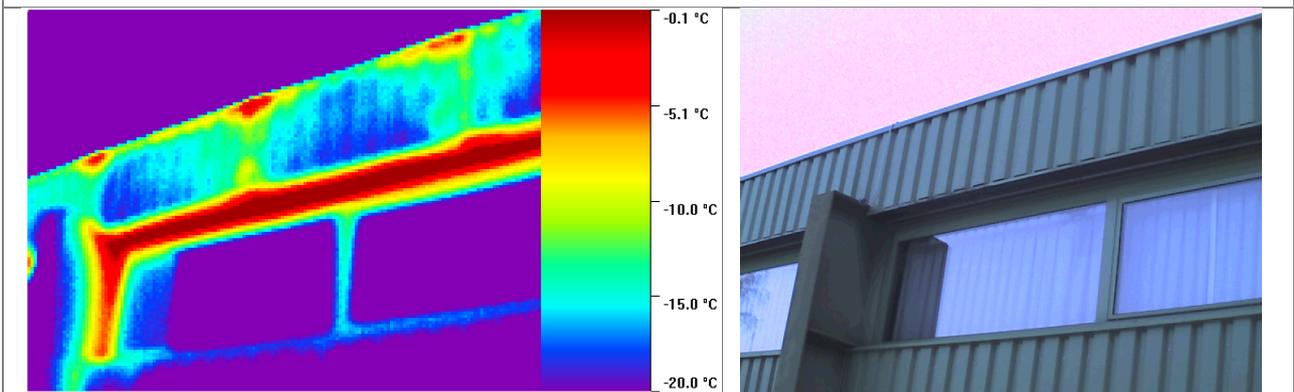
9. Window West, gym-hall Lindfeld

Here you can see the facade of the gym again. The thermal bridge to the steel beam is clearly visible. Also under the upper facade cladding an enormous heat accumulation can be seen.

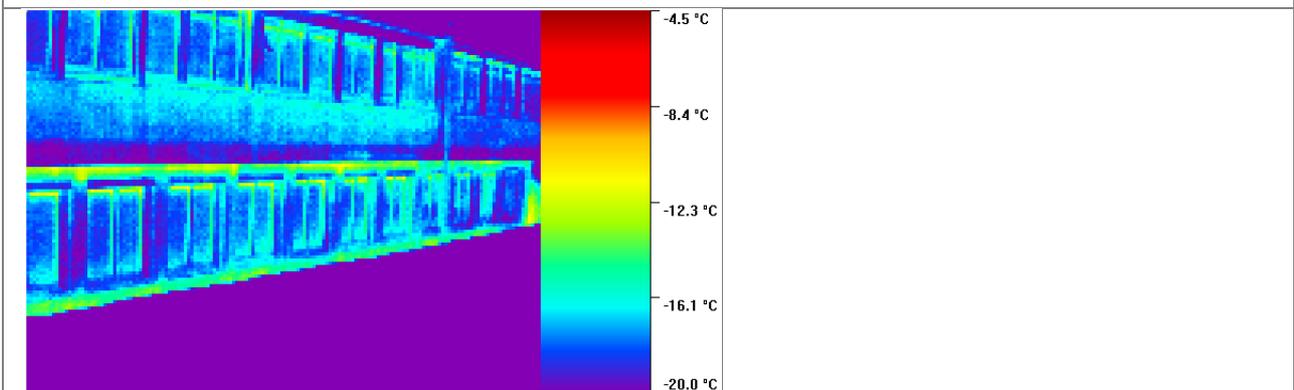
10. View East, VS

Here you can see the eastern facade of the elementary school. There are slightly increased surface temperatures above the window front on the ground floor.

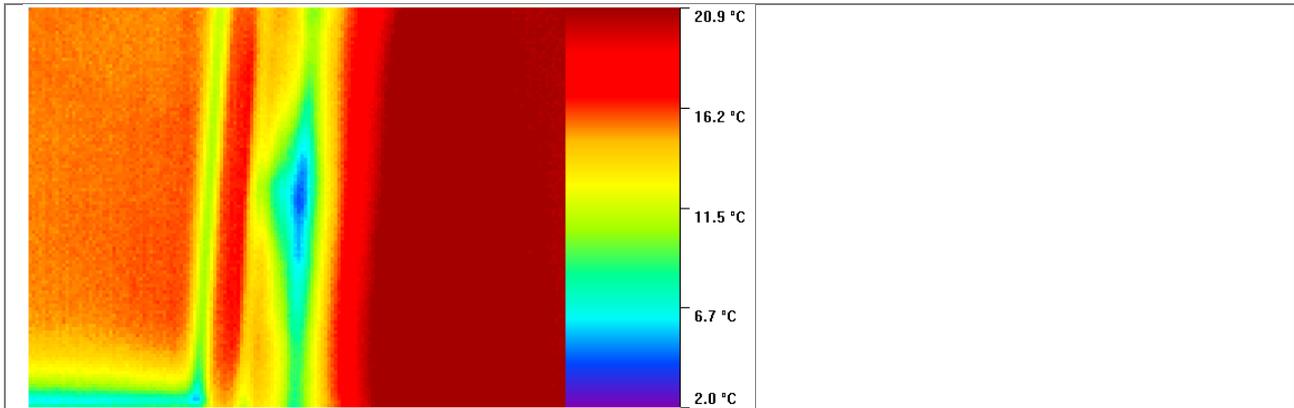
11. Window connection inside, classrooms EG SO, NMS

The picture shows the lateral window connection to the inner wall in a classroom on the ground floor of the NMS. You can clearly see a leak in the area of the connection joint

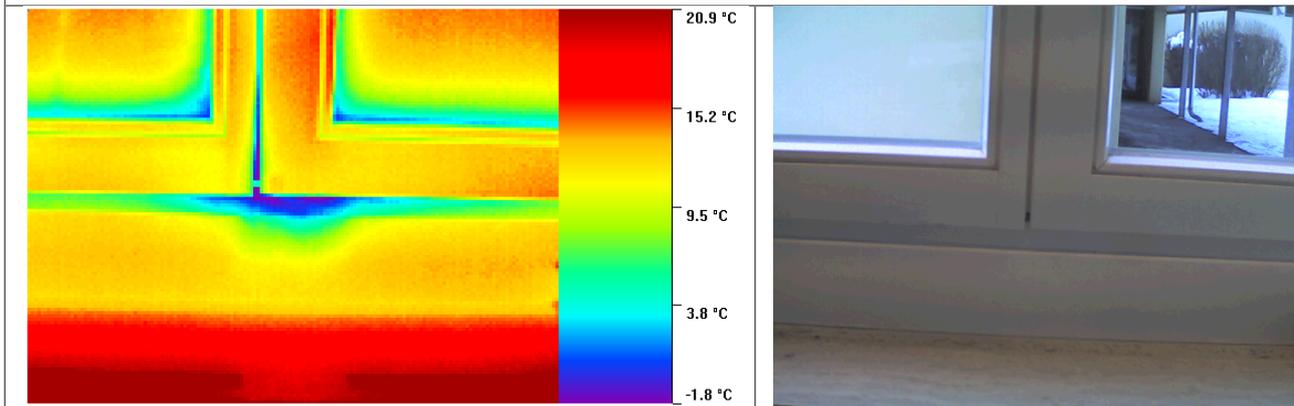
12. Window detail, classroom EG SO, NMS

This picture shows the lower middle part of a double sash window in the same classroom. Here, too, you can see clear leaks in the sealing plane. There is a radiator under the window sill. The window seal and the closing mechanism should be checked.
