**D.T1.3.3 – Estimation of heating losses from
thermal data / PA3**

A.T1.3 Estimation of PV potential and heating losses

Issued by: Partner Nr. 03 - EAZK
 Date: March 2020

Grammar school Valaske Klobouky

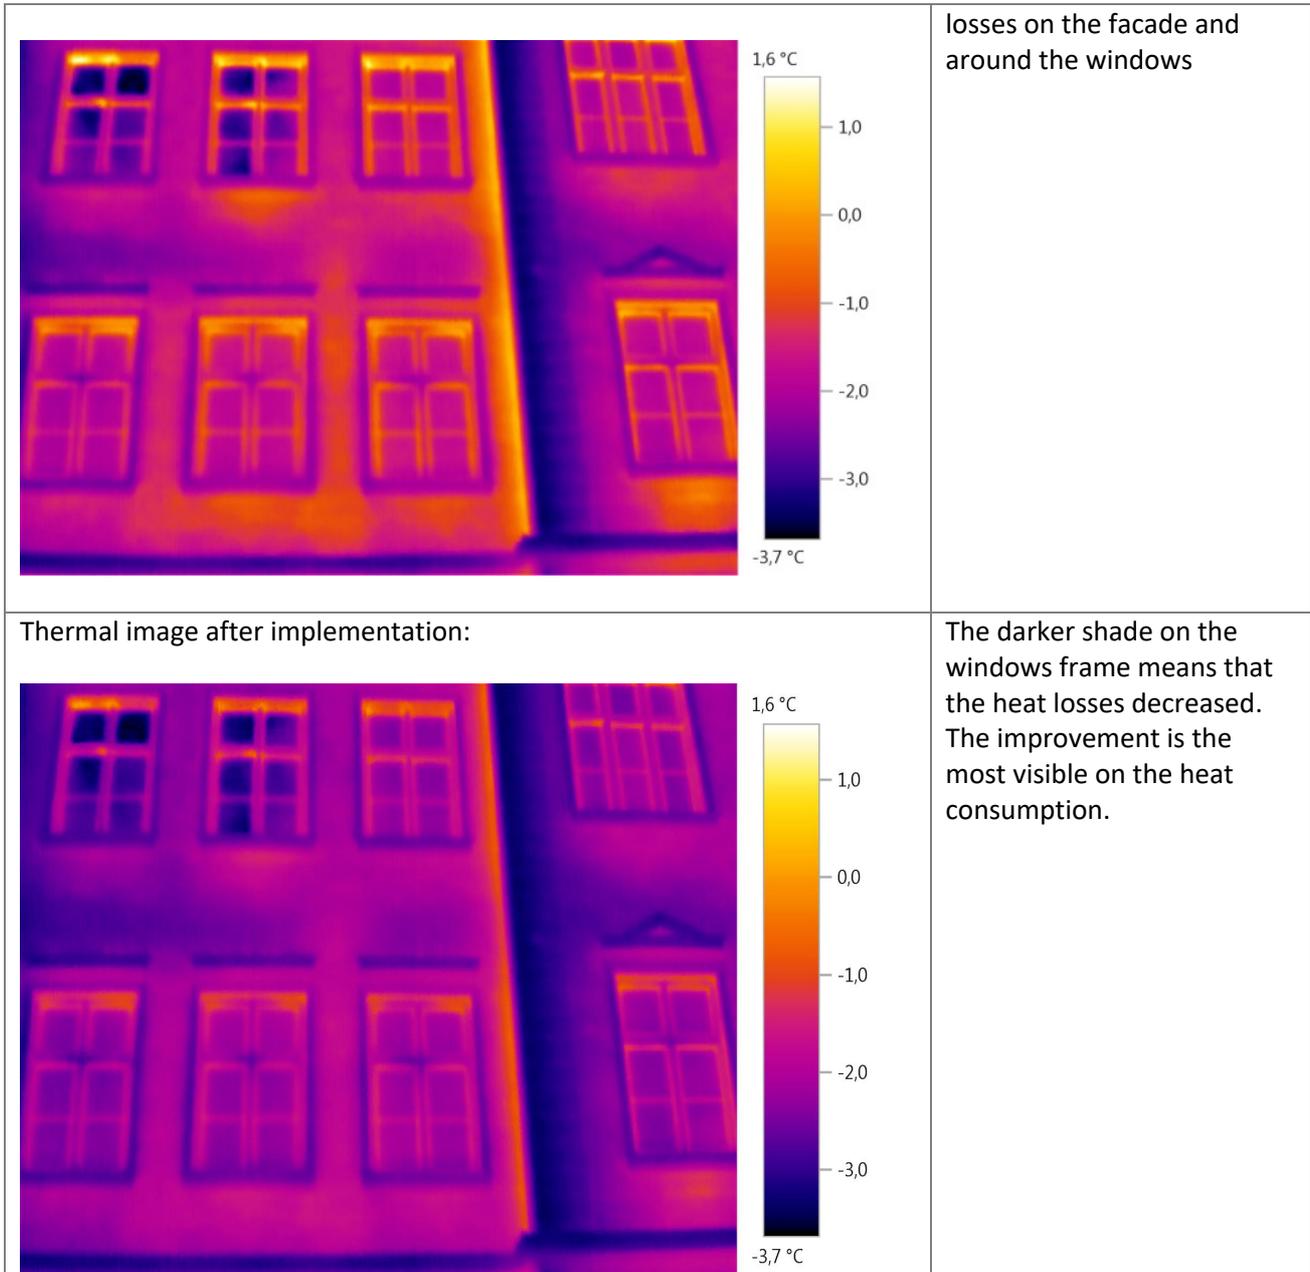
You can see the a lot heating

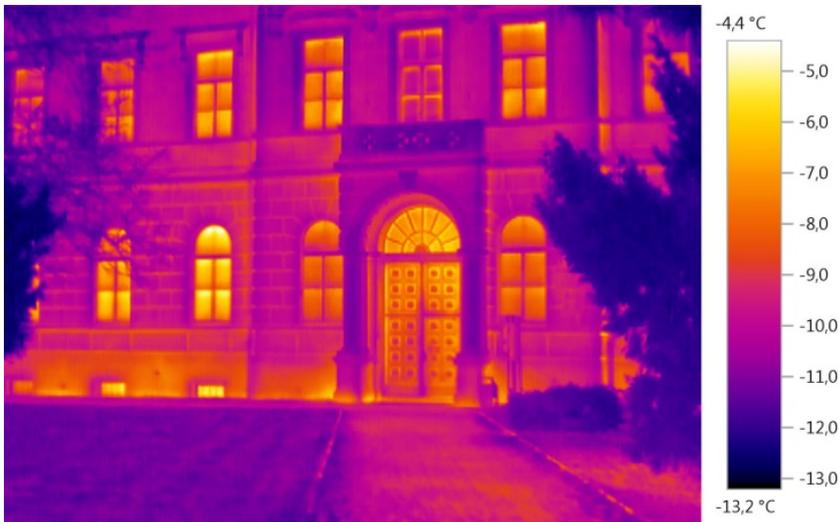
Thermal image before implementation:

Due to the historic preservation of the building are the heat losses significant.

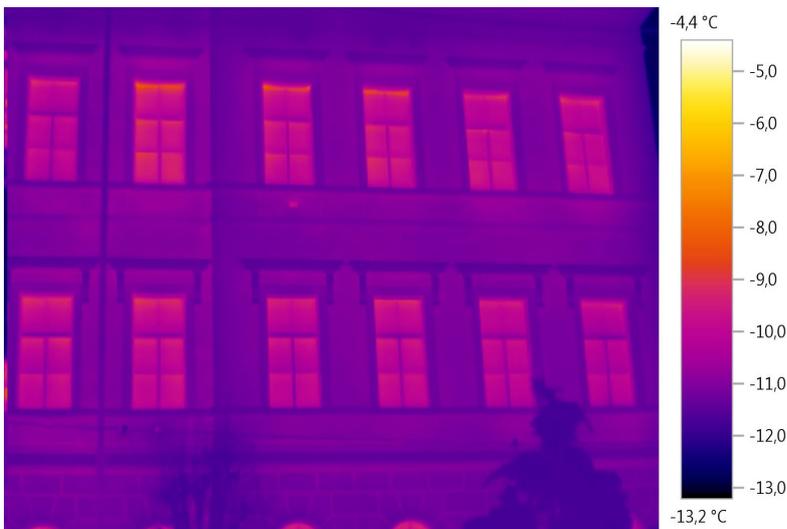
Thermal image after implementation:

The only possible improvement was the windows change. You can see on the image that the heat losses through the windows decreased

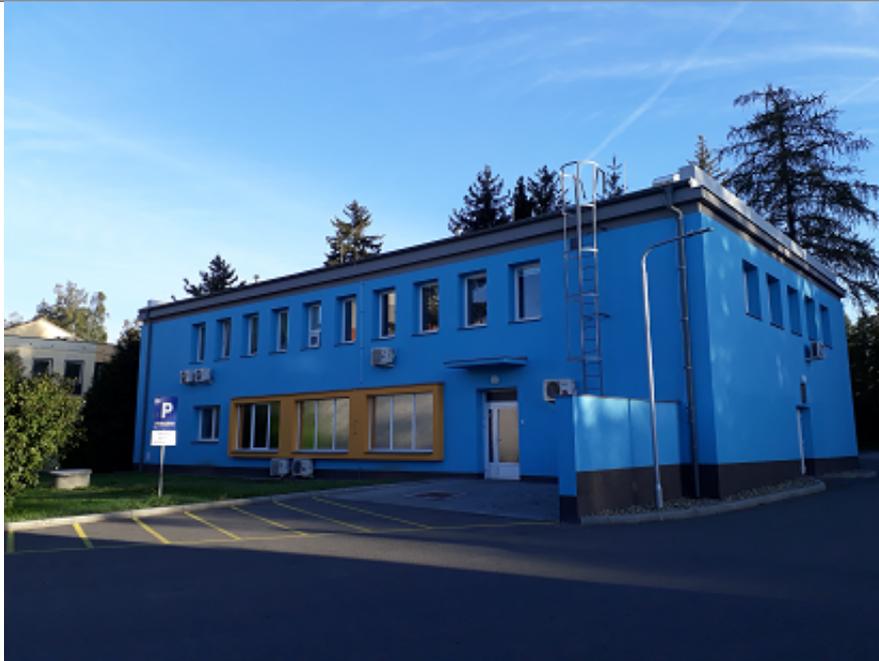
<p>Thermal image before implementation:</p>	<p>Heat losses around the windows due to heat bridges.</p>
<p>Thermal image after implementation:</p>	<p>Thermal losses were eliminated by the complex heat insulation of the building.</p>

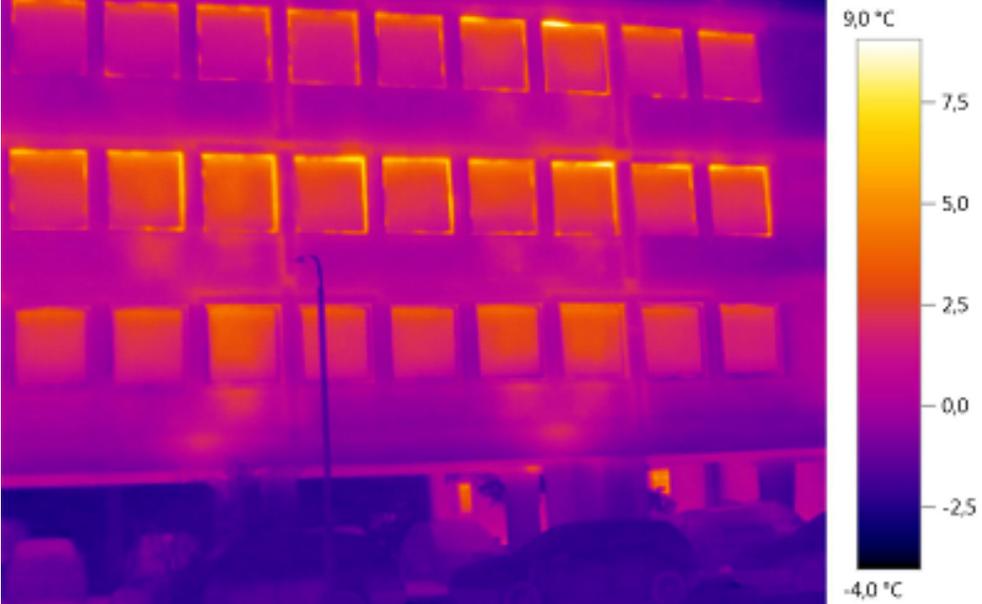
<p>Thermal image before implementation:</p>

<p>Significant heat losses through the facade and windows.</p>
<p>Thermal image after implementation:</p>

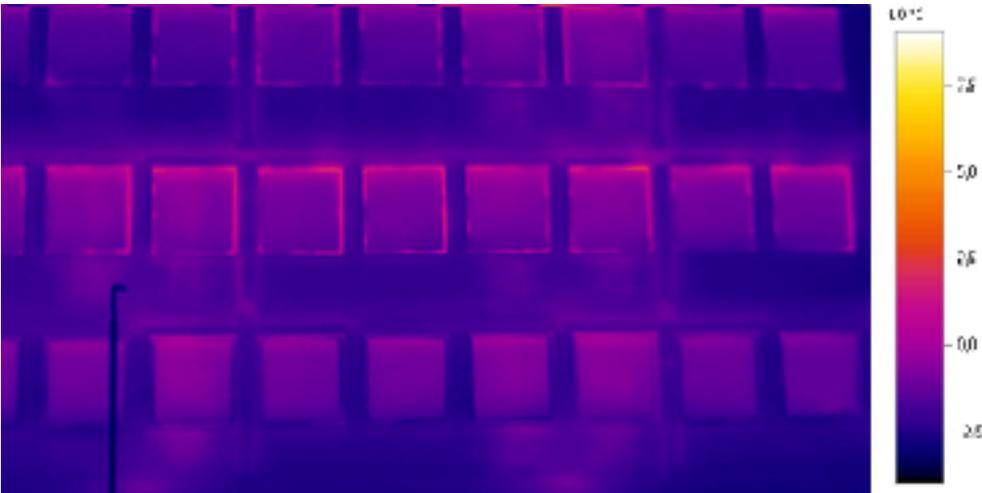
<p>Overall heat insulation of façade and roof and windows change positively improve the heat losses and energy consumption.</p>

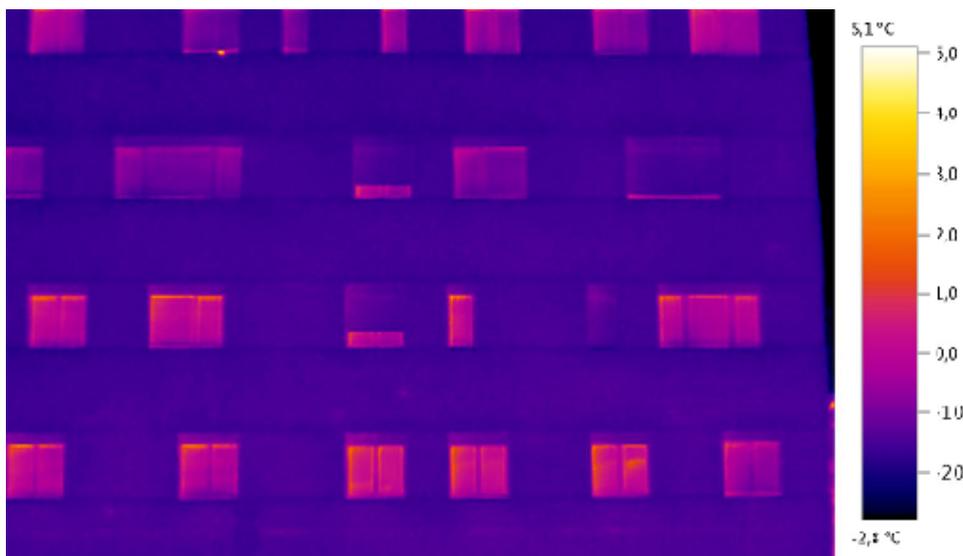
Thermal image after implementation:

Building is completely insulated with no visible heat losses. The windows are warmer because of the artificial light inside. It wasn't possible to switch off all lights in the hospital.

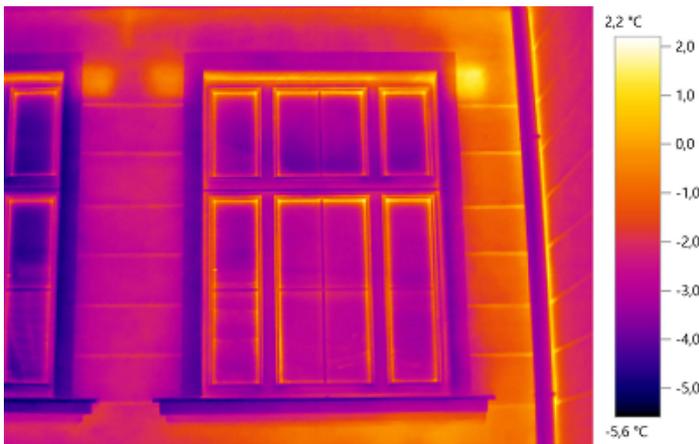
Thermal image before implementation:

Focus is mostly on the windows because the change is most visible on them.

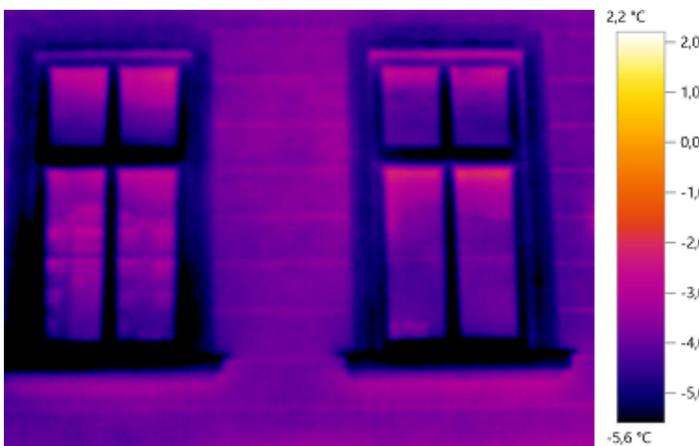
Thermal image after implementation:

You can see that the temperature of the windows are almost the temperature of the outside air which means that windows are not causing any heat losses.

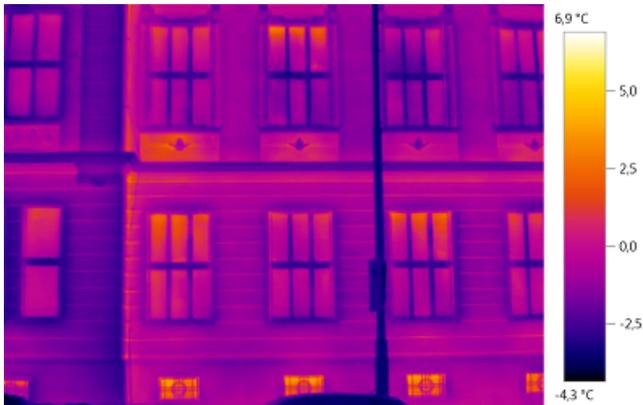
Thermal image before implementation:

A lot of energy is wasted due to the historic facade and almost original windows.

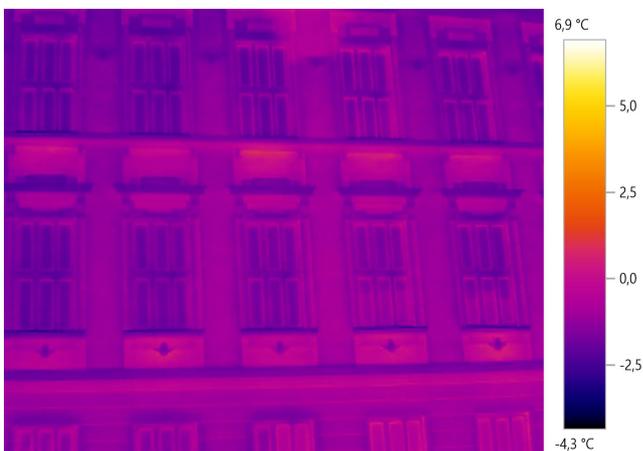
Thermal image after implementation:

Heat losses through the windows were mostly eliminated.

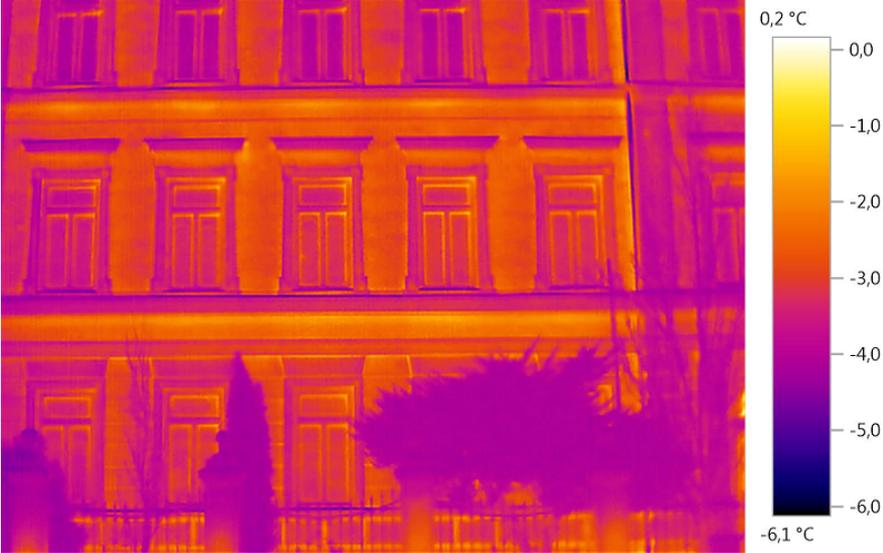
<p>After the implementation of energy management and EAZK suggest to lower the night temperature.</p>
<p>Thermal image after implementation:</p>

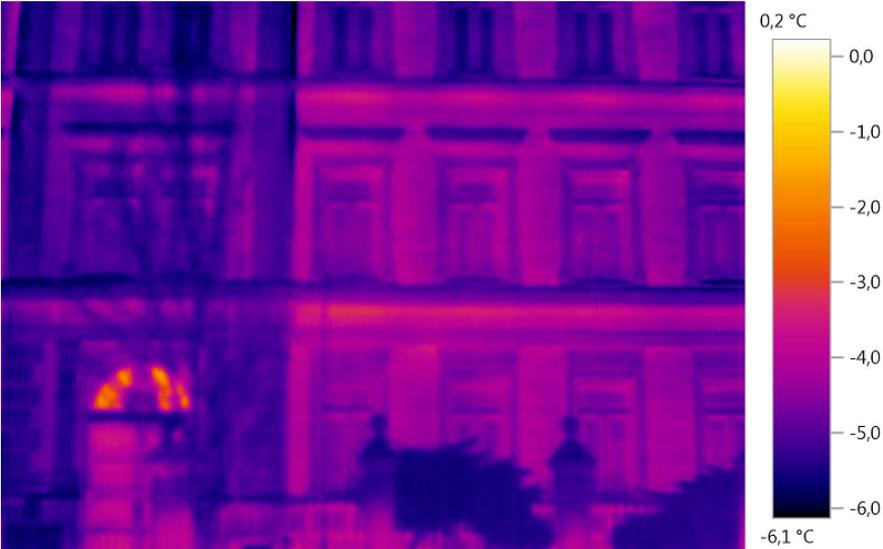
<p>After the lowering the night temperature and change of the windows the heat losses decreased and the frames of the windows are much colder.</p>
