**D.T1.3.3 – Estimation of heating losses from
thermal data / PA6**

A.T1.3 Estimation of PV potential and heating losses

Building #1 – Primary school Braca Radic – 2018/19

Building #2 – Kindergarten Loptica – 2018/19

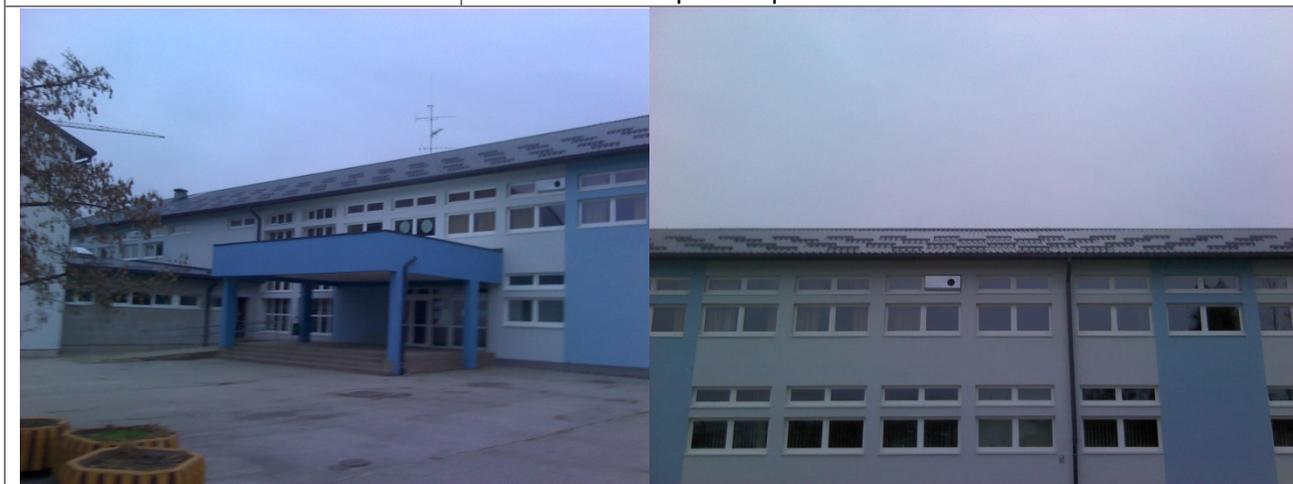
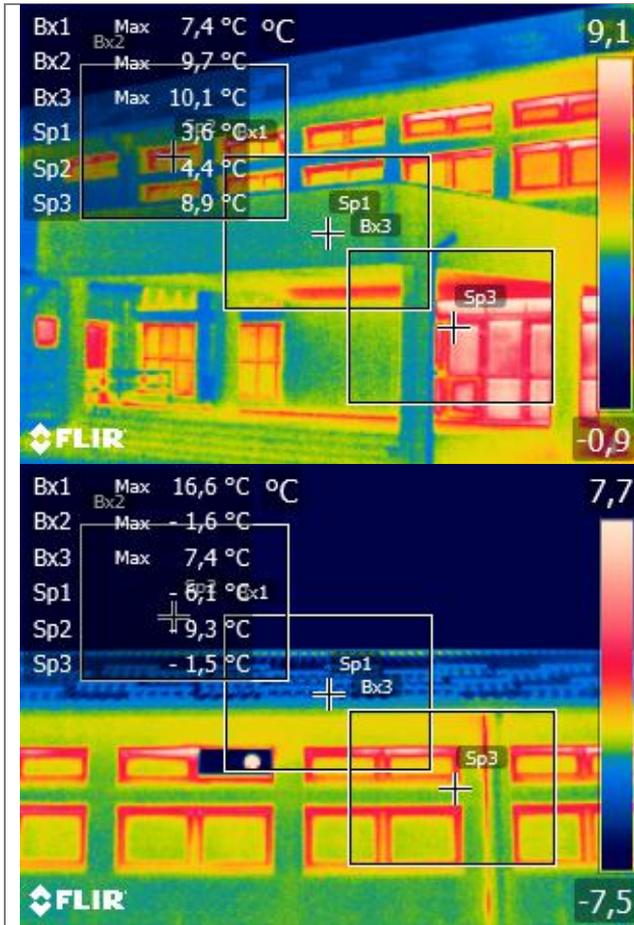
In the first thermographic image we can see uninsulated canopy which creates a thermal bridge. In the second image windows are mostly well installed, except in the upper part of the frame where, due to the very likely poor fitting of the windows, there are thermal losses in the upper parts of the windows.

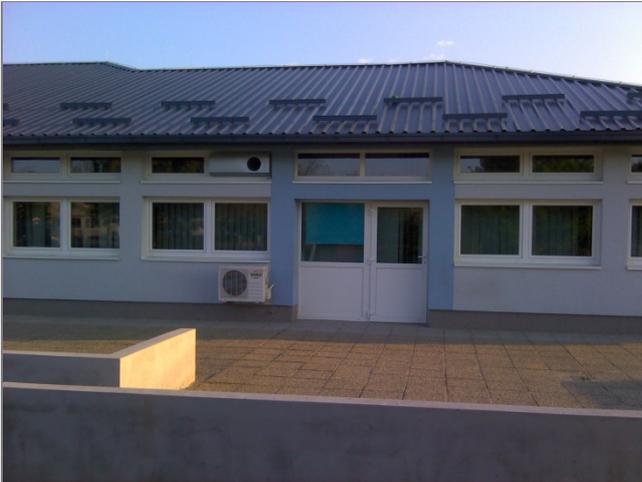
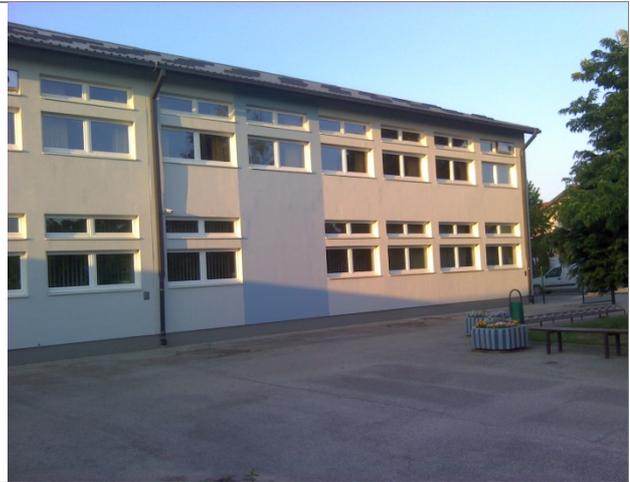
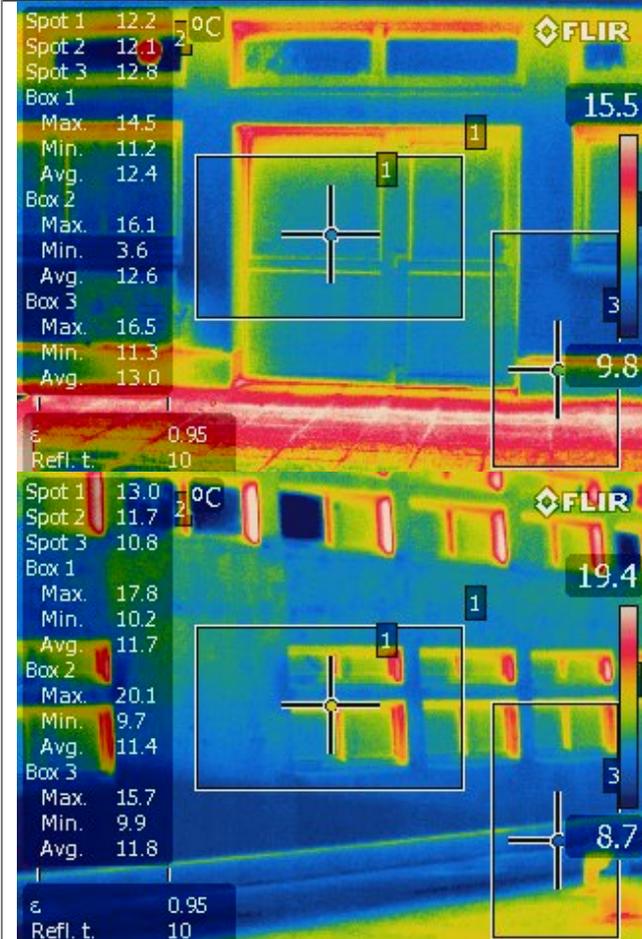
In the first and second image windows are mostly well installed, except in the upper part of the frame where, due to the very likely poor fitting of the windows, there are thermal losses in the upper parts of the windows. Also, in the first image we can see heat losses along the entire length of the plinth (socle). Facade surface is uniform, there are no point thermal bridges.

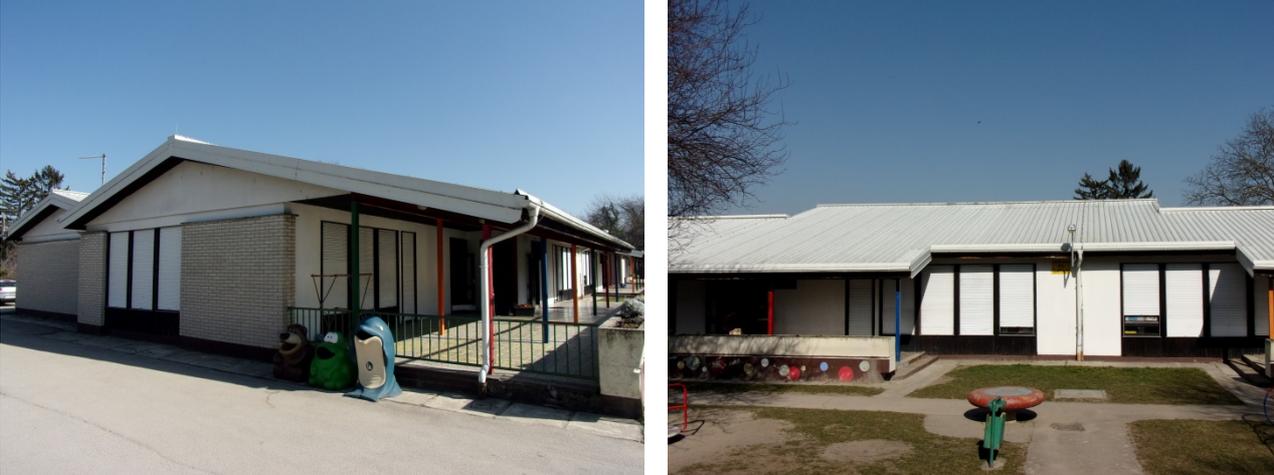
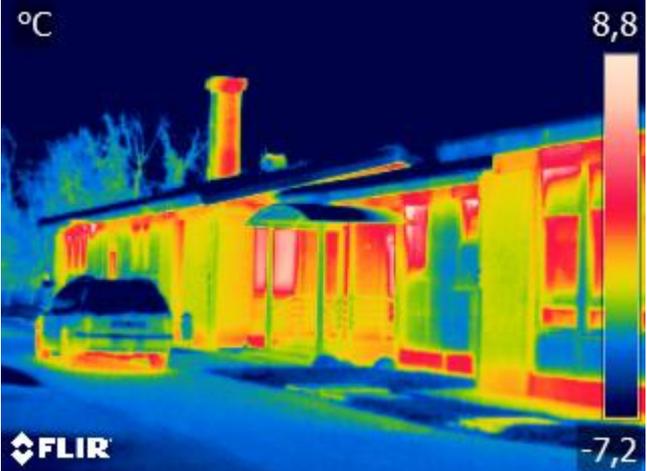
On both images you can see heat losses through windows and through outer walls due to poor quality windows and uninsulated facade.

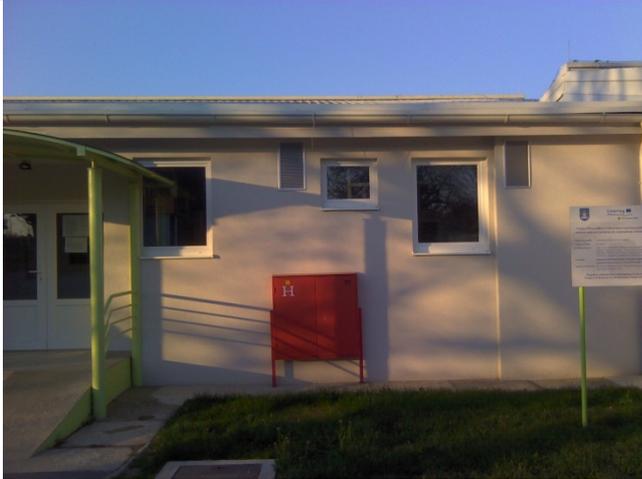
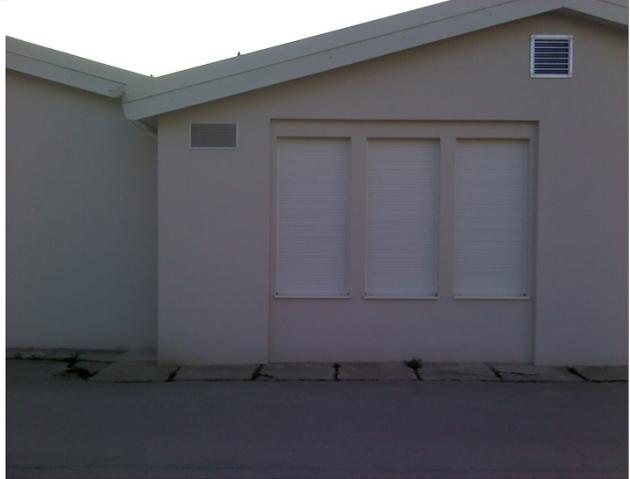
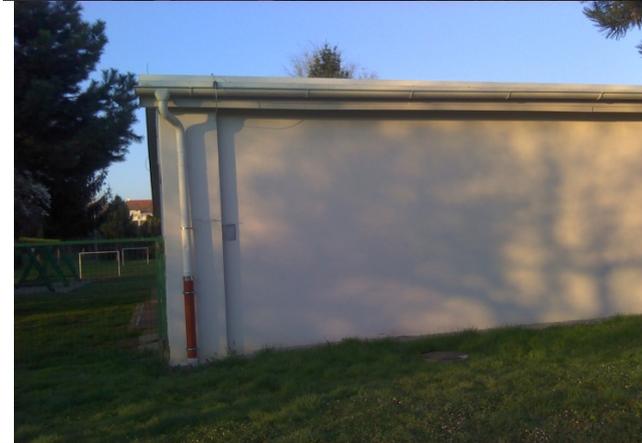
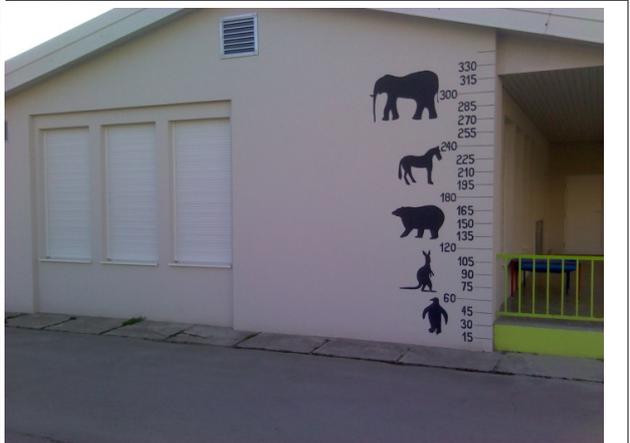
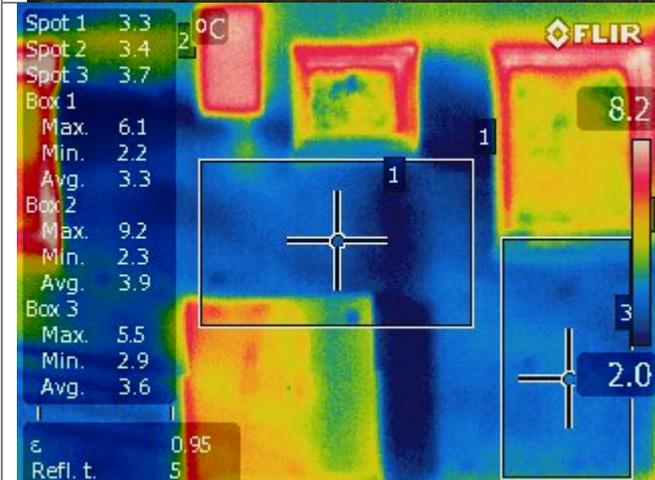
Thermal bridges in energy-renovated building could not be completely avoided, but have been reduced to minimum by correct handling of structural details. There are minor thermal bridges present around the windows and also on connection of the outer wall and slab.
