Slieve Donard Path Review Project

Draft for comment  
June 2018

2018 Condition (Amber) Survey

### Slieve Donard

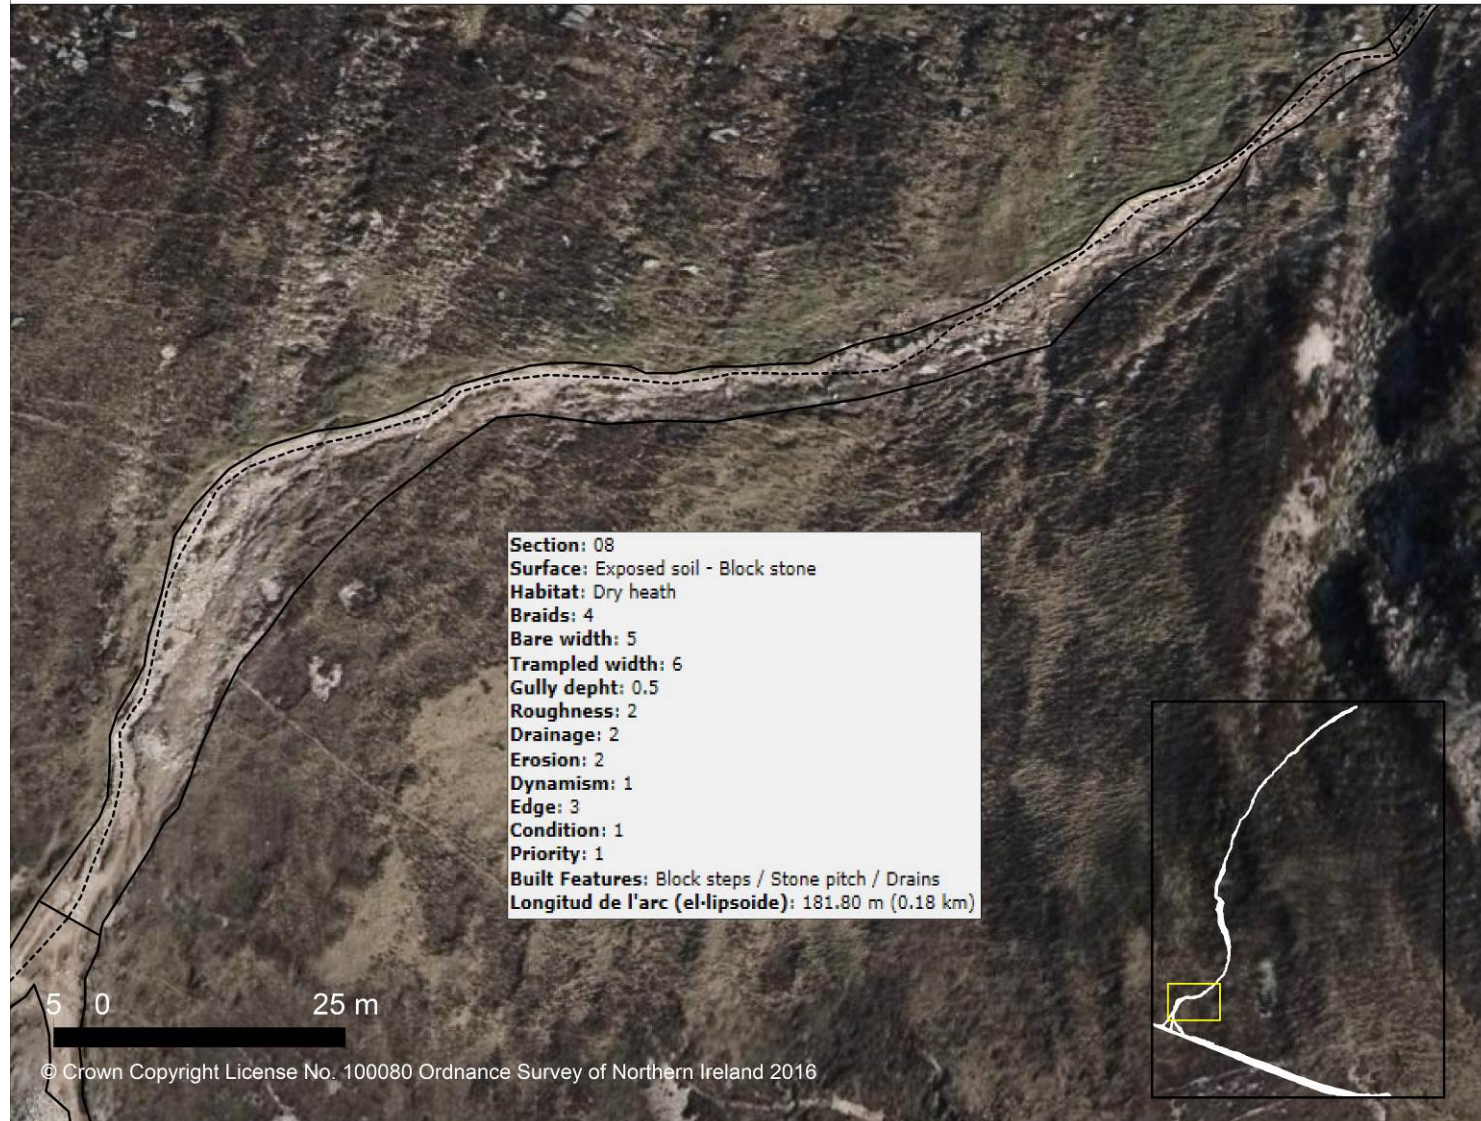
Murlough and Mourne  
Donard Path Review  
Map IV: Sections Detail Map (8/13)

Path surface badly eroded with deep trampling scars. There's a wide deep gully area in the center of this section with exposed soil and loose fine materials, actively eroding. The area is especially affected during winter, when the area, due to the bad drainage conditions, becomes temporarily icy. The scale and the location (close to

the saddle area) of the repairing intervention here, will involve the lift of non site material and machinery. At the end of this section, the stone pitching surface has been hugely deteriorating on recent years, with deep gully scars that are developing along both sides of the main path line.

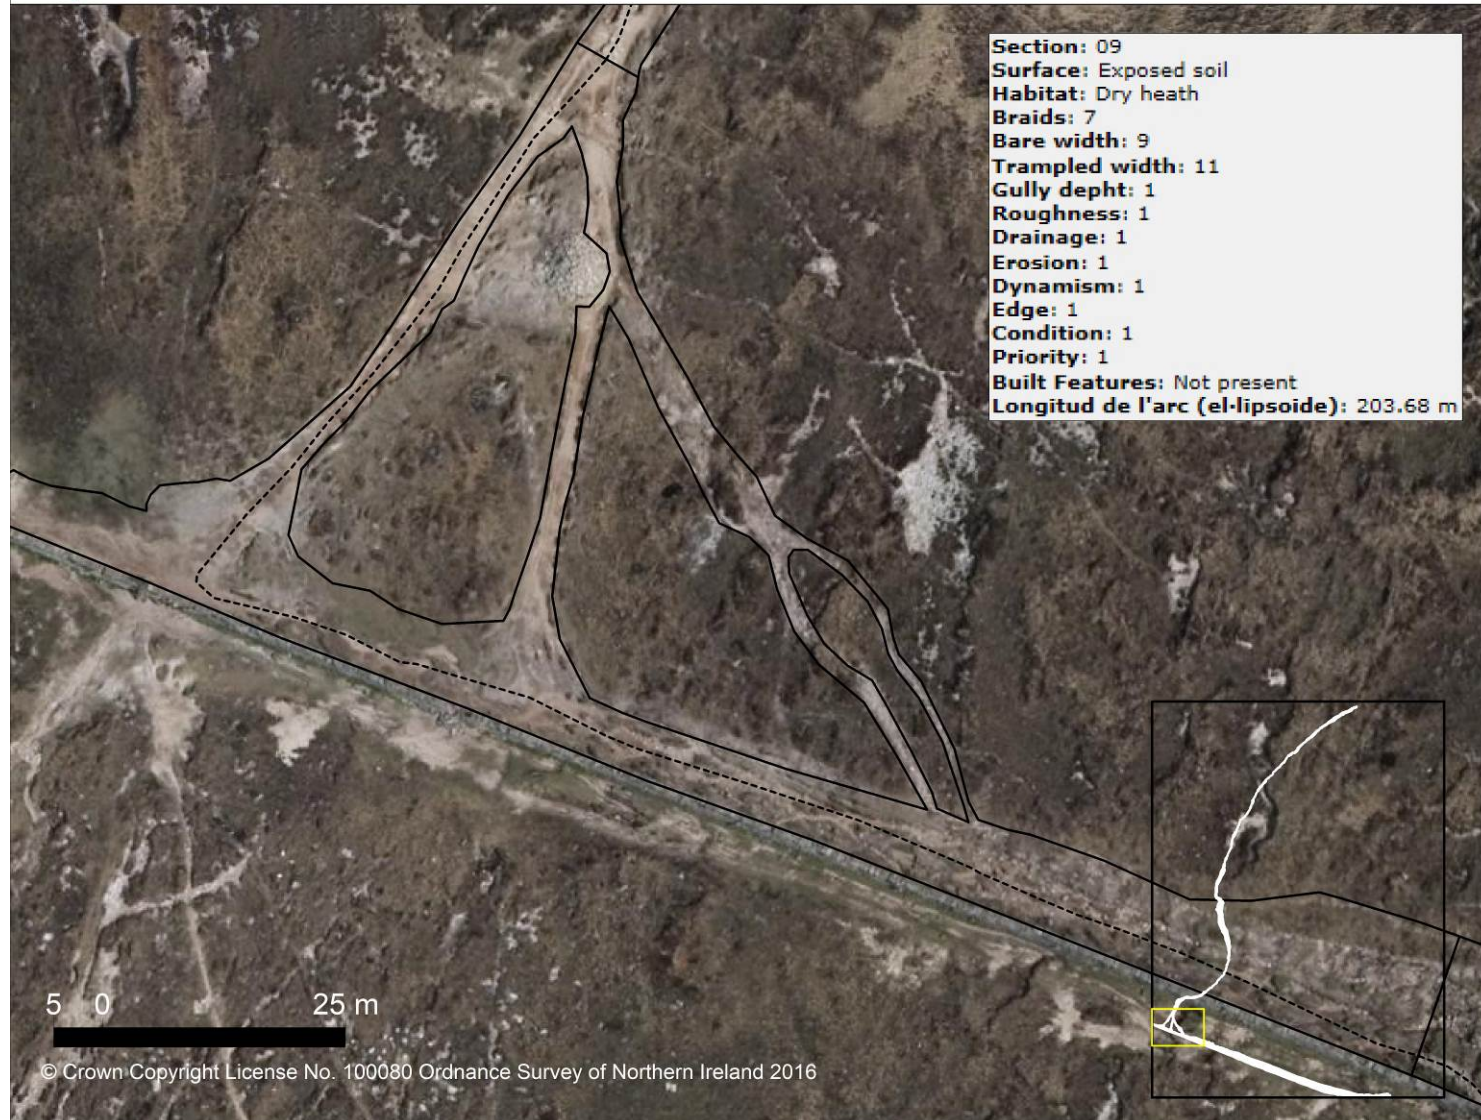
Murlough and Mourne  
Donard Path Review  
Map IV: Sections Detail Map (9/13)

Very disturbed path surface widely and deeply eroded around the saddle cairn. The path line beside the Mourne Wall presents deep trampling scars with vegetation encroachment and loose material, with raised stones giving roughness to the path surface. It is anticipated on that section major machinery intervention works and the lift of big quantity of stone materials for the building of path features.

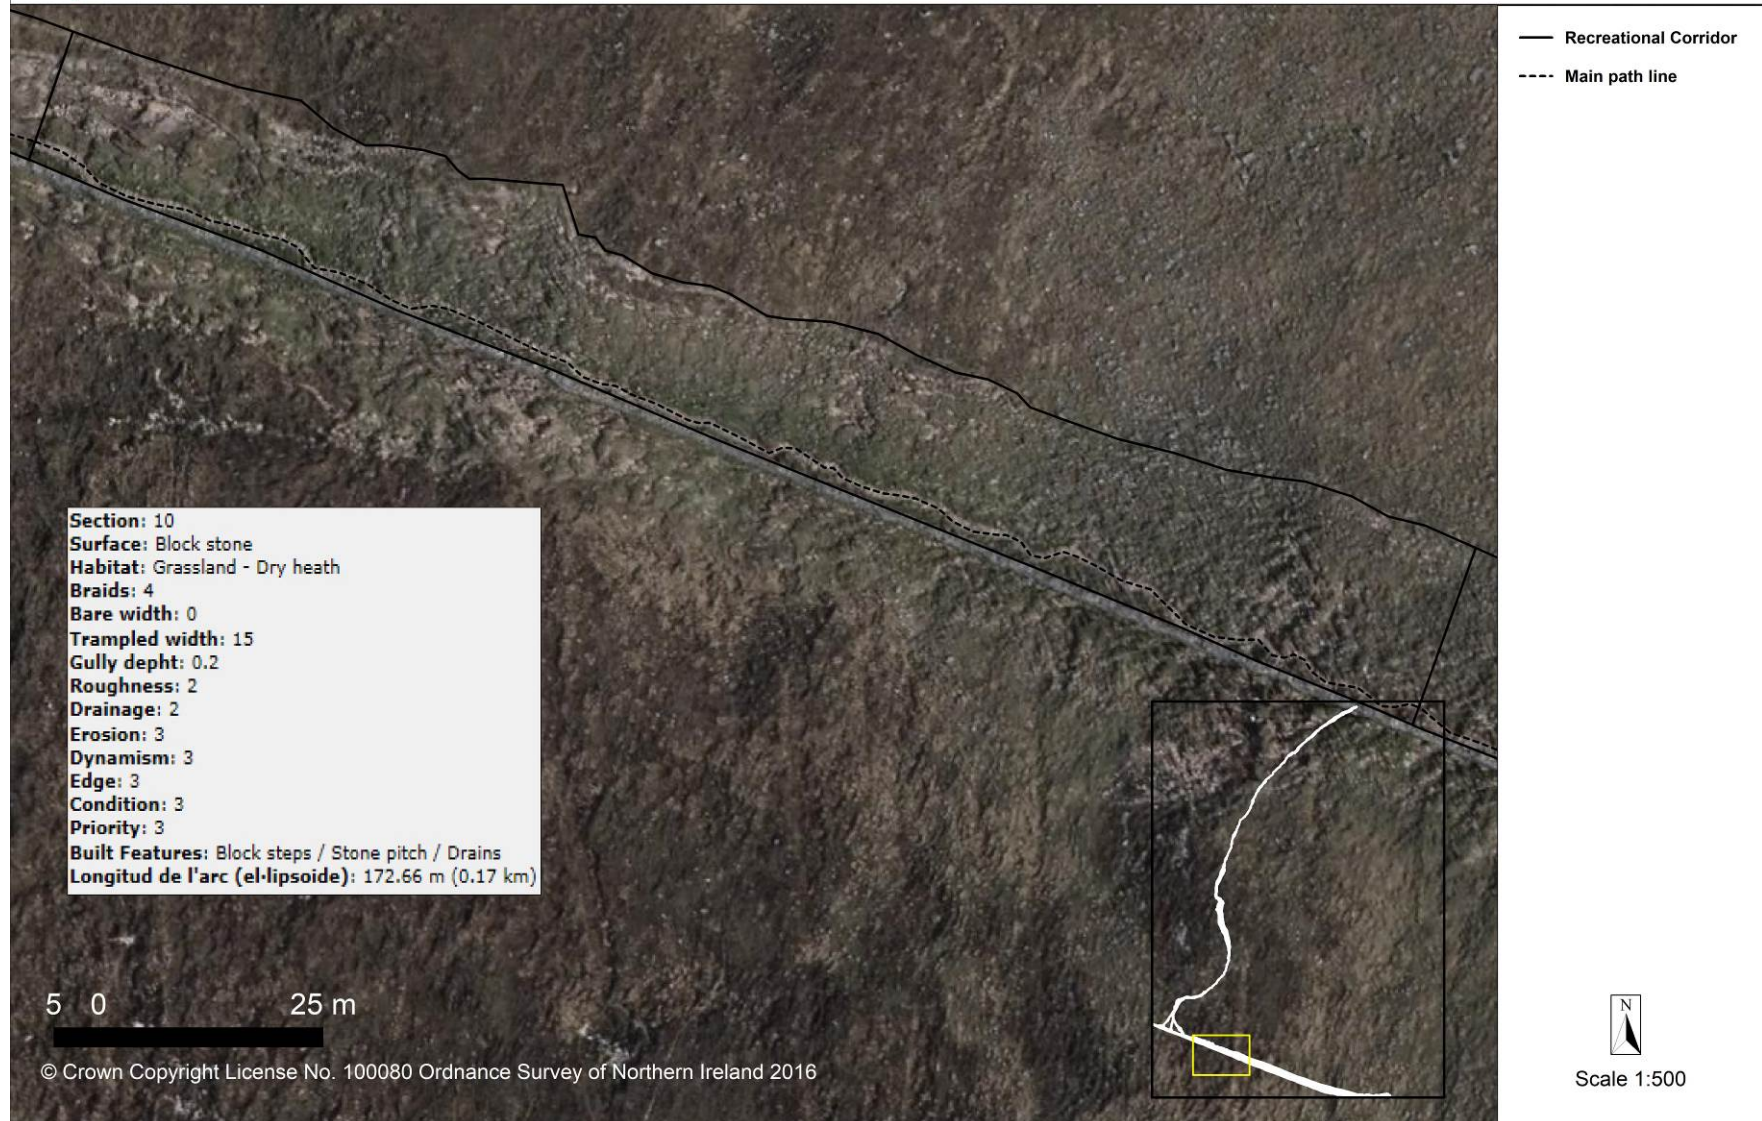
Murlough and Mourne  
Donard Path Review  
Map IV: Sections Detail Map (10/13)

Stone pitching steps path in relatively good condition especially on the first third of the section. Wide braid parallel area along the grassy side of the corridor, producing some deep scars.

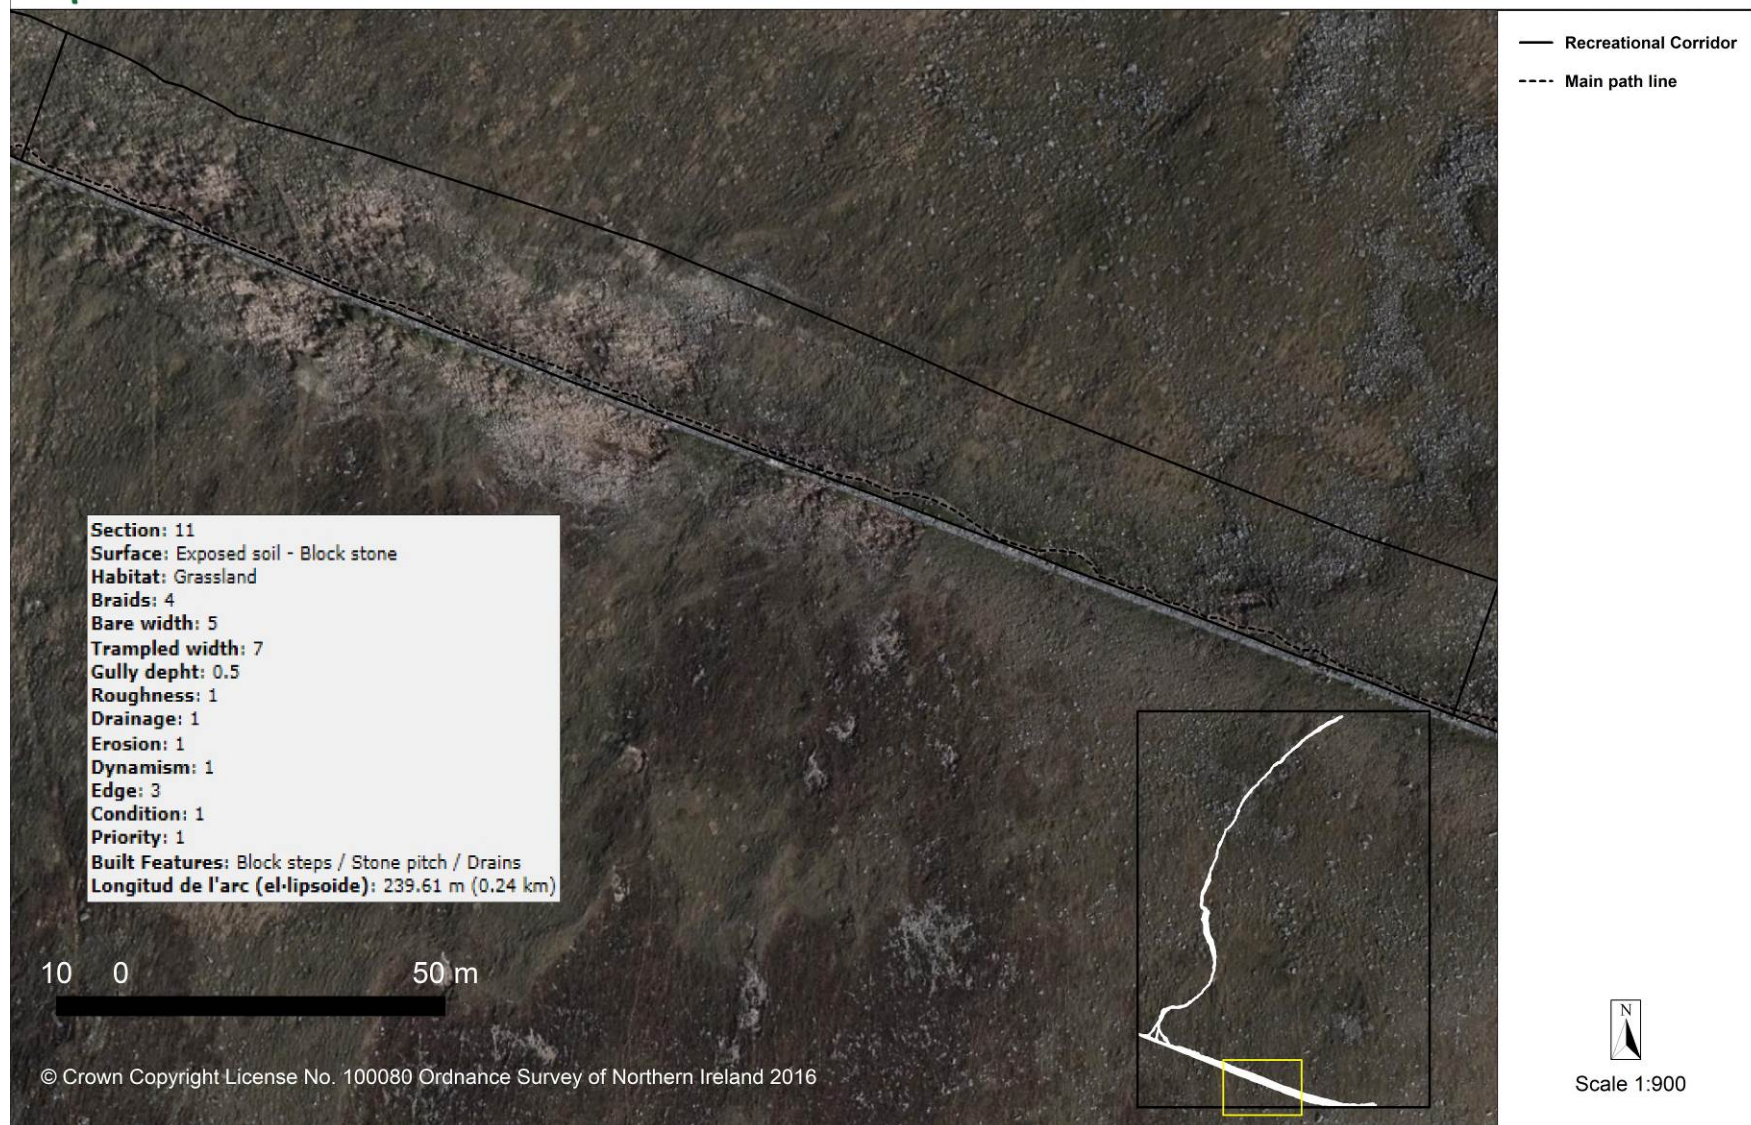
Murlough and Mourne  
Donard Path Review  
Map IV: Sections Detail Map (11/13)

Stone pitching steps path with increased stipiness in bad condition, with dramatically disturbed areas with wide bare soil gullies, ramp stone sections and fine loose material, producing serious health and safety issues. Built features badly damaged, and unsuitable gradient in most of the section. The trampling is also threatening the structure of the Mourne Wall by undermining it.

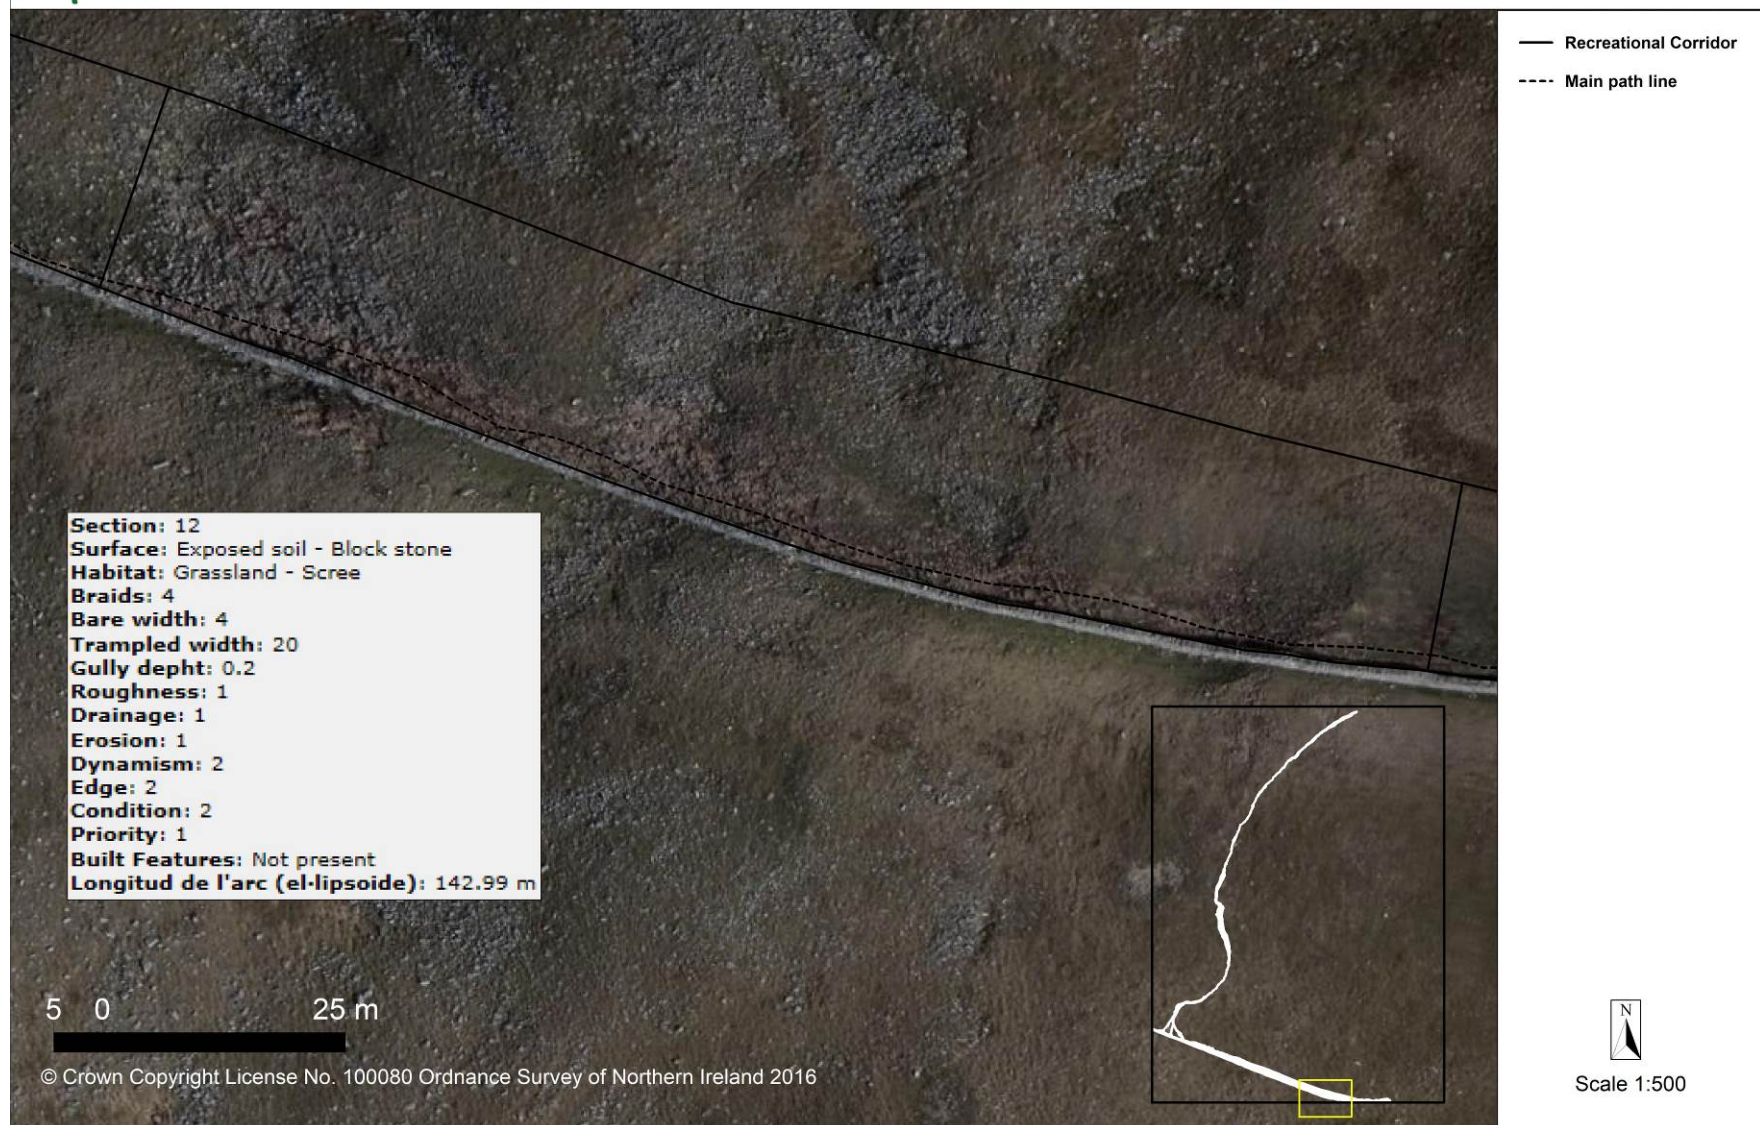
Murlough and Mourne  
Donard Path Review  
Map IV: Sections Detail Map (12/13)

Section without built features along a big stone scree patch. Rough path surface and loose material due to water washout. A lot of onsite materials available around to define the path line on that section.

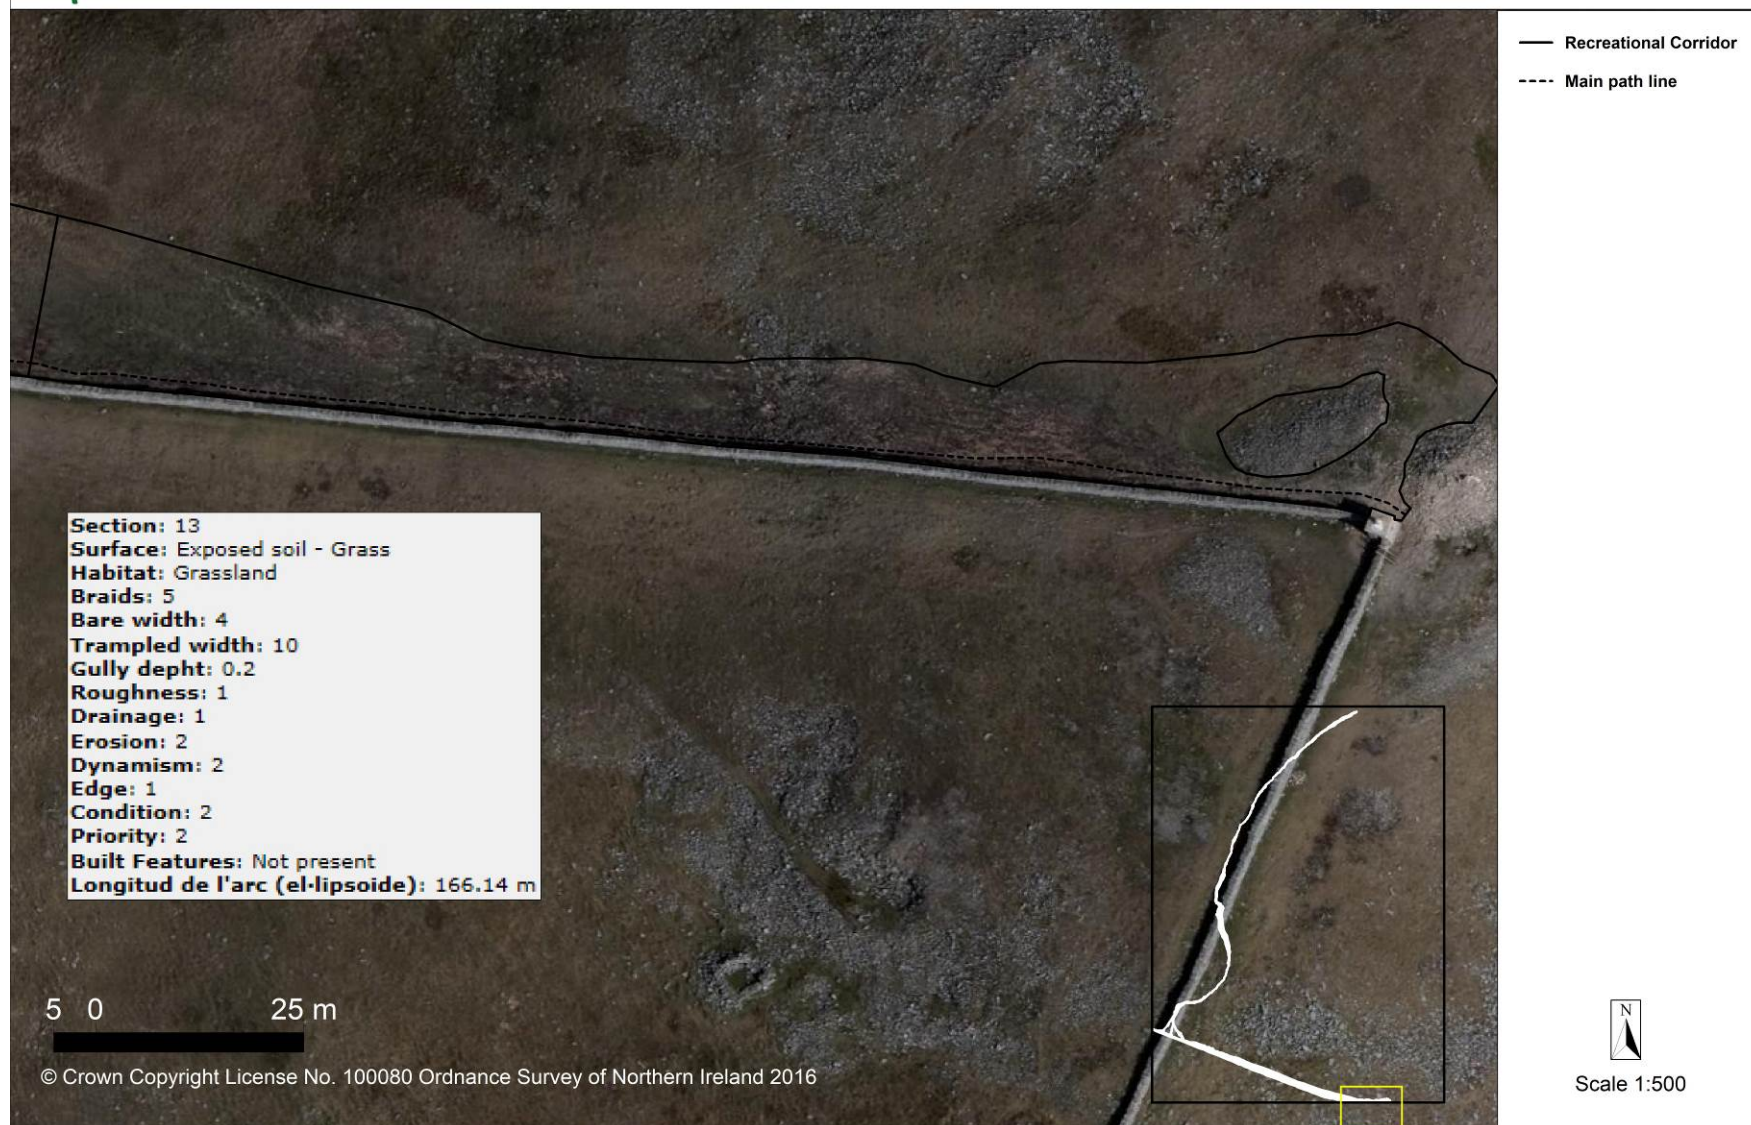
Murlough and Mourne  
Donard Path Review  
Map IV: Sections Detail Map (13/13)

Final relatively flatter bit till the summit of Donard. It consists in a wide grassy corridor where trampling is affecting the montane heath habitat. The surface becomes rougher in the last part, where the soil loss is increasing because of the combined effect of trampling and water washout.
