NANO-REGION

PROOF-OF-CONCEPT EXPERIMENT REPORT

ANALYSIS OF ANOMALIES IN ENAMEL INSULATION ON COPPER WIRE

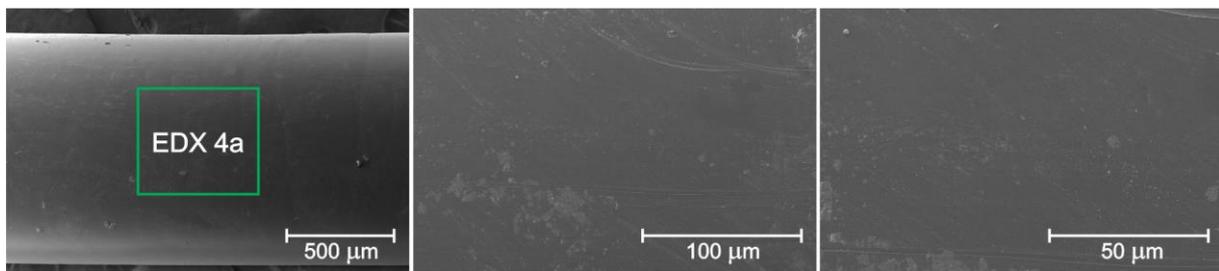
Figure 2: Surface SEM images of healthy region (ROI 4a) with denoted EDX analysis position

SEM analysis shown that the surface morphology and topography of enamel protection was very similar at healthy (ROI 4a) and blue colored region (ROI 4b) of insulated wire (Figure 2-3). At this locations cracking, degradation or any foreign contaminant on enamel surface was not detected. The later was confirmed also with EDX analysis (Table 2) which shown very similar elemental compositions on both locations (EDX 4a and EDX 4b). Contrary, at the ROI 4c, heavily enamel degradation was found which resulted in enamel layer cracking and insulation peeling of the Cu wire as shown in Figure 4. Moreover, phase contrast images shown in Figure 5 revealed presence of additional phases on top of unprotected Cu wire (at cracked part) as well as on enamel surface near the cracked region. These phases include potassium as well as traces of sodium and chlorine elements, which were not seen at healthy or blue colored enamel surfaces (Table 2). According to elemental analysis in Table 2 (EDX 4c-2 to EDX 4c-4), the content of potassium increases from the cracked enamel edge toward “peeled off” Cu wire region. This indicates that the potassium/sodium contamination was most likely present locally at the Cu wire surface, where the corrosion/degradation effect was most intense, and from there degradation process advanced in the near surrounding which caused defects in enamel insulation layers.

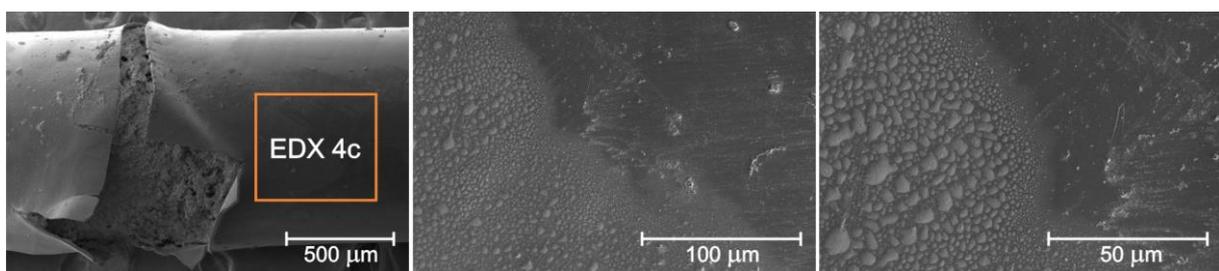
Figure 4: Surface SEM images of heavily degraded region (ROI 4c) with denoted EDX analysis positions

4. At heavily degraded region, enamel layer cracking and insulation peeling of the copper wire was observed. Presence of potassium and sodium elements were found on top of unprotected copper wire and on enamel surface near the cracked region. Their concentration was most intense at the coper wire surface and decreased towards edge of cracked enamel insulation.

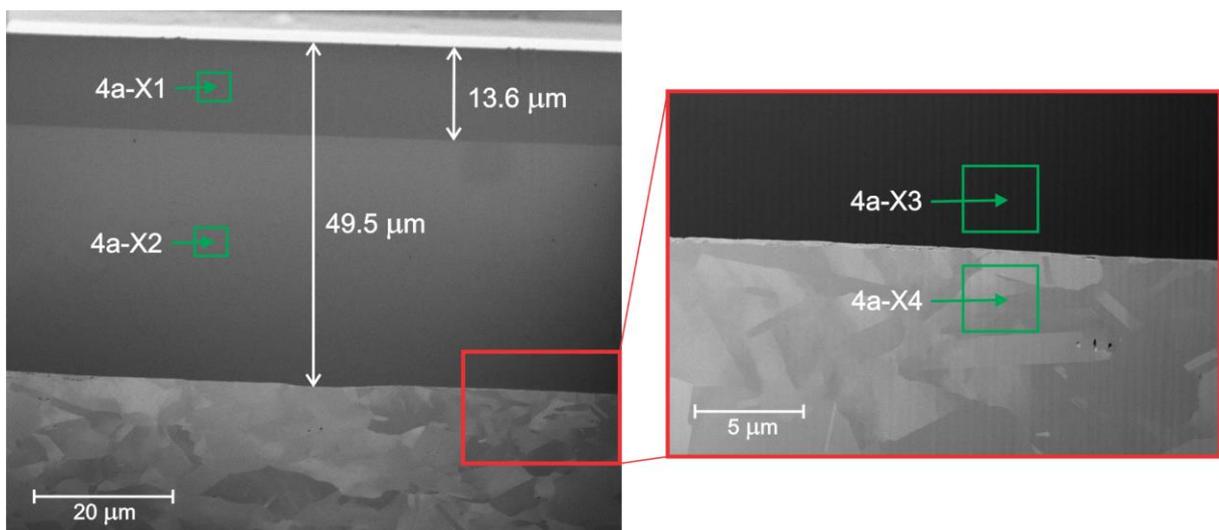
Figure 6: FIB cross-sectional analysis of Sample 4 healthy region (ROI 4a) with enlarged detail (enamel protection/copper interface) and denoted EDX analysis positions

FIB-SEM cross-sectional analysis of healthy region (ROI 4a) shown that total thickness of enamel insulation on top of Cu wire was 49.5 μm. Phase contrast images in Figure 6 revealed two different types of enamel layers which were firmly sandwiched together without any traces of foreign contaminations between them. According to the company description, the first enamel protection part

on top of Cu wire should be composed of 2-3 polyesterimide (THEIC-PEI) layers with individual thickness of ~ 10-15 μm. However, (THEIC-PEI) layers cannot be individually distinguished by phase contrast imaging (same material) and therefore are shown on phase contrast image (Figure 6) as one combined layer with total thickness of 32.9 μm. By the contrast, the topcoat polyamide-imide (PAI) layer was clearly distinguished from the initial layers and shown its uniform thickness of 13.6 μm. The difference between two different types of enamel layers was also confirmed by EDX elemental composition shown in Table 3. The interface between Cu and enamel protection presented in enlarged image in Figure 6 shown flawless adhesion of first protection layer without any cracks or defects. The wire composition near the interface shown practically pure copper with some traces of carbon which is related to Cu X-ray secondary fluorescence with enamel layers (Table 3). At the Cu/enamel interface there were not found any traces of foreign contaminants or Cu surface degradation. In addition, EDX linescan (4a-X) shown in Figure 7 confirms uniform elemental profile along both types of enamel layers (in terms of C and O) and stepwise change of C, O and Cu signals at the Cu interface without any traces of foreign contamination elements. Related to EDX linescan analysis it is also important to note that Cu signals in enamel layers could be effect of two contributions: Cu diffusion toward enamel layers and/or beam scattering effect from supporting copper due to large depth of FIB cross-sectional geometry.

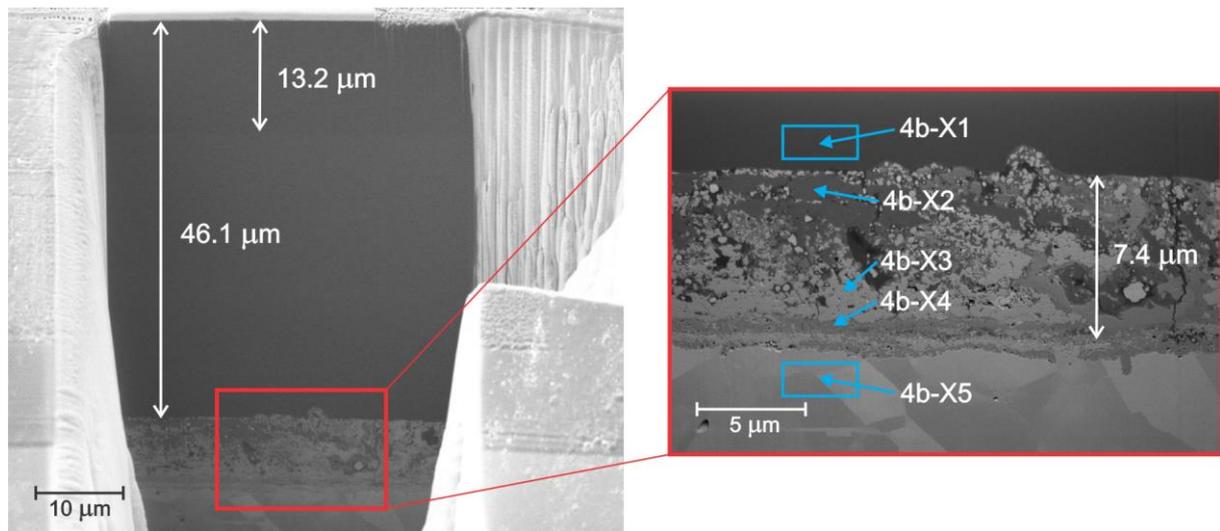
Figure 8: FIB cross-sectional analysis of blue colored region (ROI 4b) with enlarged detail (enamel protection/copper interface) and denoted EDX analysis positions

FIB-SEM cross-sectional analysis of blue colored region (ROI 4b) shown that total thickness of enamel insulation on top of Cu wire was 46.1 μm (Figure 8). Enamel layered insulation was found very similar to healthy region (ROI 4a), composed of two different enamel types with the thickness of 32.9 μm and 31.2 μm for the combined THEIC-PEI layer pack and topcoat PAI layer, respectively. All enamel layers were firmly sandwiched together and there were not found any traces of foreign contaminants between them. However, Phase contrast image in Figure 8 clearly shown corrosion/degradation of the Cu wire surface at the Cu/enamel interface. The corroded Cu surface layer at ROI 4b location was found to be 7.4 μm thick. EDX elemental analysis shown in Table 4 revealed presence of potassium (up to 27.5 Wt%) and sodium (up to 2.2 Wt%) in the Cu degraded layer. EDX linescan (4b-X) presented in Figure 9 shown uniform elemental profile along both types of enamel layers (in terms of C and O) similar as in healthy region. At the enamel/Cu wire interface K and Na elemental signals appeared and were present, together with O element, throughout entire Cu degraded surface layer (7.4 mm) until healthy Cu wire was reached at the depth of 56 μm. This indicates that the traces of K and Na contaminants were present at the Cu/enamel interface within the blue colored wire region and caused surface degradation processes of the Cu wire.

3. All the enamel layers at healthy and blue colored region were found firmly sandwiched together without anomalies or any traces of foreign contaminants between them. However, at the blue colored region, potassium and sodium contaminants were found at the enamel/copper interface. At this location potassium and sodium elements were confirmed also in the first 7.4 μm of copper wire surface, where initial copper corrosion effect was observed.

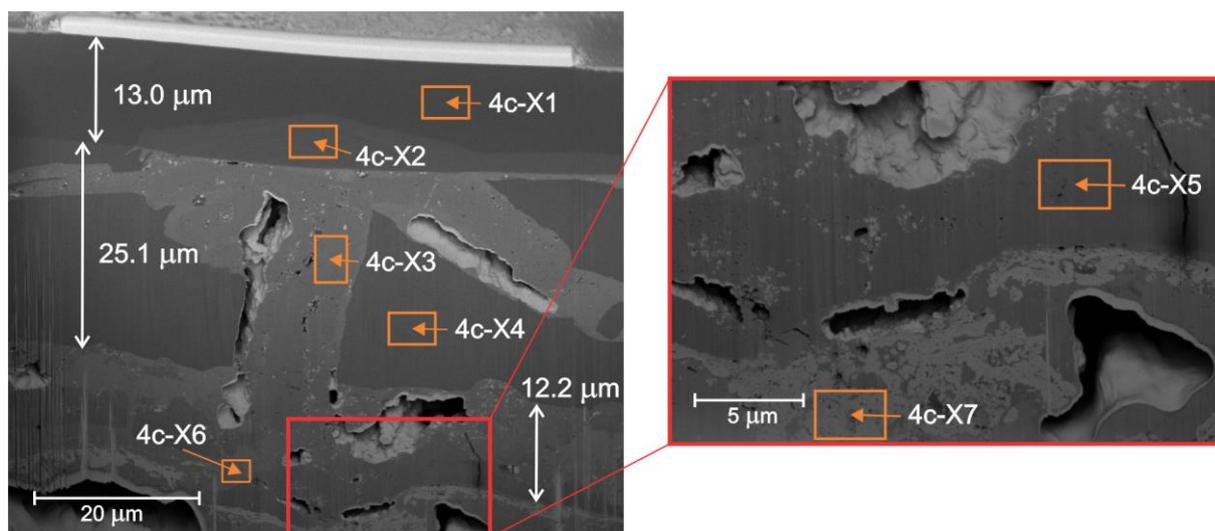
Figure 10: FIB cross-sectional analysis near heavily degraded region (ROI 4c) with enlarged detail (enamel protection/copper interface) and denoted EDX analysis positions

FIB-SEM cross-sectional analysis was performed 400 µm away from the peeled (cracked) insulation, where enamel protection was still in plain with normally attached insulation. Phase contrast image of the cross section presented in Figure 10 shown intense corrosion of Cu wire surface in terms of large pore, cracks, and secondary phase formation. Moreover, degradation of enamel protection layers was observed in several location. The enamel degradation was found most intense at the first THEIC-PEI layer (at Cu interface), where secondary phase, cracks and pores were seen over complete layer. The degradation affected also next two THEIC-PEI layers and part of the PAI layer at the THEIC-PEI interface. Phase contrast image in Figure 10 confirmed presence of secondary phase in enamel layers. EDX elemental analysis revealed that potassium element (8.1 – 17 Wt%) was present in secondary phases in enamel layers as well as in corroded Cu surface. In addition, high content of sodium element (15.8 Wt%) was found in the first enamel layer, while in all above layers its concentration was found much lower. Elemental distribution along cross-section is evident from EDX mapping shown in Figure 11.

5. Cross-sectional analysis at the heavily degraded region shown intense corrosion of Cu wire surface in terms of large pore, cracks, and secondary phase formation. At this location various anomalies were found in all enamel layers. The enamel degradation was found most intense at the first THEIC-PEI layer (at Cu interface), where secondary phase, cracks and pores were seen over entire layer. The degradation was seen also in all above layers including with part of the topcoat PAI layer. Presence of potassium and sodium phases were confirmed in all enamel layers as well as in corroded copper wire surface. High content of sodium element was localized near the first enamel layer, while in above layers its concentration was lower.

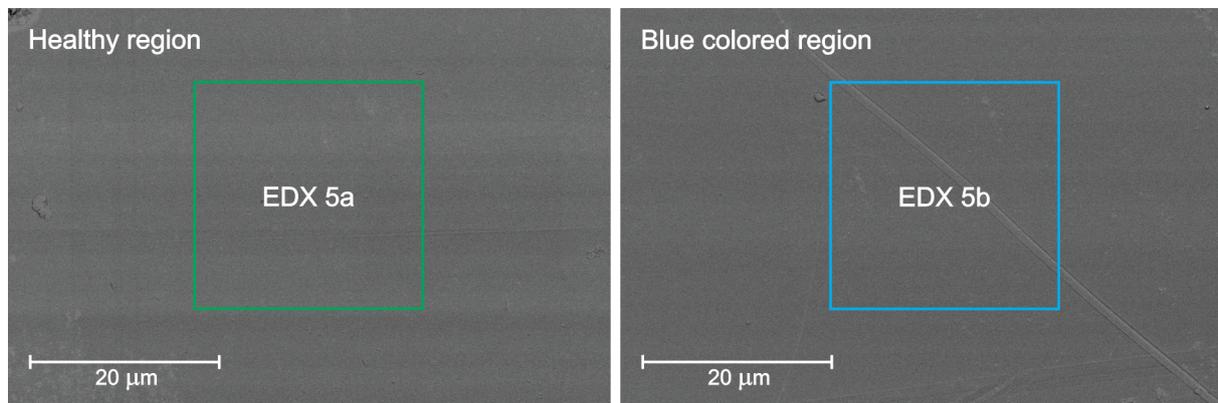
Figure 13: Surface SEM images of Sample 5 healthy (ROI 5a) and blue colored region (ROI 5b) with denoted EDX analysis positions

Surface SEM analysis (Figure 13) of insulated copper wire 5 shown that the surface morphology and topography of enamel protection was very similar at healthy (ROI 5a) and blue colored region (ROI 5b). Cracking, degradation, or foreign contaminant elements were not detected at any of those locations. The later was confirmed also with EDX analysis (Table 6) which shown very similar elemental compositions on both locations (EDX 5a and EDX 5b).

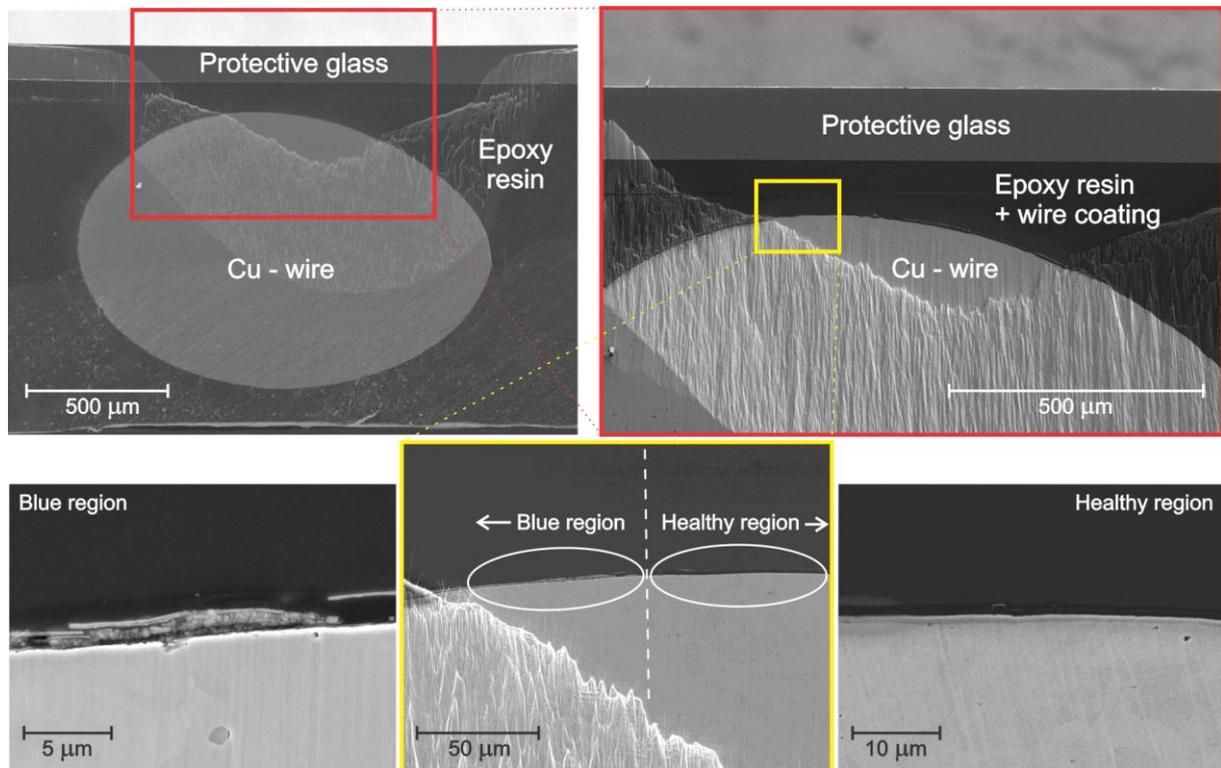
Figure 14: SEM images of Ar ion polished cross-section of insulated Cu wire (Sample 5) at color transition region (ROI 5c) with magnified blue colored and health region.

Ar ion cross-section polisher enabled generation of ~500 μm wide cross-section of insulated Cu wire without any mechanical damage or contamination of the interfaces. With this technique large cross-sectional area was exposed which included healthy (right side), blue colored (left side) and transition region between them as shown in enlarged images in Figure 14.

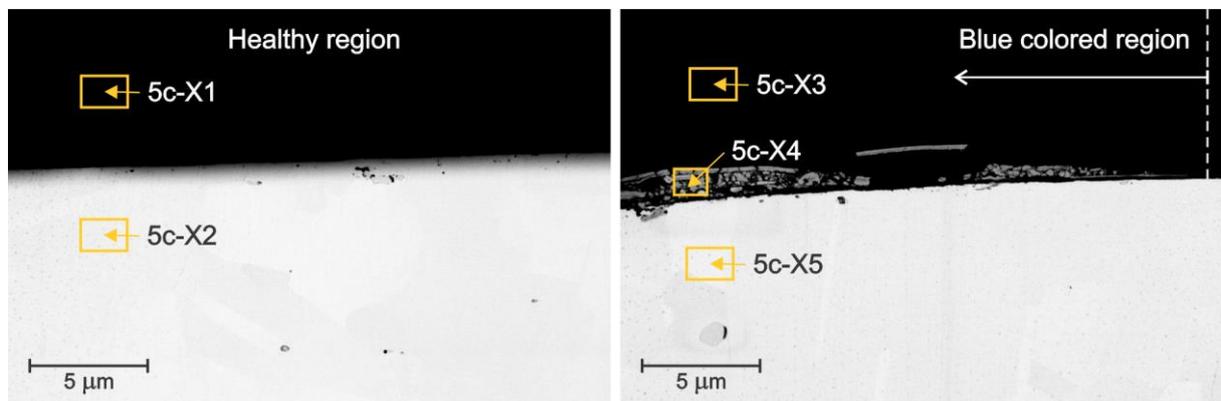
Figure 15: Phase contrast SEM images of Ar ion polished cross-section (ROI-5c) at healthy (left) and blue colored region side (right) with the denoted EDX analysis positions

Phase contrast cross-sectional images shown in Figure 15 revealed the presence of secondary phase between first enamel layer and Cu surface at the blue colored region. At the healthy insulation side, enamel coating/Cu interface was found flawless. EDX analysis shown that the secondary phase found at the blue colored region included potassium and traces of sodium element (Table 7).

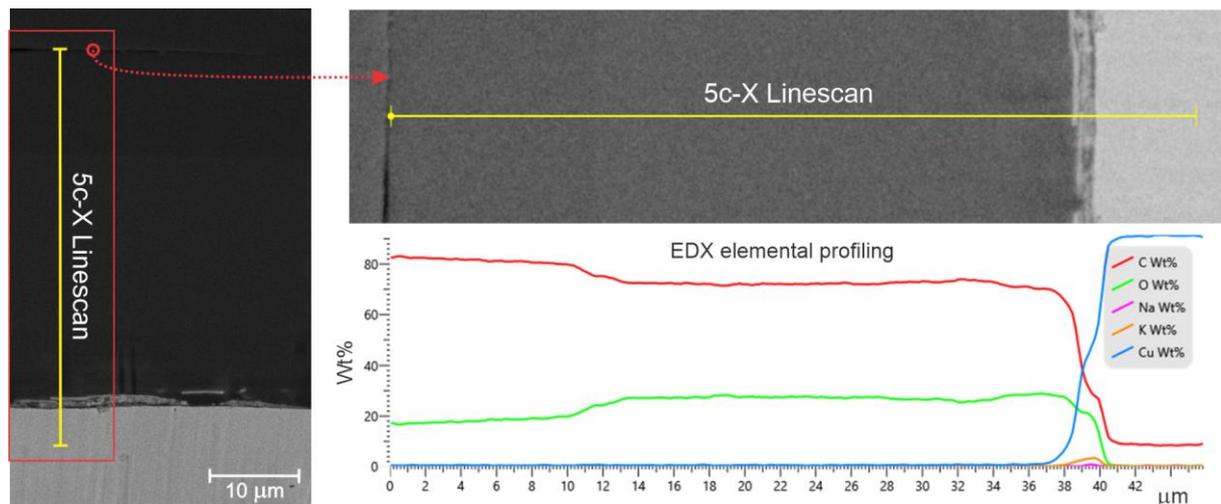
Figure 16: EDX linescan analysis along Sample 5 cross-section at blue colored region, with enlarged linescan acquisition detail and corresponding EDX elemental profiles

EDX linescan analysis (Figure 16) shown that total enamel insulation thickness was ~38 μm. According to the C and O elemental profiles the enamel layer thickness corresponded to ~12 μm and ~26 μm for the topcoat layer (PAI) and sum of THEIC-PEI layers, respectively. At the enamel/Cu wire interface K and Na elemental signals were clearly identified which indicates the presence of K and Na contaminants at the Cu/enamel interface within the blue colored region.
