Caen Hill Pumping Station

PHASE 2 SITE TEST SUMMARY REPORT

Report No: 10031024-00536

Work Package: Trialling Emerging Technologies (Canal & River Trust) I1

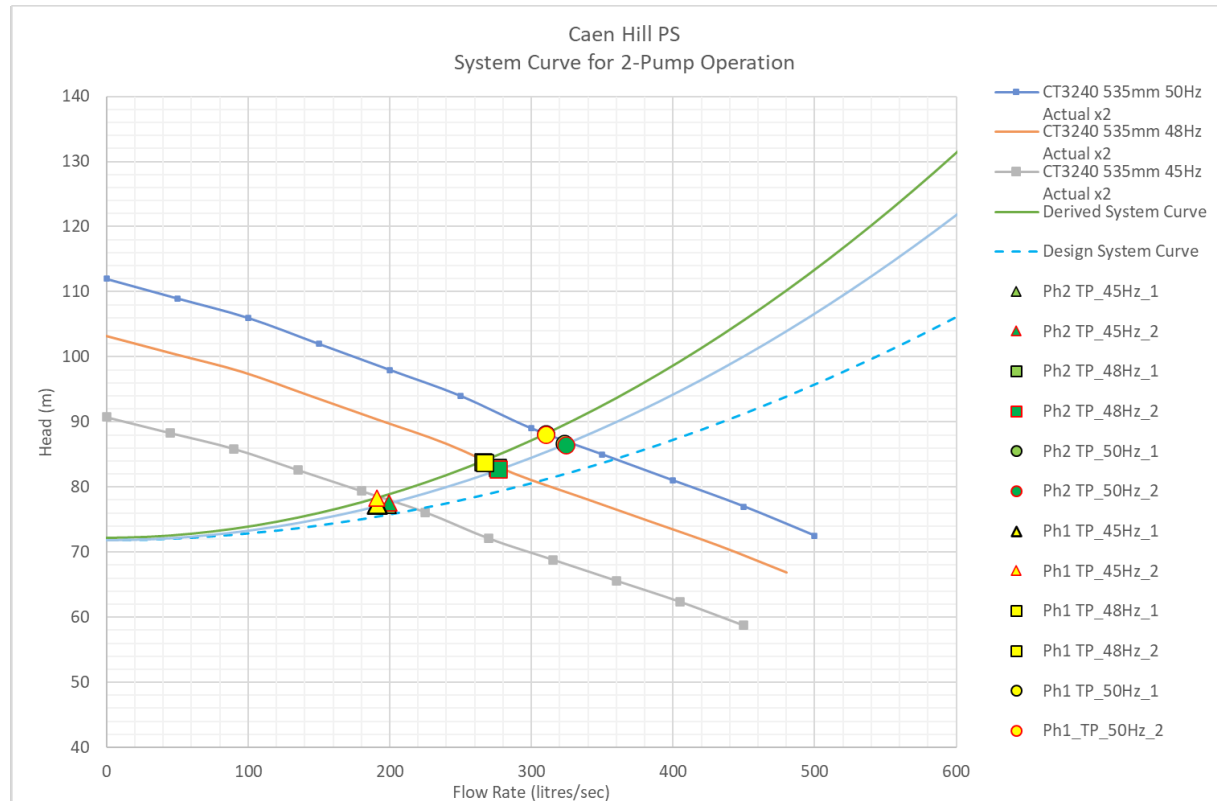
Figure no. 3: Derived System Curves for 2-Pump Operation

- The site test results backed up by the SCADA data indicate a marginal improvement on rising main head losses. A reduction of approximately 2m to 3m at 300 l/s between Phase 1 and Phase 2 and removal of the intermediate NRVs was found. However, the rising main dynamic losses are still 3m to 4m higher than expected at 300l/s as indicated by the dashed “design system curve” in Figure no. 3.

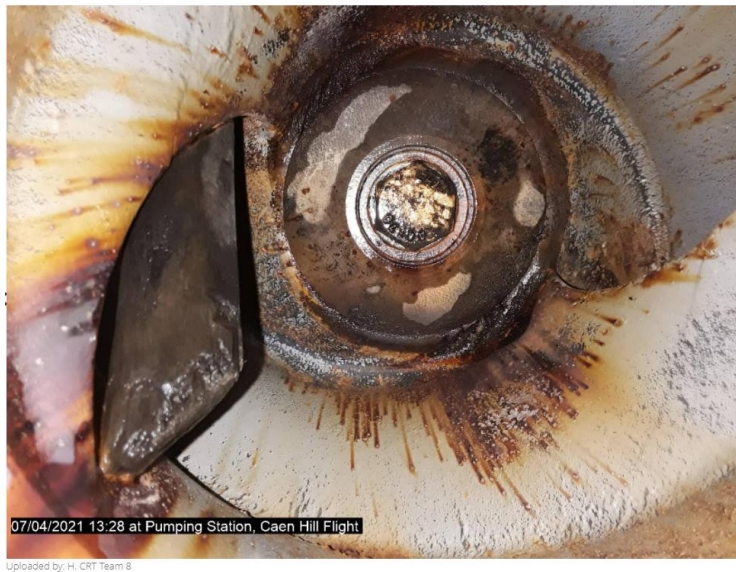
Evidence of cavitation was found during the 2019 overhaul of Pump 1 as shown in Figure no. 6.

Figure no. 6: Pump 1 Impeller Cavitation

The pump operating point, being left of the preferred operating region, could lead to local flow recirculation at the pump entry. This is a known cause of cavitation.

Given the calculated suction head available, possible reasons for the presence of cavitation marks as found in the pump impeller include:

- Inlet pipework design causing hydraulic instability, and poor presentation leading to turbulent low pressure or air entrainment;
- Internal or entry recirculation of flows at the pump due to operation left of preferred operating region (POR).

The inlet pressures monitored during the Phase 2 testing fluctuate which suggests less than ideal hydraulic conditions at the pump inlet and potentially contributing to cavitation damage. Operating left of the POR may also be a contributing factor to the cavitation wear of the impeller.

Adopting a simple modification such as lowering the bellmouth and adding a suction cone (see adjacent figure) or divider plate may address this issue

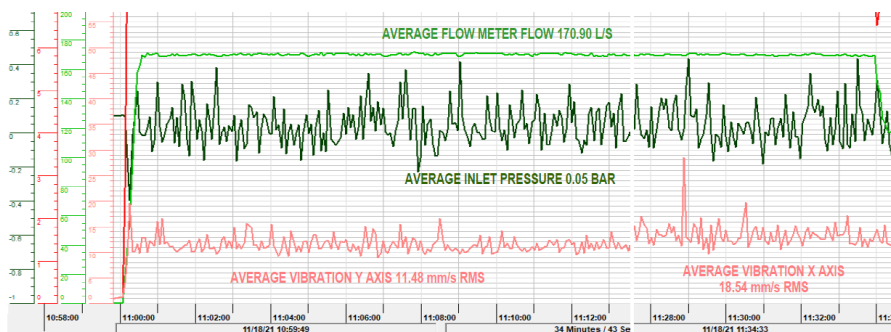
From NSPH calculations undertaken during Phase 1 and the site test results. An estimated NPSH margin of between 2 m and 10 m due to the fluctuation in measured pump inlet pressure.

Figure no. 7: Measured Inlet Pressure (in black) for Pump 1 showing fluctuation

The measured pump inlet pressures were seen to fluctuate significantly, more noticeably in Pump 1, which could indicate excessive flow turbulence / instability.

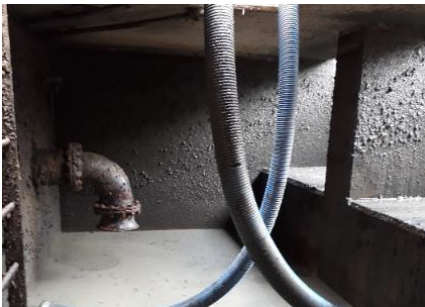
The key deviance from “recommended” practice is the height of the inlet bellmouths above the wet well floor, presumably due to silt concerns.

Figure 8 – Wet Well Intake during 2019 Desilting Activities

This could result in the inlet pipework being susceptible to adverse hydraulic conditions such as vorticity and potentially air entrainment or local low-pressure zones that could cause cavitation.

Siltation can impact on flow presentation to the inlet pipes. The well was desilted in February 2022 and, although a possibility, this is not considered the most likely root cause issue.

The inlet suction bellmouths are located higher above the floor than recommended by established pump intake design literature including *ANSI/HI-9.8 Pump Intake Design*. This may be contributing to hydraulic instability issues and cavitation.

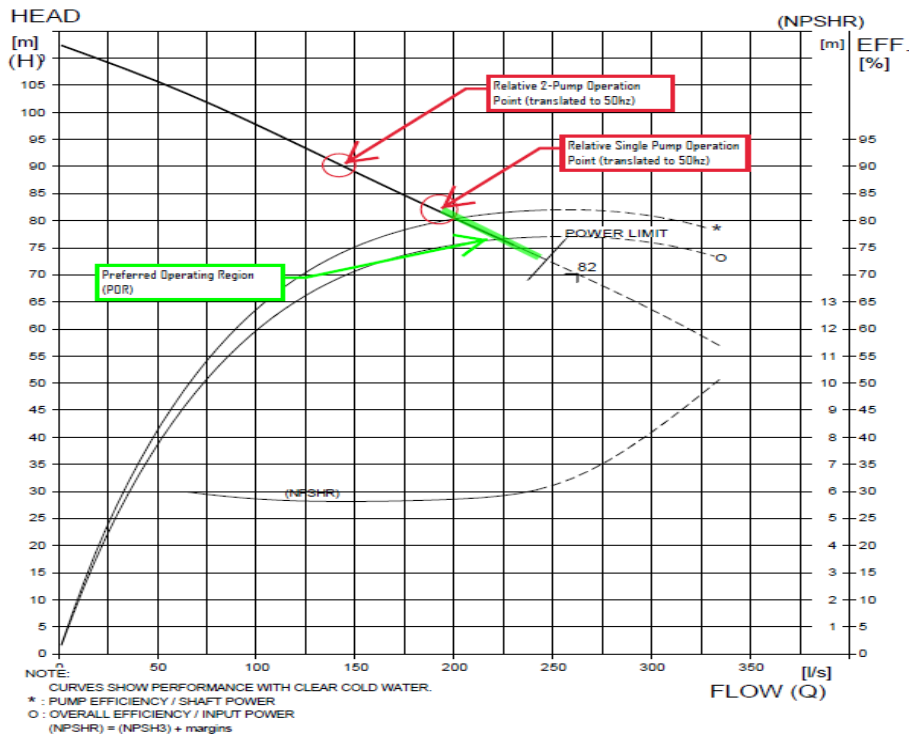
- Under 2-pump operation at 48Hz the operating flow rate is 55% of the flow rate at BEP. This falls outside and to the left of the typical preferred operation region (POR) of the pumps (see Figure no. 9).

Figure no. 9: Manufacturer's Pump Curve and Relative Operating Points at Caen Hill

The pump curve has a preferred operating region (POR), defined by being 70 % to 120 % of flow rate at the best efficiency point (BEP), where vibration should be lowest. This is highlighted in green in and shows that single pump operation is within the POR but falls to the left of POR under 2-pump operation, which may be an indicator of higher vibration.

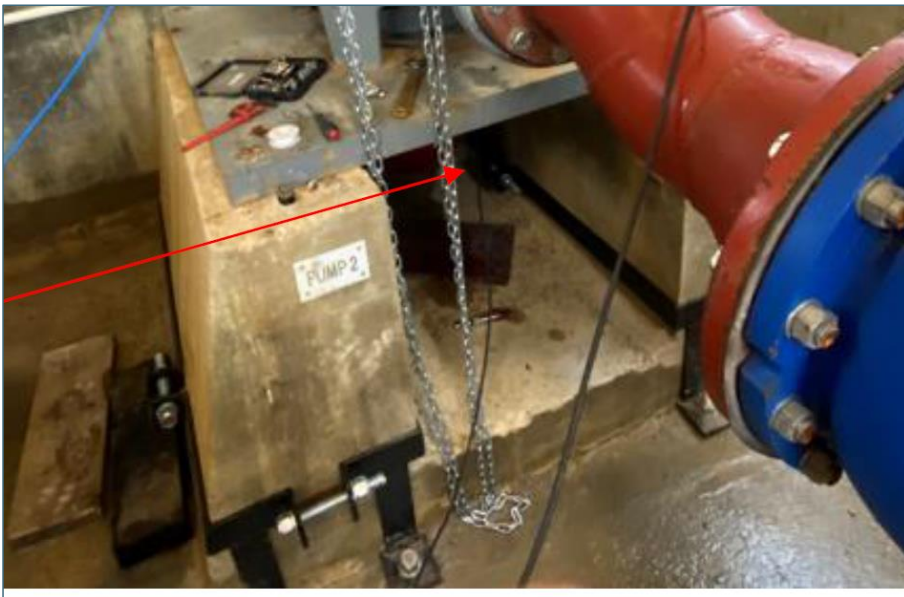
Since the 2019 Phase testing, the pump foundation plinths have been repaired and reinforced with steel straps and plates, though other concrete support/restraints have failed.

Figure no. 10: Steel Reinforcement to Concrete Pump Plinth

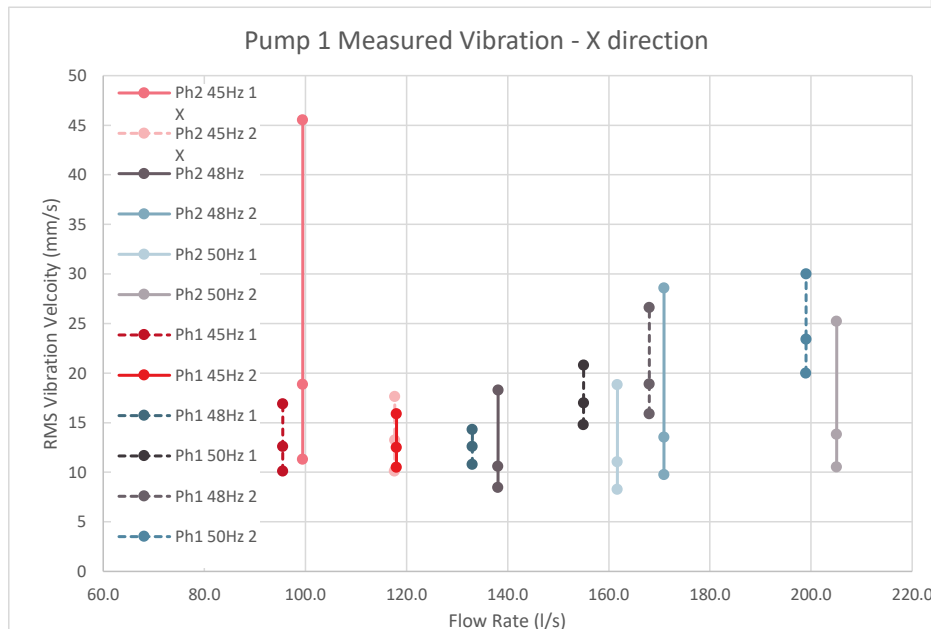
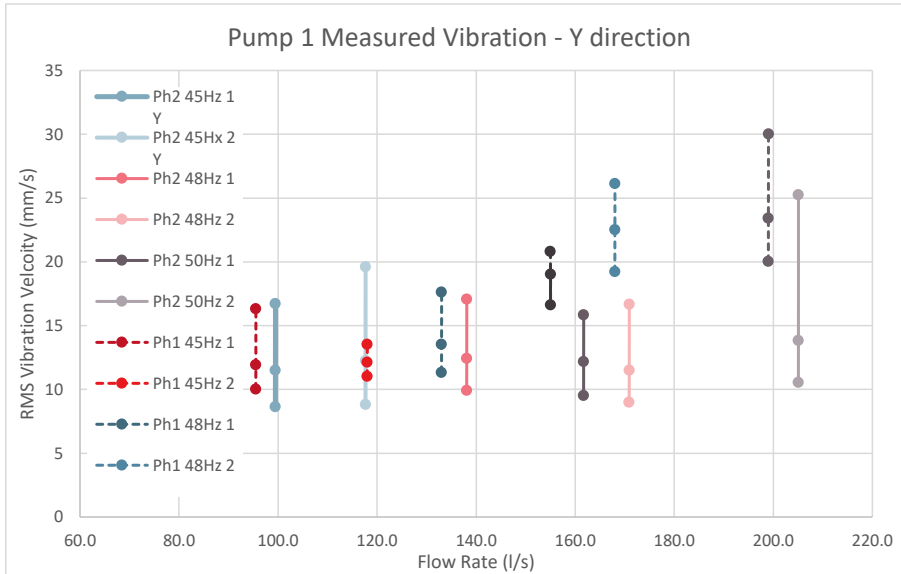
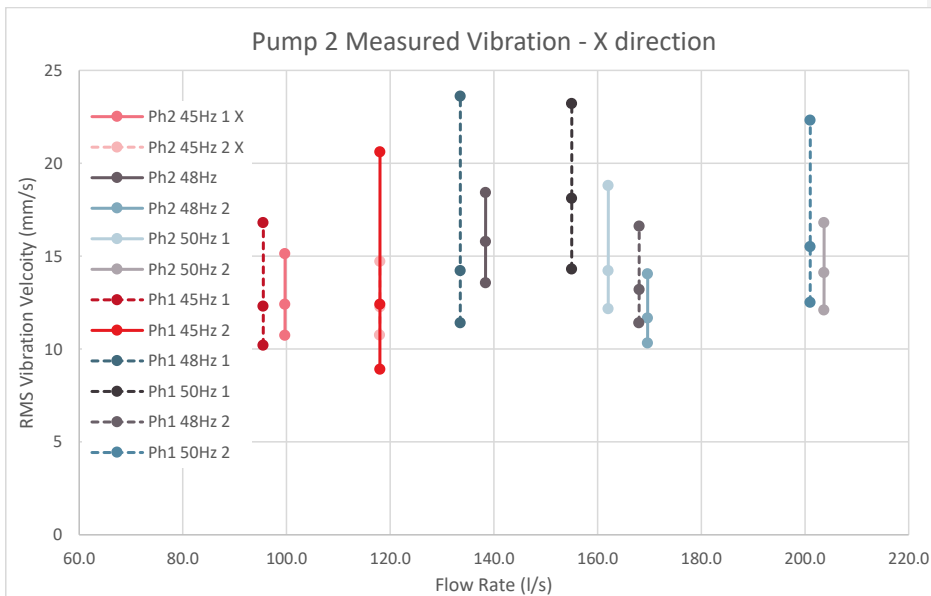
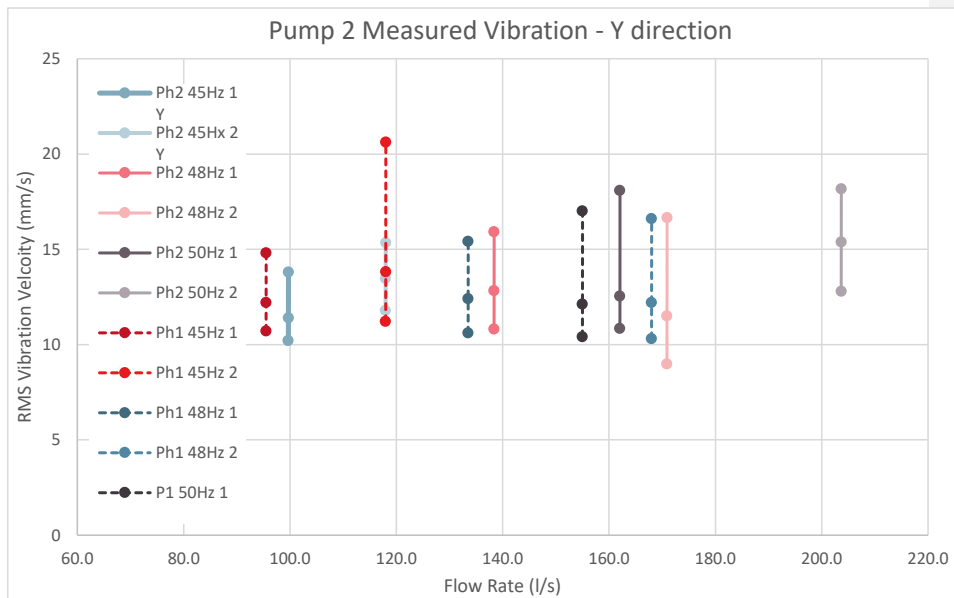
BS ISO 10816 Part 7 defines the requirements for the measurement and evaluation of rotodynamic pumps. This suggests that risk of damage occurs at vibration velocities of above 9.5 mm/s RMS. However, it should be noted that submersible pumps are excluded from the scope of this standard.

Under Water Industry Mechanical and Electrical Specification (WIMES) 1.03 (dry well submersible pumps), a vibration limit of 11.2 mm/s RMS would apply to the 2-channel impeller pump. However, the manufacturer would need to advise their recommended limits.

As can be seen from Figure no. 11 to Figure no. 14, although there is a slight improvement since the Phase 1 testing, the peak vibration from both pumps significantly exceed the 11.2 mm/s RMS value under all tested operation scenarios. Therefore, we conclude that, despite the plinth improvements, vibration remains a concern and a probable cause of premature pump failure.

Despite the recent installation of bracing to the pumping station pump plinths, concerning high levels of vibration were measured on both pumps. Although, both pumps show slightly lower levels of vibration than measured during Phase 1 site testing. This excessive vibration is a probable cause of the short bearing and seal life being experienced by both pumps.

A dedicated test by a vibration specialist would help to understand the root causes from Fast Fourier Transform (FFT) spectrum analysis and motion analysis. This would identify the vibration frequencies and if the vibration cause is related to foundation, pump structure, imbalance, or hydraulics. The results should then inform on the required solution focus, e.g., foundation, flow presentation, supporting.

Resolution can be difficult under such circumstances, but further improvements to resolve the situation should be based upon the results of a specialist vibration audit including FFT spectrum analysis and motion analysis.

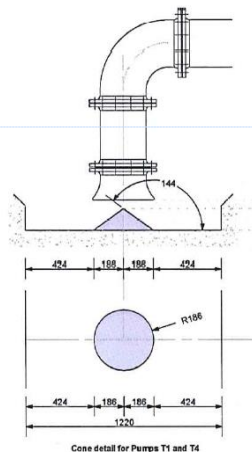
Figure 15 – Example of suction cone to improve inlet hydraulic stability
