National analyses of nourishments;

*Coastal state indicators and driving forces for Domburg,
the Netherlands*

Date: 05/08/2019

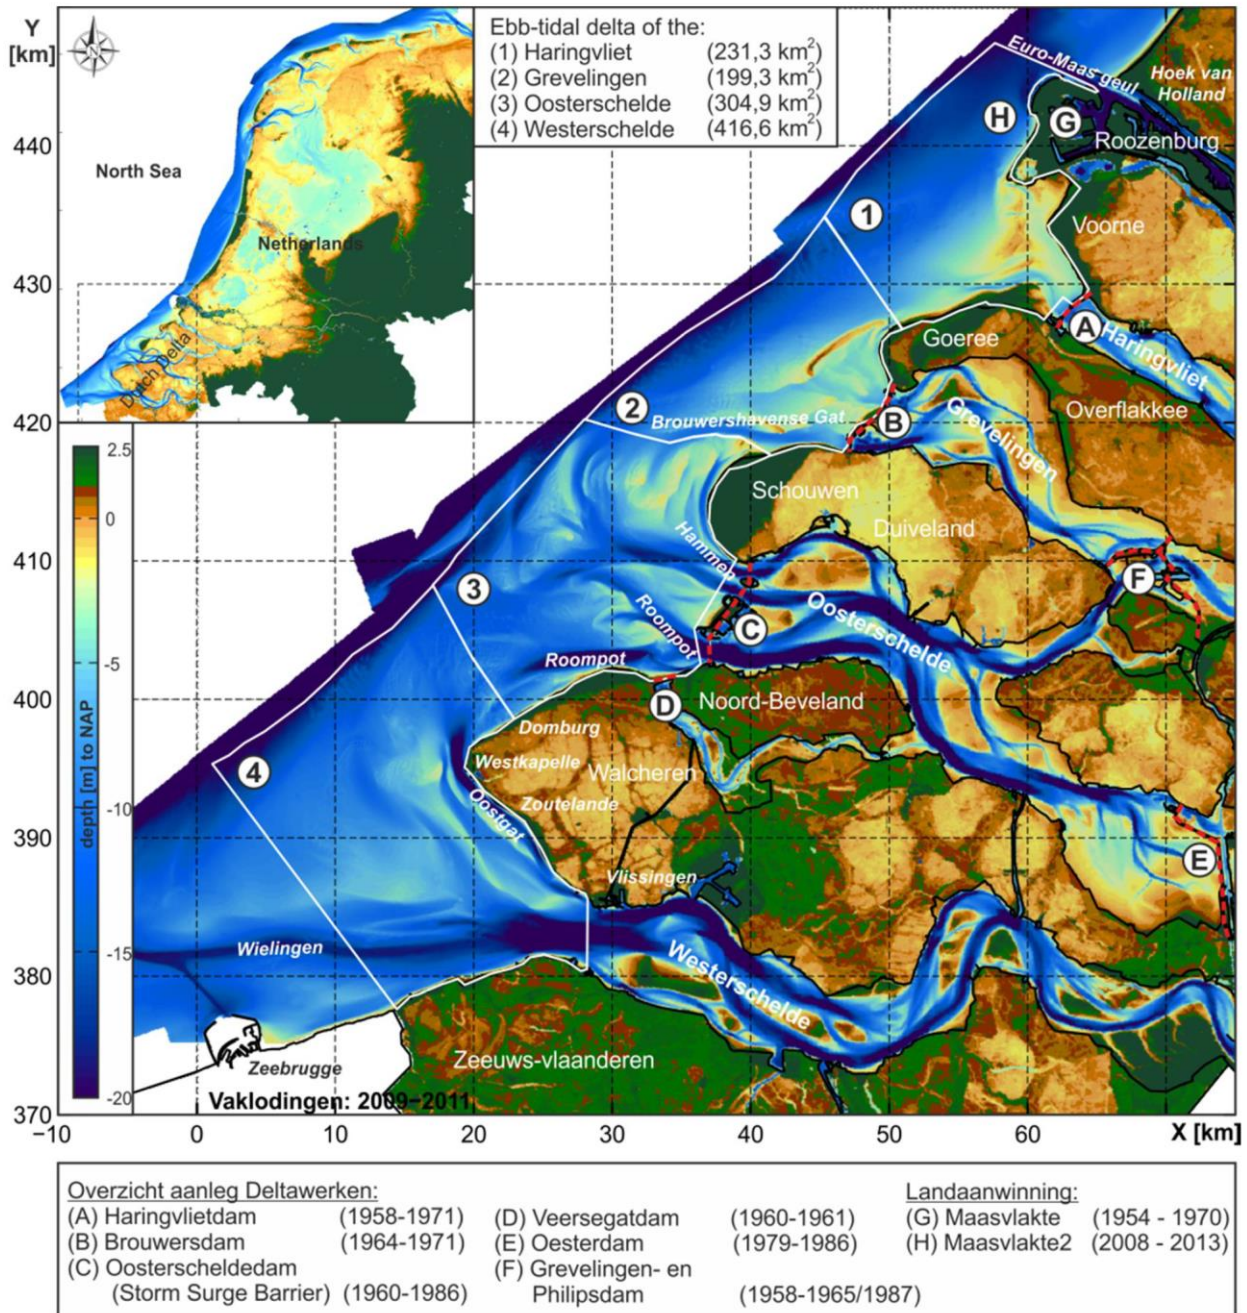
Figure 2: An overview of the coastal area near Domburg. The numbers and white lines indicate the ebb-tidal deltas. The dotted red lines and the letters indicate the major closer dams of the Delta Works. Reprint from (Elias , Spek, & Lazar , 2016)

The coastal laboratory of Domburg is located in the southwestern part of the Netherlands situated near the city Domburg (Figure 2). It is enclosed by the Eastern Scheldt estuary to the North and by the Western Scheldt to the South. The area is characterised by morphological features typical for such an environment, like ebb tidal deltas and tidal channels. The behaviour of these features strongly influences the management and maintenance of the coast. The area are strongly influenced by the waves, (tidal) currents, human interference and interactions between these processes.

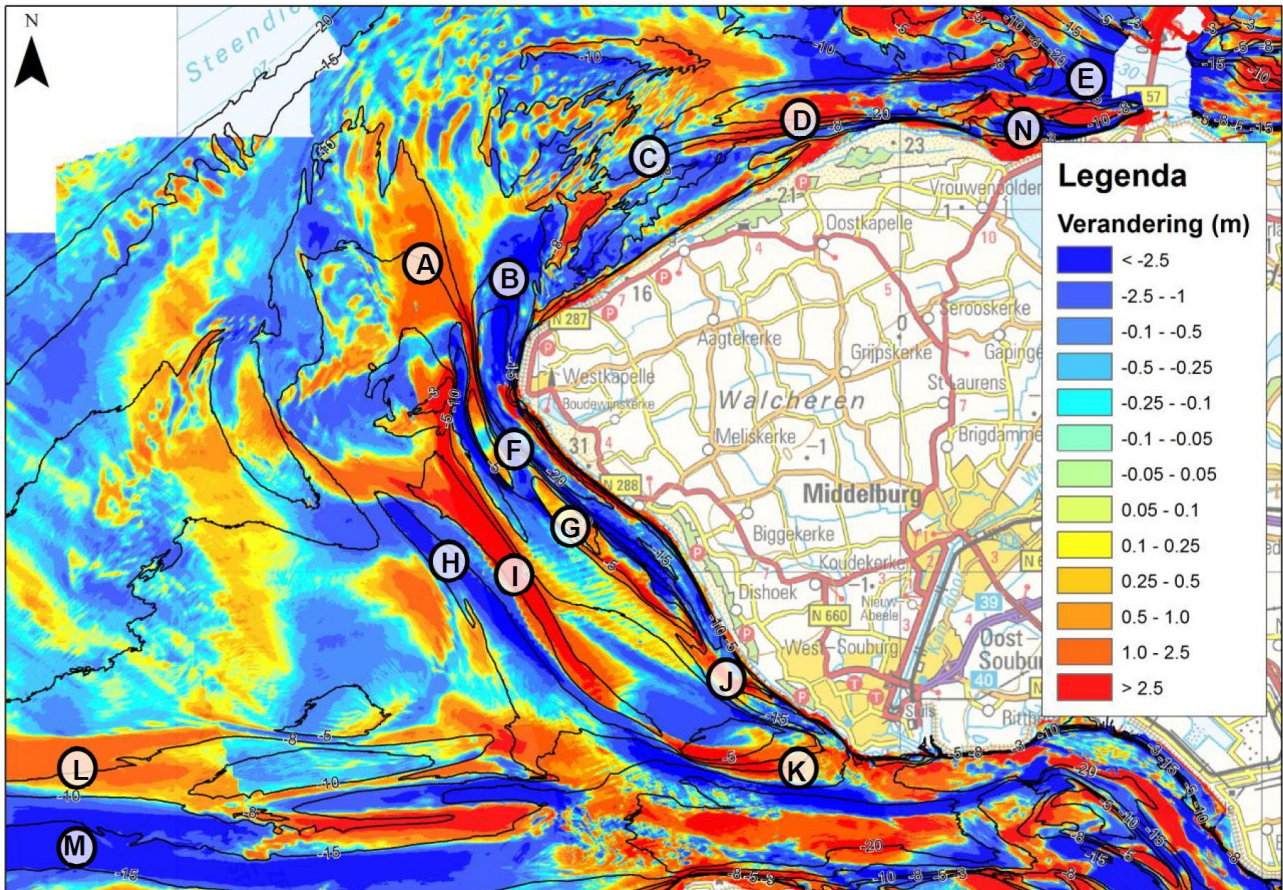
Figure 3: Map of the difference in bed level 1964 – 2010/2011 combined with the contours of 2010/2011. Several important morphological changes are indicated by the letter A till N. East of "L" an abrupt jump can be observed. This jump results from a difference in grid resolution between datasets and has no physical meaning. Reprint from (Vermaas & Bruens , 2012).

To indicate the dynamics in the system the morphological changes are shown in Figure 3. The letters indicate several large morphological changes:

- A. Sedimentation North of the Rassen.
- B. The Oostgat is expending northward.
- C. The Roompot is expending westward.
- D. Sedimentation of the Roompot.
- E. Erosion in front of the Eastern Scheldt storm surge barrier.
- F. Deepening of the Oostgat.
- G. Narrowing of the Bankje van Zouteland
- H. Merging of de Geul van de Walvischstaart and Deurloo-West
- I. A sandbar arises between Rassen and Nolleplaat.
- J. Sedimentation of the sandbar at Oostgat/Sardijngeul
- K. Sedimentation eastward of the Nolleplaat
- L. Dumping ground for dredged sediment
- M. Deepening of the Wielingen due to dredging works.
- N. Sedimentation of the sandbar at the Veerse Gatdam and deepening of the Schaar van Onrust.

The figure suggests that the erosion of the beaches is limited and in several locations the dunes are growing. It should be taken into account that results from all the nourishment executed in this area are being displayed in the figure. Without these nourishments the coast would have been eroded significantly.

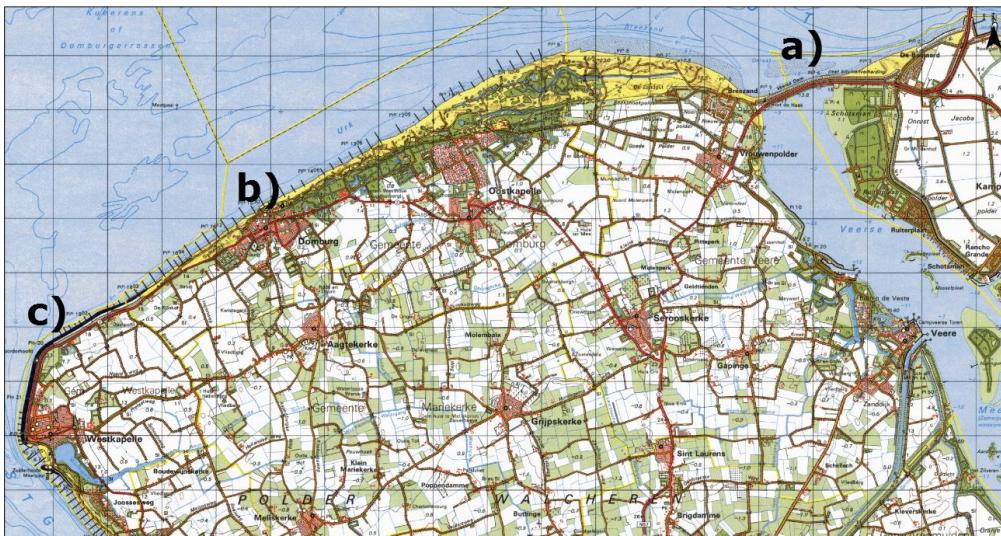
Figure 4: Overview map with coastal infrastructure: a) Veerse Gatdam with Eastern Scheldt storm surge barrier in the background, b) pole rows on the beach (black lines perpendicular to the coast), c) Westkapelse Seadijk.

At and in the vicinity of the nourishment location several coastal defence constructions are present. East of the location a former sea arm is closed off by a dam and the Eastern Scheldt storm surge barrier is located to the North. To the west, at the town Westkapelle, a sea dike is constructed. At the nourishment location itself wooden poles in rows perpendicular to the shore are present on the beach. An overview of the locations is given in Figure 4, images can be found in Figure 5.

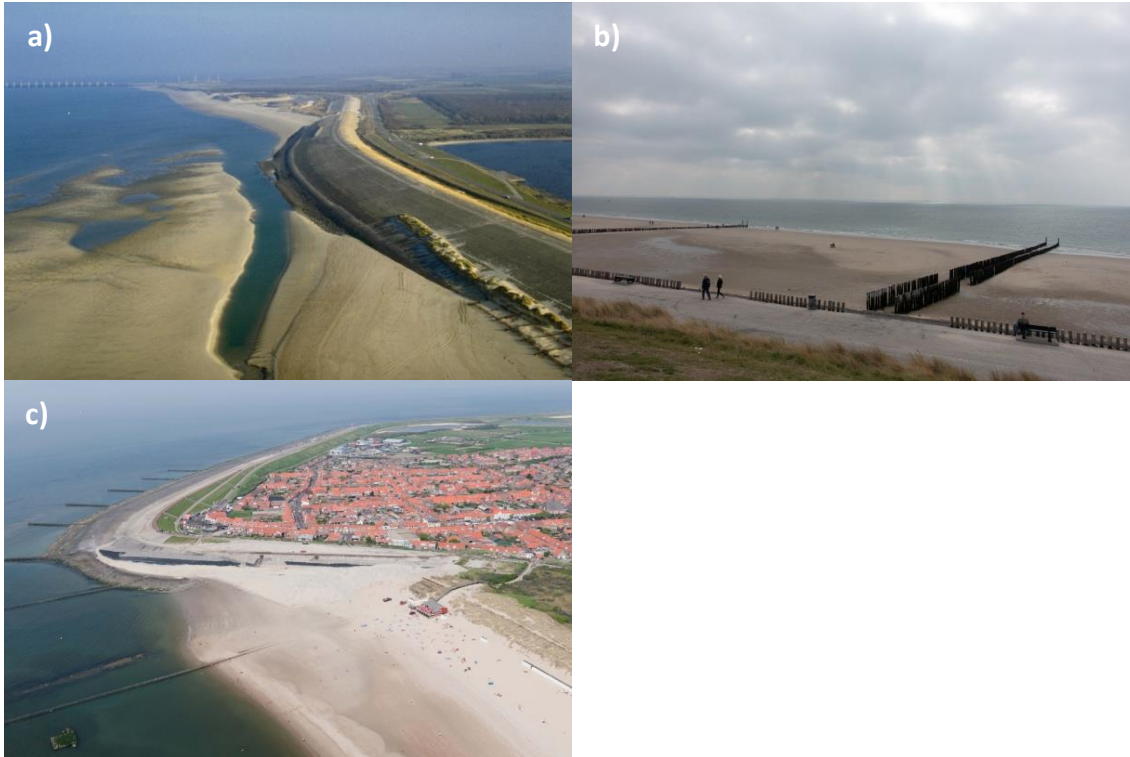
Figure 5: Coastal infrastructure around the nourishment location: a) Veerse Gatdam with Eastern Scheldt storm surge barrier in the background, b) pole rows on the beach, c) Westkapelse Seadijk. Source: <http://beeldbank.rws.nl/>.

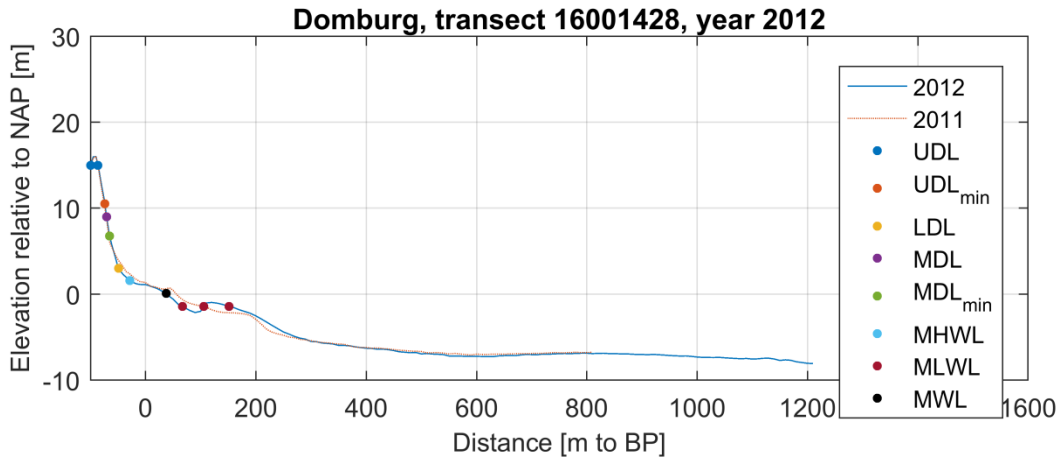
Figure 6: An example of coastal profile and the levels described as in 4.2.1. UDLmin means the Upper Dune Level minimum and the MDLmin the Mid Dune Level minimum.

A typical beach profile at Domburg is visualised in Figure 6, including the levels of the coastal state indicators (CSI's) for this lab (see paragraph 4.2.1). The values of the CSI's are given in Table 2. The profiles shows the first dune, a relatively small beach and a gently sloping shoreface without breaker bars.

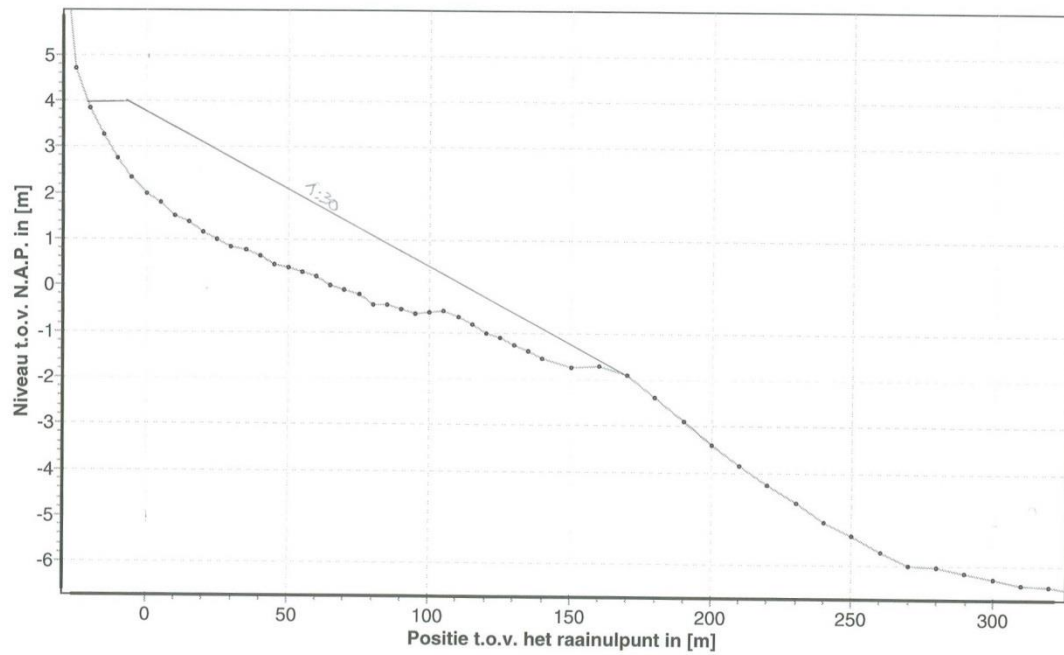
Figure 7: The design of the nourishment at Domburg for transects 15.30. The design was based on the bathymetry of 2006.

The nourishment at Domburg consisted of a beach nourishment where sand was placed directly on the beach. This is typical for nourishments at Domburg. The nourishment is placed attached to the dunes and is designed at a height of NAP +4m. Like frequently done, a slope of 1/30 is applied resulting in landward position of the nourishment at a vertical position of NAP -1.9 m, see Figure 7. Other details of the nourishment are given in Table 3.

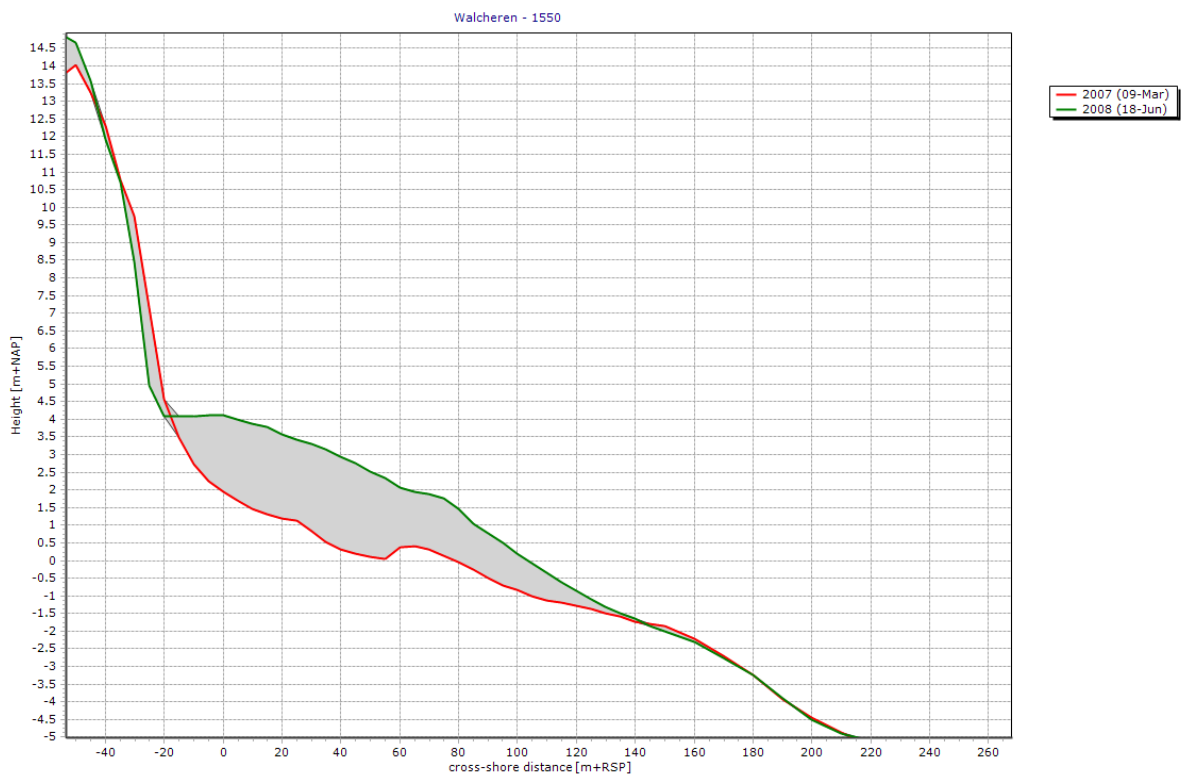
Figure 8: Placement of nourishment in transect 1550

The actual placement of the nourishment is very close to its design, see Figure 8 and Figure 9. During the measurement of 2008 only the central part of the nourishment was placed, approximately between transect 1509 and 1571. The other parts are visible in the measurement of 2009, as can be seen in Figure 9 and Figure 10.

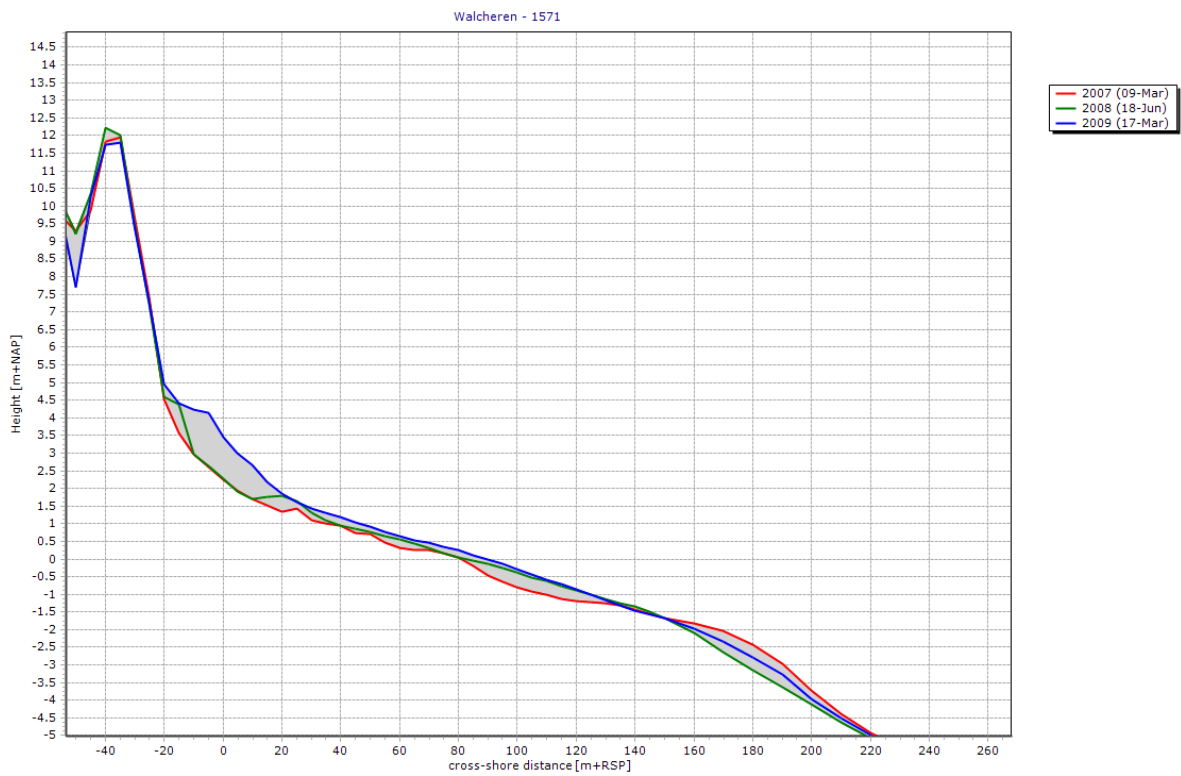
Figure 9: Placement of nourishment in transect 1571

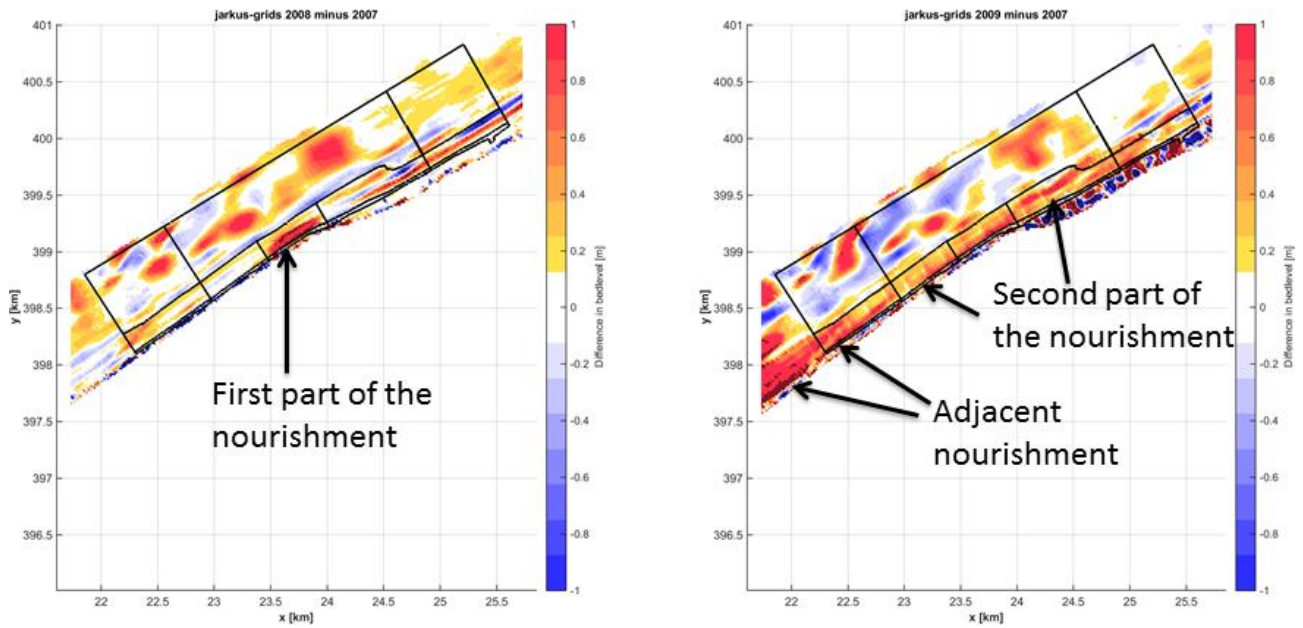
Figure 10: Placement of nourishment visible on difference maps 2008-2007 (left) and 2009-2007 (right)

In the central part the sediment volume increased between 2007 and 2008 with ca. 80.000 m³, in the entire nourished area with ca. 100.000 m³. In 2009 the entire nourished area gained ca. 180.000 m³ of sediment. This is much lower than the designed volume of ca. 370.000 m³, probably due to the long period between placement and, mainly, following measurement (2009) for the side parts, during which part of the nourished sediment already eroded.

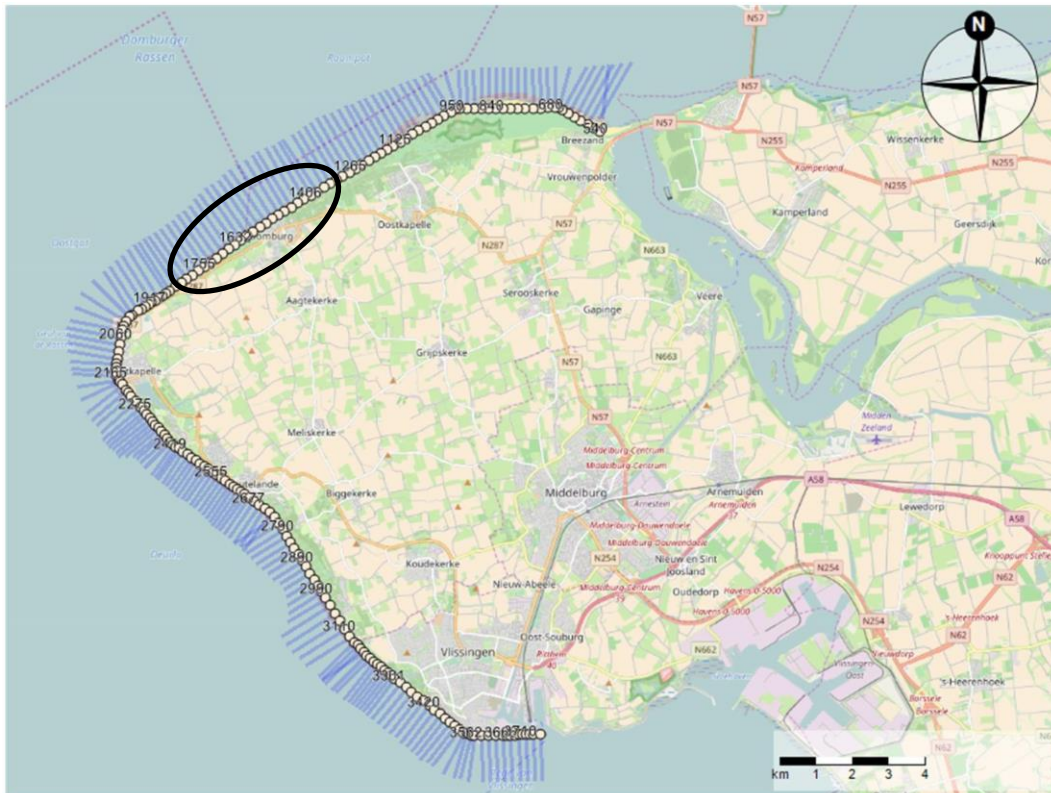
Figure 11: A top view of Walcheren. The blue lines indicate transect 540 till 1883. The black circle marks the transects which are considered in this report. Reprint from (Masterberg, Nederhoff, Valk, & Maarse, 2017)

Since 1965 the Dutch coast is yearly measured along cross-shore transects: the JARKUS transects, see Figure 11. These transects are located over the entire Dutch coast and are 130 to 210 m apart. For each transect part of the dunes, the beach and the shoreface is measured. The dry areas are measured using laser altimetry and the wet area by singlebeam echosounders. The data is combined to determine the vertical level along each transect. Because several sources are used, the cross-shore resolution changes from a 5 m resolution when altimetry data is used to a vertical level every 10 m for the echosounder data. Each year the position of the transects and the location of a vertical level along a transect are identical but extension of the measurement offshore differs.

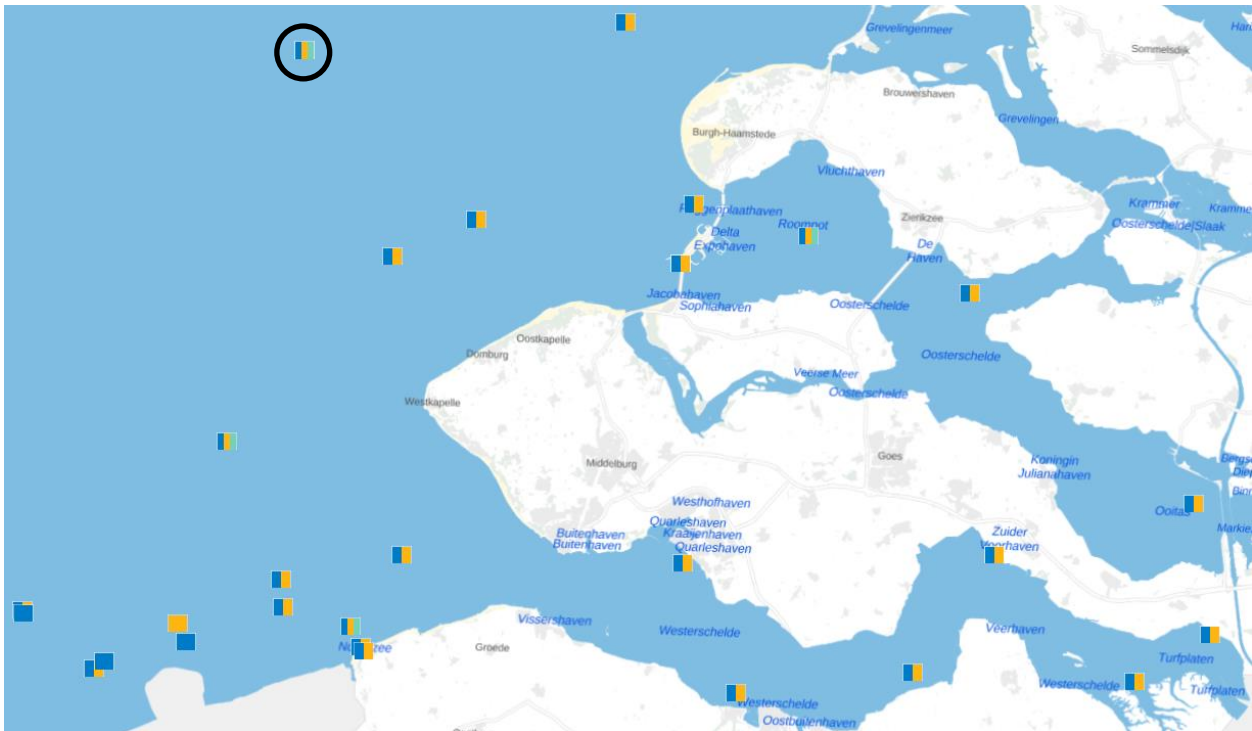
Figure 12: The measuring location for the wave height located in the area of Domburg. The vertical stripes of the symbols indicate which bulk wave condition is available at a station. The black circle marks the Europlatform; the station which is analysed in this report.

In front of the Dutch coast a considerable number of measuring locations are available, see Figure 12. Their data is freely provided by Rijkswaterstaat (waterinfo.rws.nl). The physical quantities measured at each station can be different at each location. Also, the duration of the measurements varies from location to location. For Domburg, several locations are combined to obtain sufficient data. The combination procedure is explained in Chapter 5.

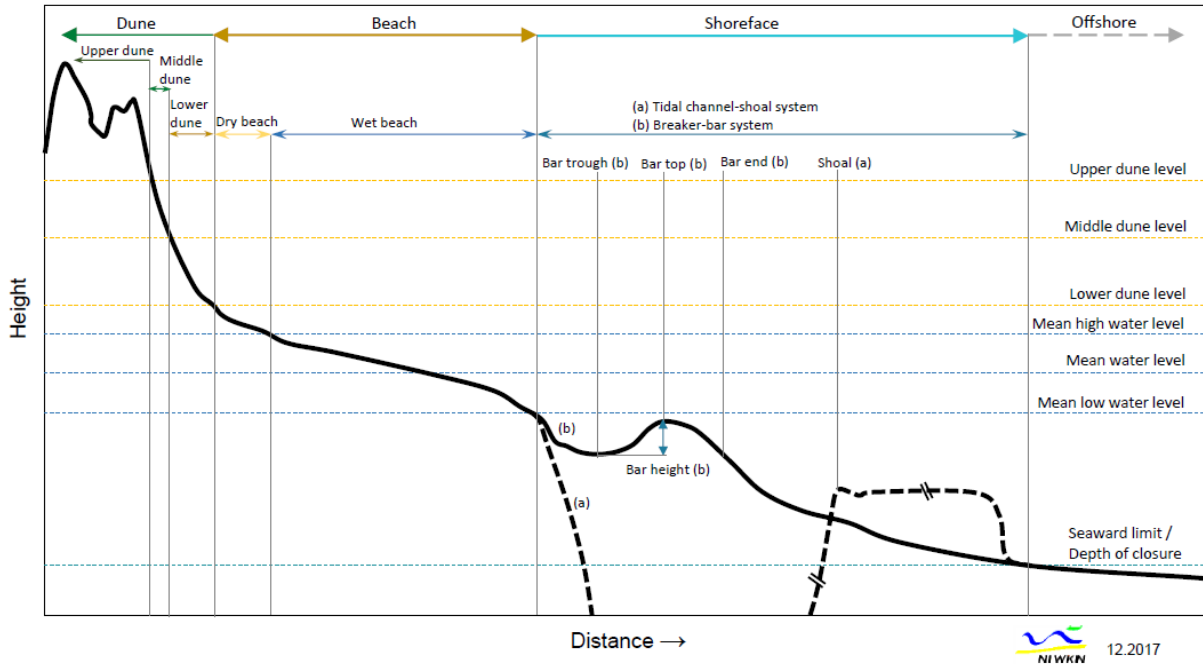
Figure 13: General definition/terminology coastal profile used. On the vertical axis various levels in the profile are shown. The horizontal axis shows different zones in the profile. Source: Simon Hillmann (NLWKN)

The coastal zone terminology in figure 1 will be applied throughout the analysis. The CSI's corresponding to the coastal terminology are shown in Figure 13 and described in Table 4. The morphological development

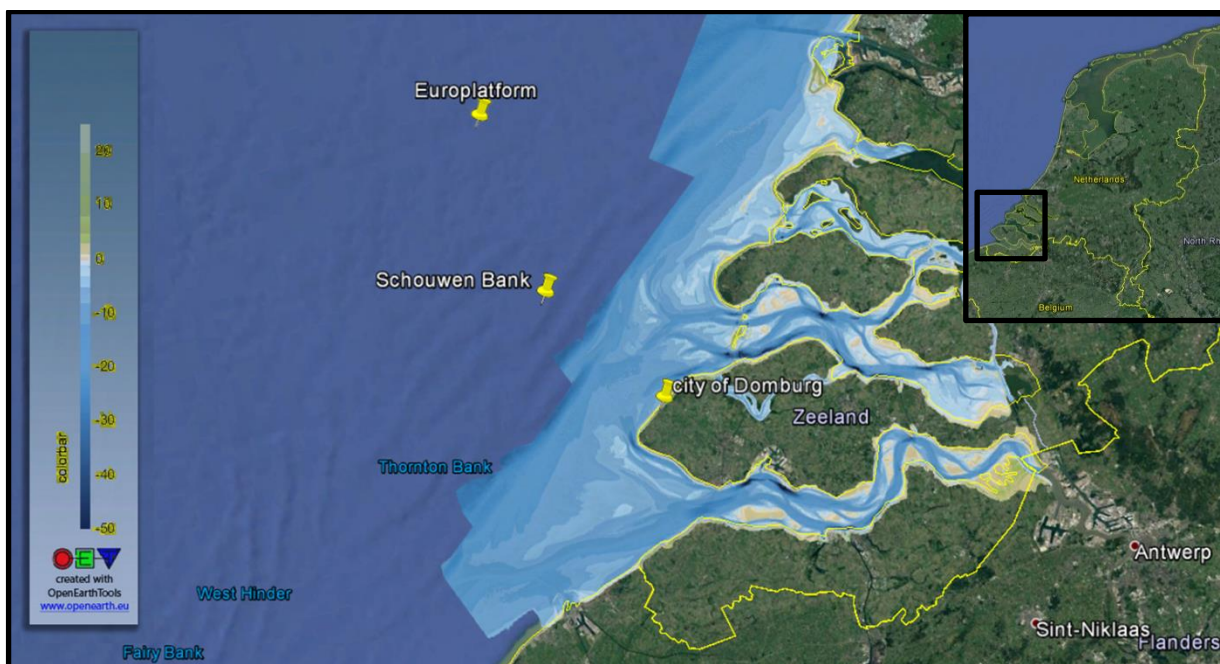
Figure 15: A google earth screenshot indicating the location of the Europlatform and the Schouwen Bank. The figure also contains the bathymetry based on the vaklodgingen.

For Domburg two logical measuring stations can be chosen: measuring location Europlatform and measuring location Schouwen Bank, see Figure 15. The measuring station Schouwen Bank is the station closest to the coastal laboratory. Therefore, the waves measured at this station should be most representative for the conditions at Domburg. On the other hand, only since 2004 measurements have been taken at the Schouwen Bank and the time series contains several intervals with no data, see Figure 16.

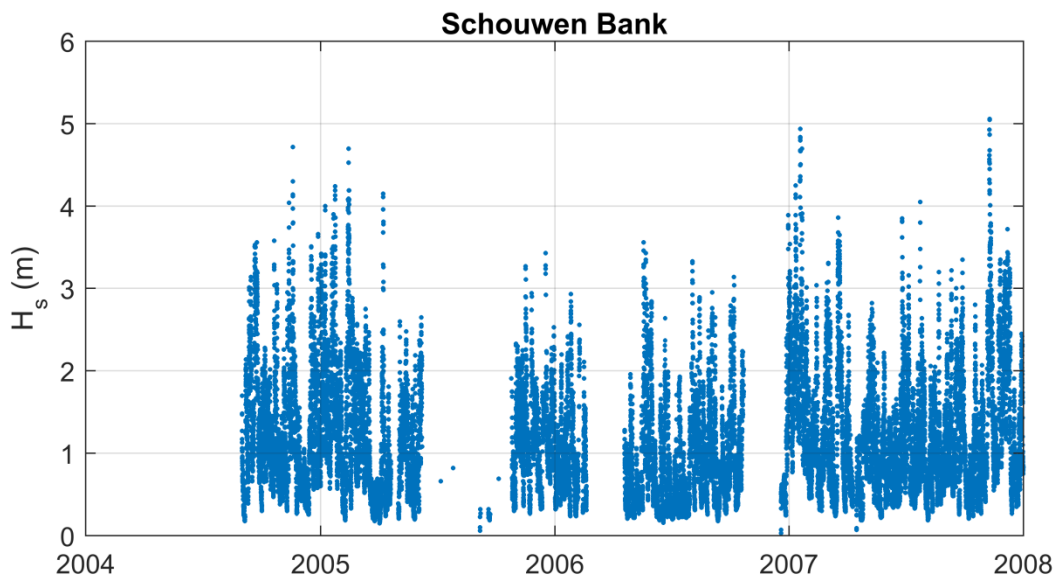
Figure 16: H_s measured at the Schouwen Bank before from 2004 till 2008.

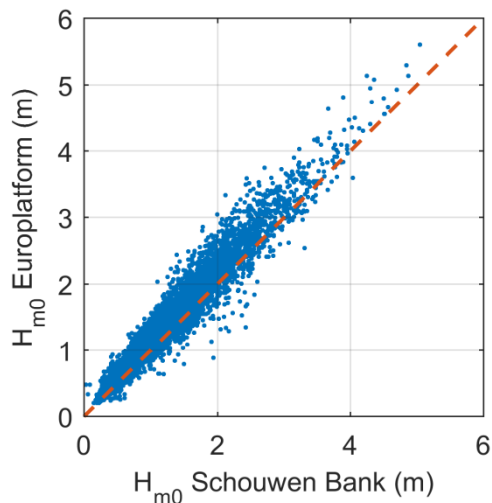
Figure 17: A scatterplot of the H_s measured at the Schouwen Bank and at the Europlatform from 2004 till 2008.

At the Europlatform the wave height is measured since 1989. These measurements can be used in the analysis if they show the same pattern as the measurements at Schouwen Bank. Only the pattern requires to be the same because it is going to be used in a qualitative analysis. Figure 17, Figure 18 and Figure 19 show scatterplots of the measurements from 2004 till 2008 for which at both location measurements were available. The scatterplots reveal a good comparison between the hydraulic conditions. Therefore, the hydraulic conditions measured at the Europlatform are used as a measure for the hydraulic condition at Domburg.

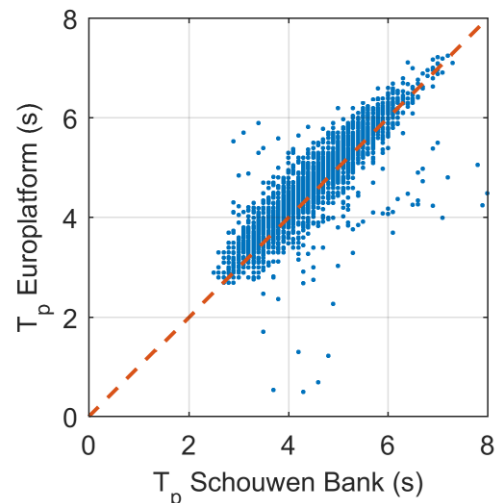
Figure 18: A scatterplot of the T_p measured at the Schouwen Bank and at the Europlatform from 2004 till 2008.

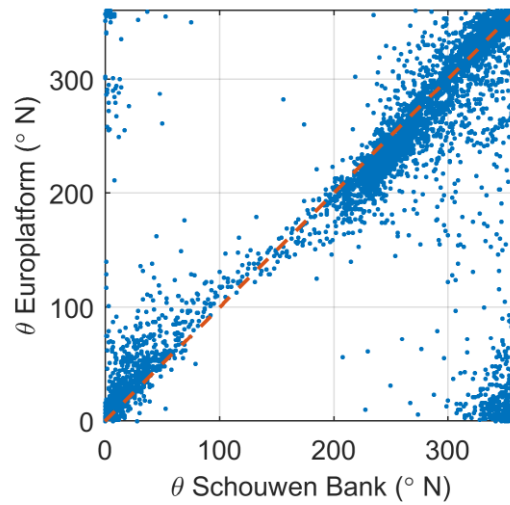
Figure 19: A scatterplot of the θ measured at the Schouwen Bank and at the Europlatform from 2004 till 2008.

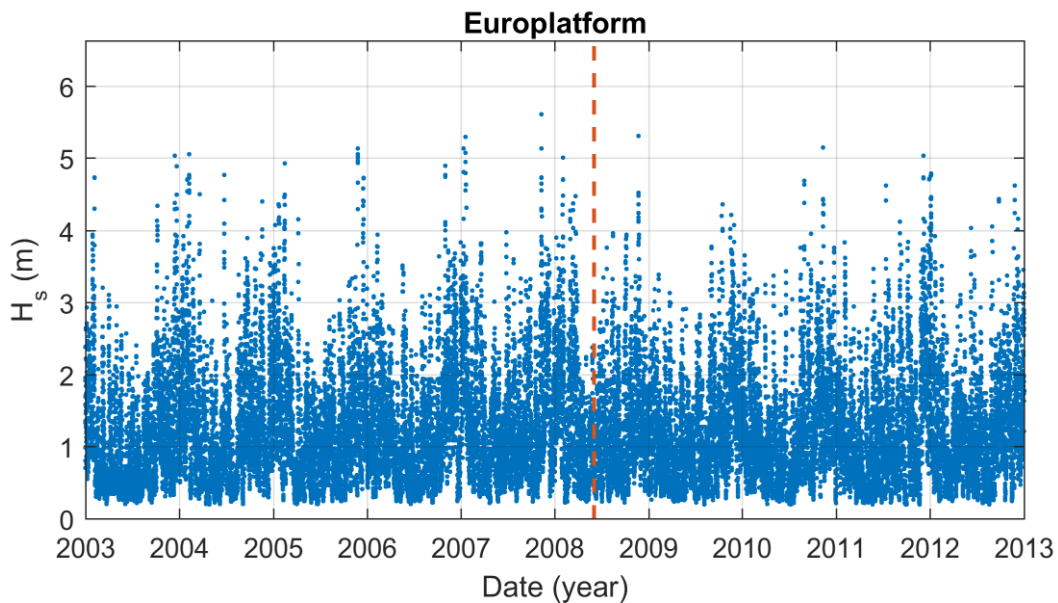
Figure 20: The measured value of H_s at the Europlatform. The red dotted line indicates the nourishment.

The measured time series at the Europlatform are given in Figure 20, Figure 21, Figure 22. The time signal for H_s shows several local maxima due to storms. The maximum H_s during a storm is in the order of 5~6 m and each year contains multiple storms. The peak period is in the order of 7 s during these events. The 7 s period is typical for wind generated waves. The direction shows a dominant direction from the 200° till 50°.

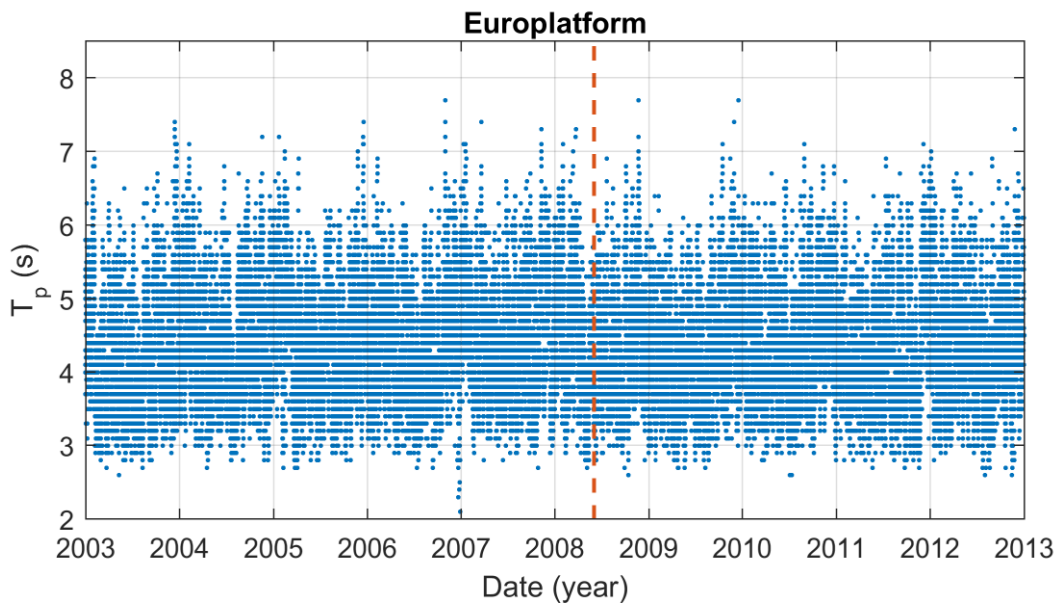
Figure 21: The measured value of T_p at the Europlatform. The red dotted line indicates the nourishment.

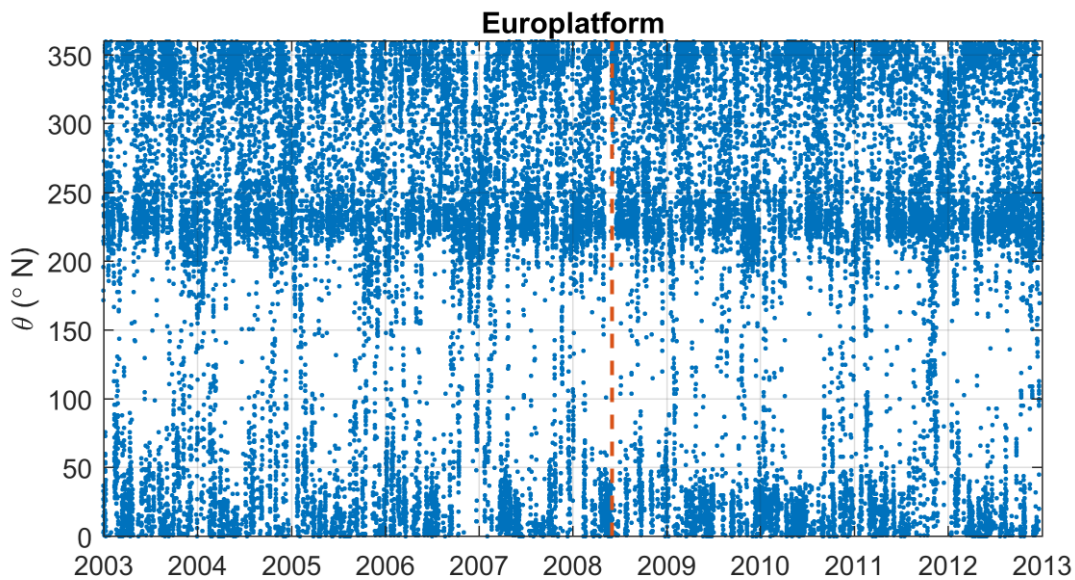
Figure 22: The measured value of θ at the Europlatform. The red dotted line indicates the nourishment.

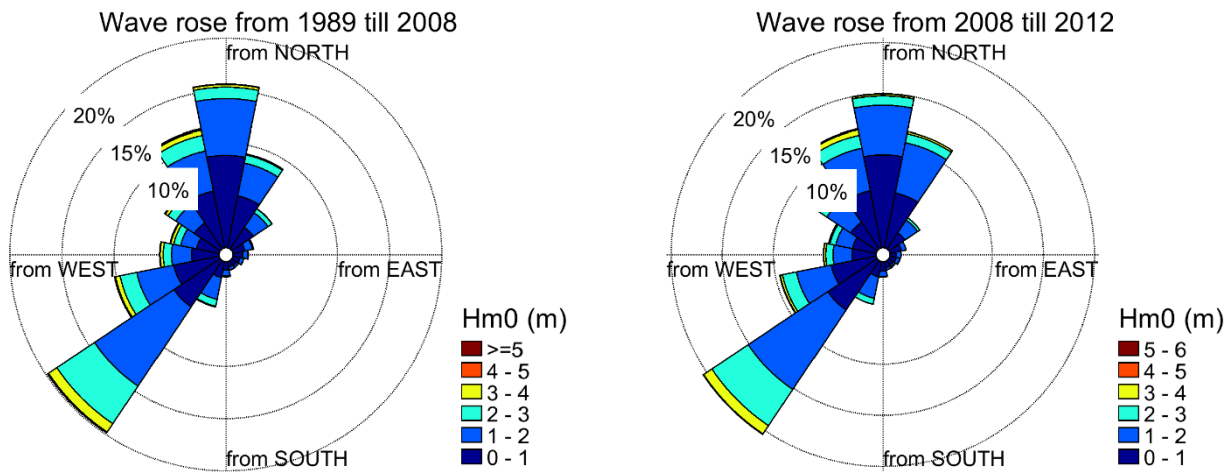
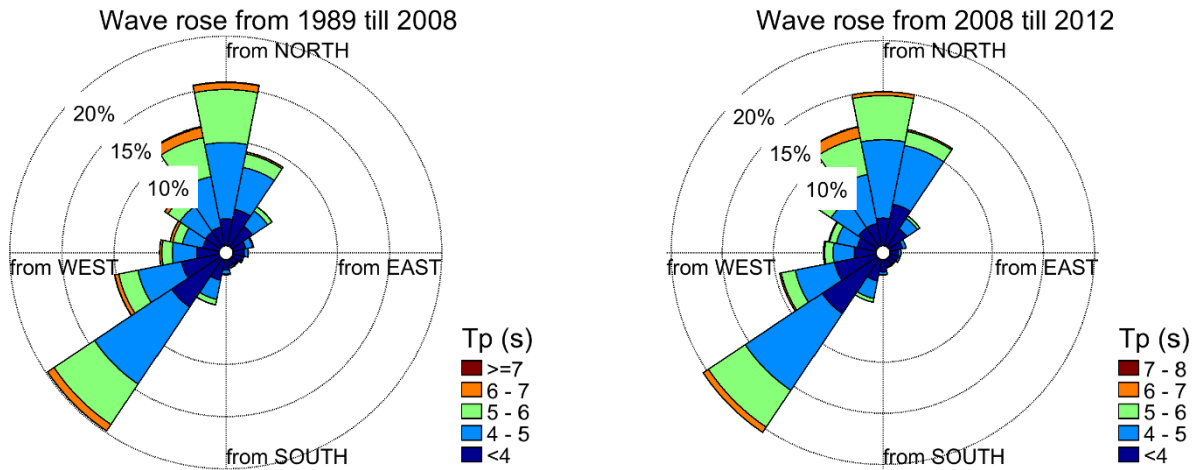
Figure 23: Wave roses based on the measurements at the Europlatform. The year 2003 till 2008 is before the nourishment and 2008 till 2012 is after the nourishment.

To further analyse the direction, wave roses are plotted, see Figure 23. All the four roses show two dominant peaks, from the North West and South West direction. It is a so-called bidirectional system. The wave rose for T_p has a similar shape as for H_s indicating the correlation between T_p and H_s . It means the waves are mainly wind generated. When the wave rose is investigated in more detail, it shows that the highest waves are coming from the North-West, the typical northwest storm. Most importantly, the wave roses show a similar pattern before and after the nourishment. In other words, similar hydrodynamic conditions took place before and after the nourishment.

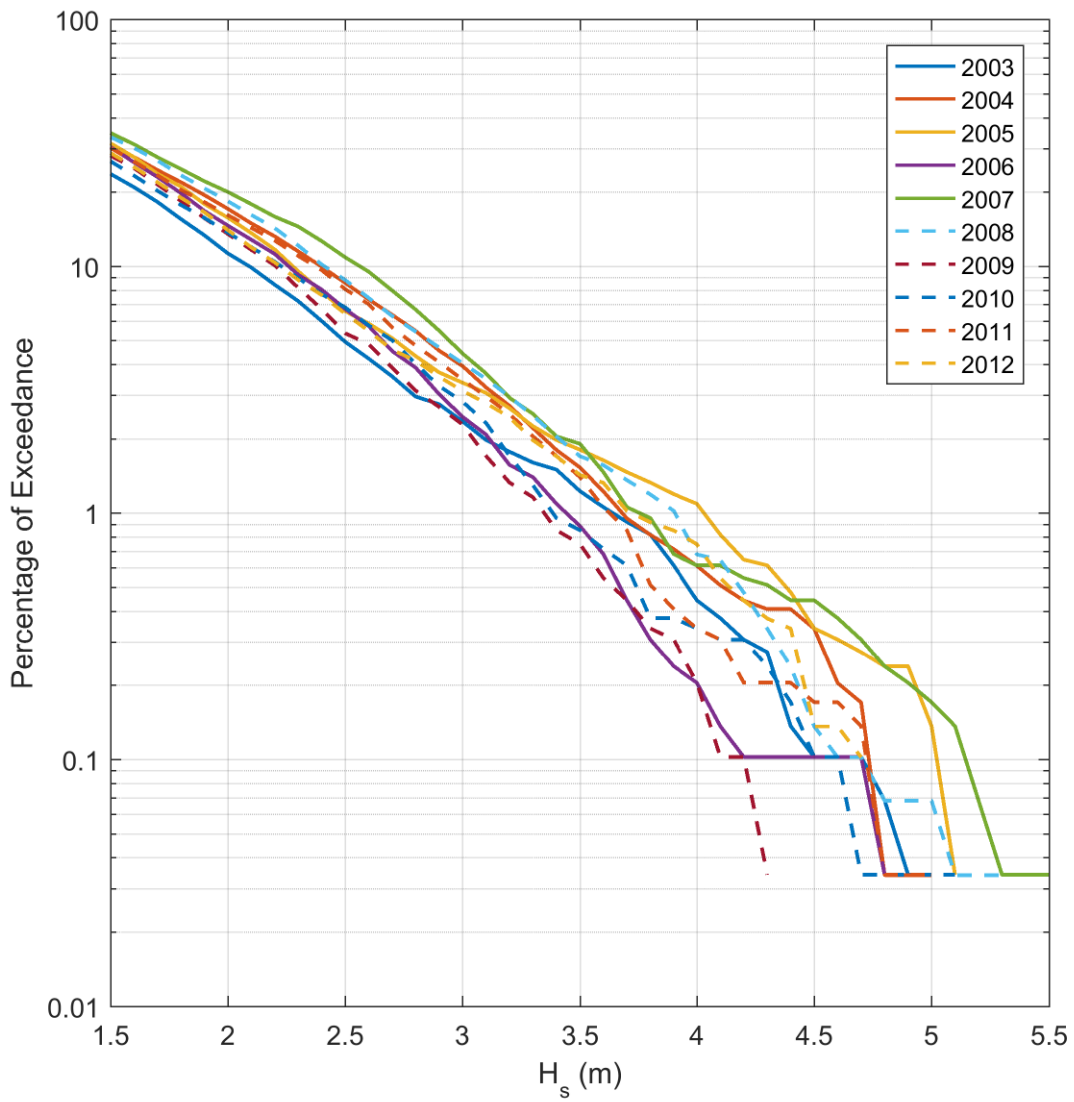
Figure 24: Percentage of exceedance of the measurements H_s at the Europlatform for each year.

In Figure 24 and Figure 25 the percentages of exceedance of H_s and T_p are visualised to compare the severeness of the hydraulic conditions. The solid lines are the years before the nourishment and the dotted lines after the nourishment. Overall, the percentage of exceedance for the solid lines is higher for the same value of H_s or T_p . It means that the hydraulic conditions before the nourishment were more harsh than after the conditions. Note, the percentage of exceedance is based on the number of measurements and not on the duration of a specific value.

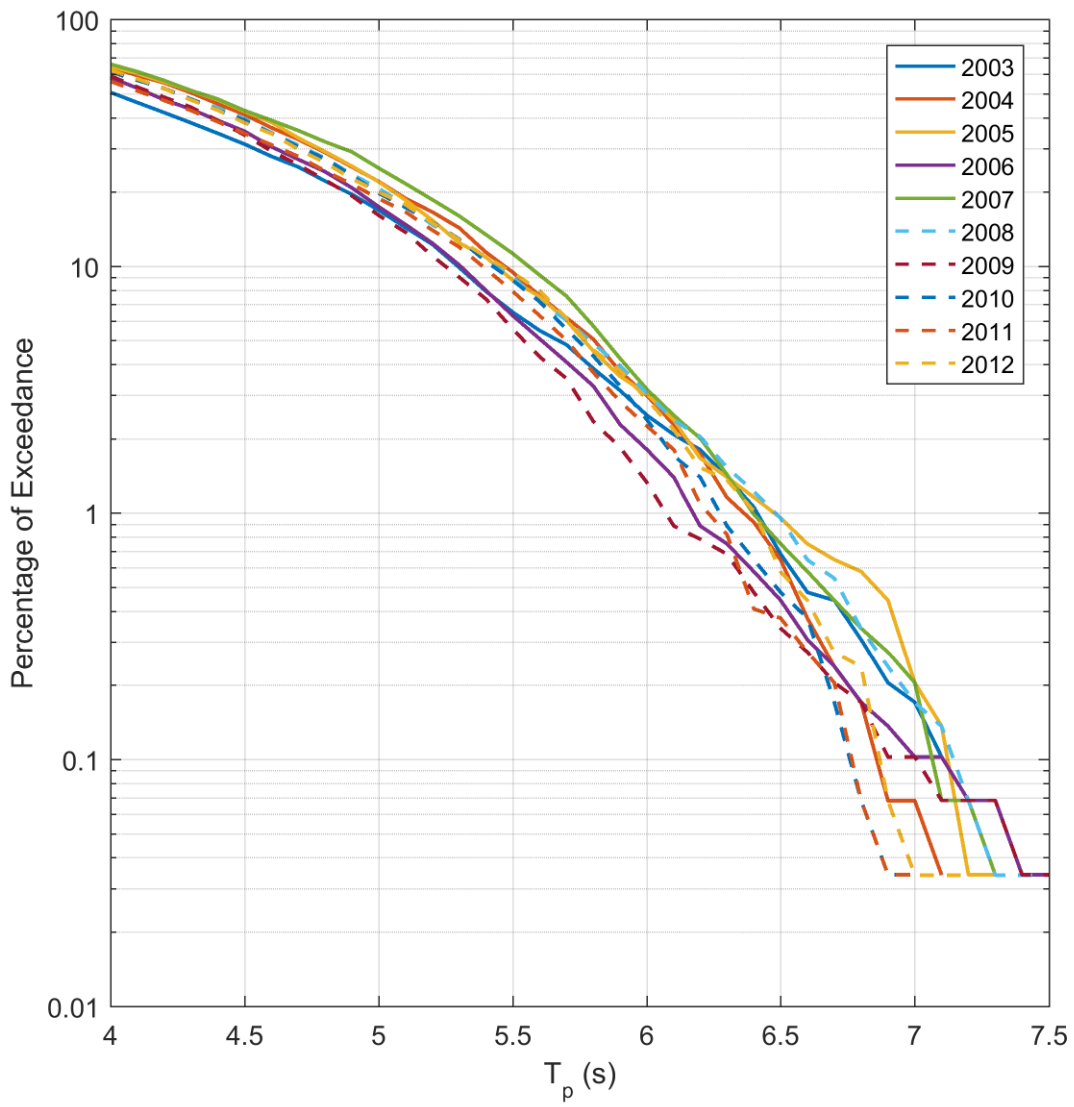
Figure 25: Percentage of exceedance of the measurements for T_p at the Europlatform for each year.

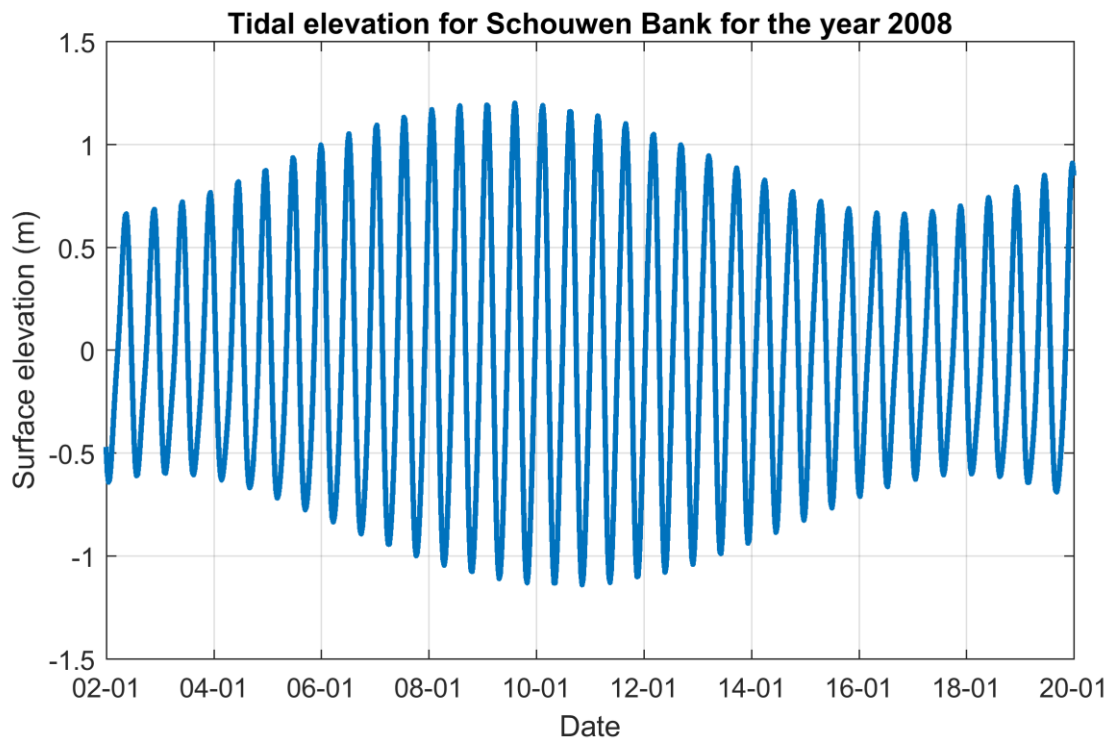
Figure 26: Part of the tidal signal from the IHO station Schouwen Bank.

For tidal information the IHO station Schouwen Bank is used to provide the tidal elevation from 2000 till 2016. This data can easily be accessed by the Delft Dashboard (Nederhoff, Dongeren, & Ormond, 2016). Part of the tidal signal is visualized in Figure 26. The signal reveals that the elevation is mainly semidiurnal (two low waters and two high waters each day) but also higher harmonics are visible. The three dominant tidal constituents are given in Table 6. The values for the constituents are in line with the tidal signal. The tidal signal shows two peaks each day due to the M2 and S2 tide. One peak is slightly higher than the other. The M4 tide is responsible for this difference. Also, the signal shows a long periodicity in the order of 14 days. This follows from the phase difference between M2 and S2.
