National analyses of nourishments;

*Coastal state indicators and driving forces for Domburg,
the Netherlands*

Date: 05/08/2019

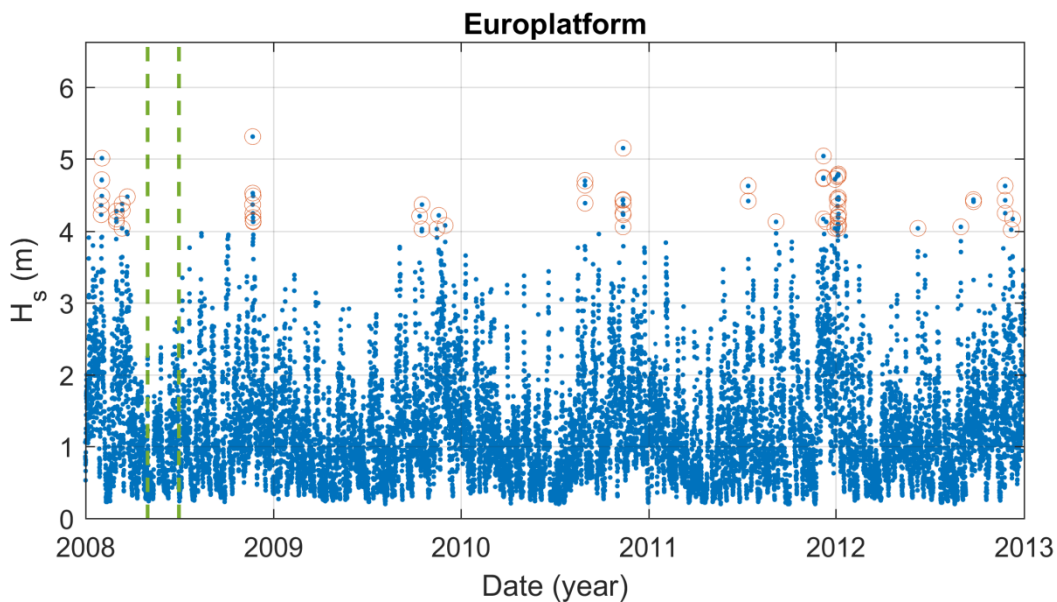
Figure 27: A time series of the wave height. The red circles indicate the events with $H_s > 4m$ and the green lines the start and end time the nourishment.

Part of the events is shown in Figure 27. The figure reveals that the events are nicely grouped in storms. How many times the value of H_s is larger than 4 m indicates how long a high storm surge has occurred. From 1989 till 2008 (before the investigated nourishment) 0.6439% of the time the value of H_s was larger than 4 m. Furthermore, between 2008 and the end of 2012 the percentage was 0.4323%. In other words, slightly less extreme wave heights occurred after than before the nourishment.

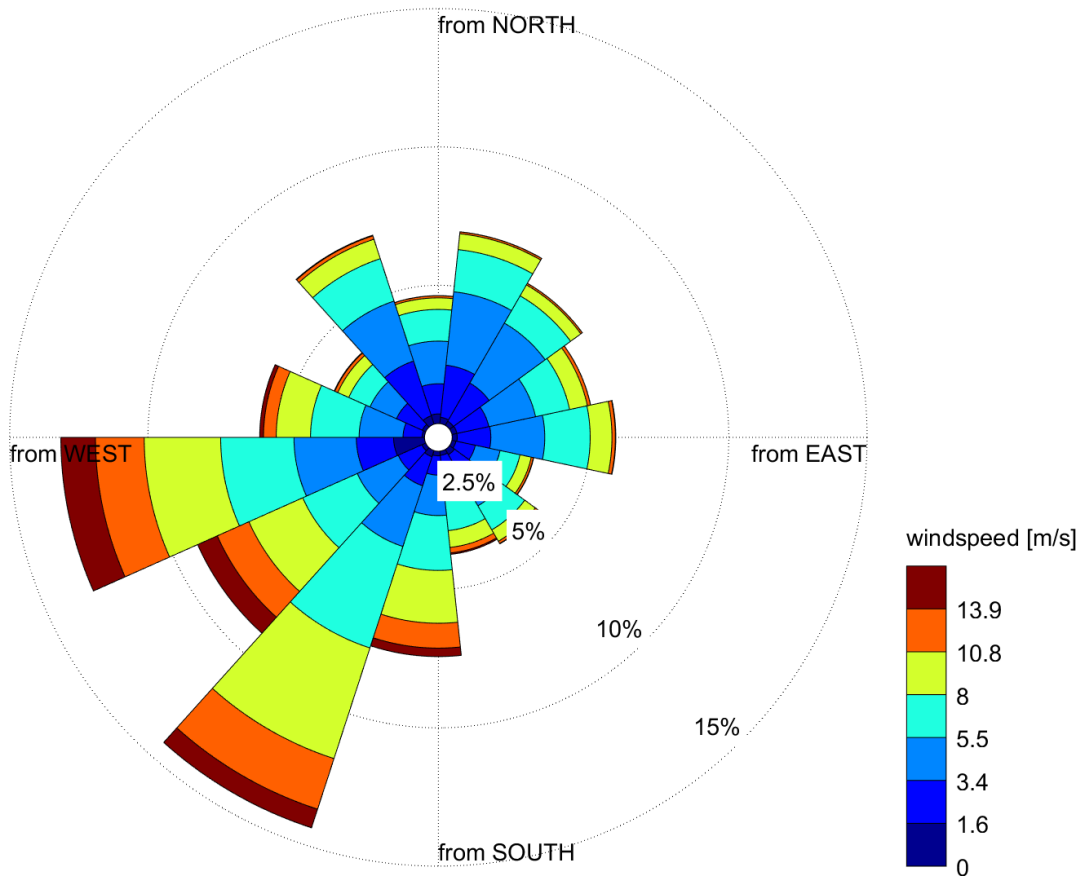
Figure 28: Wind conditions for the long term, pre nourishment period 1989-2008

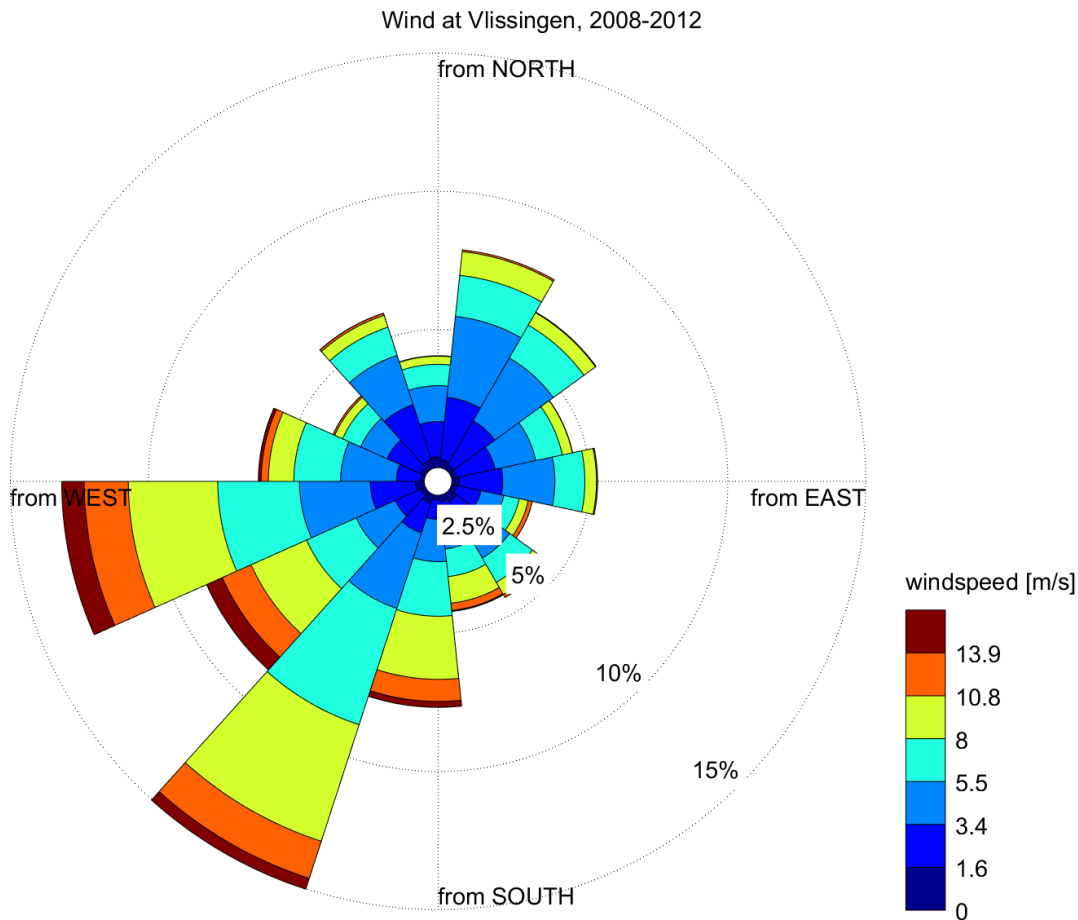
Figure 29: Wind conditions in the nourishment period

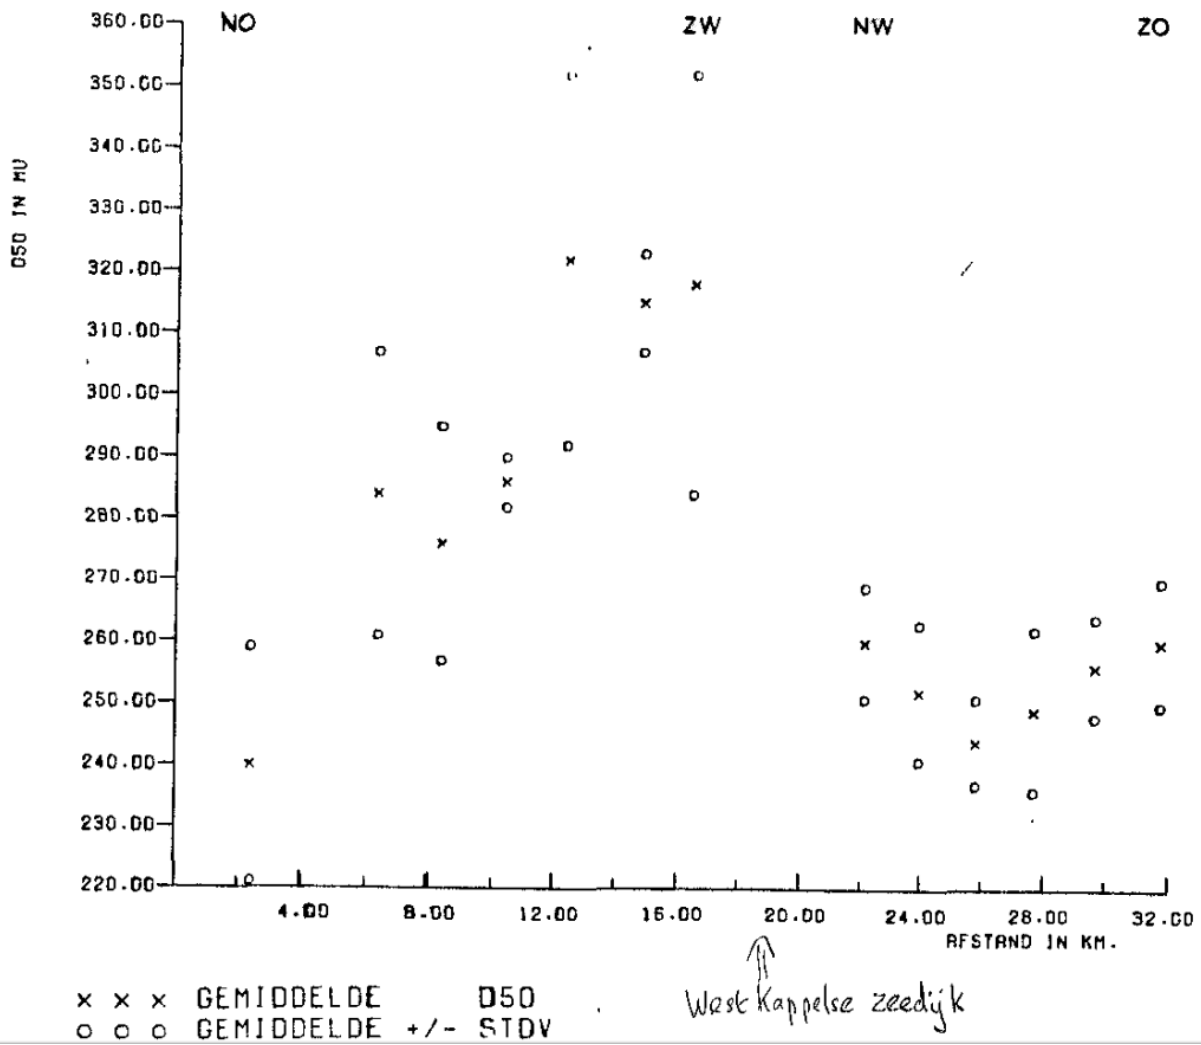
Figure 30: Average median grain size for the dunes of Walcheren, the studied nourishment is around 15.00 with a D50 around 300 micron. Source: Koksiek (1984)

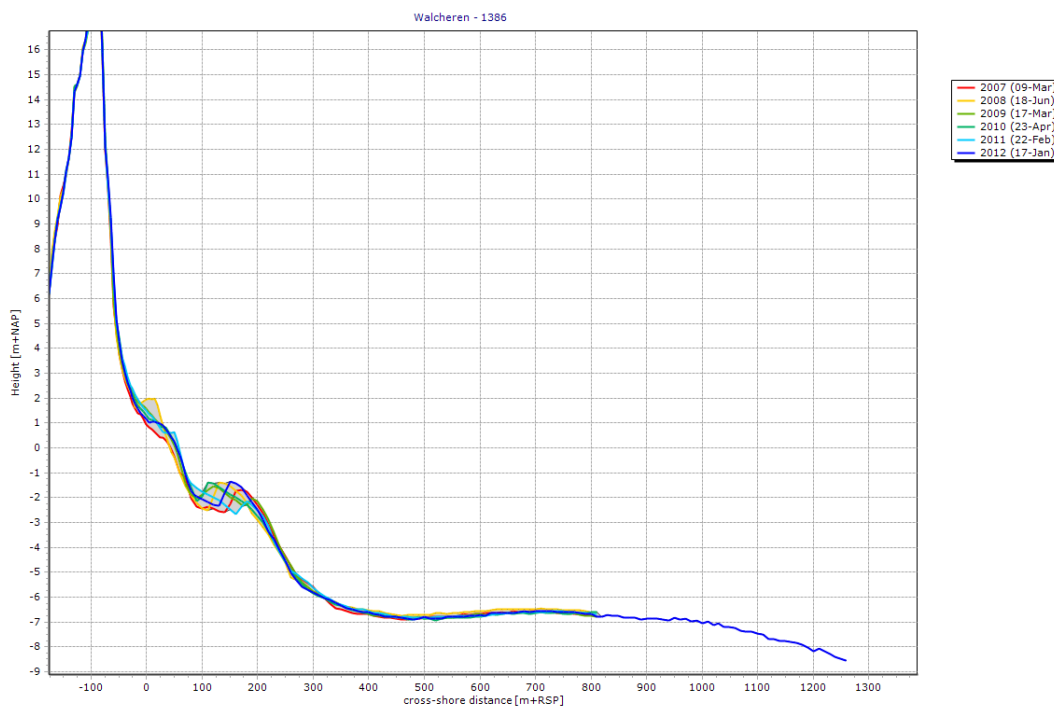
Figure 31: Development of shoreface in transect 1386 between 2007 and 2012

The shoreface at the nourishment location deepens up to about NAP -8 m and remains at this depth for ca. 600 m, where the Roompot channel begins. The shoreface is relatively stable on the short term, see Figure 31 and Figure 32. Small undulations that are visible are caused by morphological bed forms similar to sand waves, which are visible in multibeam bathymetry, see Figure 33. No significant change in the shoreface is visible in the years after the beach nourishment.

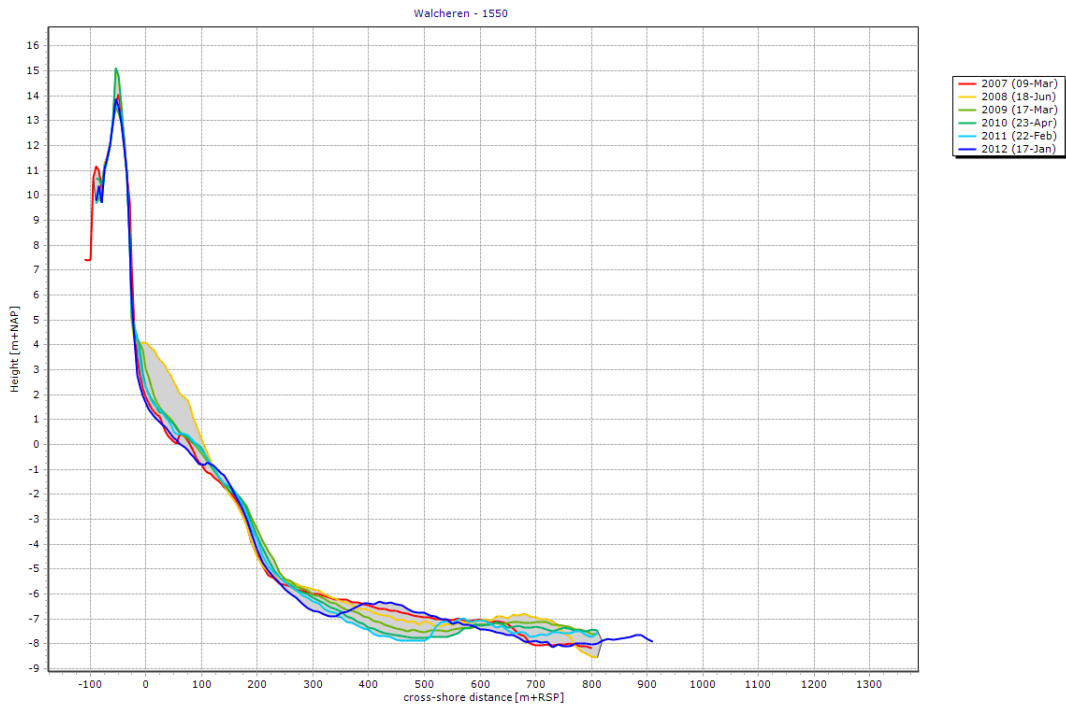
Figure 32: Development of shoreface in transect 1550 between 2007 and 2012

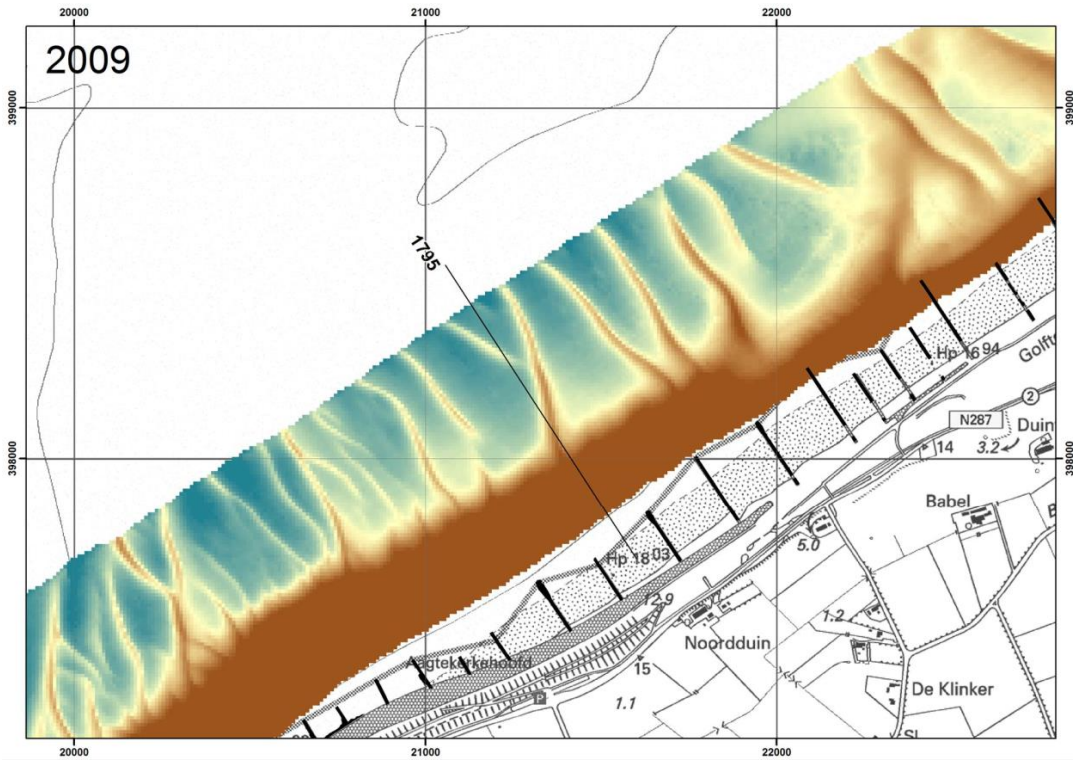
Figure 33: Multibeam bathymetry of shoreface close to Domburg (source: Mastbergen et al., 2017)

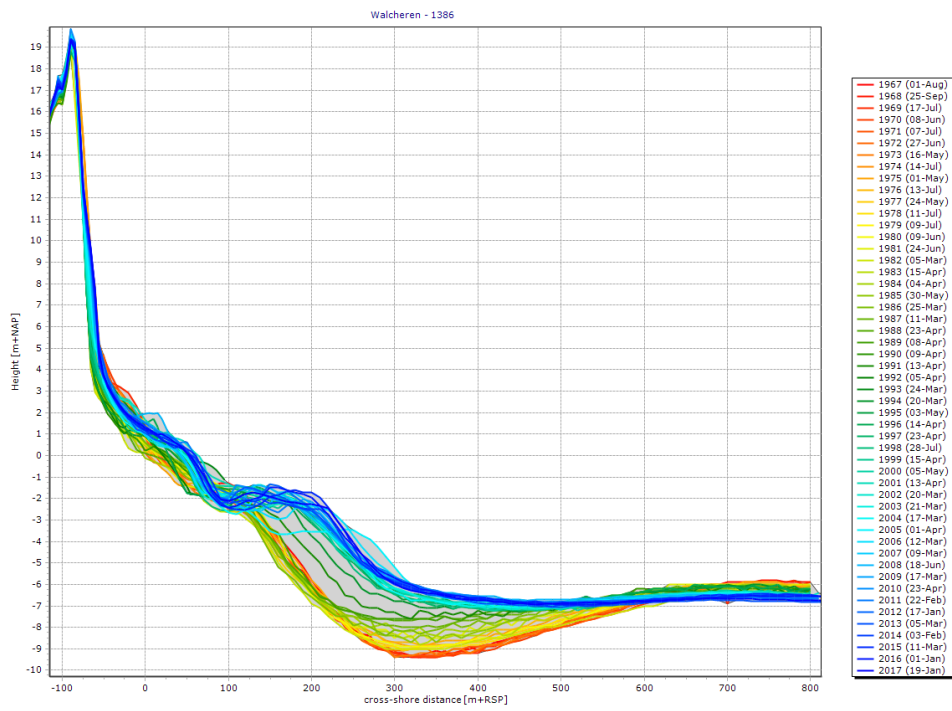
Figure 34: Development of shoreface in transect 1386 between 1967 and 2017

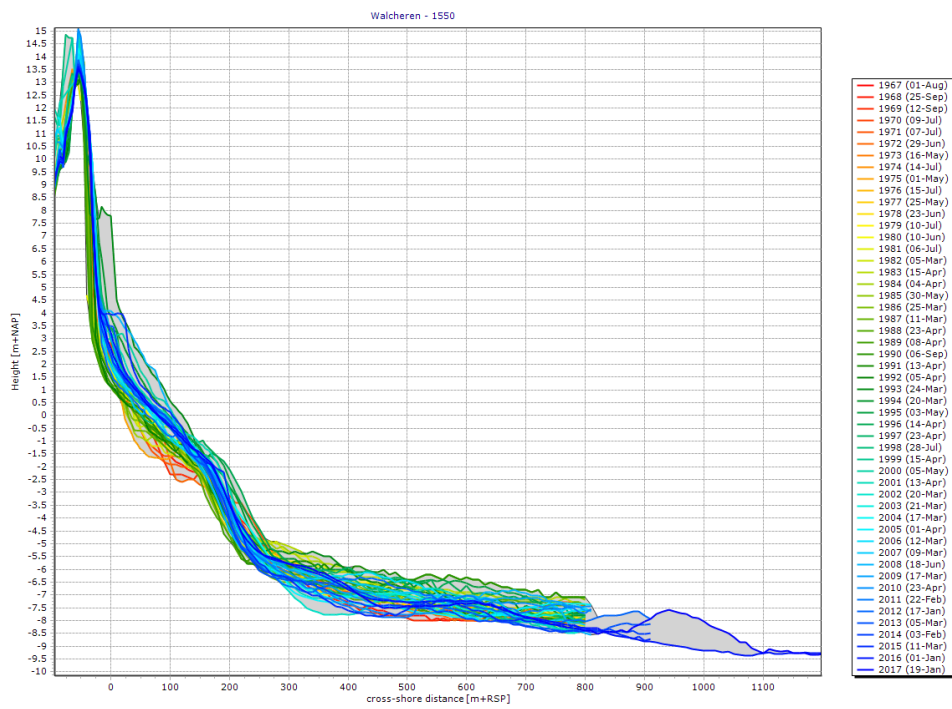
Figure 35: Development of shoreface in transect 1550 between 1967 and 2017

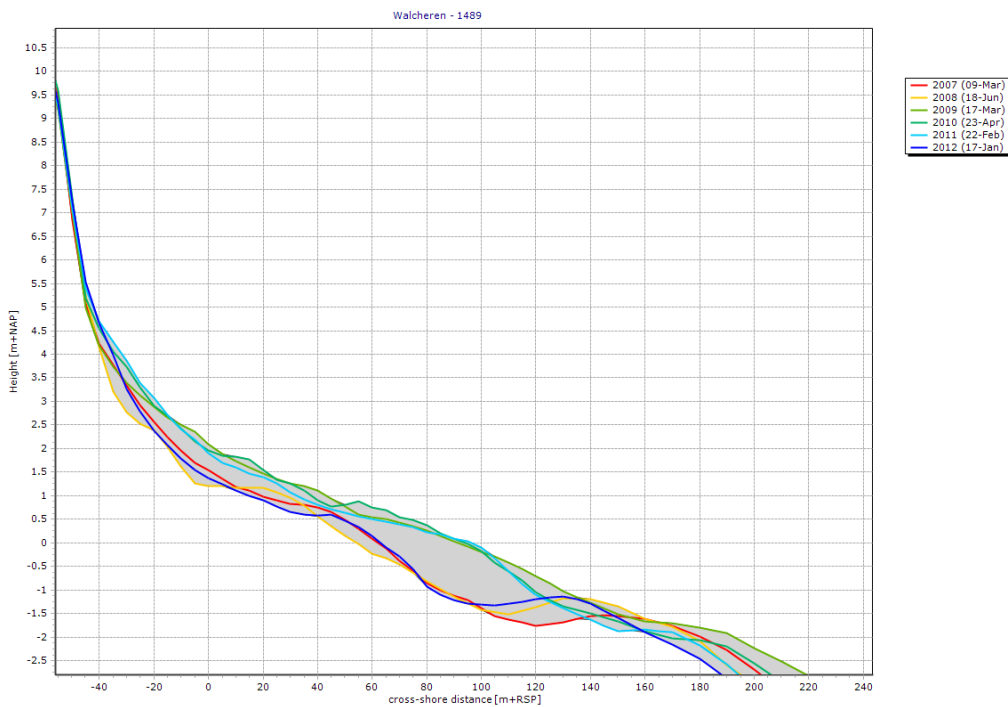
Figure 36: Development of beach and dune in transect 1489 between 2007 and 2012

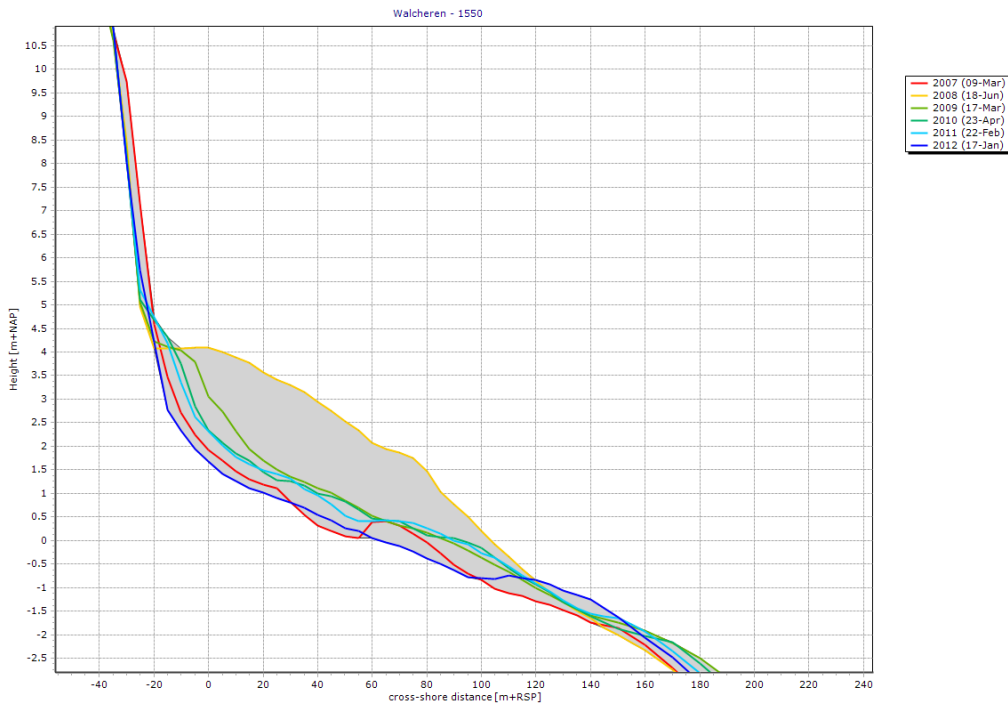
Figure 37: Development of beach and dune in transect 1550 between 2007 and 2012.

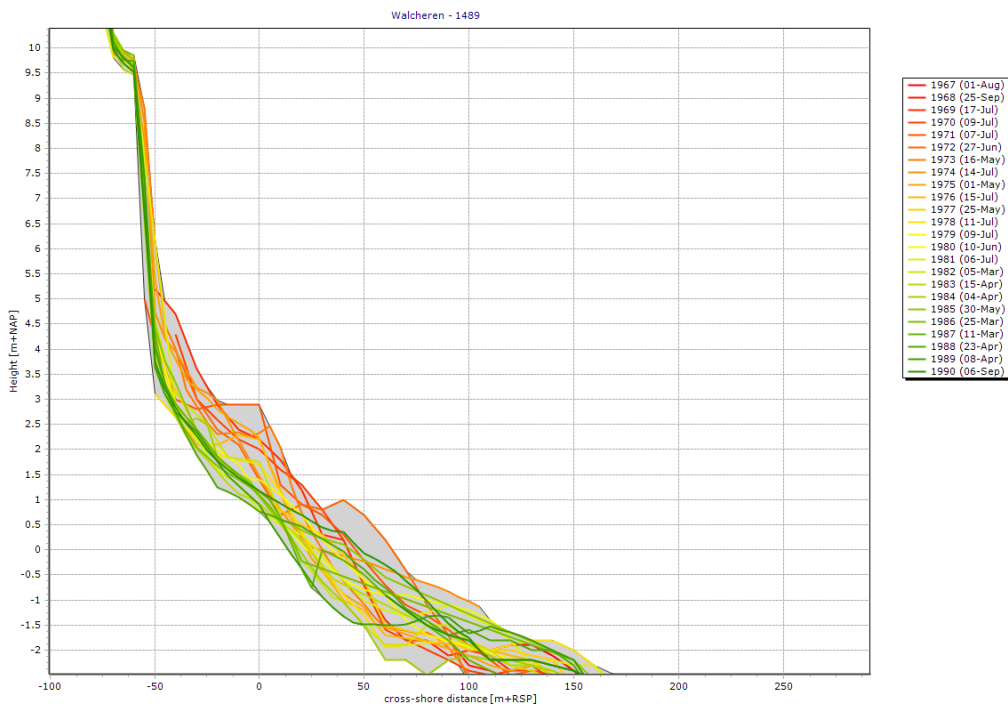
Figure 38: Development of beach and dune in transect 1489 between 1967 and 1990.

On the long term a division in two periods can be made: before and after approximately 1990. In the period up to 1990 erosion occurred at the beach. Especially the upper part of the beach, above ca. NAP +0.5 m, shows constant erosion, see Figure 38, and Figure 39. After 1990 there is still erosion, however regular nourishments cause large jumps in the profile, with a small 'plateau' around NAP +4 m, see Figure 40 and Figure 41.

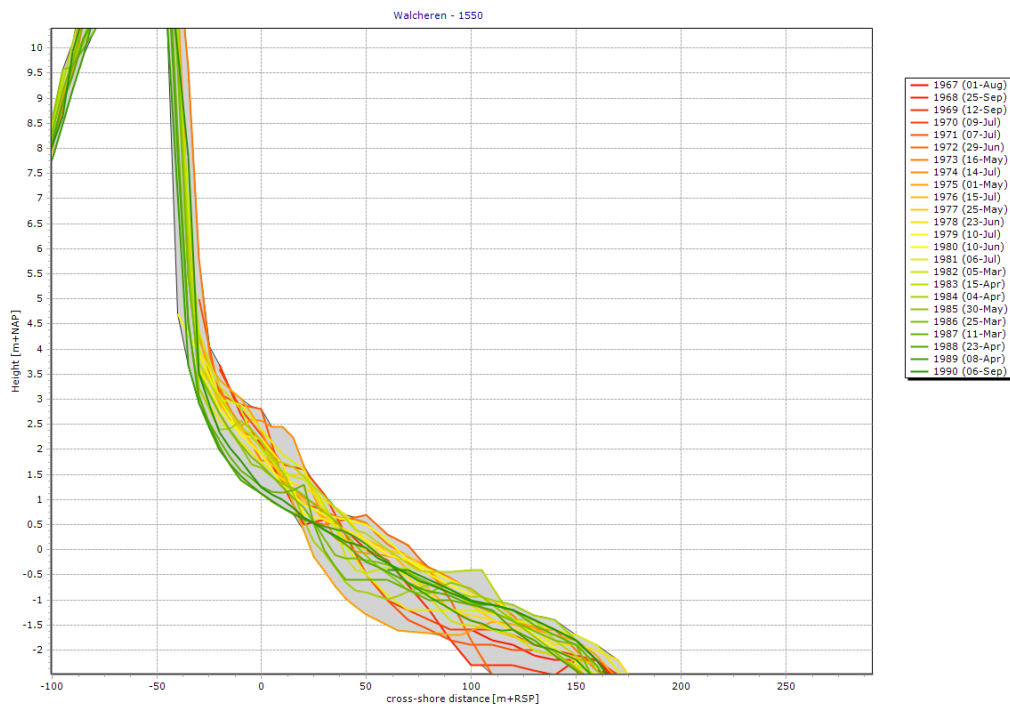
Figure 39: Development of beach and dune in transect 1550 between 1967 and 1990.

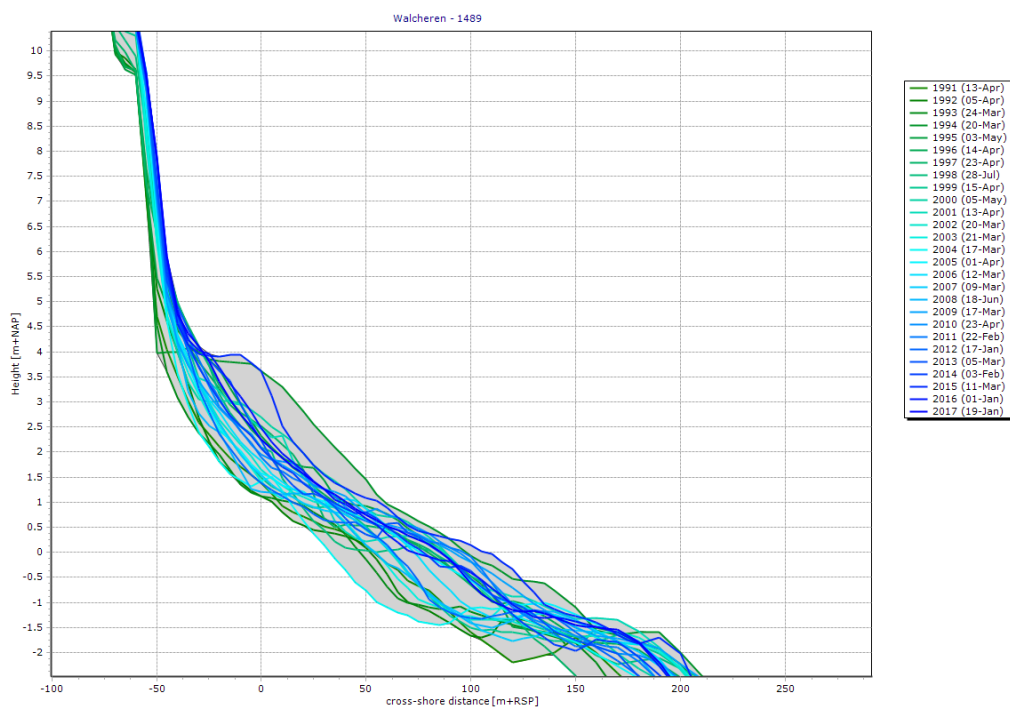
Figure 40: Development of beach and dune in transect 1489 between 1990 and 2017

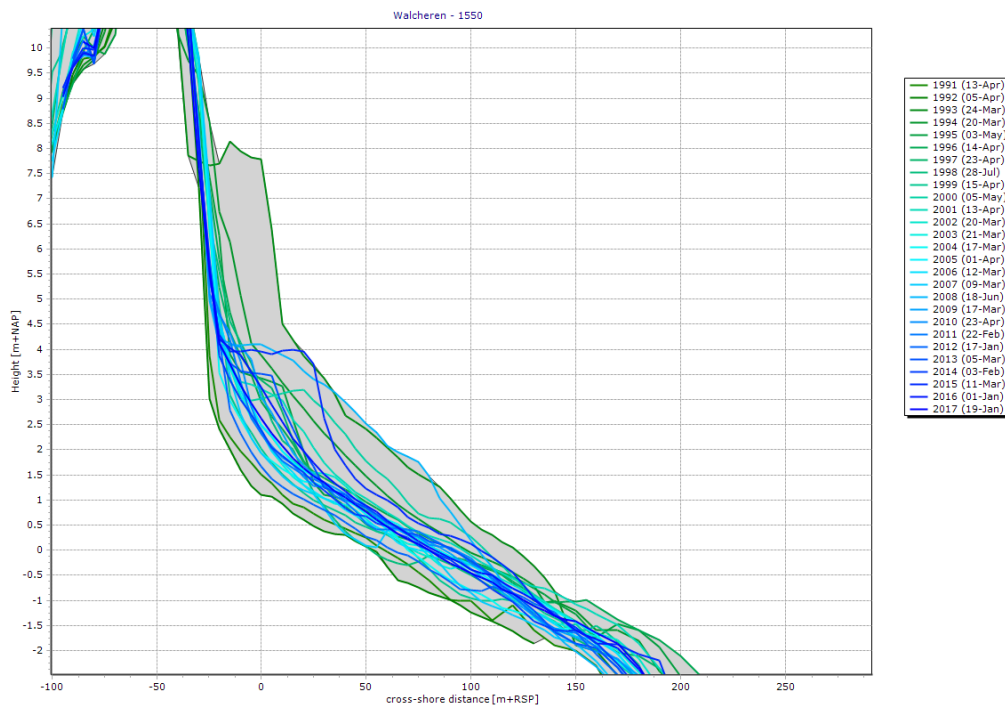
Figure 41: Development of beach and dune in transect 1550 between 1990 and 2017

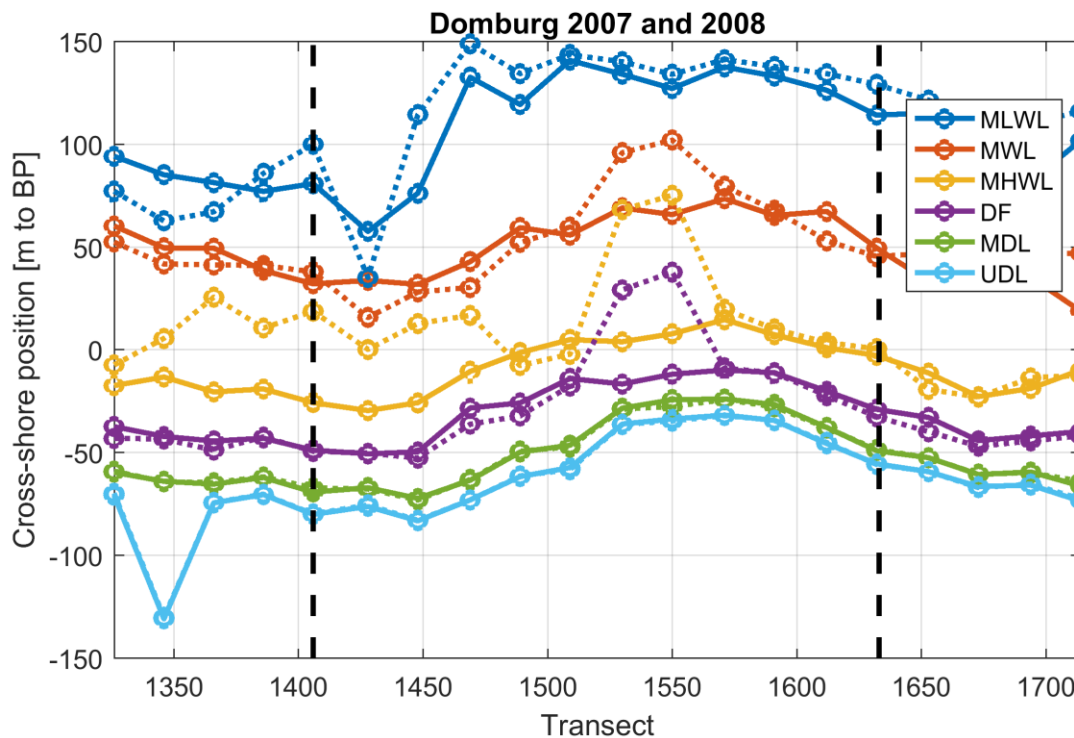
Figure 42: The physical marks of the transects at Domburg for the year 2007 (solid line) and the year 2008 (coloured dashed line). The colours indicate the defined level, see 4.2.1. The black dashed line indicates the prescribed boundary of the nourishment.

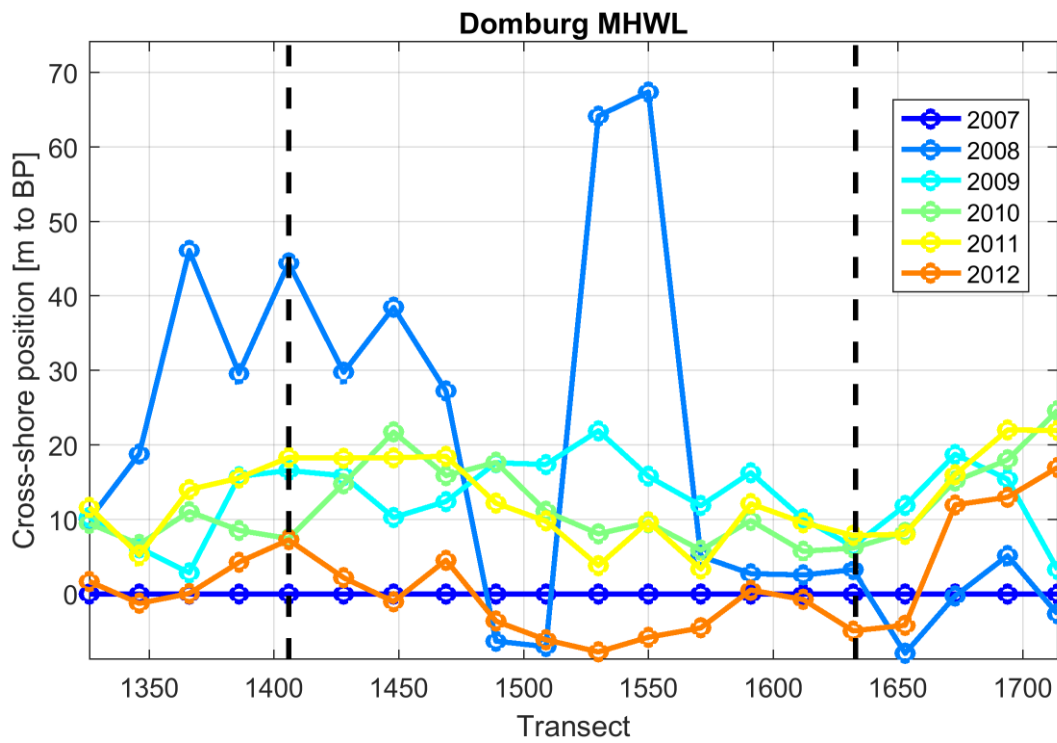
Figure 43: The difference in cross-shore position of MHWL with respect to 2007. When the value is positive the position lays more offshore than in 2007.

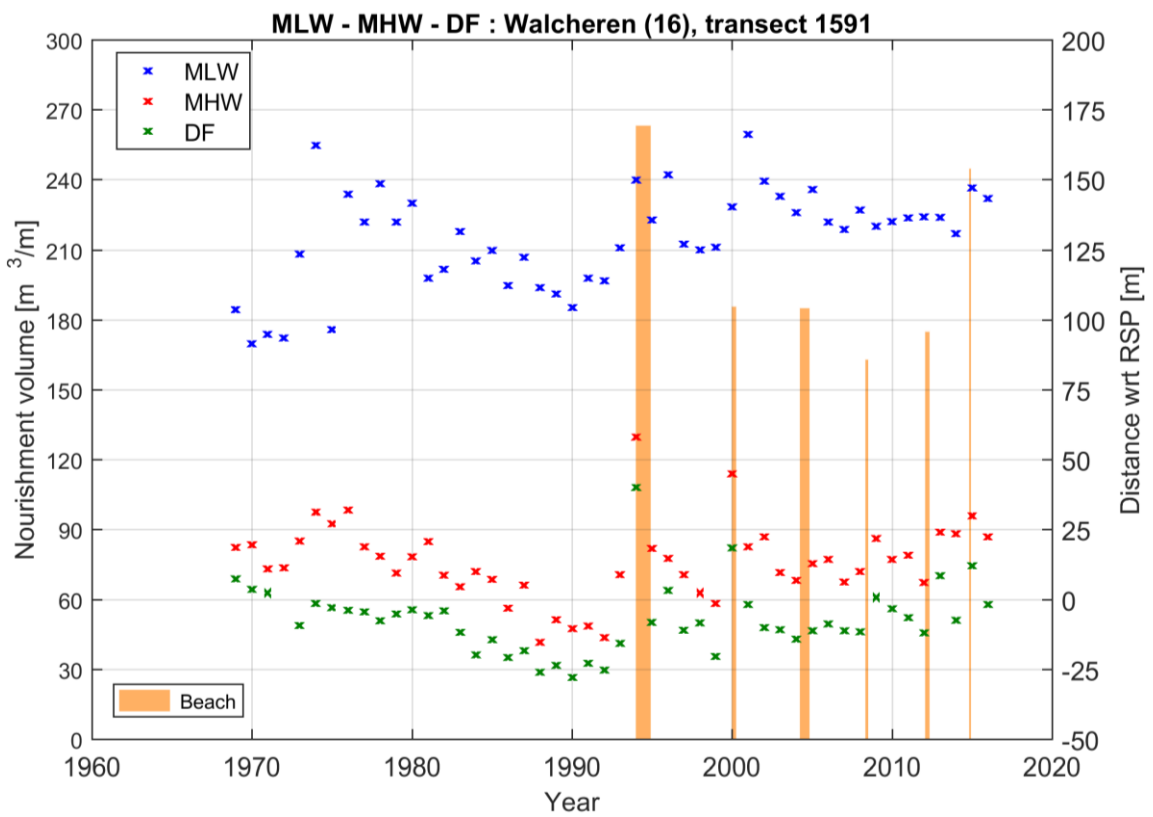
Figure 44: Long term location of the MLW (Mean Low Water), MHW (Mean High Water) and the Dune Foot (DF) as a function of time for transect 1591. The orange bars indicate the volume for a nourishment.

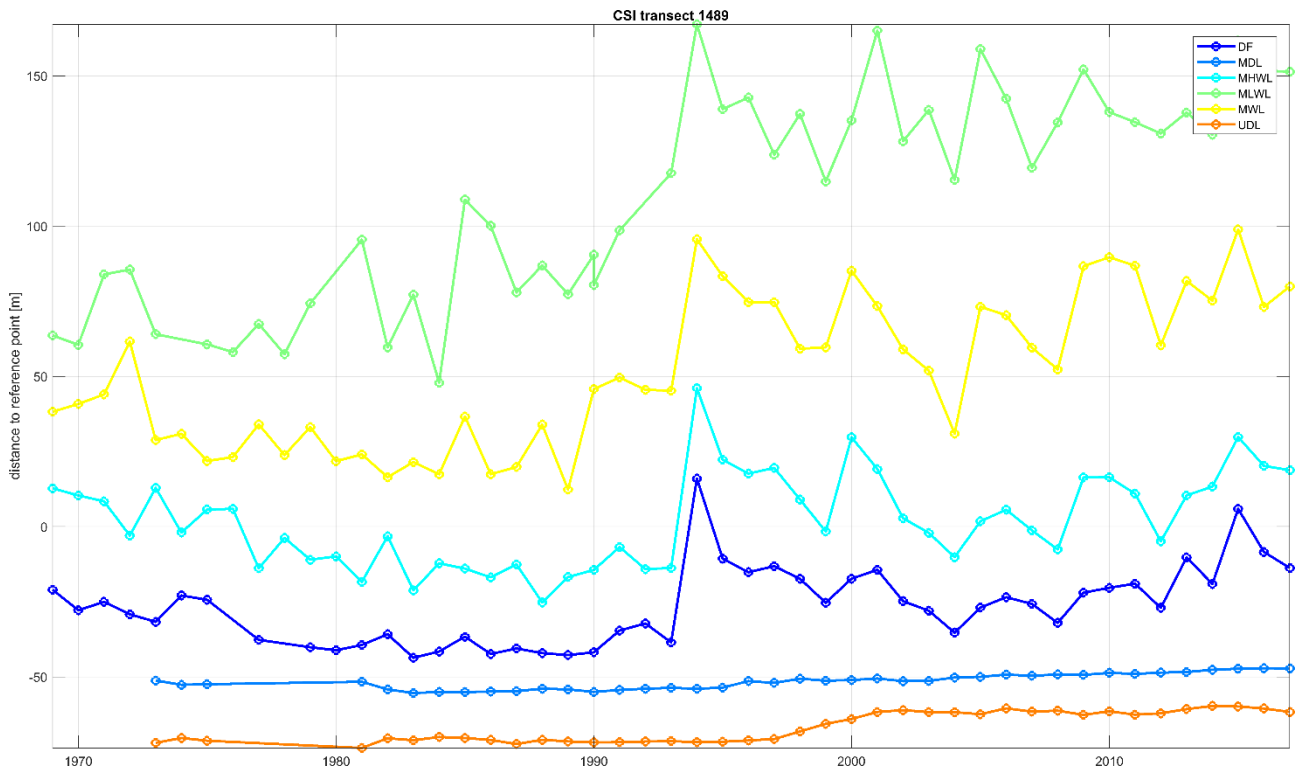
Figure 45: Timeseries of physical marks for transect 1489

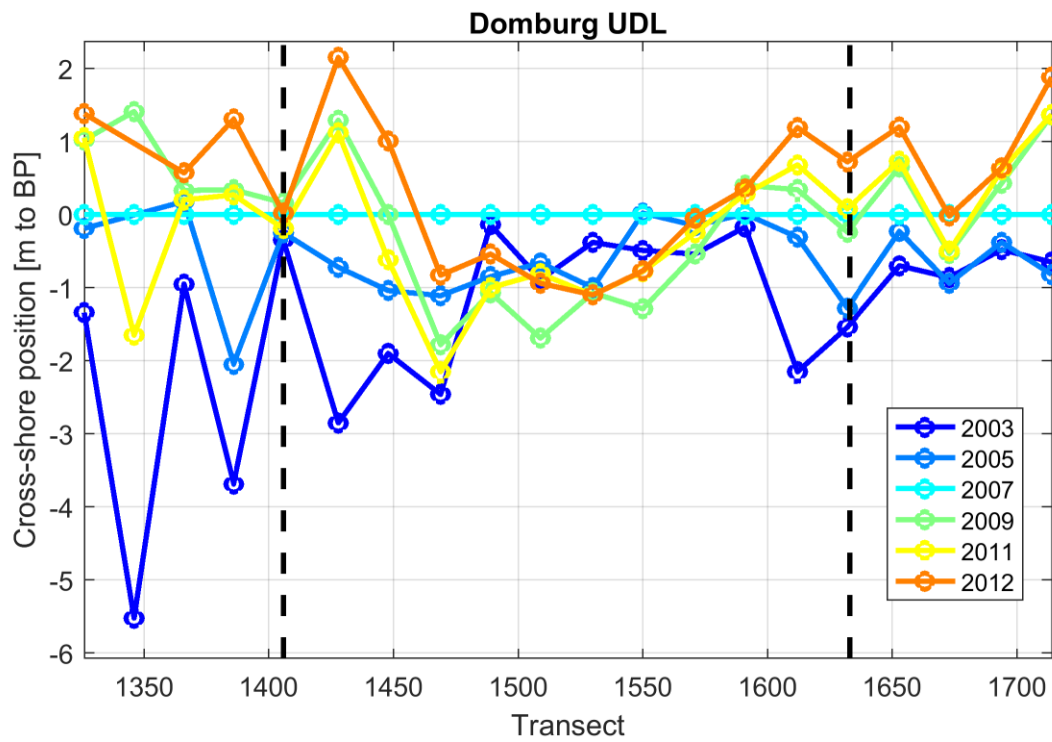
Figure 46: The difference in cross-shore position of MHWL with respect to 2007. When the value is positive the position lays more offshore than in 2007.

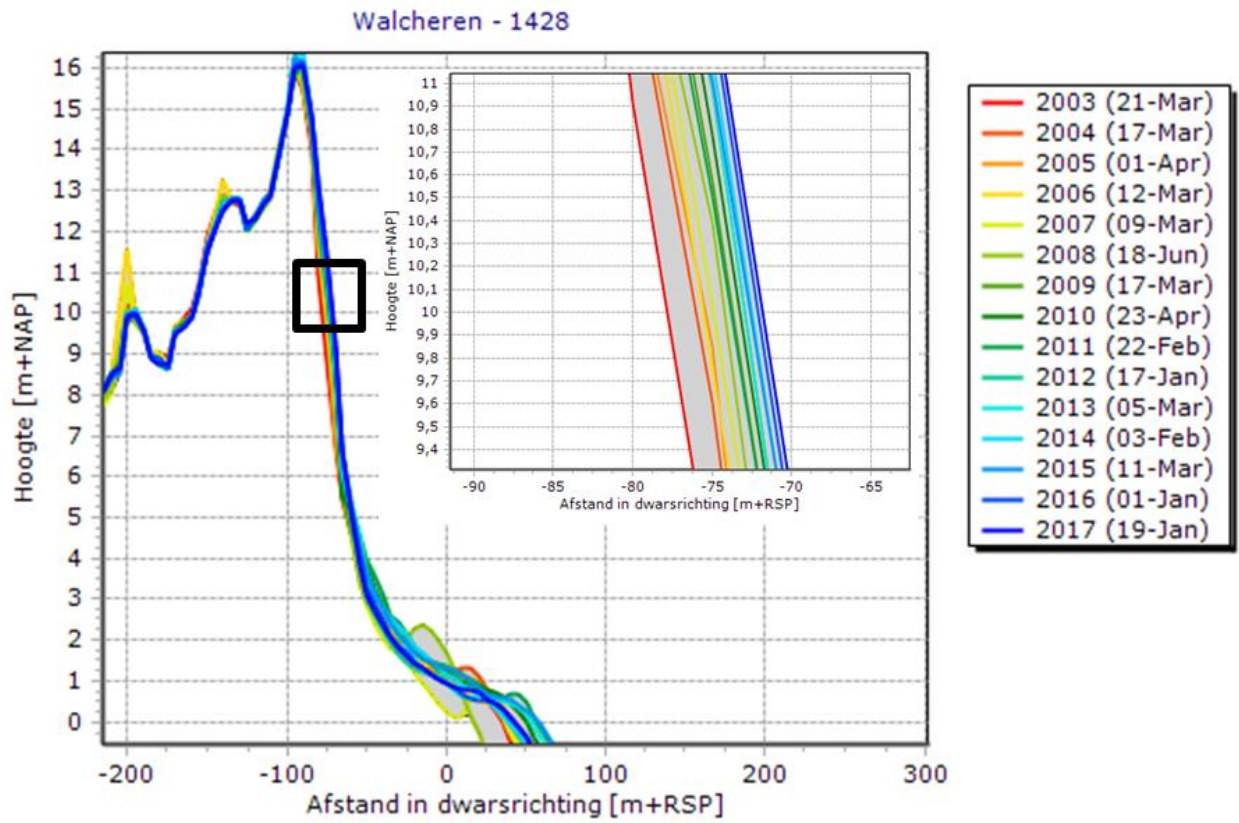
Figure 47: The dune profile for transect 1428 for the years 2003 till 2017. The colours represent various years. The figure also contains a zoom in of the profile. The black square indicates the location off the zoom in.

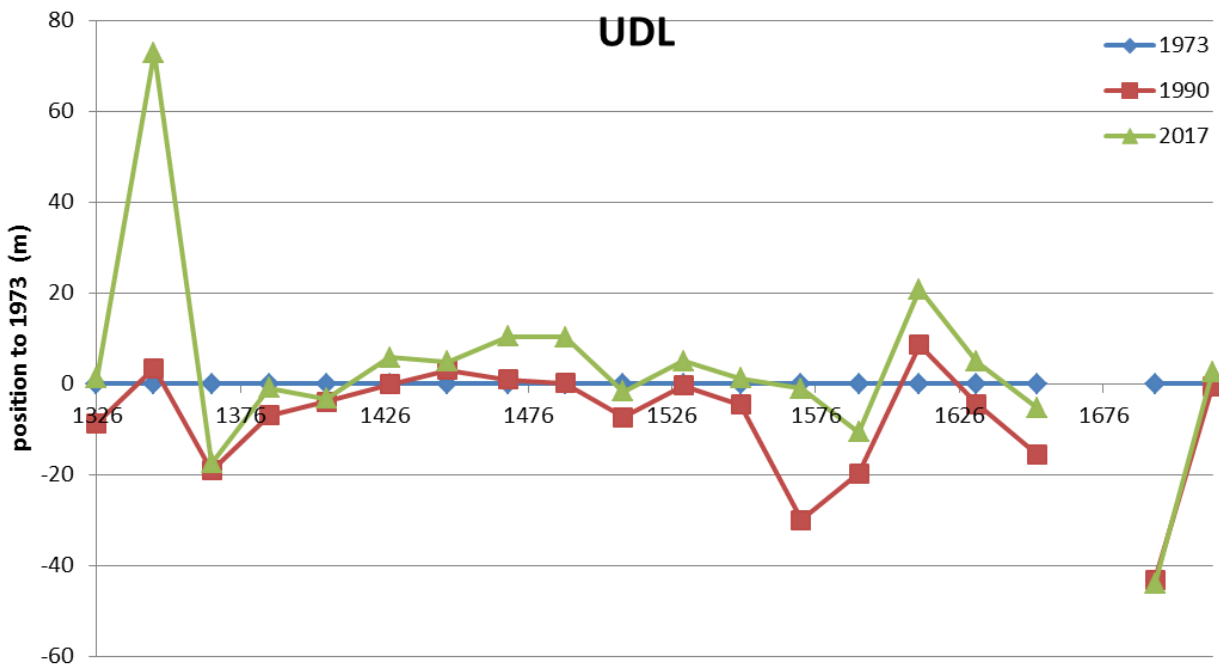
Figure 48: Position of the upper dune level for studied transects in 1973, 1990 and 2017

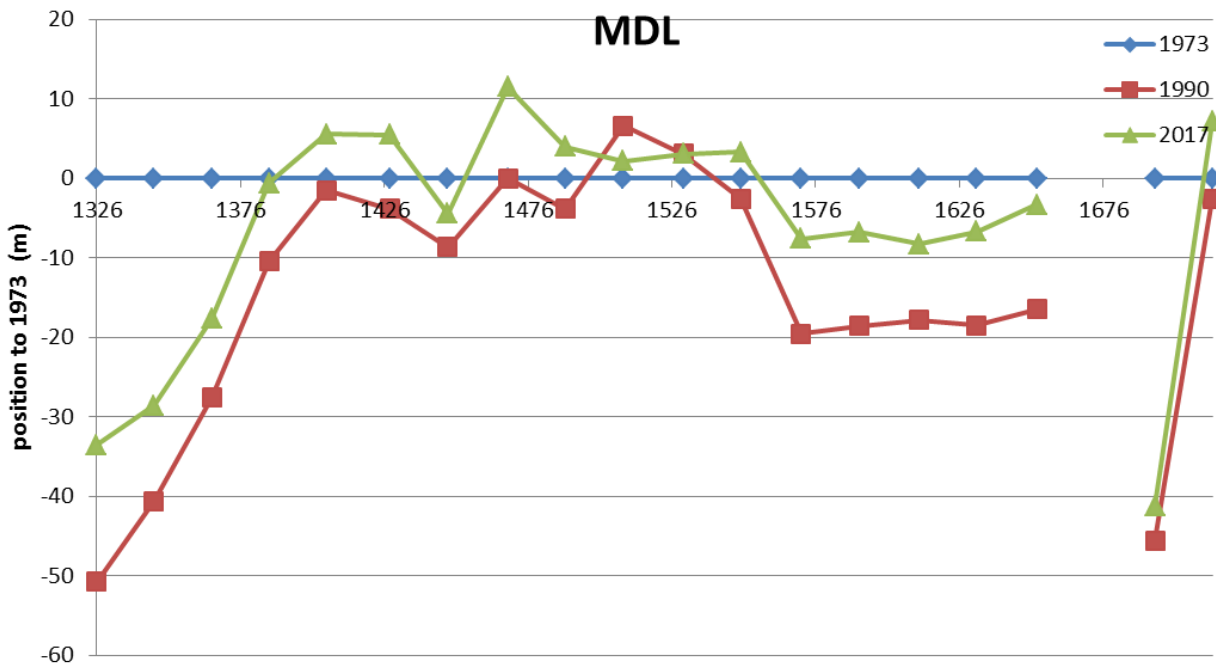
Figure 49: Position of the middle dune level for studied transects in 1973, 1990 and 2017

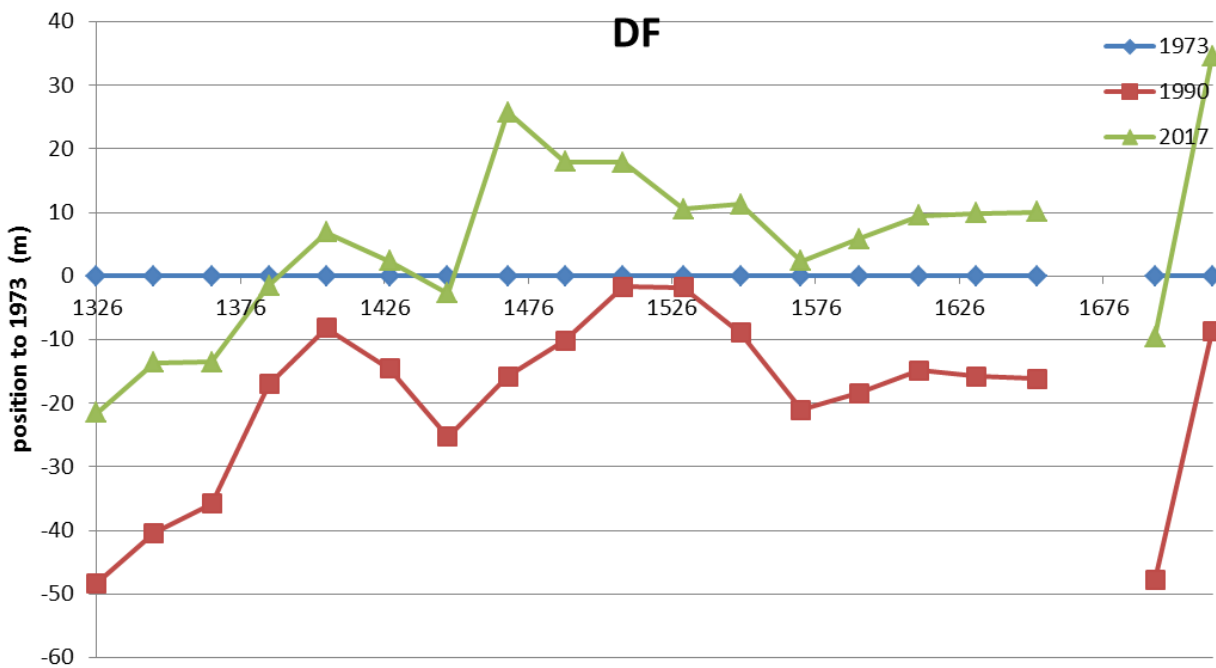
Figure 50: Position of the dune foot for studied transects in 1973, 1990 and 2017

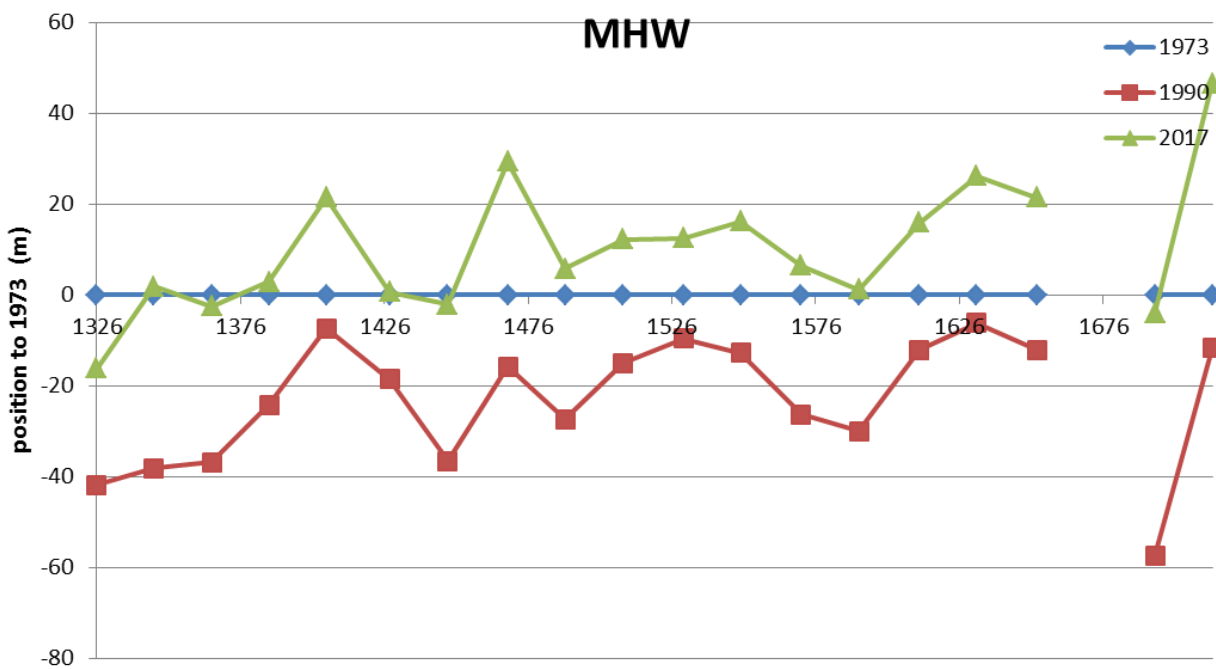
Figure 51: Position of the mean high water level for studied transects in 1973, 1990 and 2017

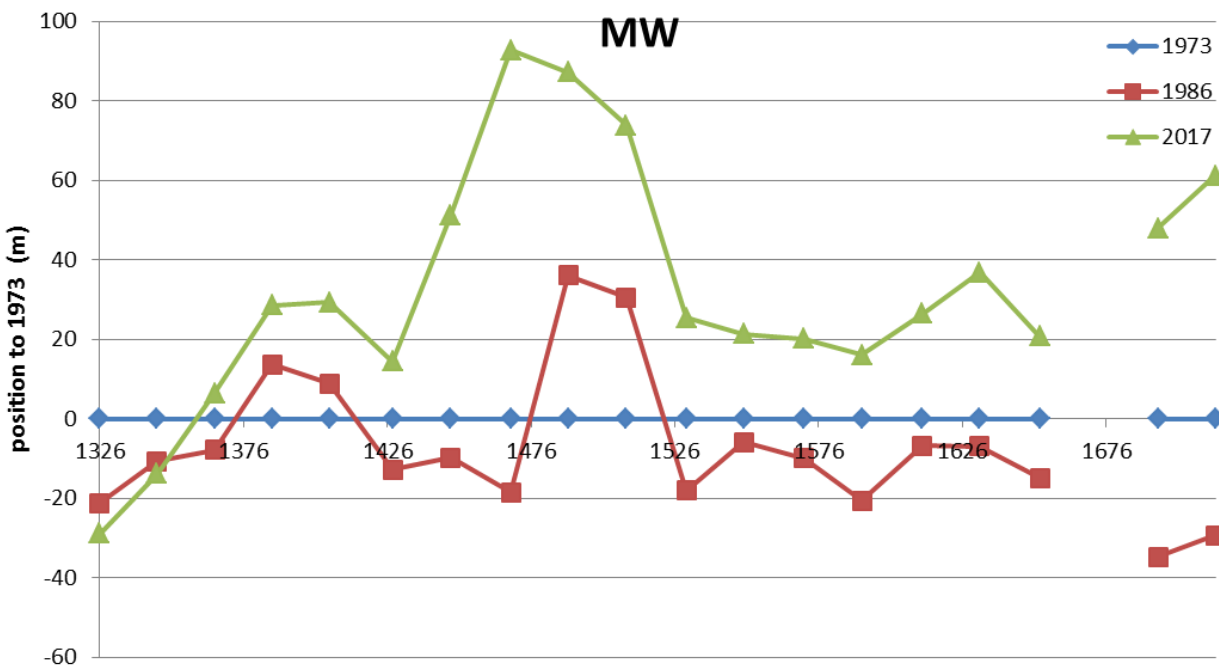
Figure 52: Position of the mean water level for studied transects in 1973, 1986 and 2017

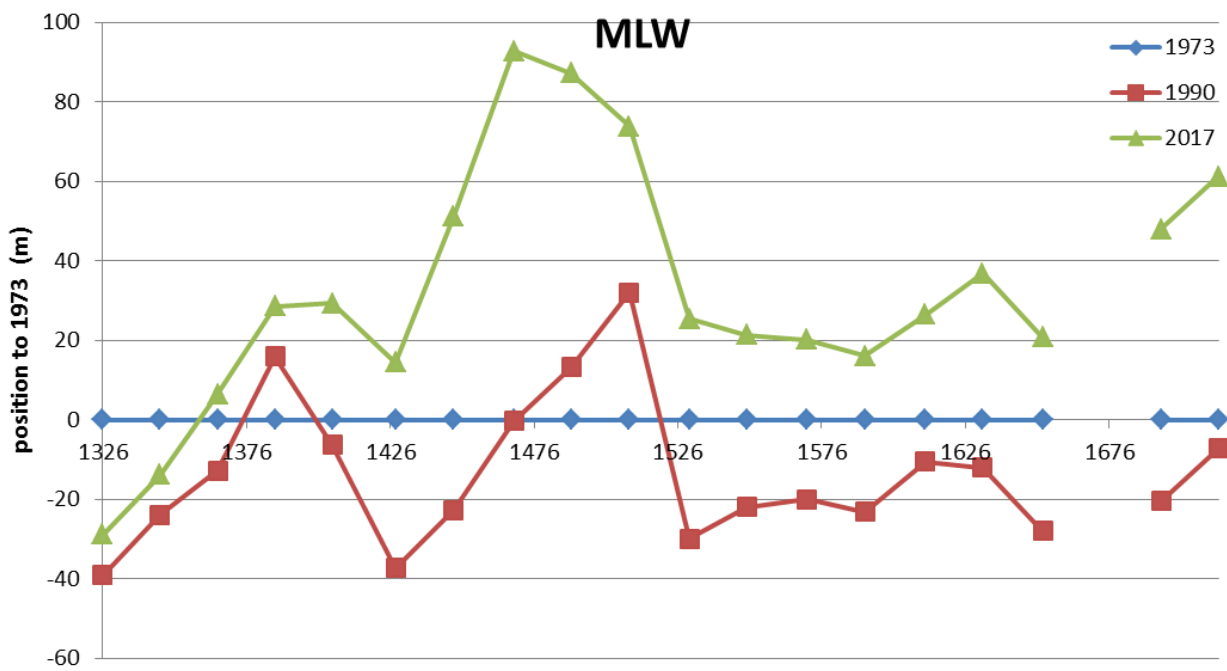
Figure 53: Position of the mean low water level for studied transects in 1973, 1990 and 2017
