National analyses of nourishments;

*Coastal state indicators and driving forces for Domburg,
the Netherlands*

Date: 05/08/2019

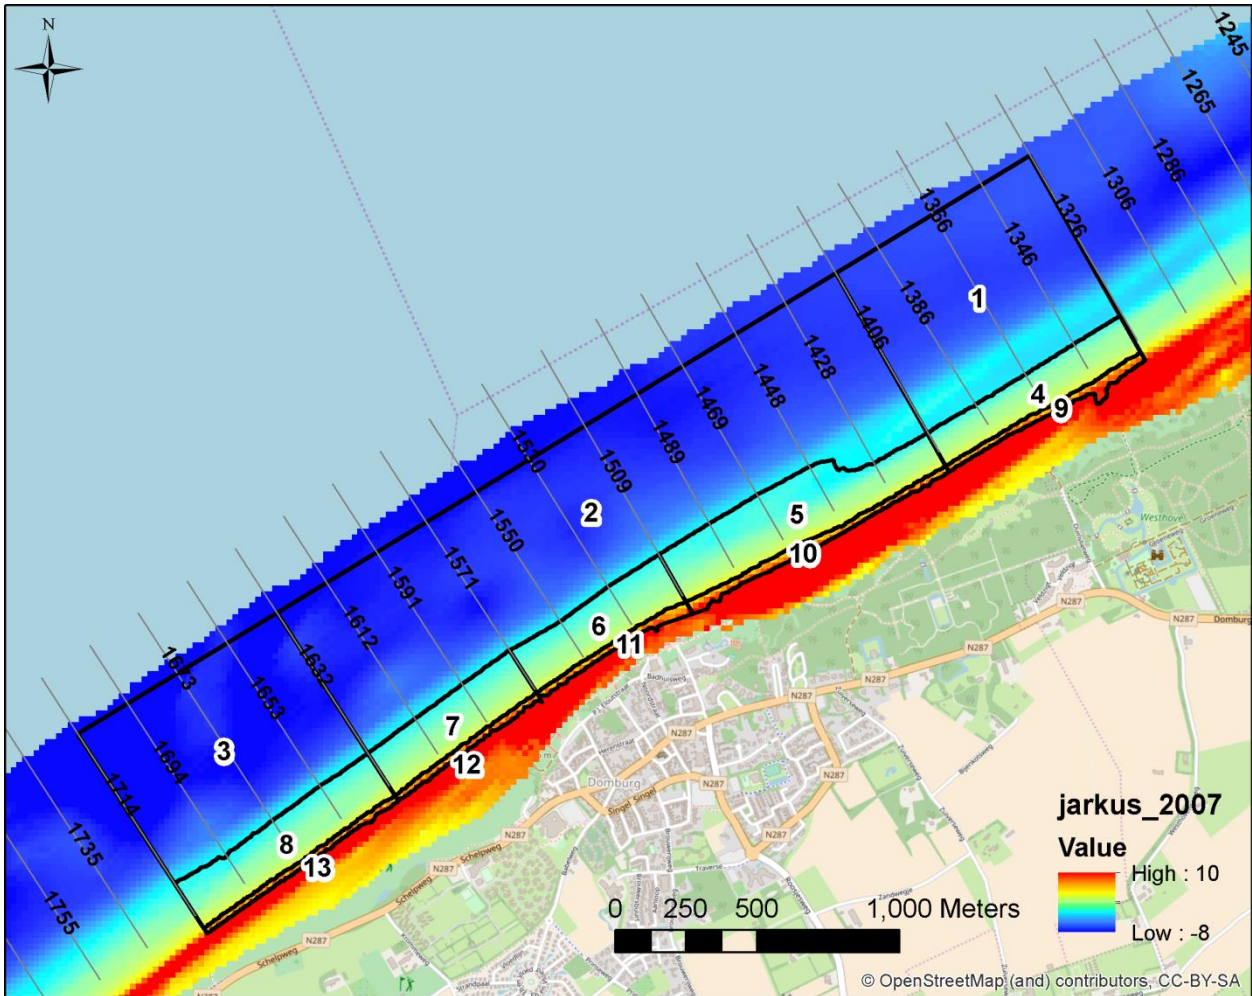
Figure 54 Areas used for calculation of volumes

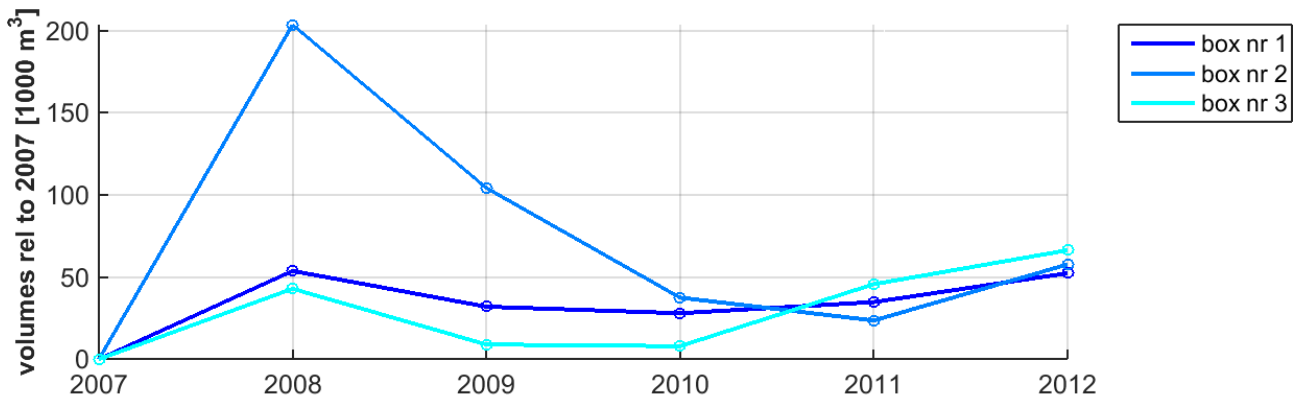
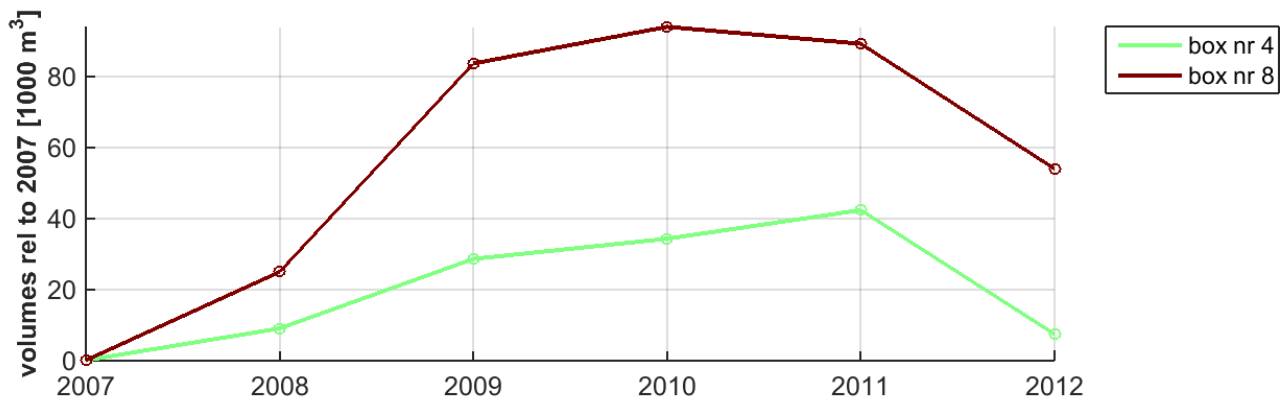
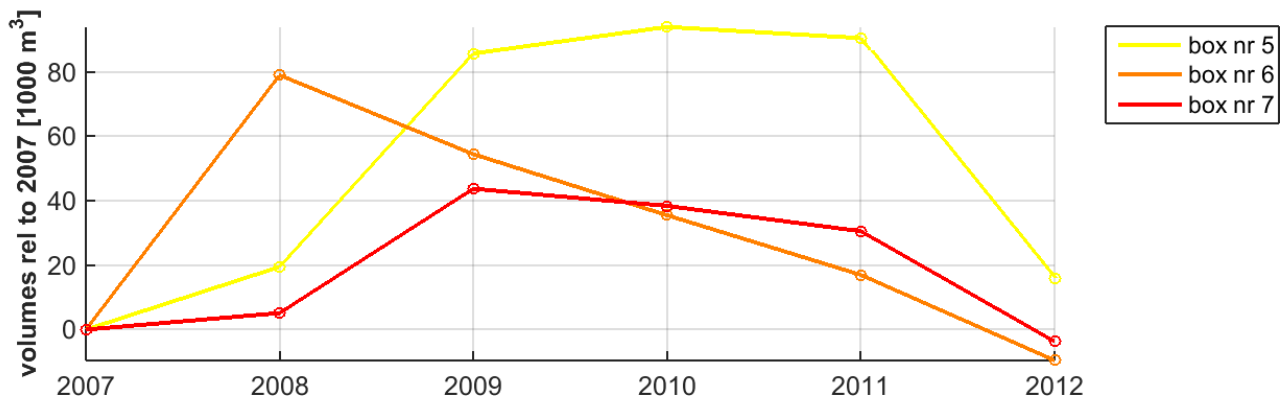
Figure 55 Volume development from one year before the nourishment until the last year before the next nourishment

The average vertical changes (Figure 58) show similar change in time as the volumes (Figure 55). The most significant difference is the much lower vertical change in the shoreface areas (1-3), caused by the much larger surface area.

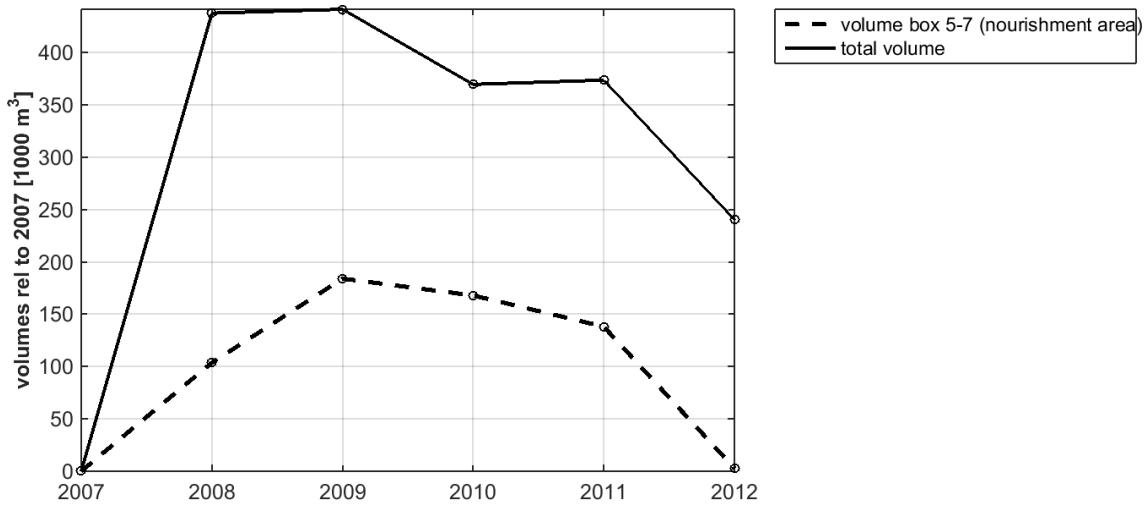
Figure 56 Volume development nourishment polygons (5-7) and polygons 1-8 (total volume)

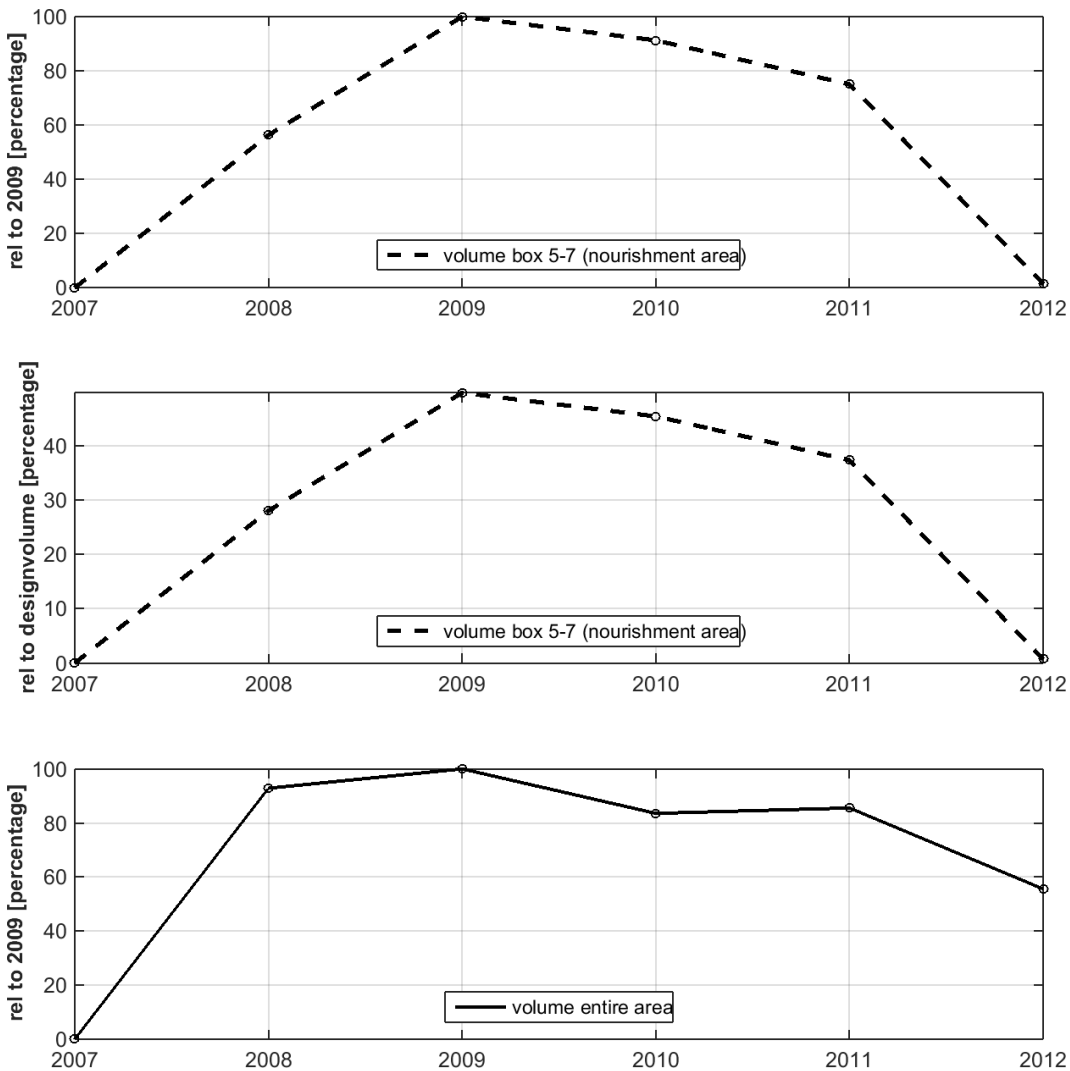
Figure 57 Volume development in percentages for nourishment area relative to maximum volume in 2009 (top), relative to design volume of 370.000 m³ (middle) and for entire area (area 1-8) relative to maximum volume (bottom)

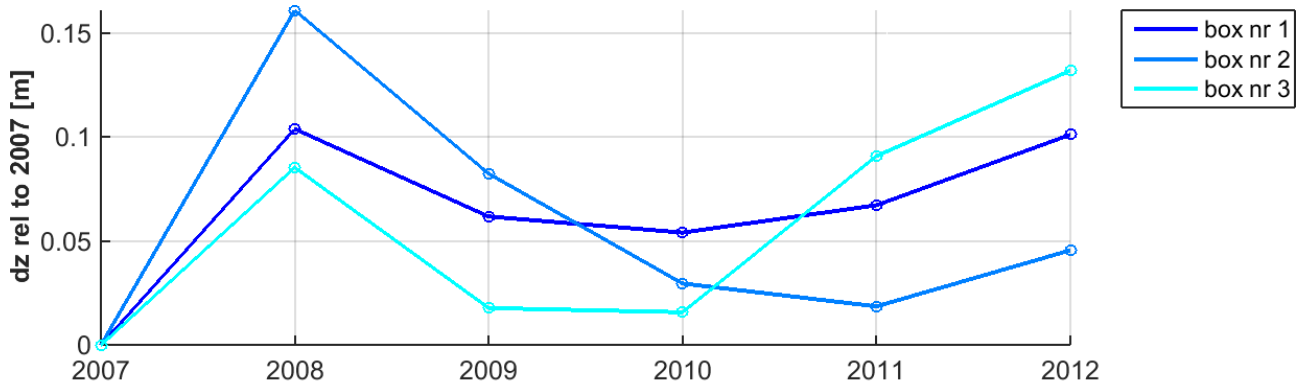
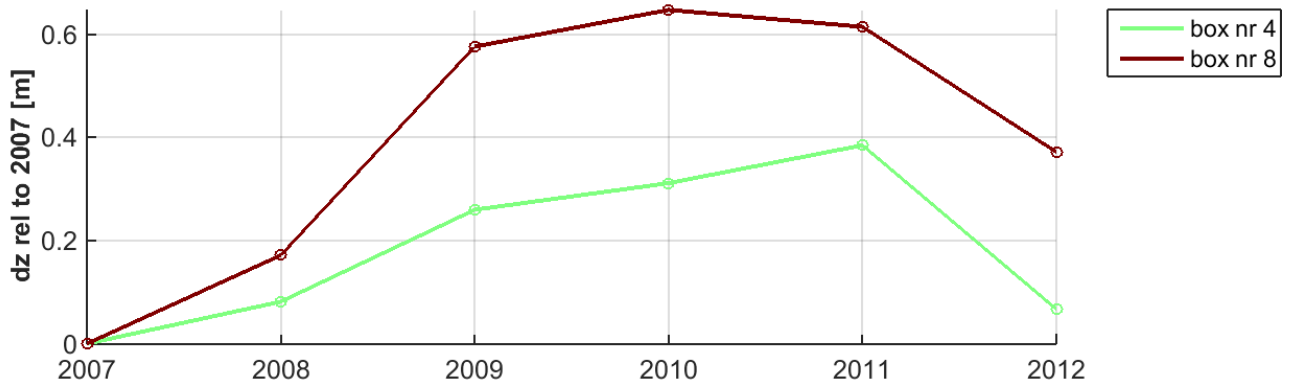
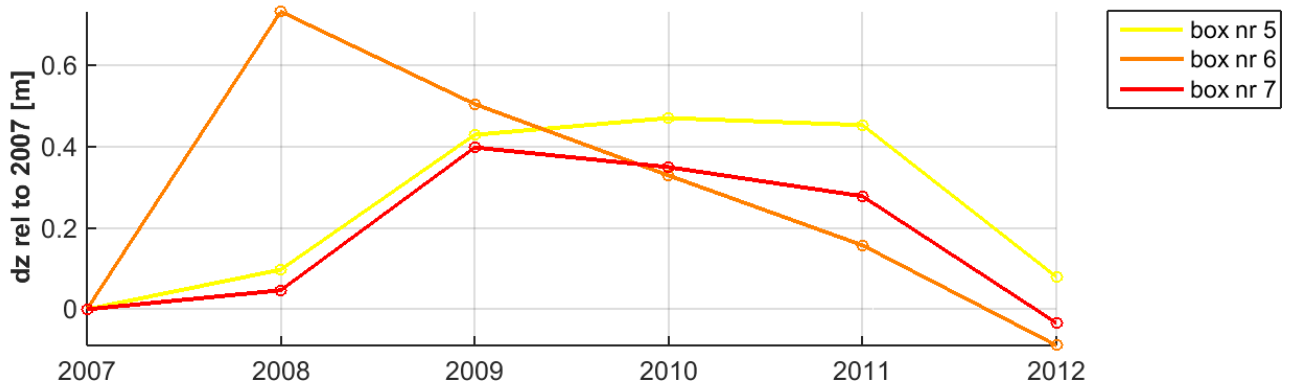
Figure 58 Change in average bed level for each polygon

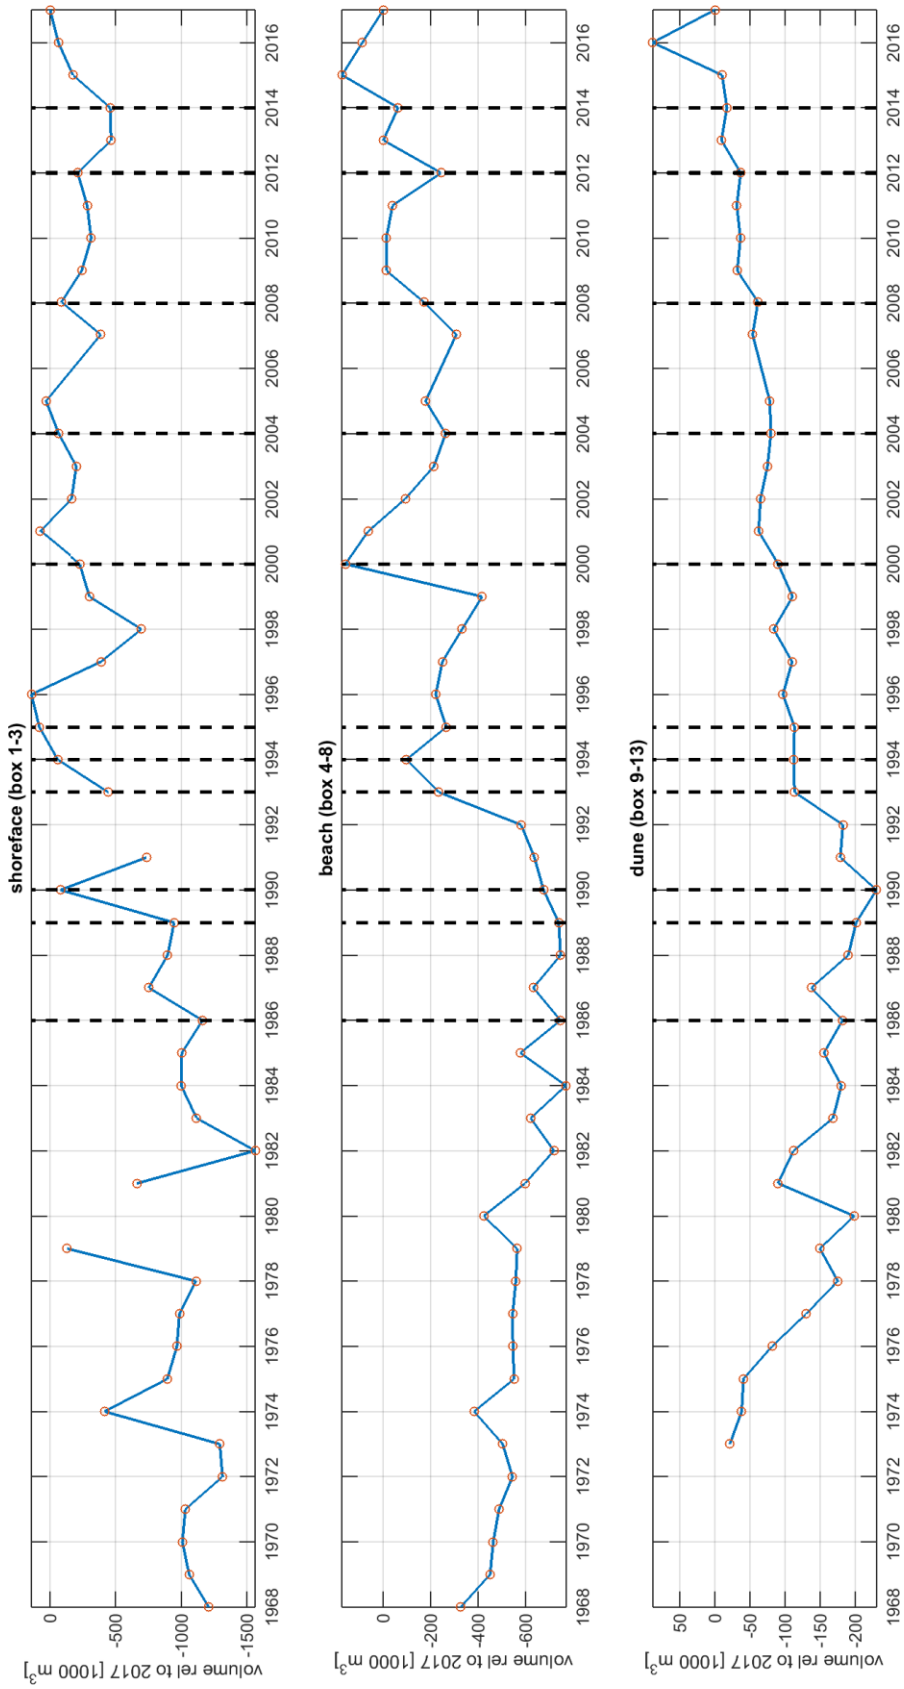
Figure 59 Long term volume development shoreface, beach and dune, dashed lines indicate nourishments

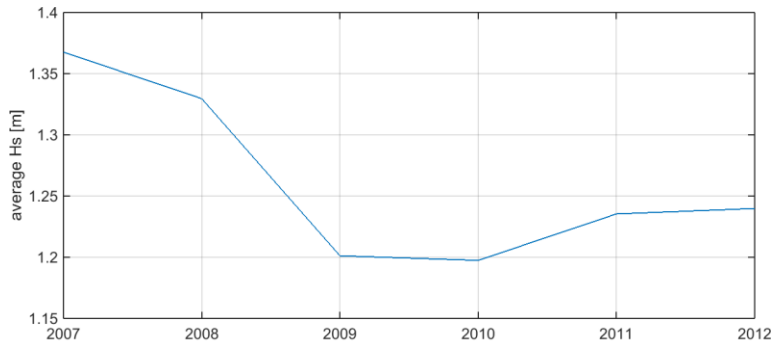
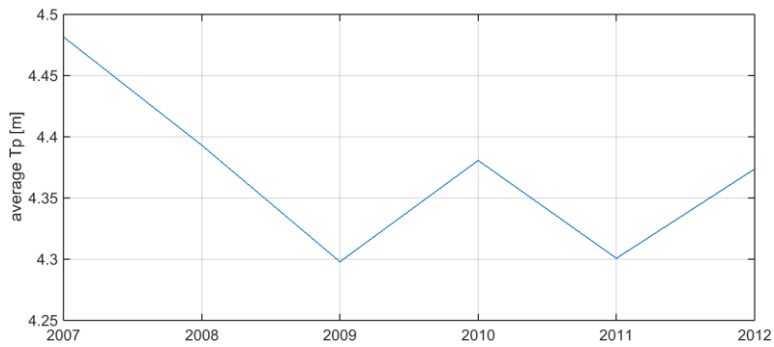
Figure 60 Yearly averaged significant wave height (top) and period (bottom)
