National analysis of nourishments;

*Coastal state indicators and driving forces for Bergen-
Egmond, the Netherlands*

Date: 05/08/2019

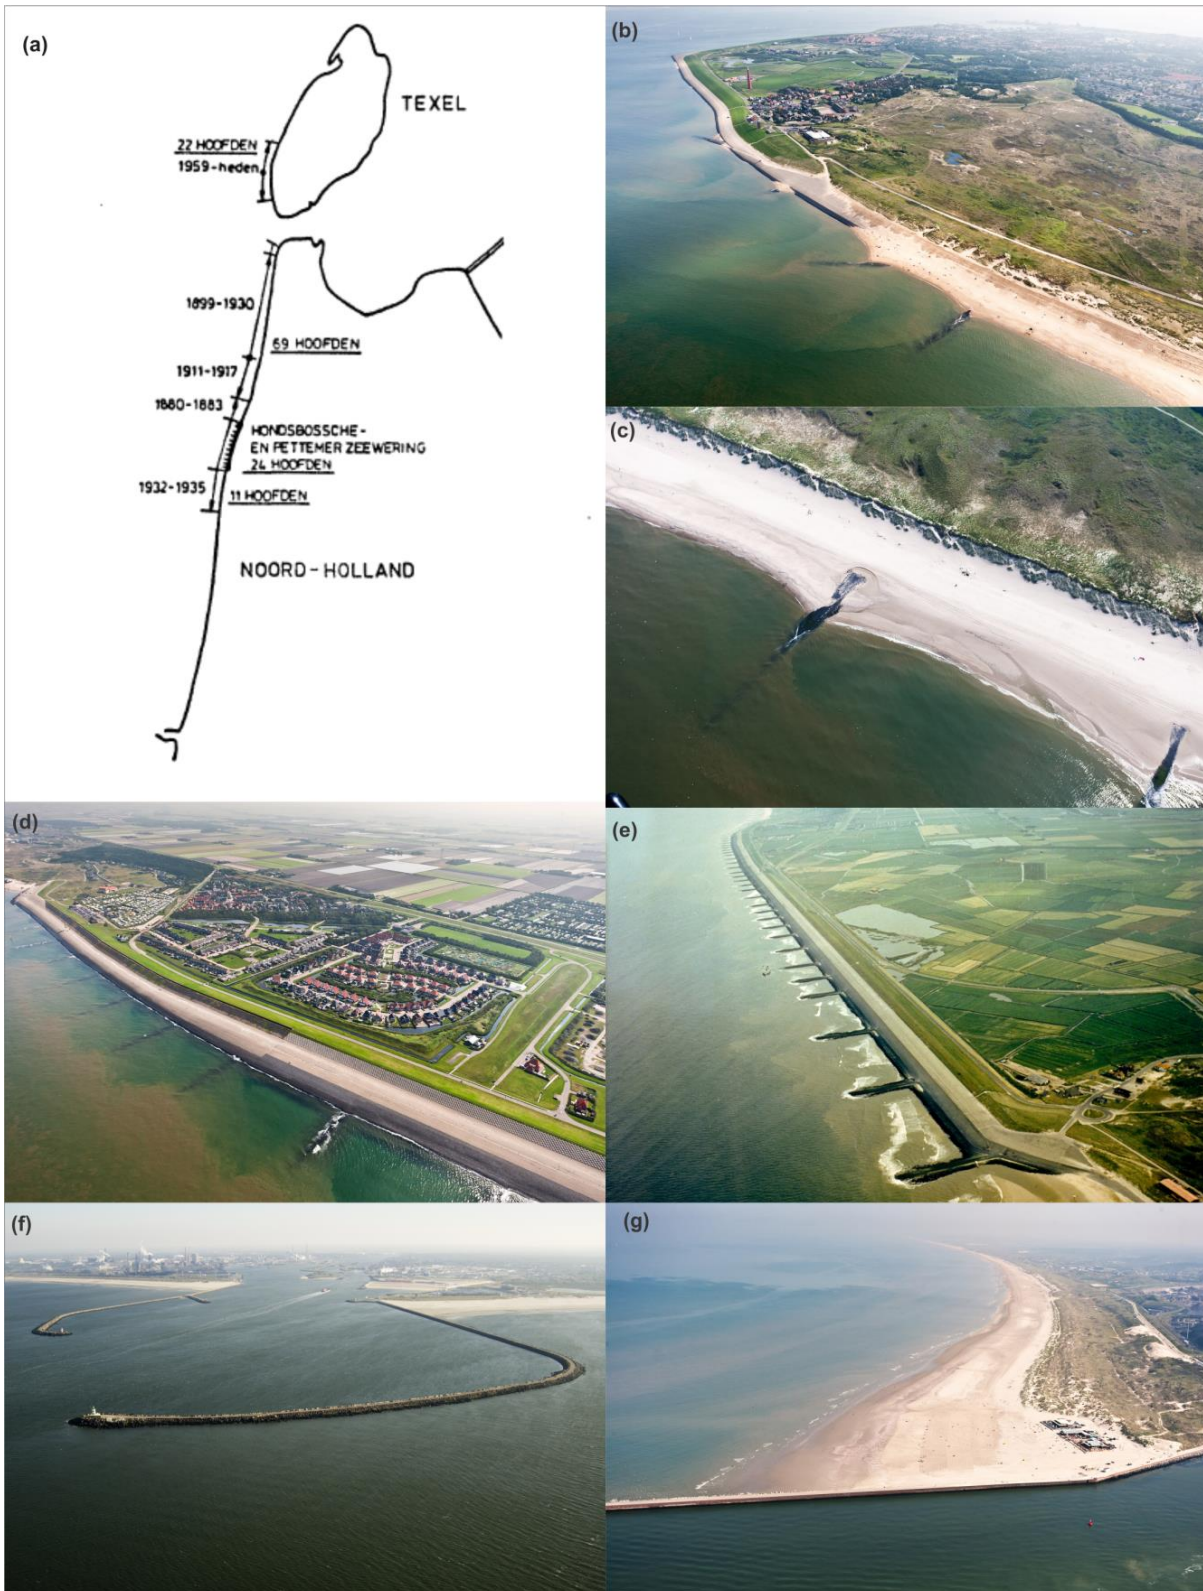
Figure 3: Overview of coastal infrastructure for the Noord-Holland area: (a) construction periods of groins, from: Verhagen en van Rossum (1990), (b) seawall at Den Helder, (c) groins between seawalls of Den Helder and Hondsbosche-Pettemer, (d) Hondsbosche and Pettemer seawall in 1982, (e) south end of Hondsbosche and Pettemer seawall in 2011, and (f,g) harbour jetties of IJmuiden and sedimentation on the north side in 2011. Images from: <https://beeldbank.rws.nl>, Rijkswaterstaat. Source entire figure: Deltares, 2017

In the coastal area Noord-Holland several hard constructions are built in the past, an overview is given in Figure 3 and Table 1. The seawall at Den Helder is not influencing the area of Bergen-Egmond directly, but relevant for the changes of the tidal inlet. The Hondsbosche and Pettemer seawall might still affect the north part of the study area. In the northern part of the study area groins are present. The harbour jetties of IJmuiden influence the area south of the study area: directly north of the jetties sedimentation occurs for about 3 km, and north of this area erosion occurs for the next 5-6 km.

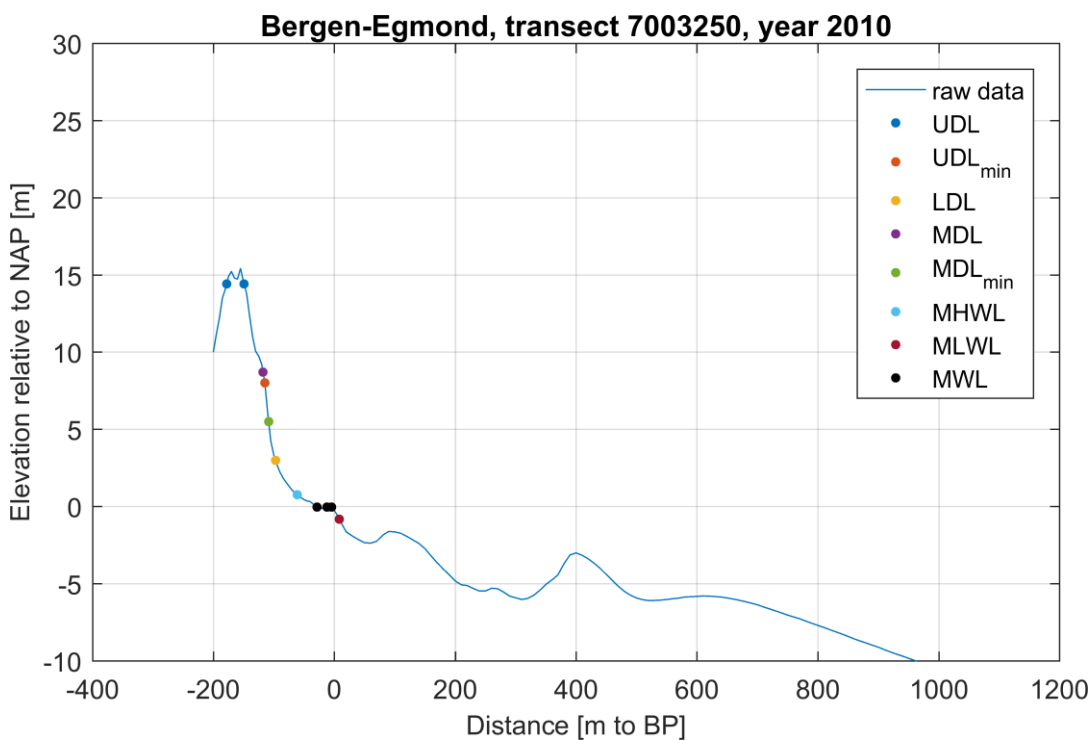
Figure 4: An example of the levels described in paragraph 4.2. UDLmin means the Upper Dune Level minimum and the MDLmin the Mid Dune Level minimum

A typical profile for the study area is shown in Figure 4. The calculated coastal state indicators (see also paragraph 4.2) are shown in this profile and given in Table 3. The indicators are calculated for the nourishment area and 1 km north and 1 km south of the nourishment area for the year of nourishment.

The profile shows the first dune with a height at NAP +15 m and a steep slope towards the beach. The (wet) beach width is around 100 m. In the shoreface 1 to 2 breaker bars are present, in the example profile at 100 m and 400 m to reference (beach pole, BP).

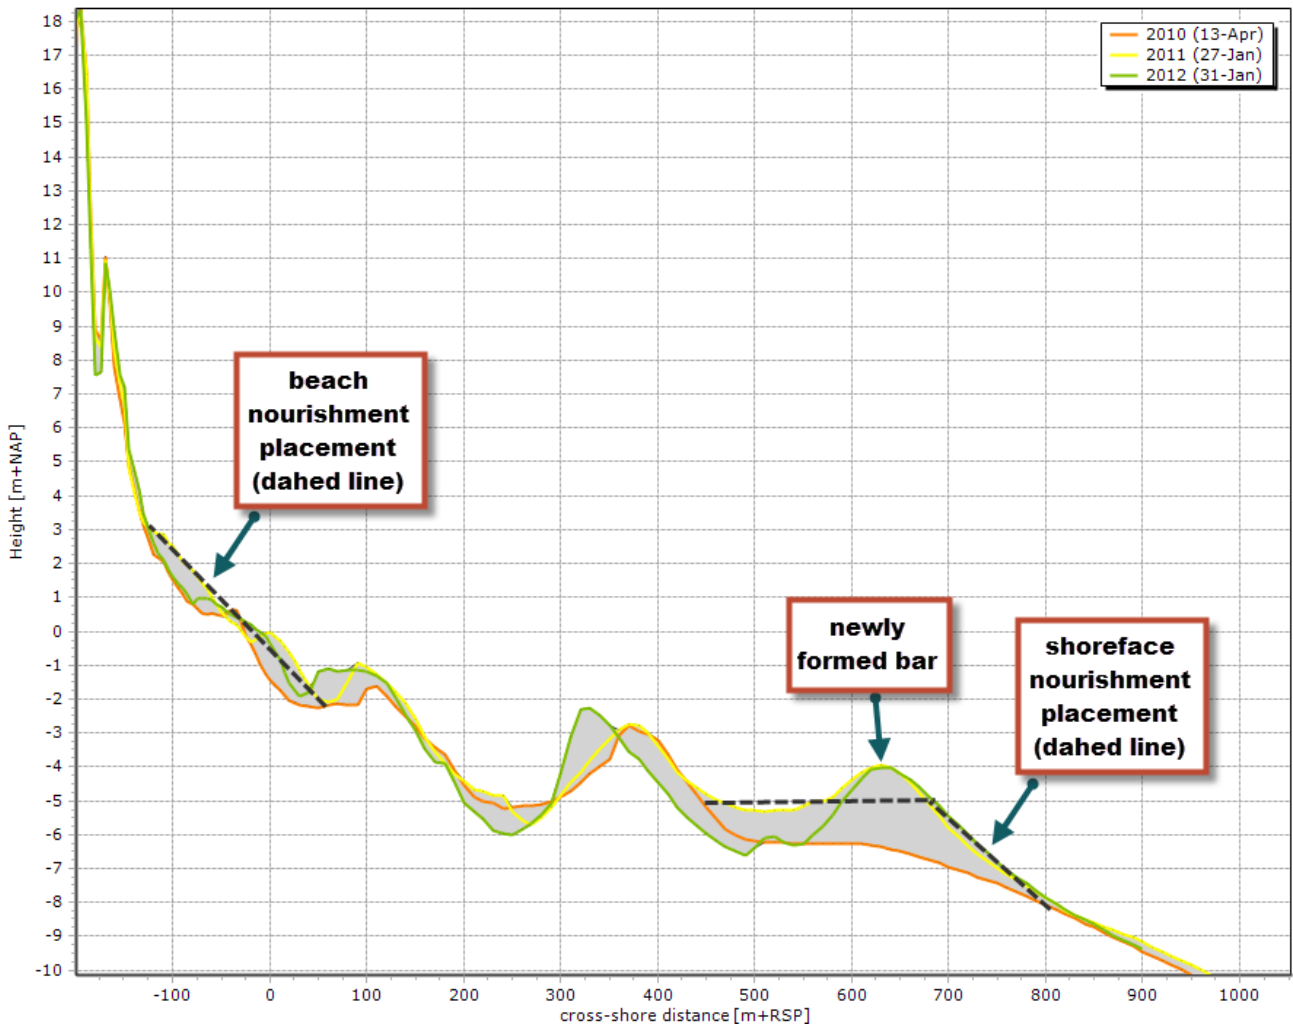
Figure 5: Transect 3200 showing the placement of the beach and shoreface nourishments. The actual placement of the beach nourishment is likely ending around NAP -1 m, not NAP -2 m as seen in this profile due to changes after construction.

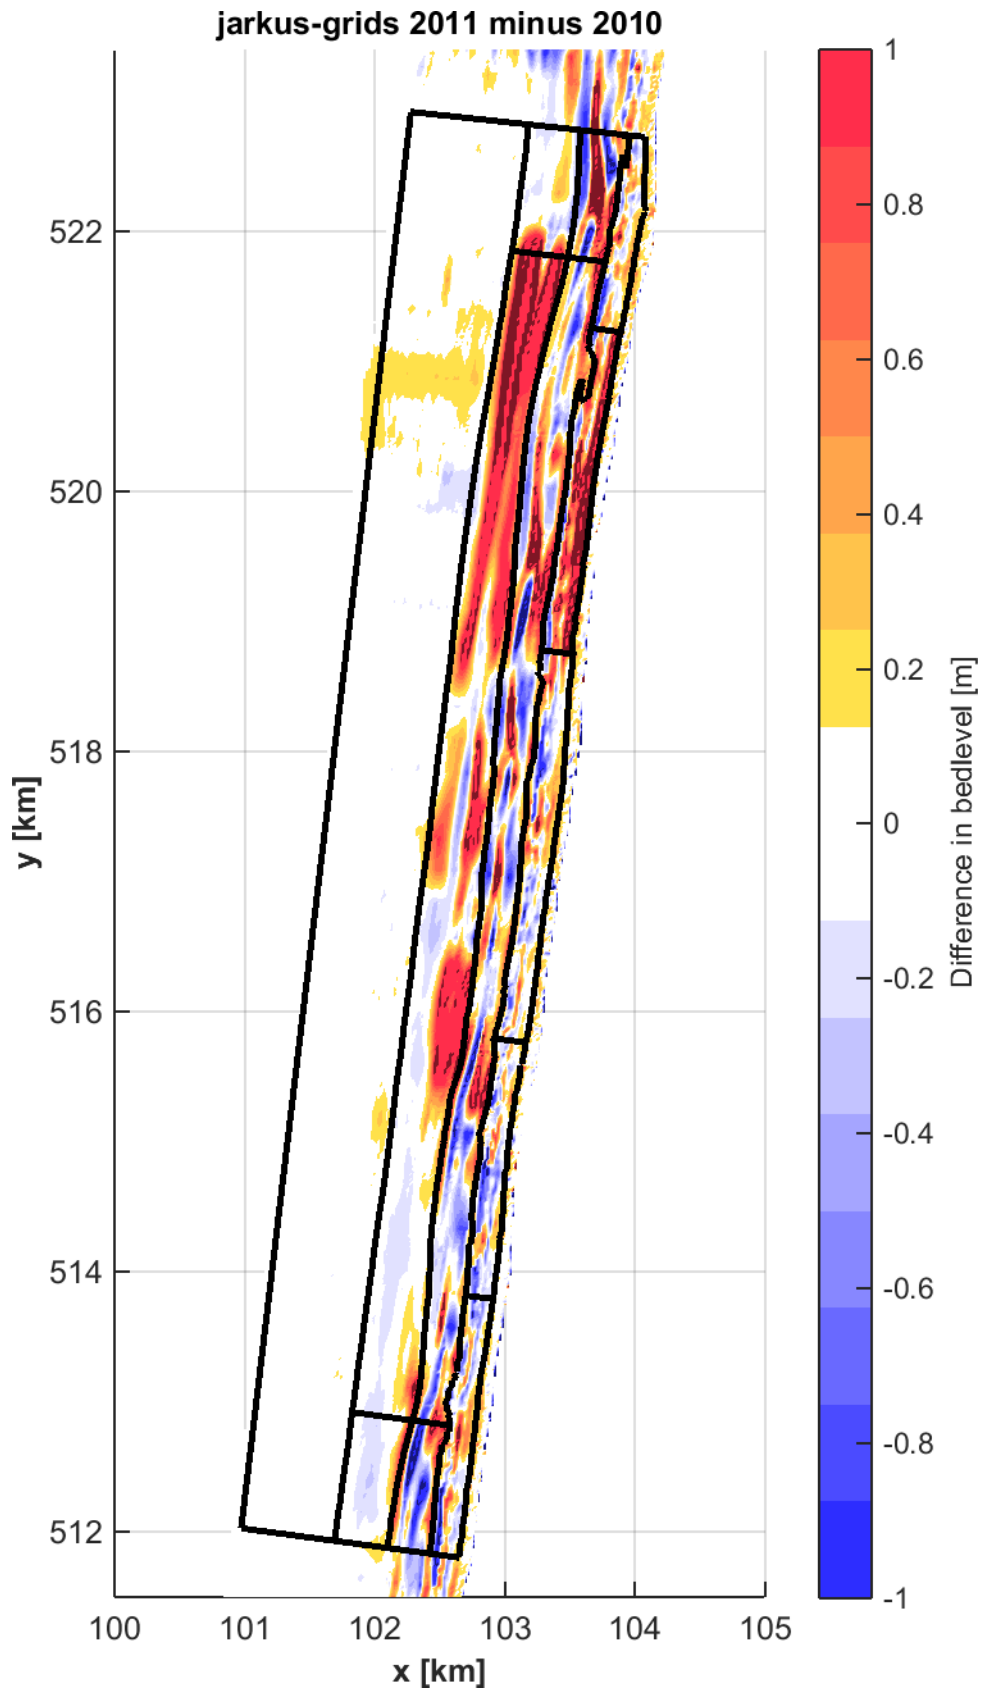
Figure 6: Difference map between 2010 and 2011 (positive = sedimentation, negative = erosion), showing placement of (part of) the shoreface nourishment and northern part of the beach nourishment

Both the beach and the shoreface nourishment consisted of multiple parts, which had different volumes and construction periods, see Table 4. The beach nourishment is placed between the dunefoot (NAP +3 m) and approximately low water (NAP -1 m). The shoreface nourishment is placed against the outer breaker bar with a top level at NAP -5 m. The sediment has a horizontal part of approximately 200 m and is then sloping to ca. NAP -8 m (see Figure 5, also for beach nourishment). The placement of the nourishment parts can also be seen in difference maps (Figure 6 and Figure 7).

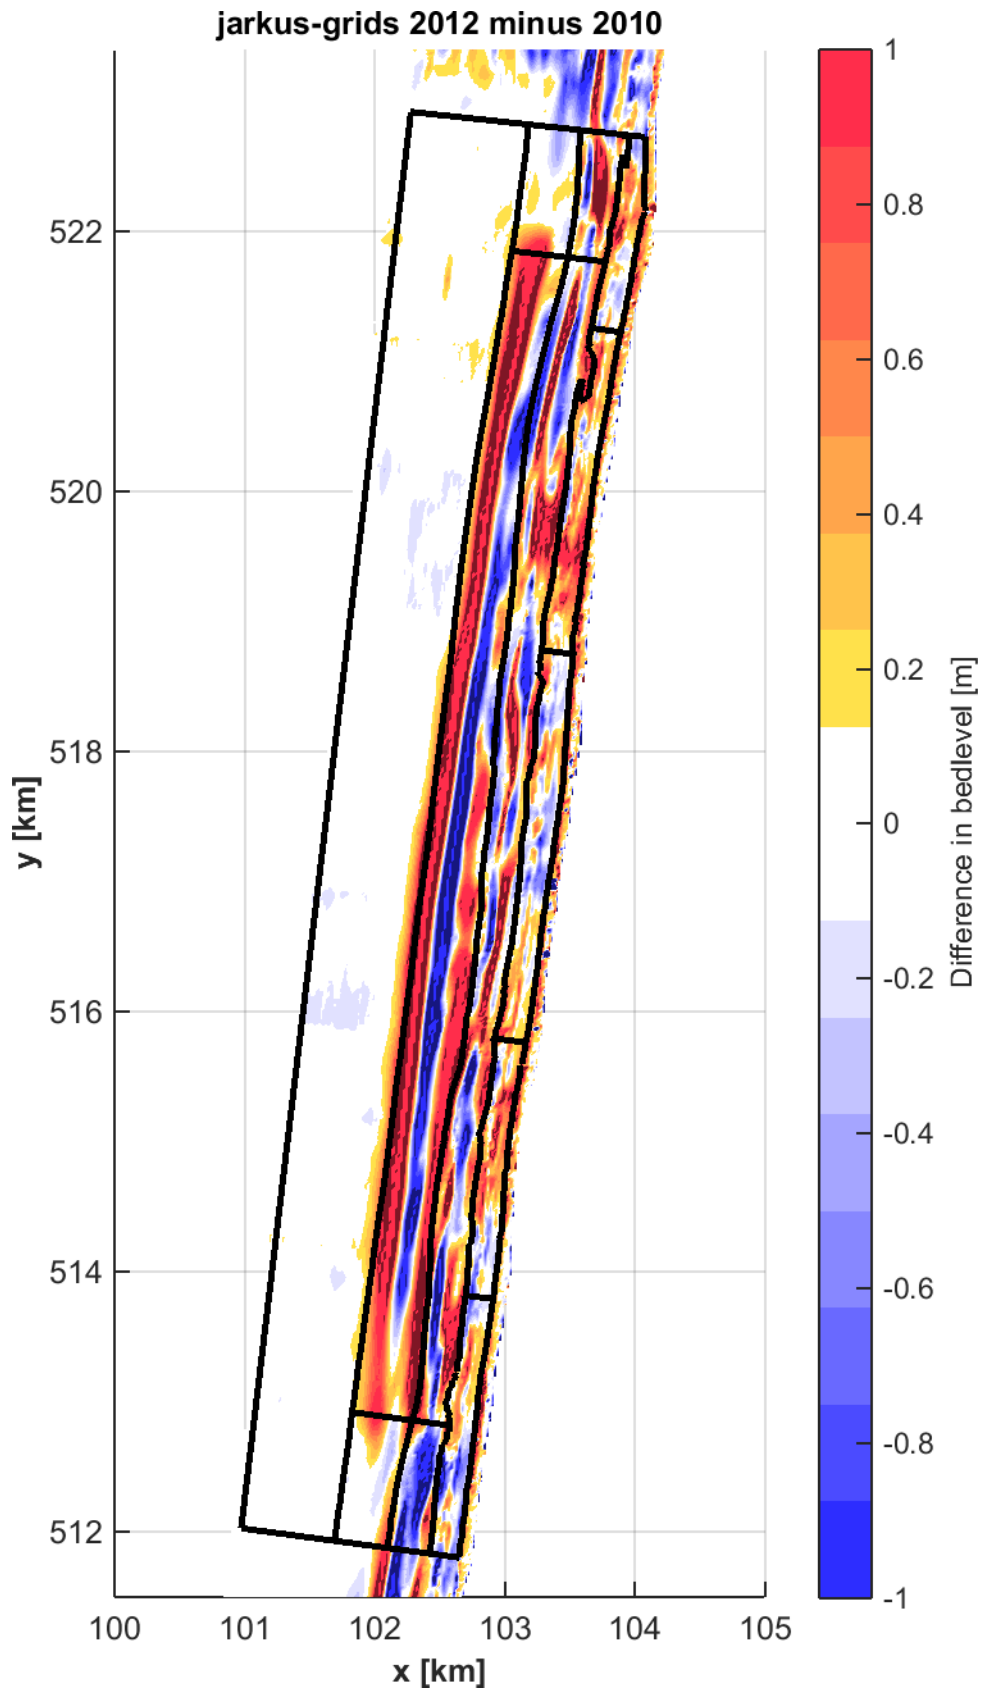
Figure 7: Difference map between 2010 and 2012 (positive = sedimentation, negative = erosion), showing placement of the shoreface nourishment and the beach nourishments

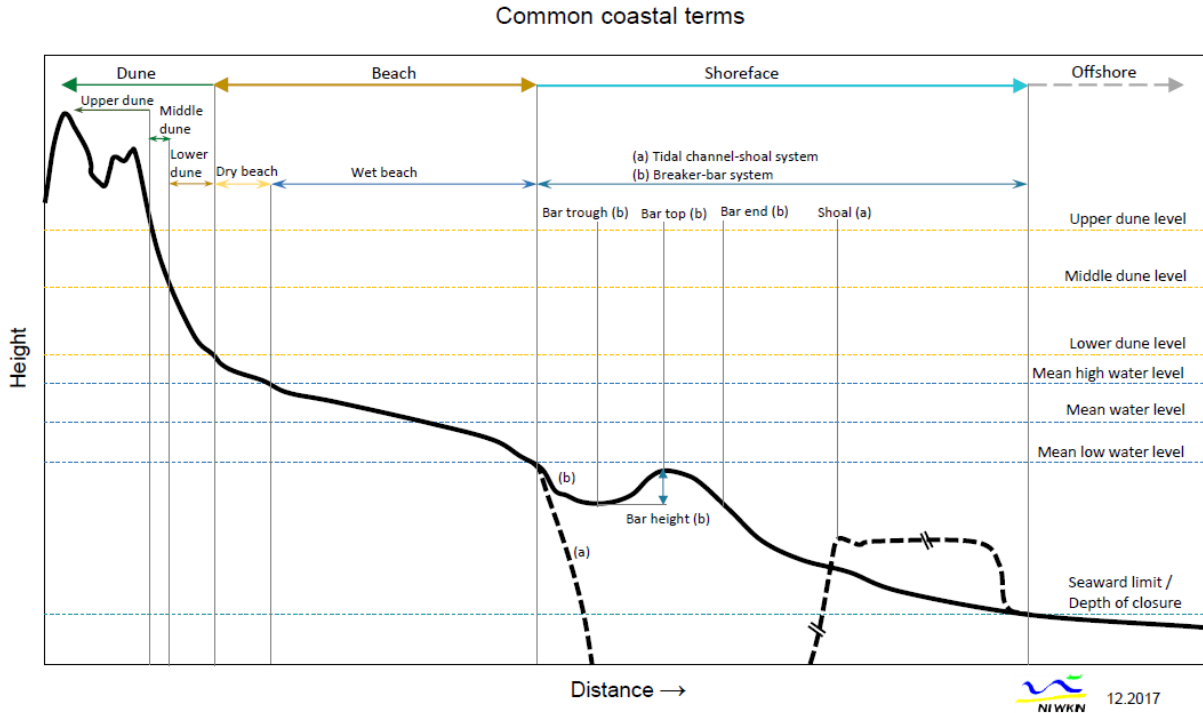
Figure 9: General definition/terminology coastal profile used. On the vertical axis various levels in the profile are shown. The horizontal axis shows different zones in the profile. Source: Simon Hillmann (NLWKN)

The coastal zone terminology in figure 1 will be applied throughout the analysis. The CSI's corresponding to the coastal terminology are shown in Figure 9 and described in Table 5. The morphological development represented by the CSI will be analysed in order to reveal the morphodynamics and the effects of nourishments.

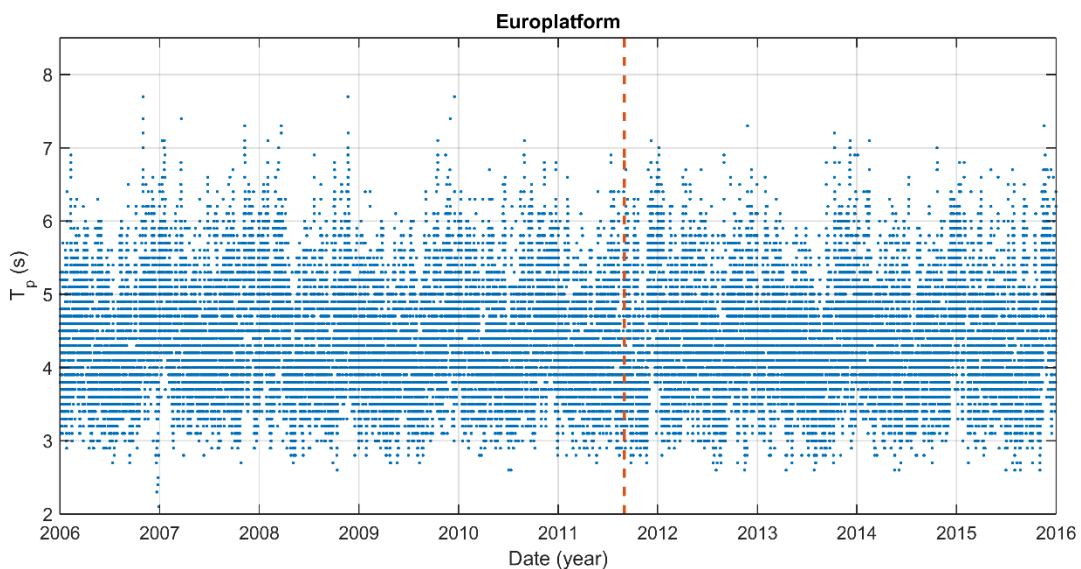
Figure 13: The measured value of T_p at the Europlatform. The red dotted lines indicate the nourishments

To indicate the wave conditions at the coastal laboratory the hydraulic conditions at the Europlatform are analysed. The measured time series at the Europlatform are given in Figure 12 to Figure 14. The time signal for H_s shows several local maxima due to storms. The maximum H_s during a storm is in the order of 4~6 m and each year contains multiple storm. The peak period is in the order of 7 s during these events. The 7 s period is typical for wind generated waves. The direction shows a dominant direction from the 200°N till 50°N.

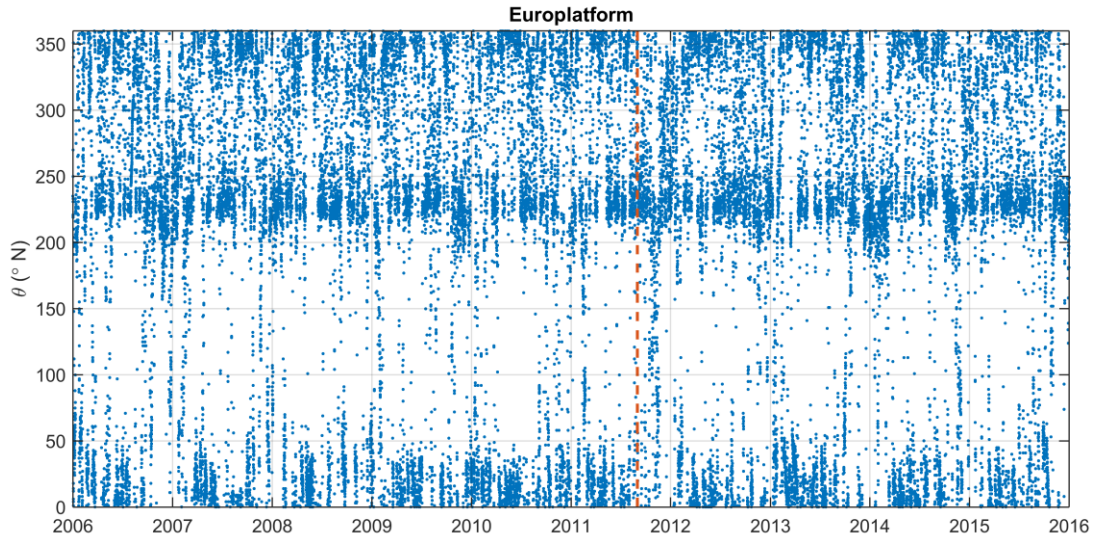
Figure 14: The measured value of Θ at the Europlatform. The red dotted lines indicate the nourishments

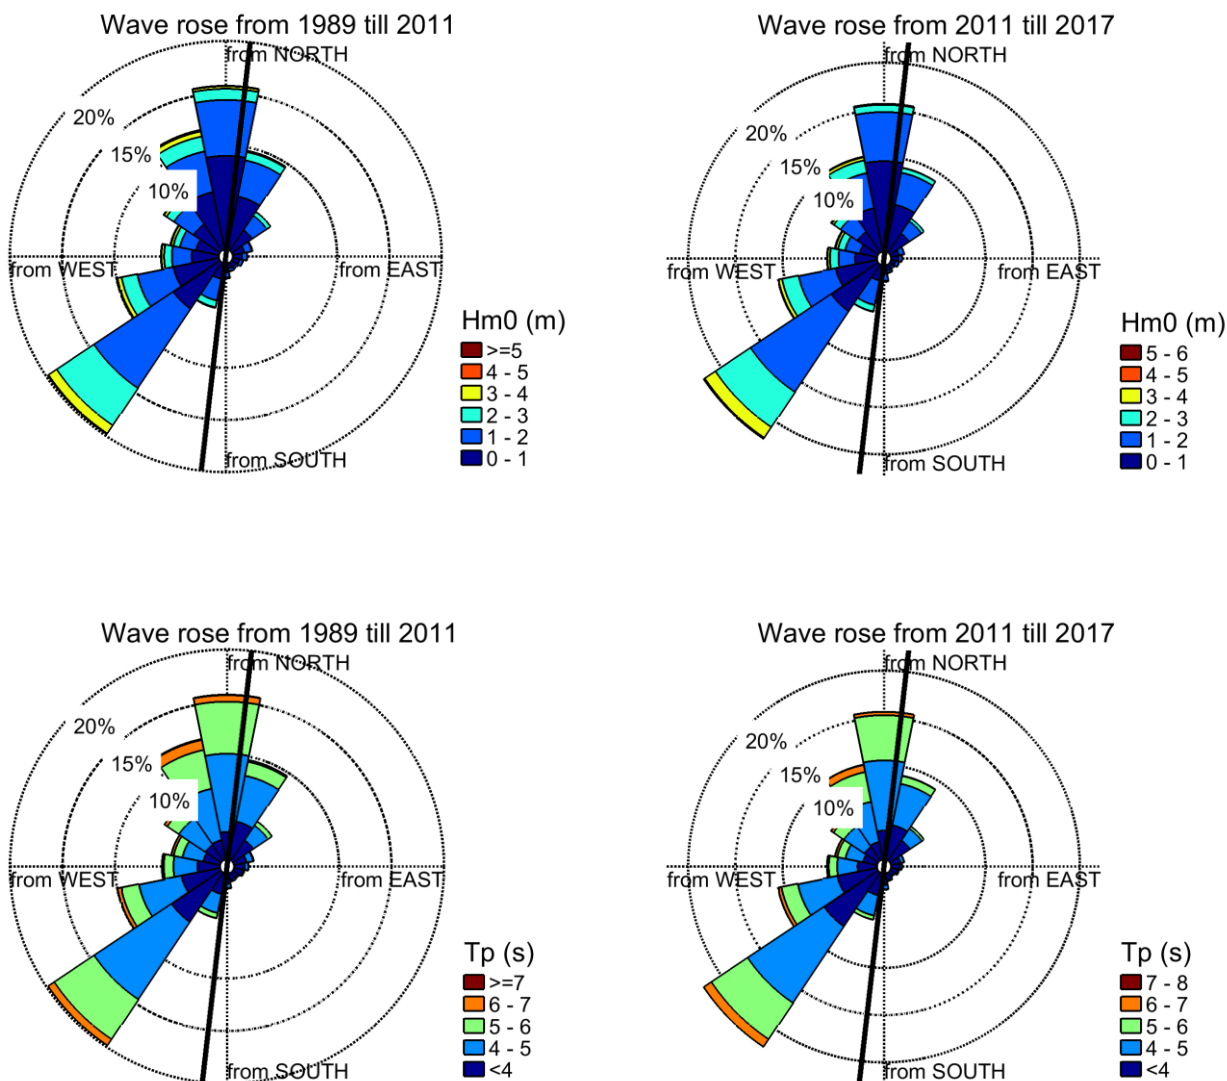
Figure 17: Wave roses based on the measurements at the Europlatform. The year 1989 till 2011 are before the nourishment and 2011 till 2017 is after the nourishment

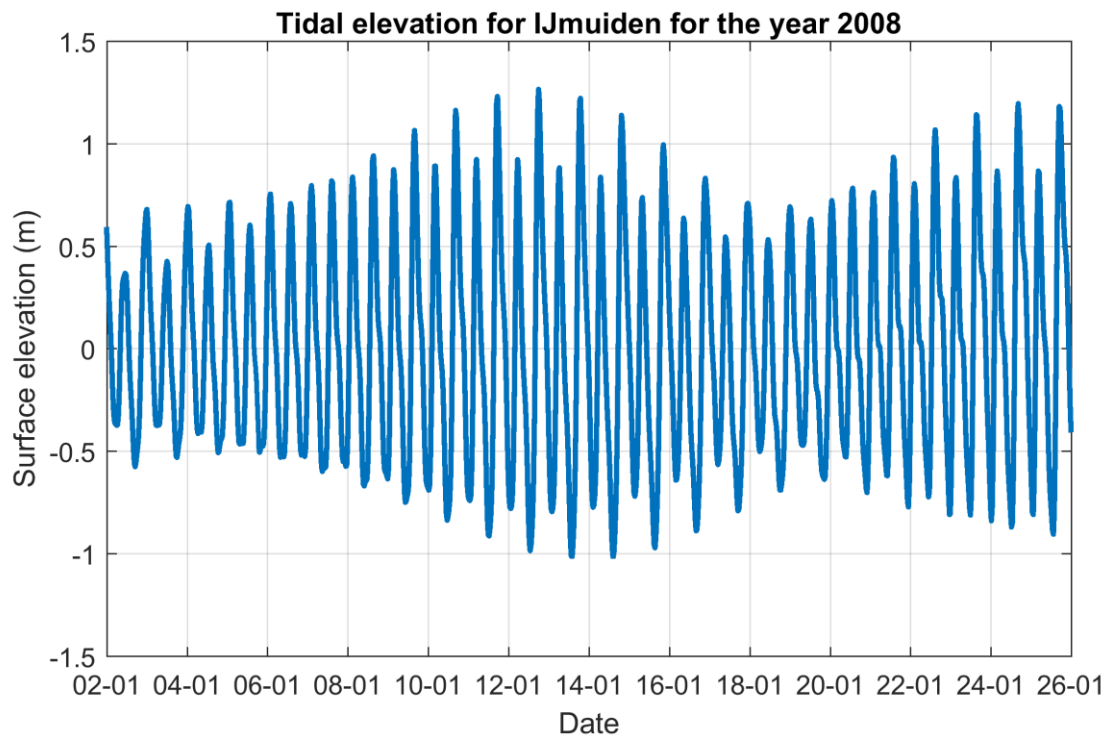
Figure 20: Part of the tidal signal from the IHO station IJmuiden.

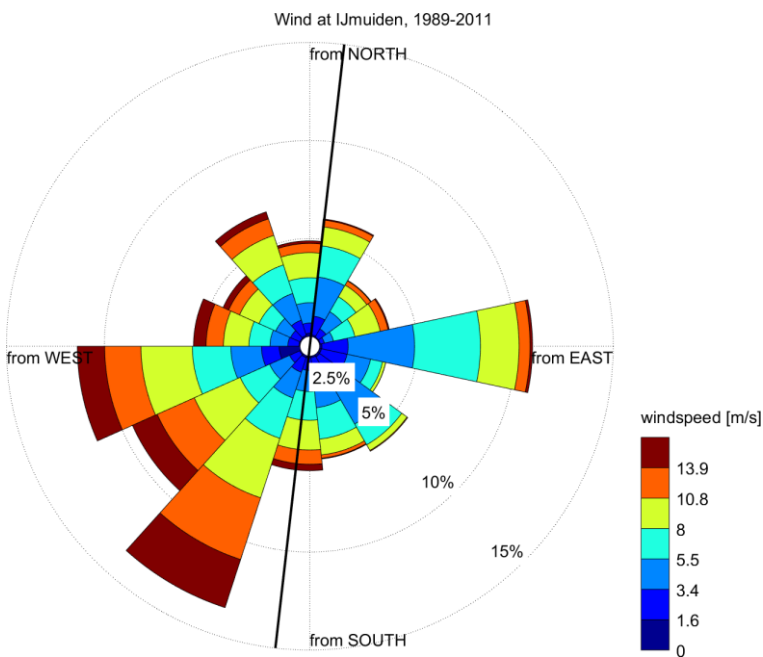
Figure 22: Wind conditions for the long term, pre nourishment period 1989-2011

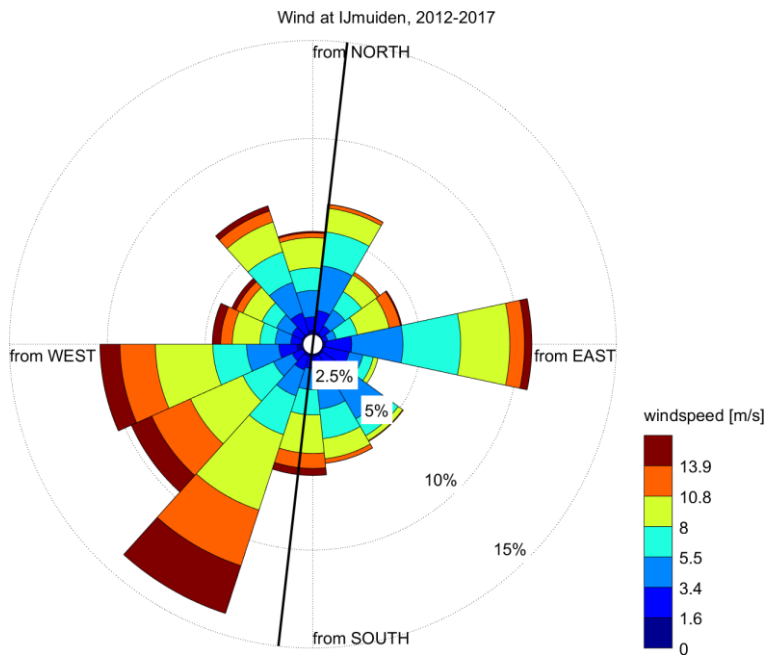
Figure 23: Wind conditions in the nourishment period

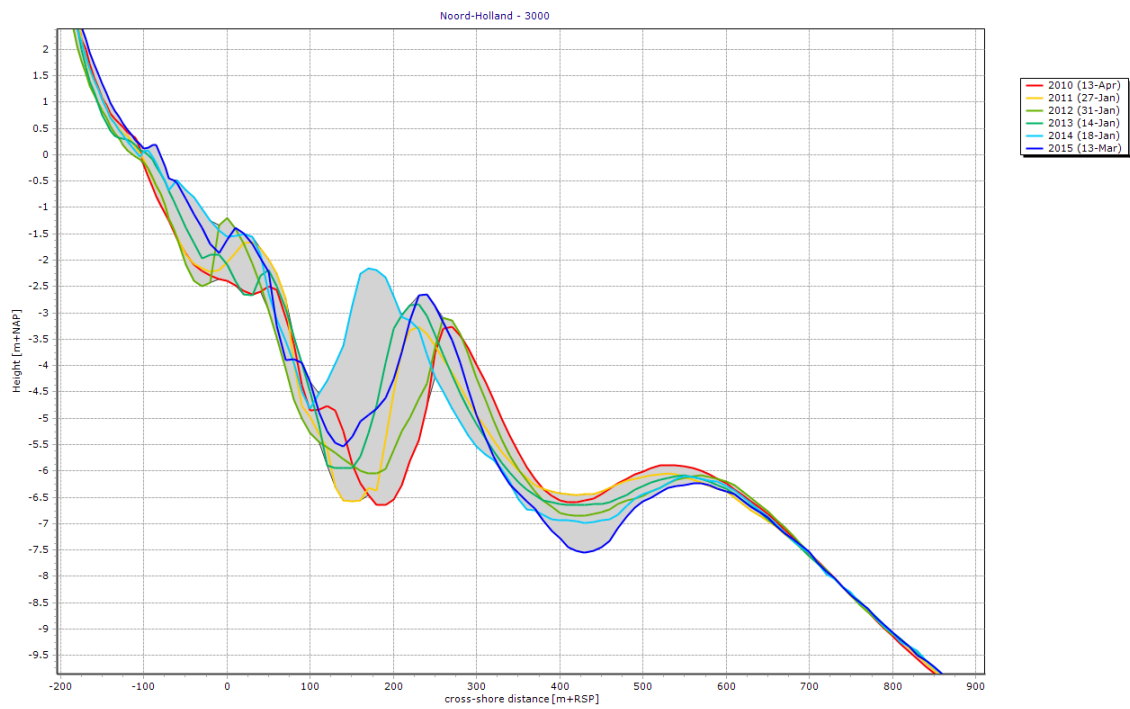
Figure 24: Profile 3000 showing the shoreface just north of the shoreface nourishment

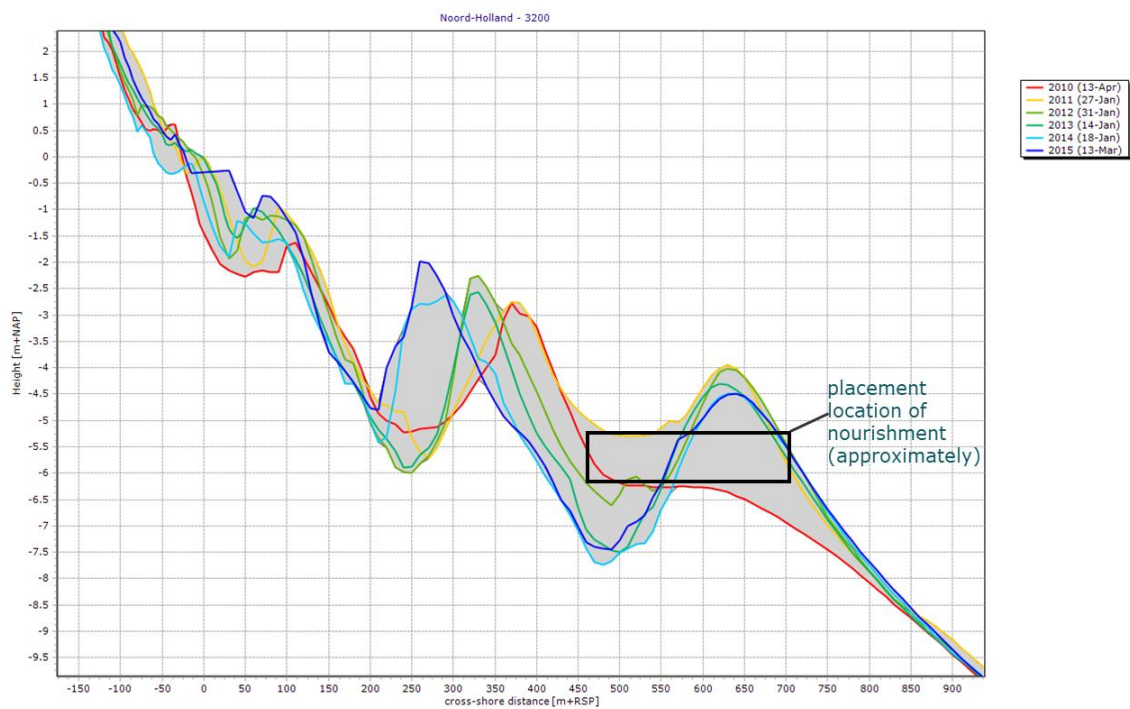
Figure 25: Profile 3200 showing the shoreface at the north side of the shoreface nourishment

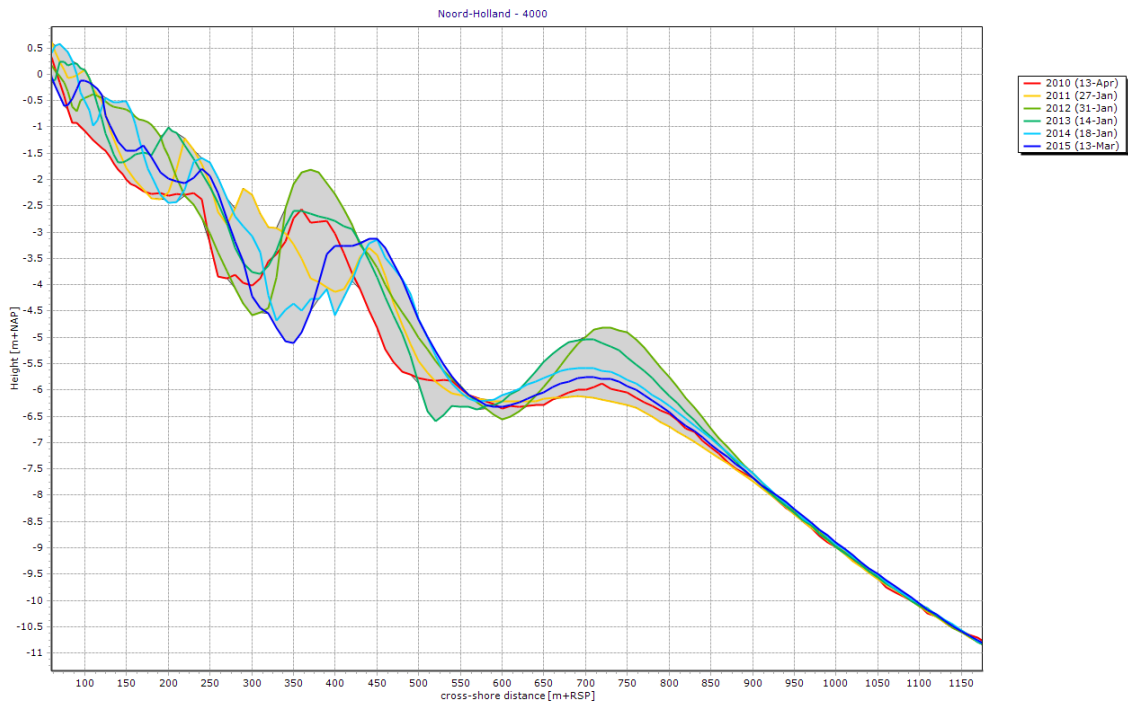
Figure 27: Profile 4000 showing the shoreface just south of the shoreface nourishment

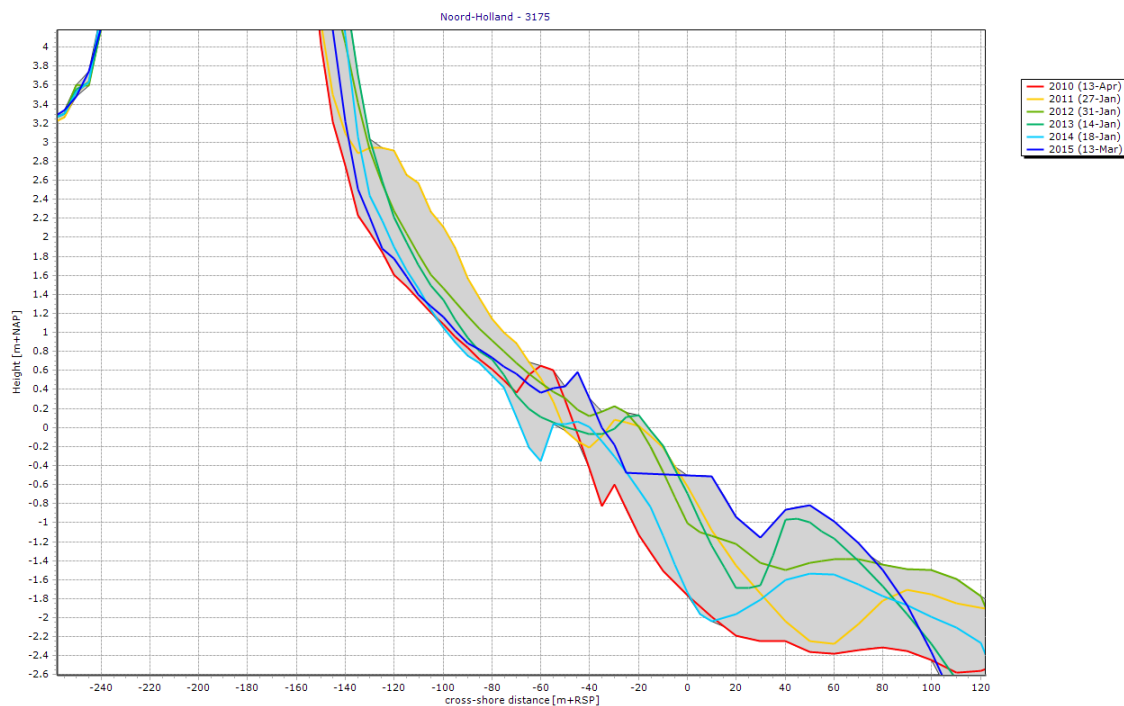
Figure 29: Profile 3175 showing the zone around the beach at the north end of the northern beach nourishment

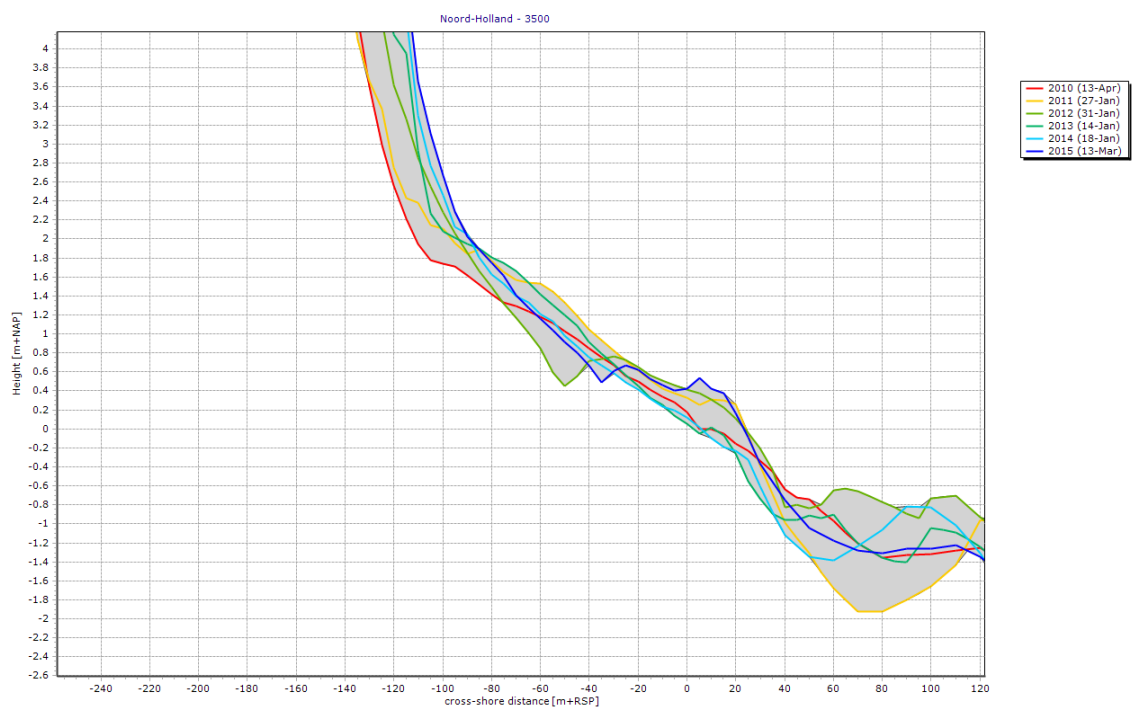
Figure 31: Profile 3500 showing the zone around the beach in between the northern and southern beach nourishments

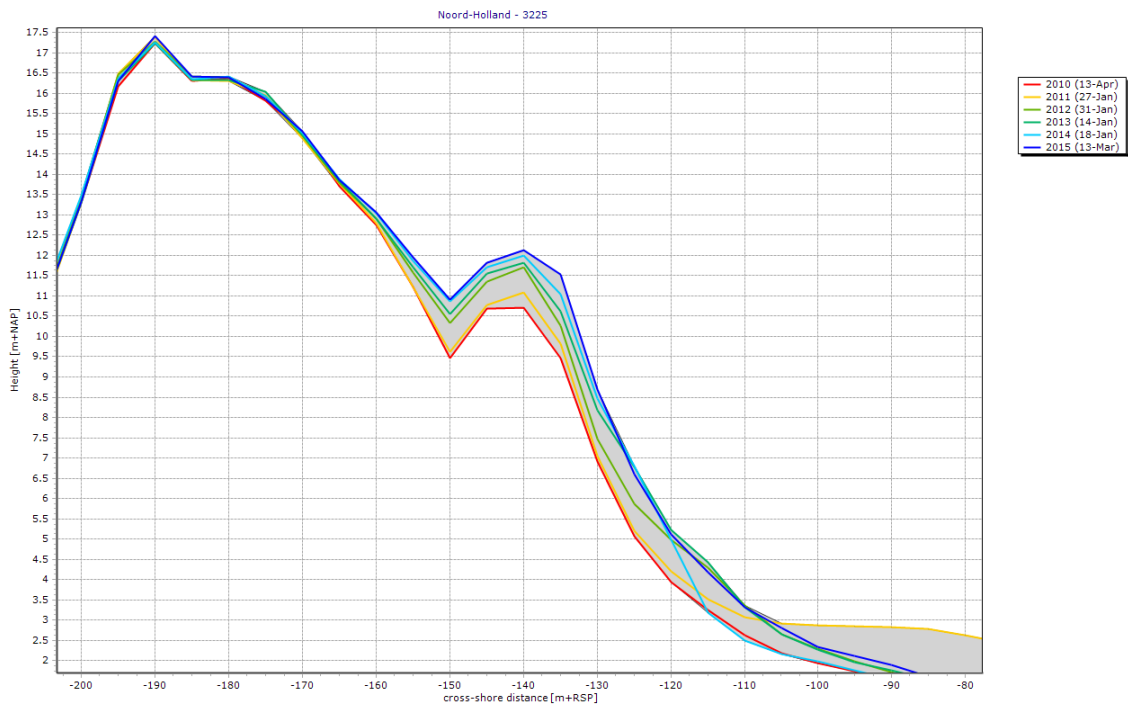
Figure 38: Profile 3225 showing the first dune at the centre of the northern beach nourishment

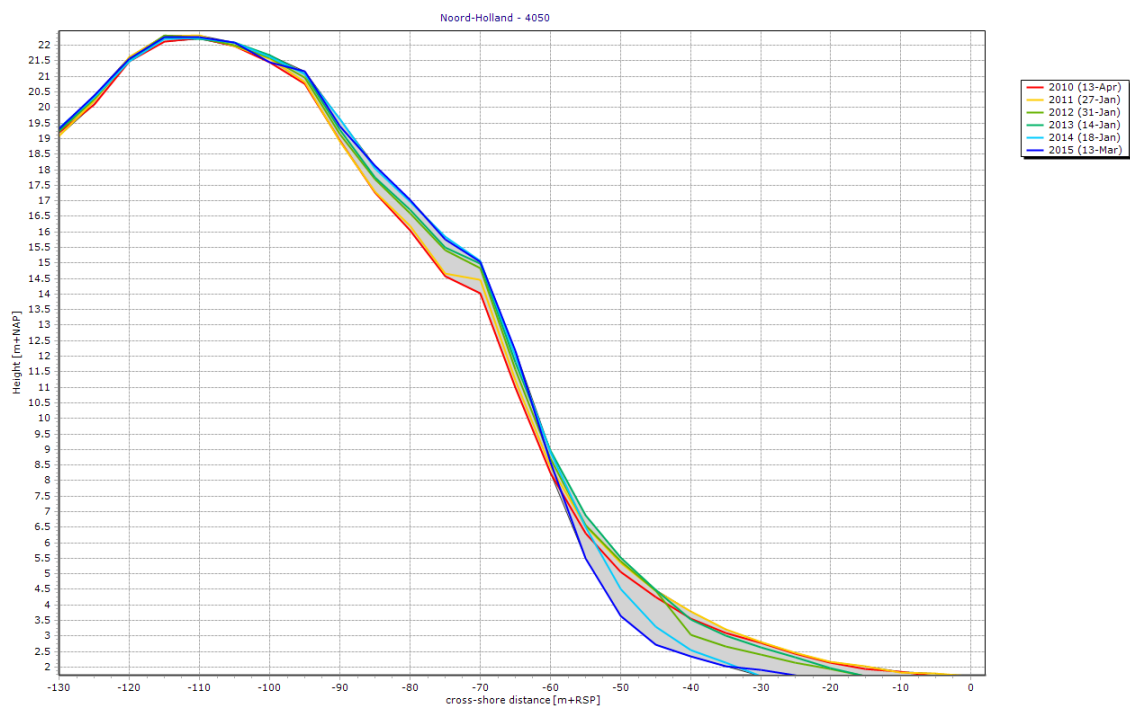
Figure 42: Profile 4050 showing the first dune just south of the southern beach nourishment

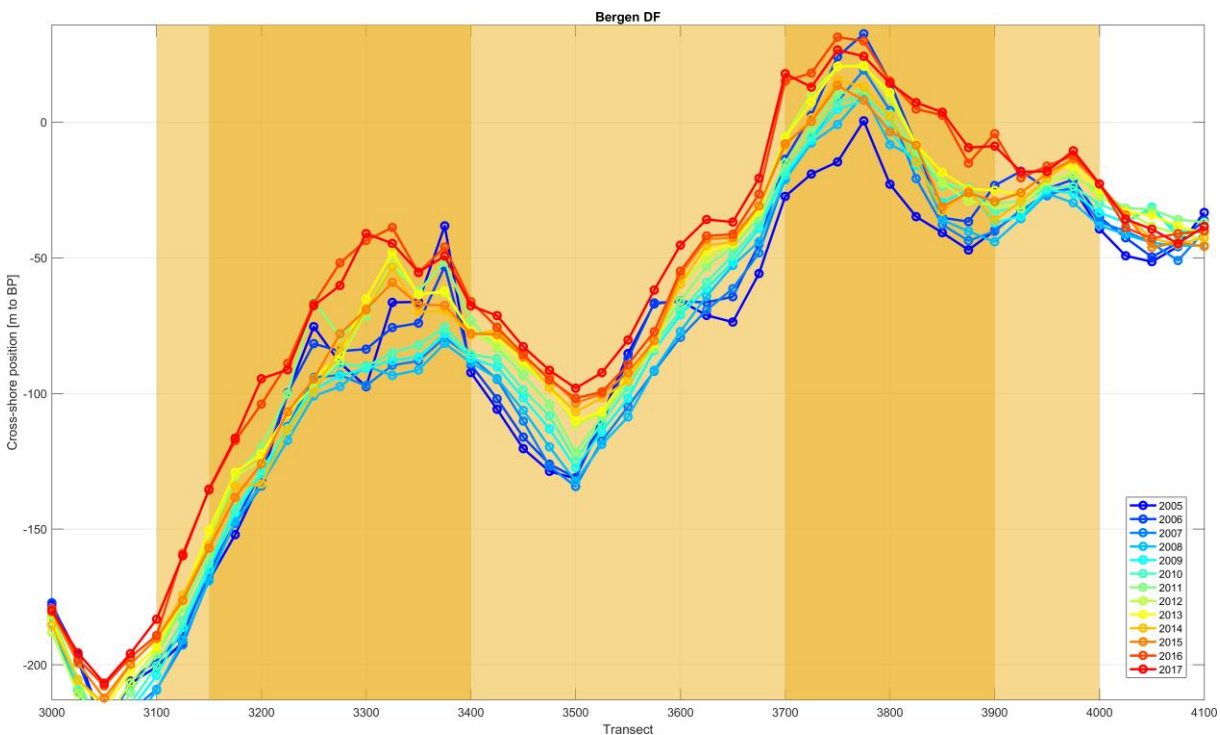
Figure 43: Position of the dunefoot for the transects in the study area (3000 is in the north, 4100 in the south) from 2005 to 2017. Squares indicate nourishment positions: shoreface nourishment (yellow) and two parts of the beach nourishment (orange).

All three dune indicators (dunefoot, mid dune level and upper dune level, Figure 43 to Figure 45) show a similar change. In general there is a seaward movement, indicating sedimentation of the first dune. In the dunefoot sudden large movement in seaward direction followed by a large landward direction is caused by the beach nourishments, which are constructed up to this level.

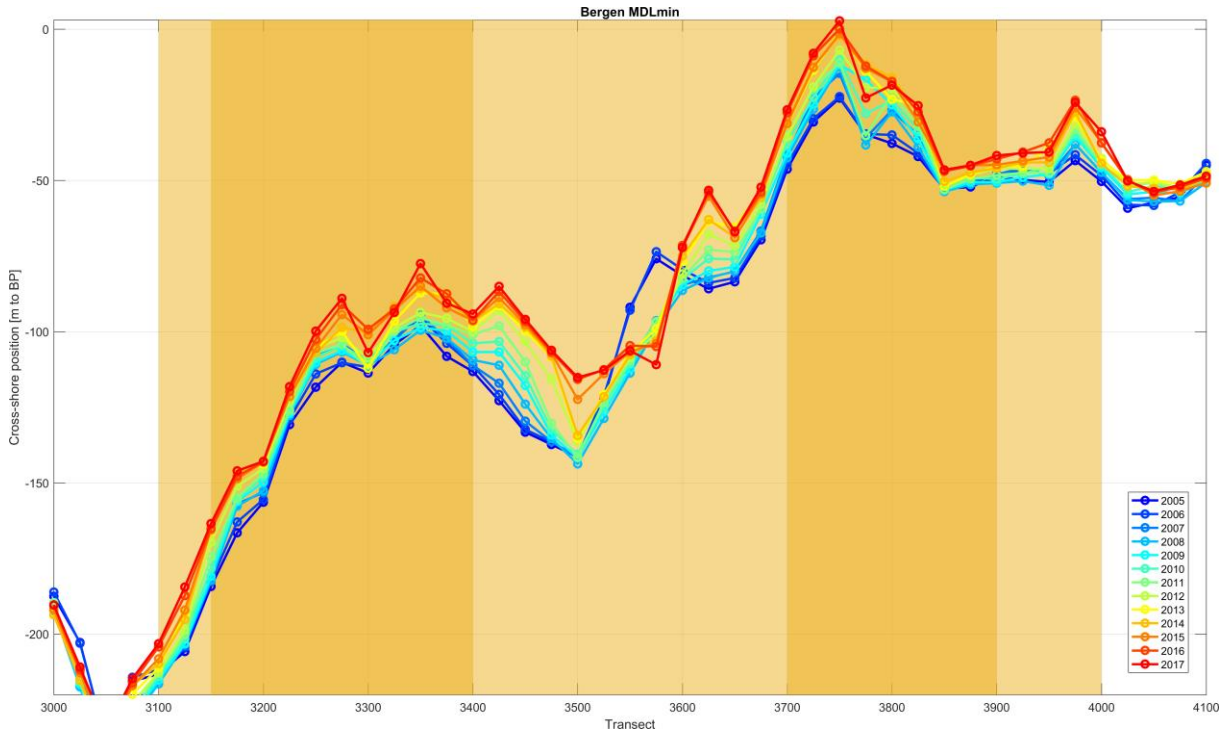
Figure 44: Position of the mid dune level for the transects in the study area (3000 is in the north, 4100 in the south) from 2005 to 2017. Squares indicate nourishment positions: shoreface nourishment (yellow) and two parts of the beach nourishment (orange).

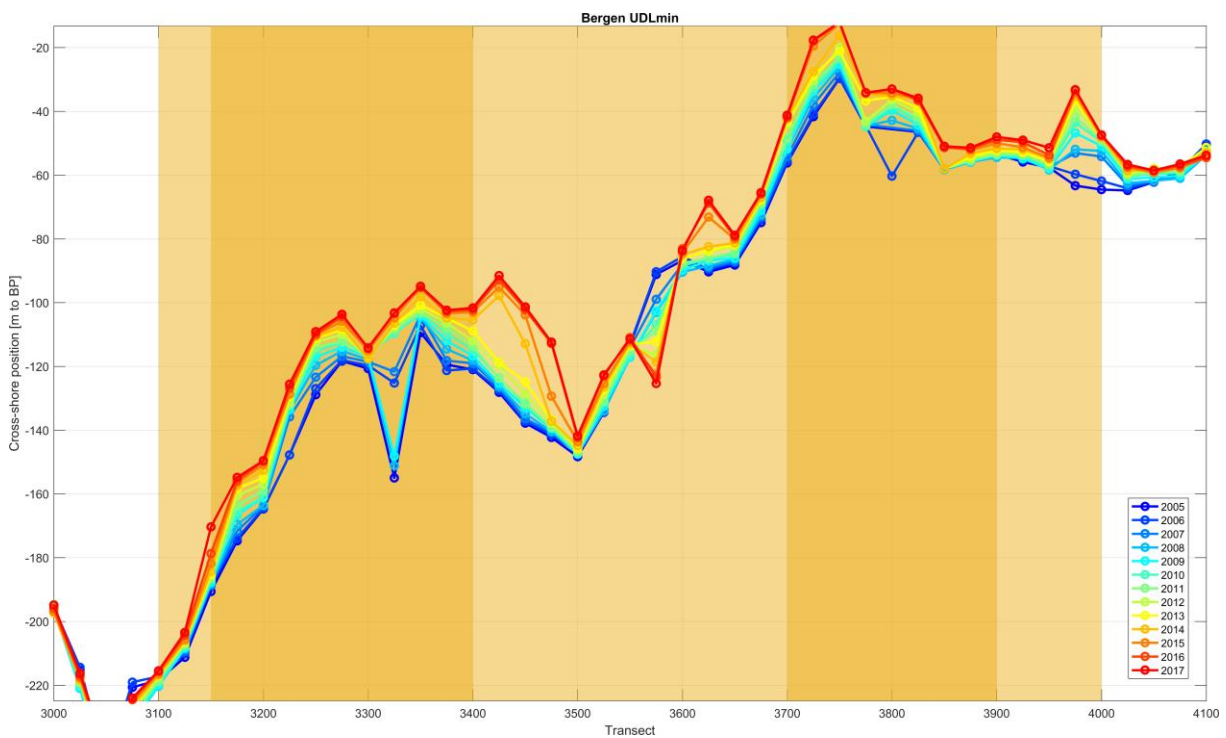
Figure 45: Position of the upper dune level for the transects in the study area (3000 is in the north, 4100 in the south) from 2005 to 2017. Squares indicate nourishment positions: shoreface nourishment (yellow) and two parts of the beach nourishment (orange).
