National analysis of nourishments;

*Coastal state indicators and driving forces for Bergen-
Egmond, the Netherlands*

Date: 05/08/2019

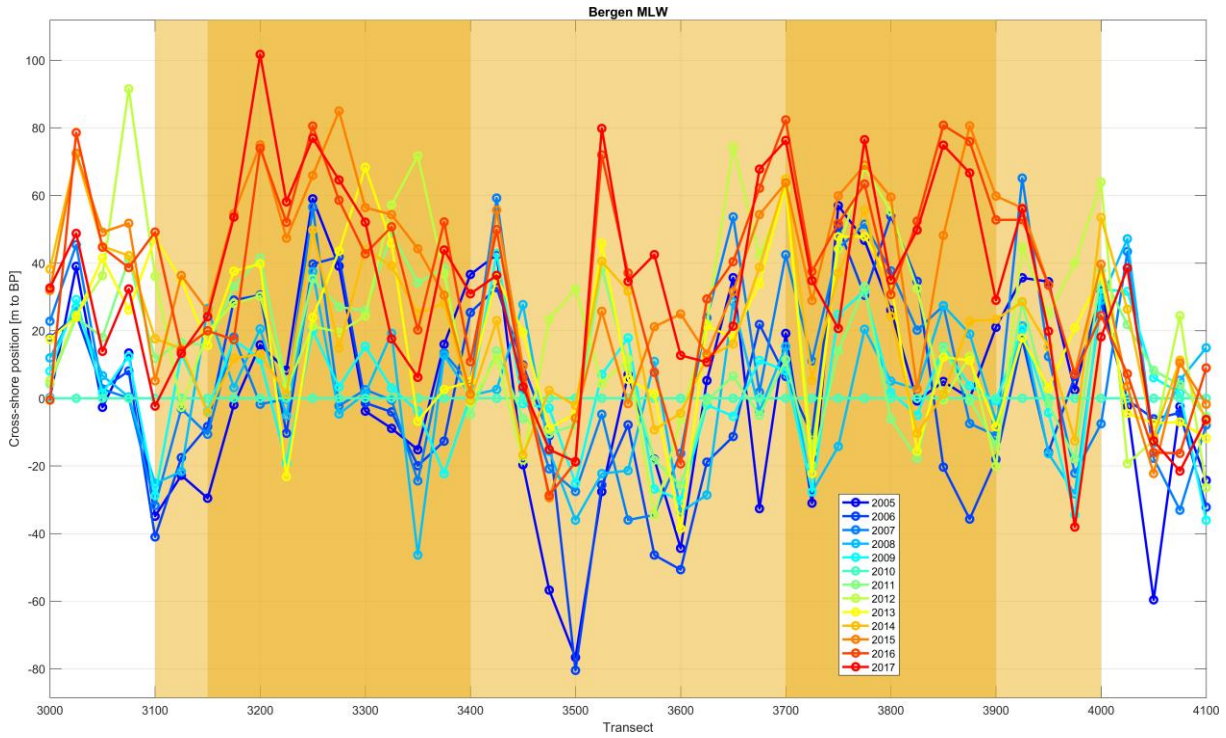
Figure 46: Position of the mean low water line relative to the position in 2010 for the transects in the study area (3000 is in the north, 4100 in the south) from 2005 to 2017. Squares indicate nourishment positions: shoreface nourishment (yellow) and two parts of the beach nourishment (orange).

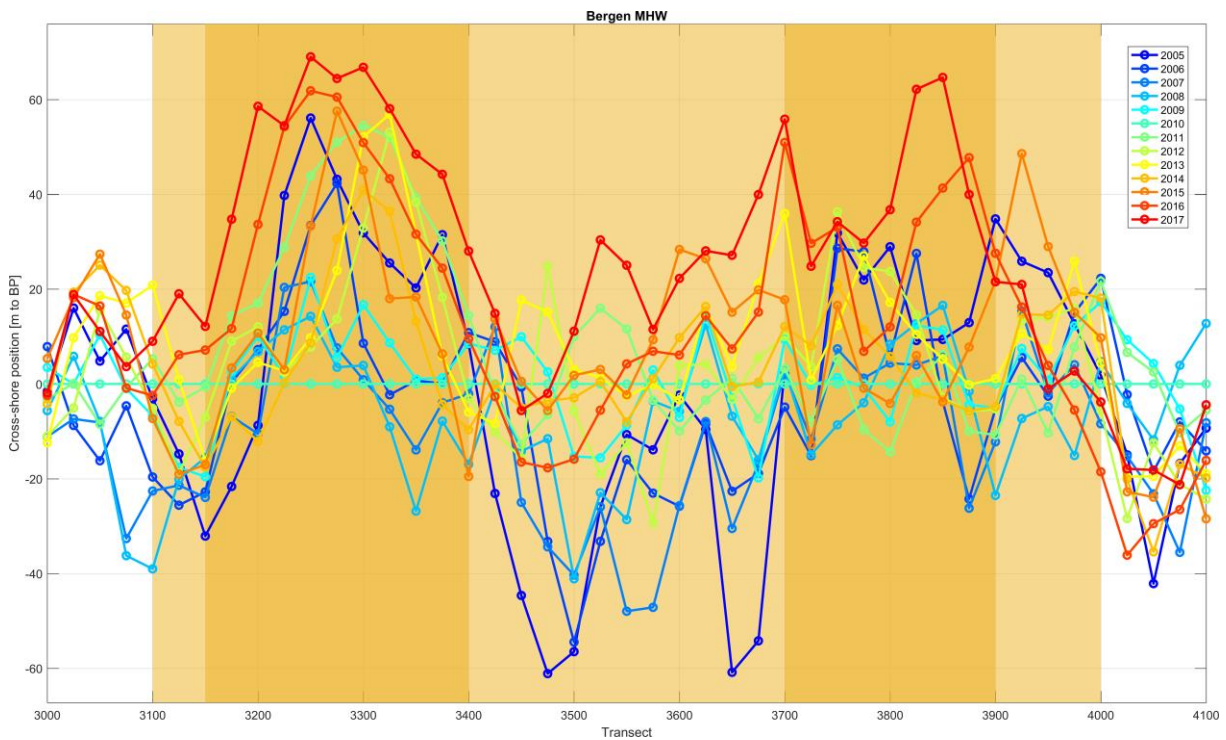
Figure 47: Position of the mean high water line relative to the position in 2010 for the transects in the study area (3000 is in the north, 4100 in the south) from 2005 to 2017. Squares indicate nourishment positions: shoreface nourishment (yellow) and two parts of the beach nourishment (orange).

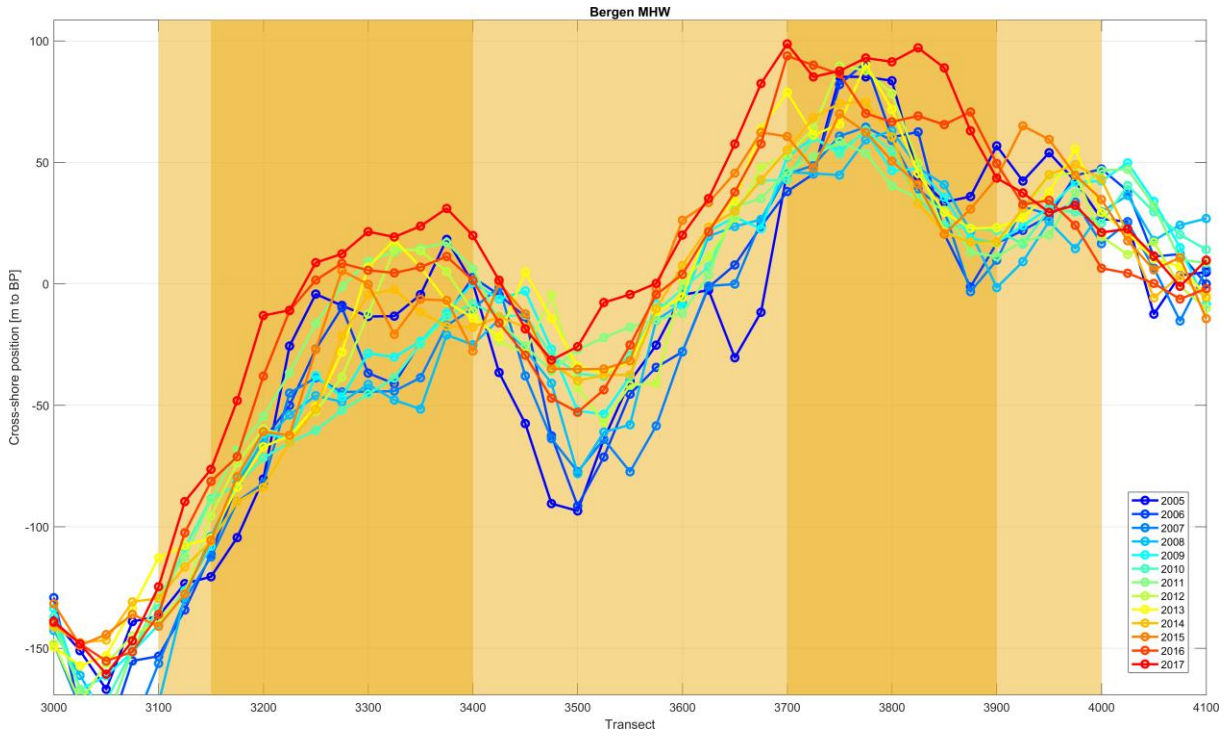
Figure 48: Position of the mean high water line for the transects in the study area (3000 is in the north, 4100 in the south) from 2005 to 2017. Squares indicate nourishment positions: shoreface nourishment (yellow) and two parts of the beach nourishment (orange).

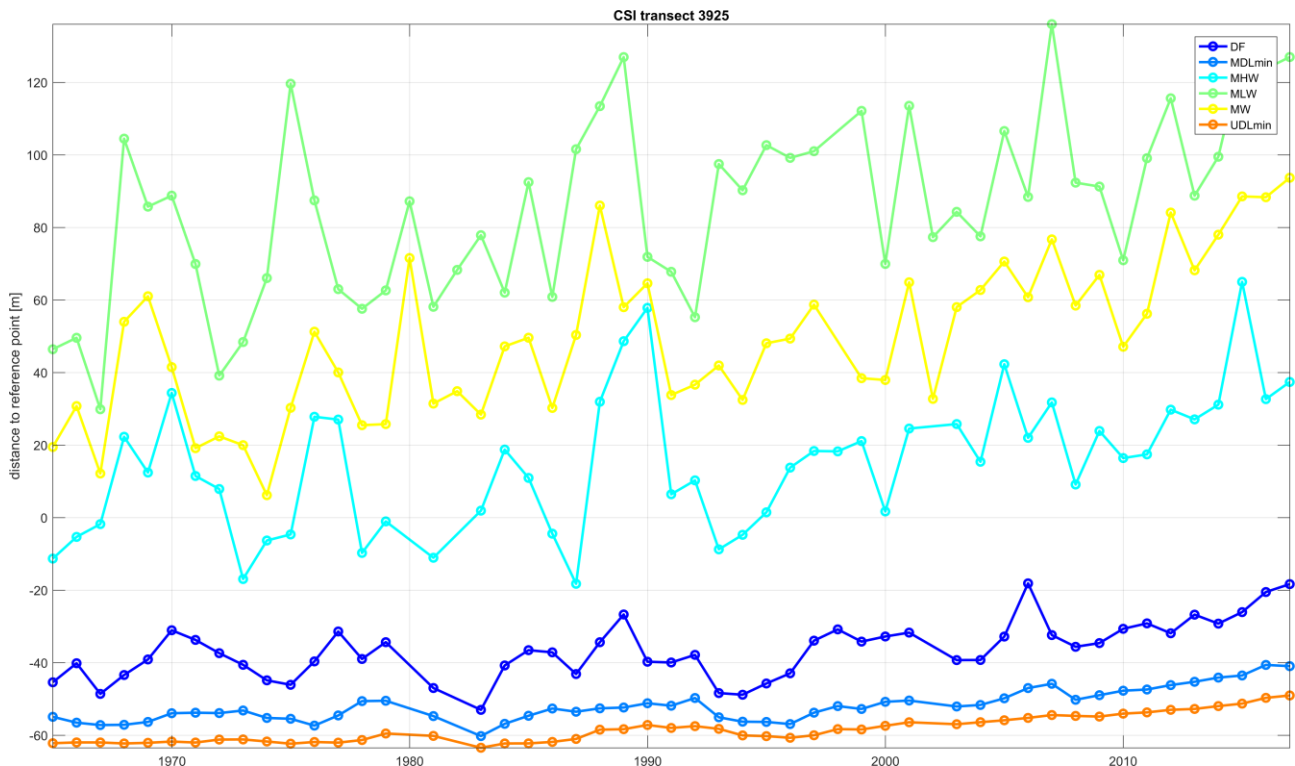
Figure 51: Development of all coastal state indicators in time for transect 3925

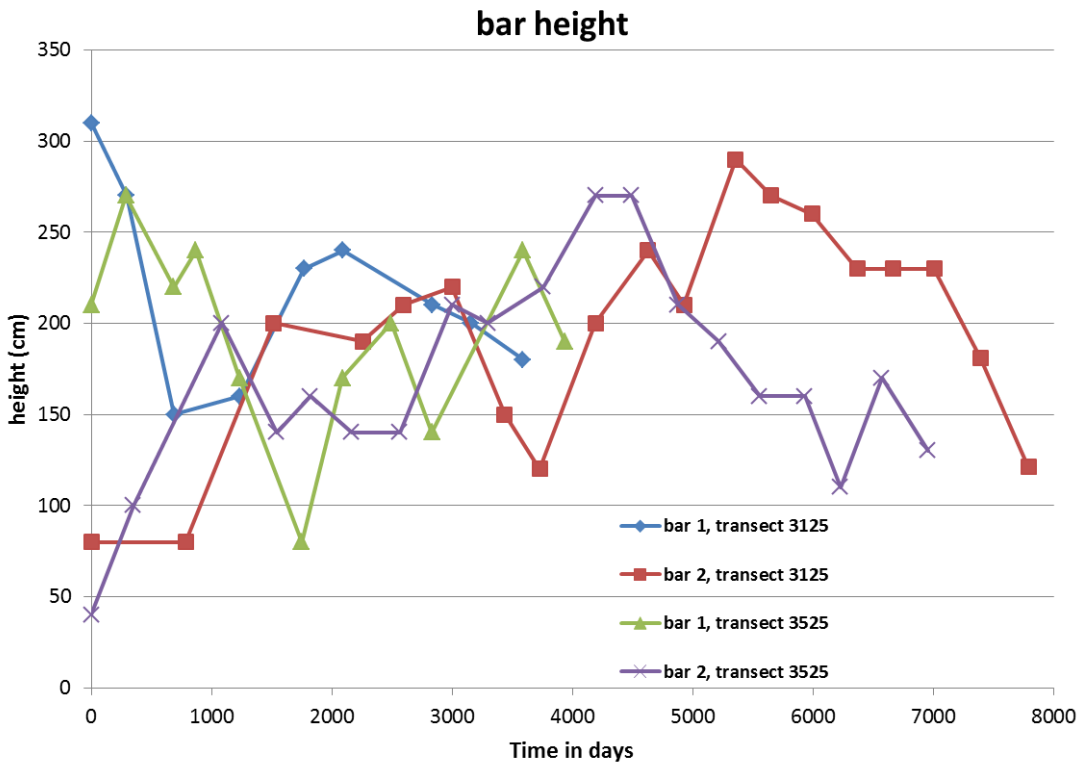
Figure 54: Change of bar height in time for randomly chosen bars

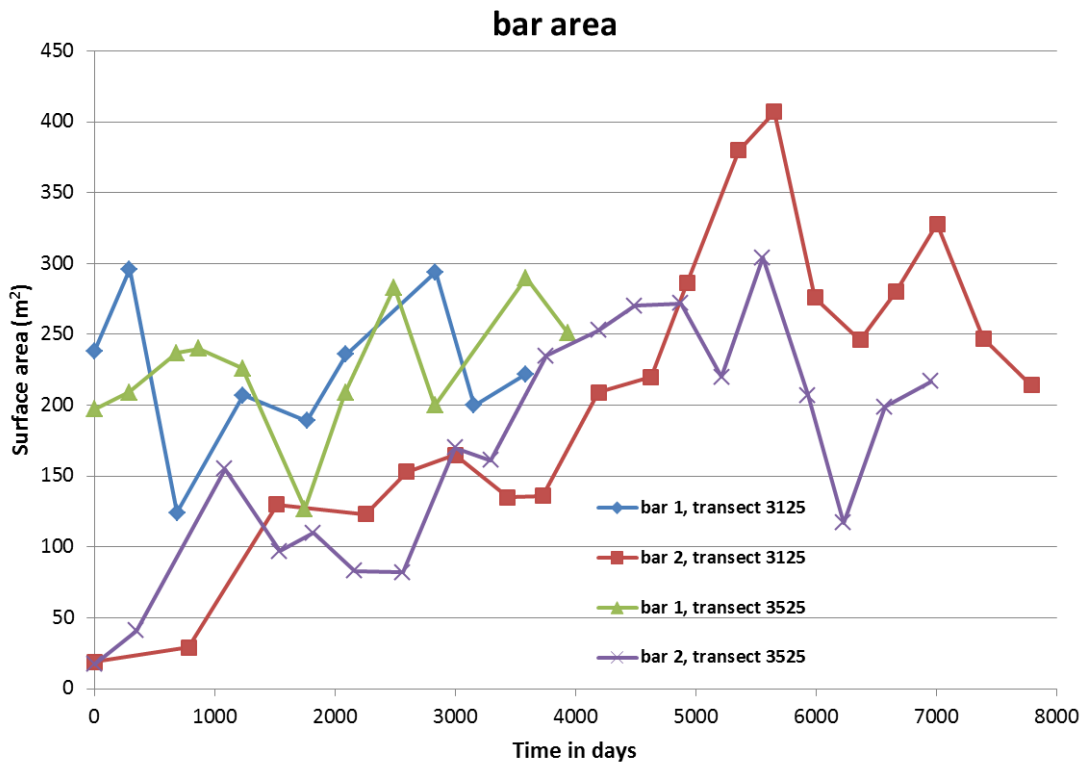
Figure 55: Change of surface area in time for a randomly chosen bars

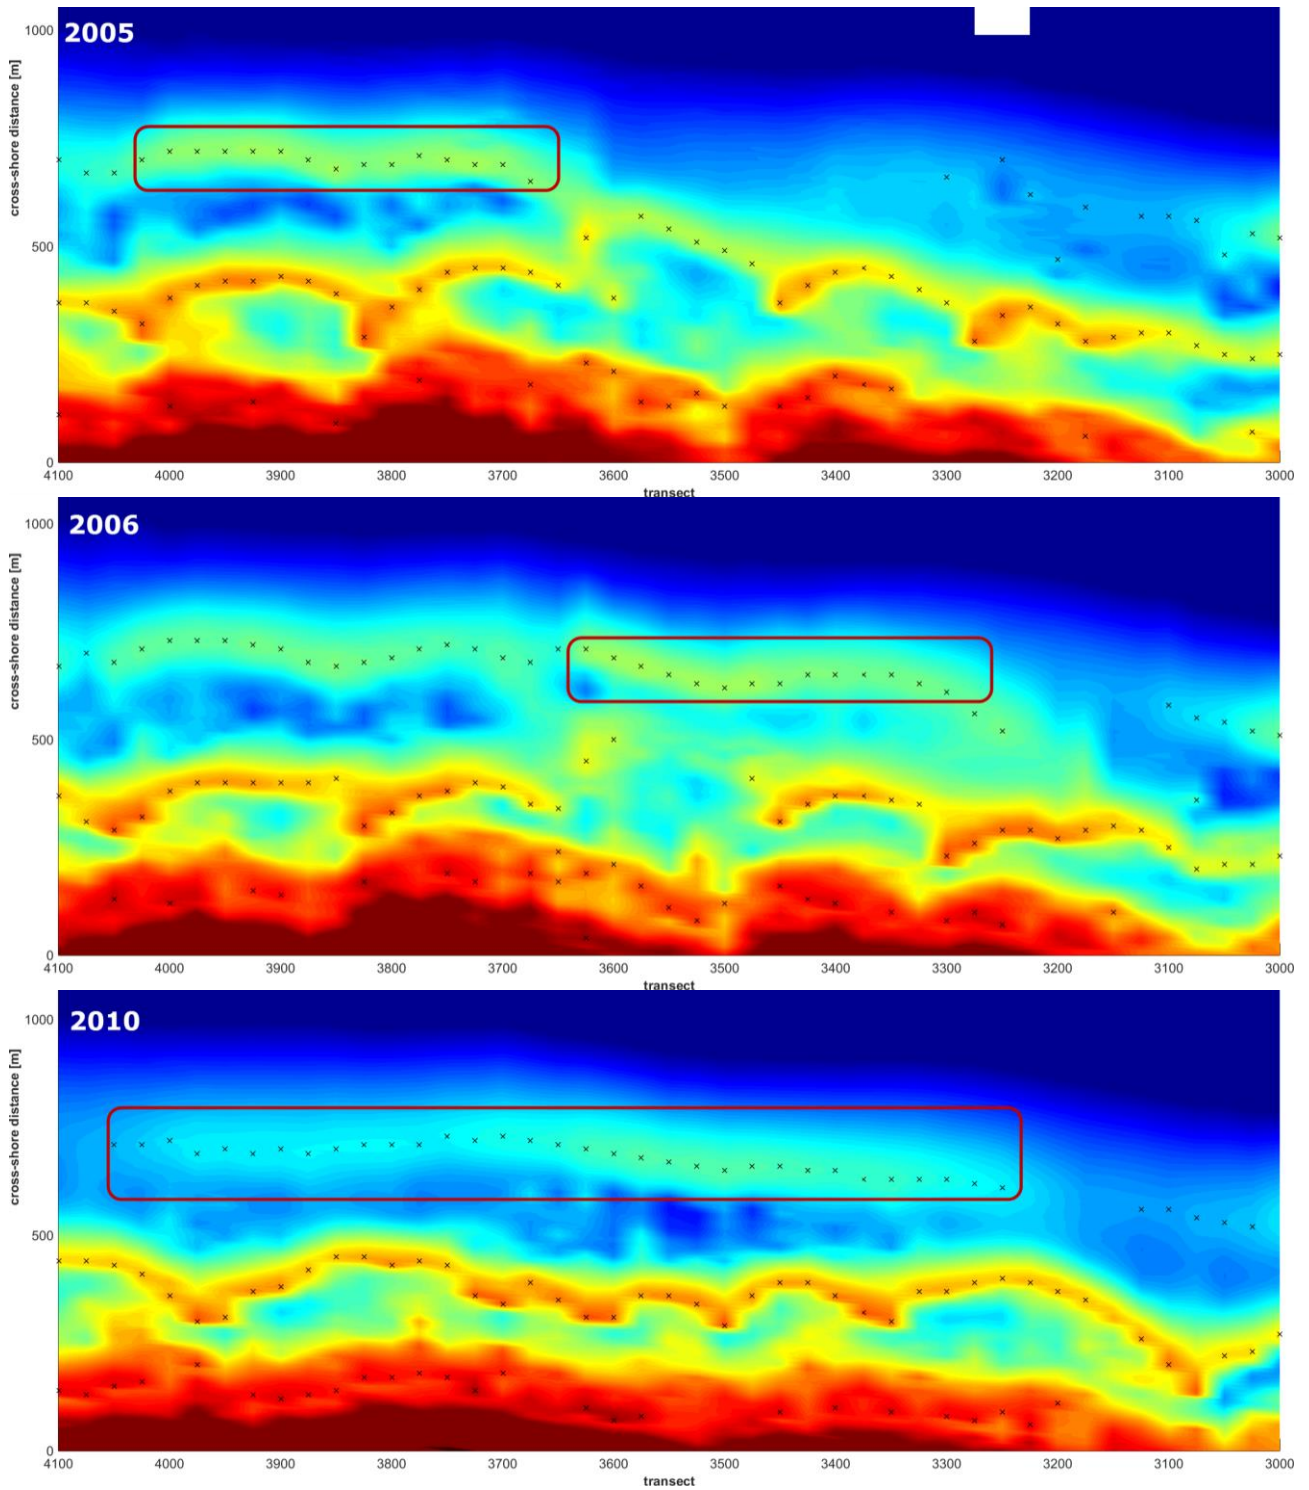
Figure 59: Bathymetry plot based on transect data (not gridded data) measured in 2005, 2006 and 2010 with the detected bar crest position indicated with crosses. The indicated areas show the shoreface nourishments of 2004 (top) and 2005 (middle), and their remaining sediment in 2010 (bottom)

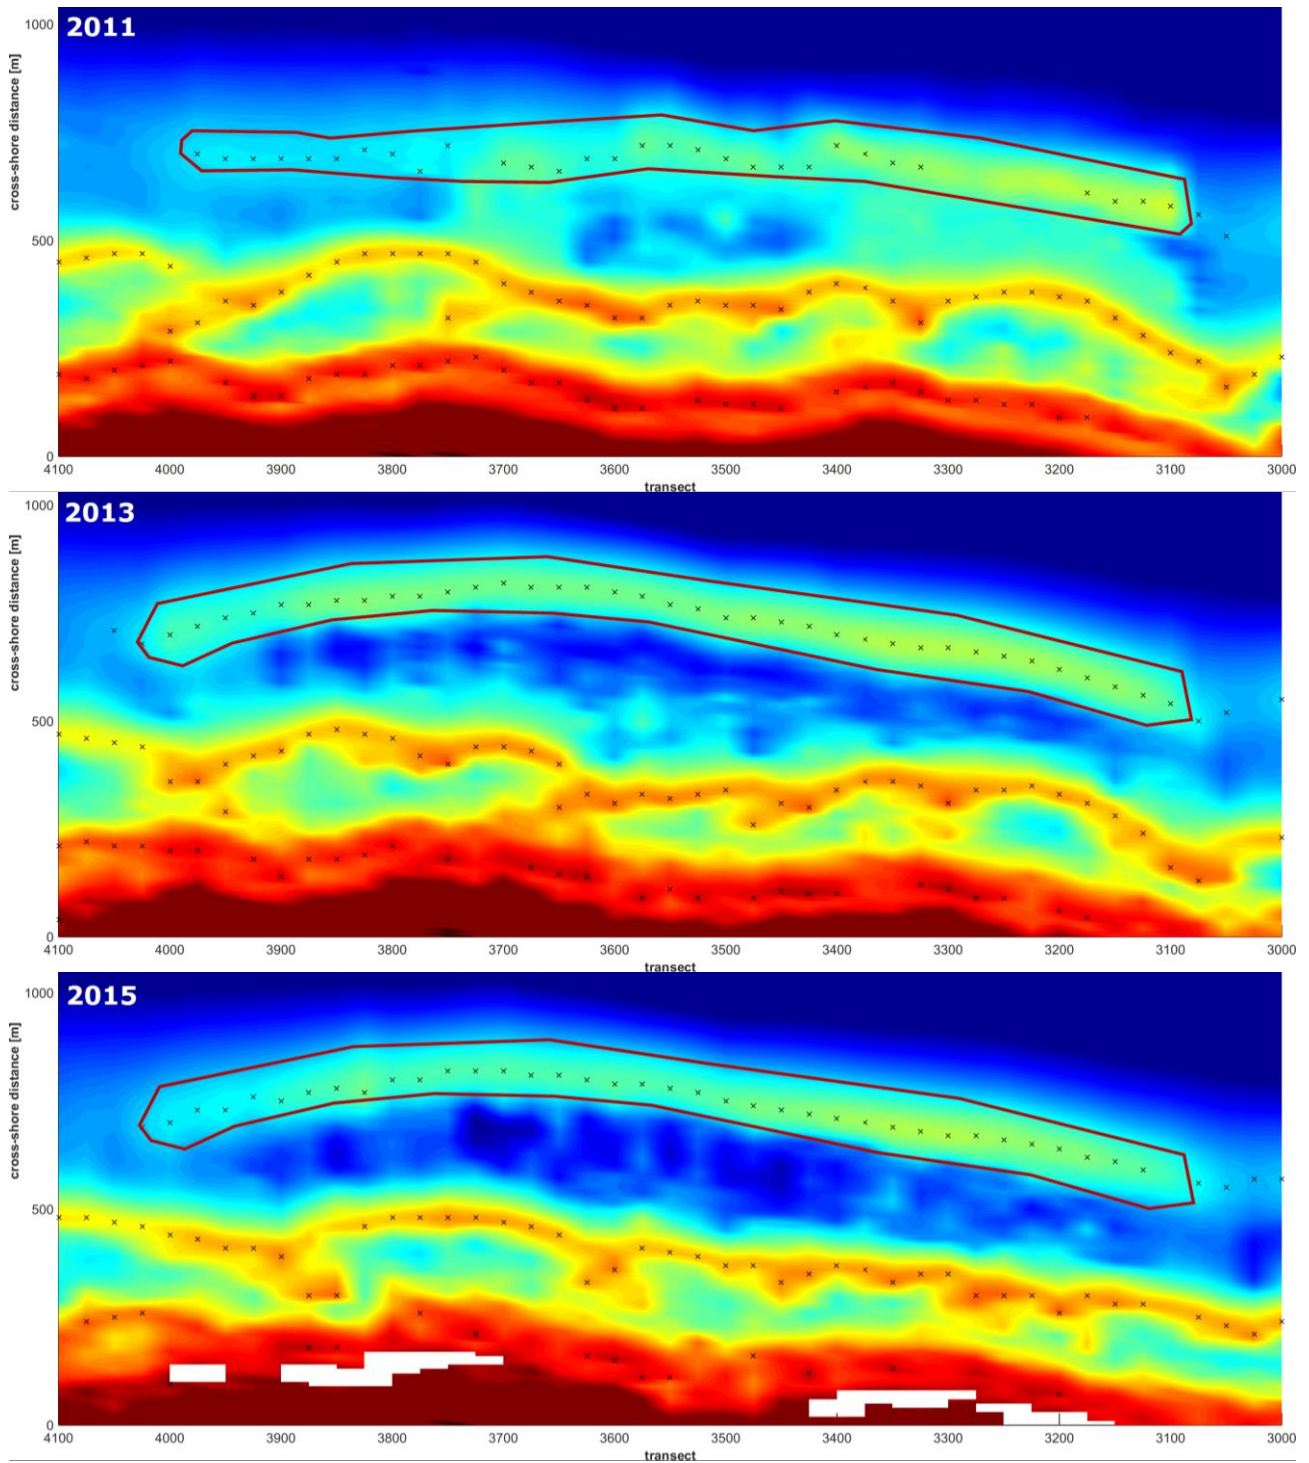
Figure 60: Bathymetry plot based on transect data (not gridded data) measured in 2011, 2013 and 2015 with the detected bar crest position indicated with crosses. The indicated areas show the shoreface nourishments considered in this study of 2010 (top) and 2011 (middle), and their remaining sediment in 2015 (bottom)

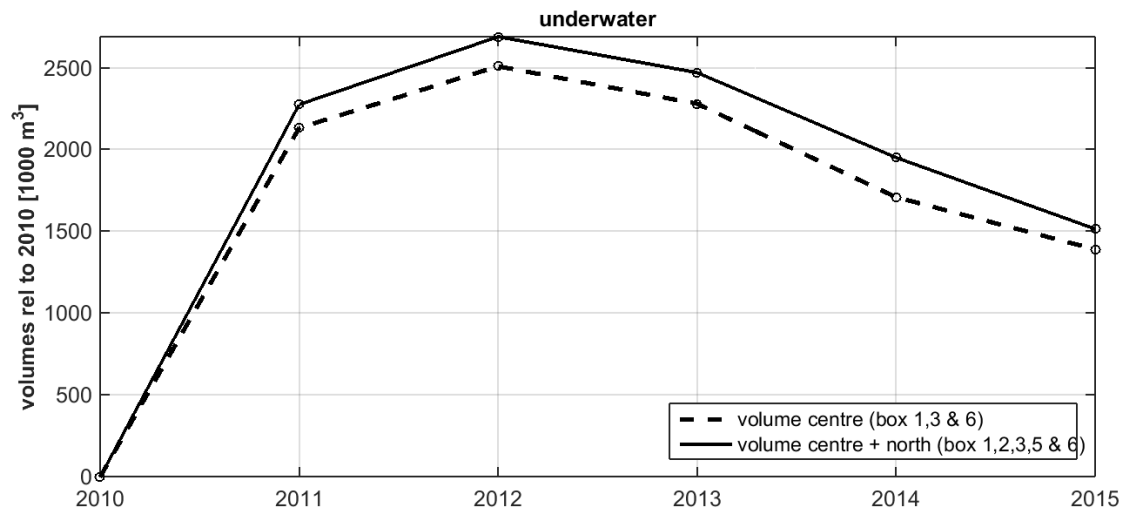
Figure 63: Volume development nourishment boxes and larger area for shoreface (upper) and beach (lower)
