Ministry of Environment
and Food of Denmark
Coastal Authority

Building with Nature: Systems Description of Krogen

August 2018

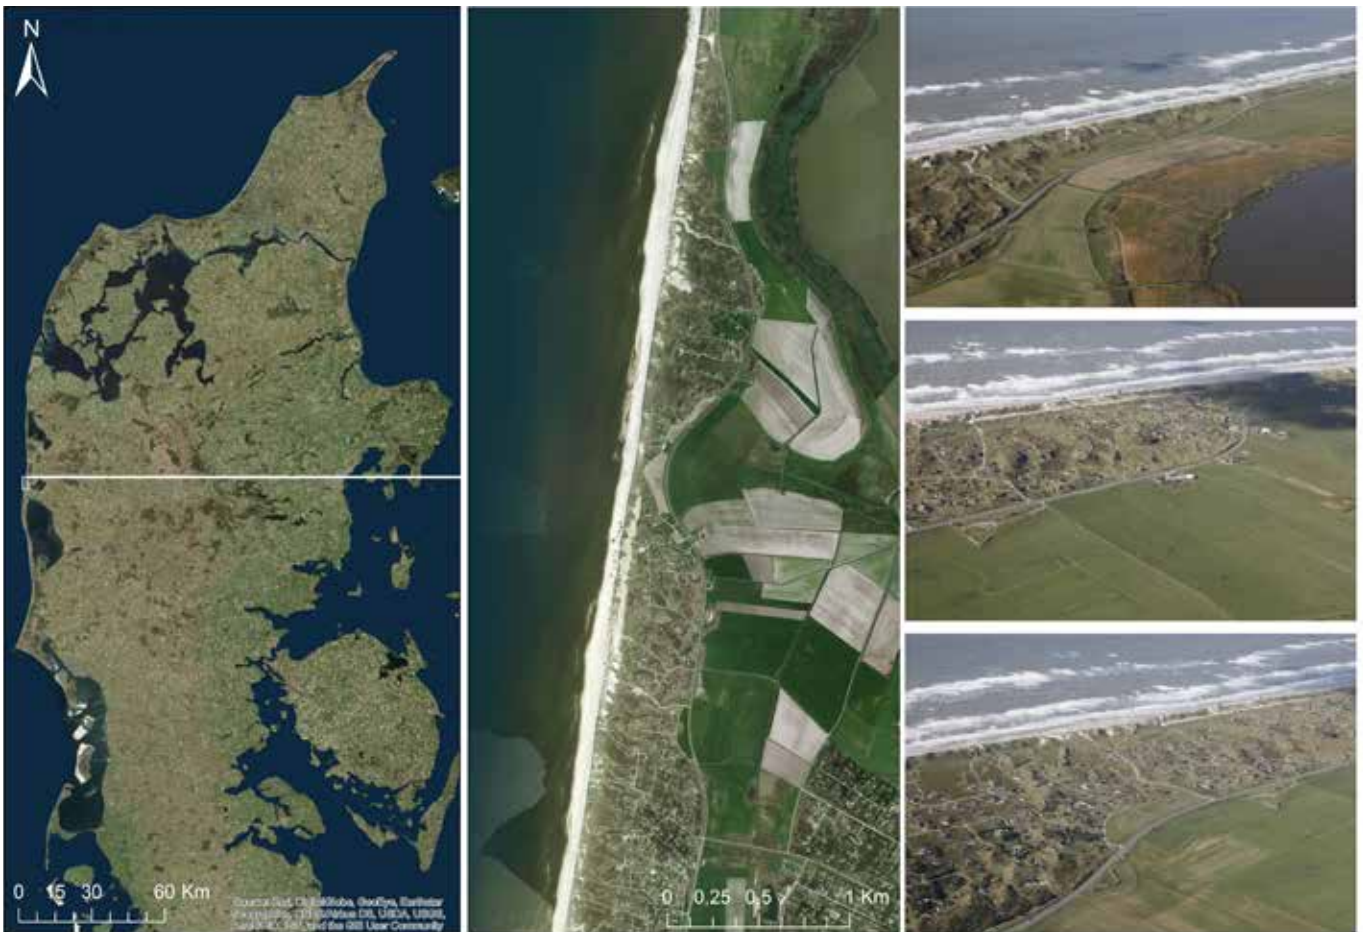
Figure 4 Location and photo of the living laboratory Krogen (© SDFE).

At Krogen the main road, Houvig Klitvej, takes a turn to the west and is less than 170 meters from the dune front, the smaller access road to the vacation homes is within 50 meters of the dune belt, see Figure 4. Along the beach and within the dunes are both hidden and visible wartime bunkers. Vacation homes are scattered in and between the dunes, and further inland denser populations of vacation homes, such as Lodbjerg Hede, are found. The hinterland is mainly farmland used for grazing. Large parts of the area are governed by Natura 2000 and Ramsar legislation, as it is of great importance to migrating and nesting birds.

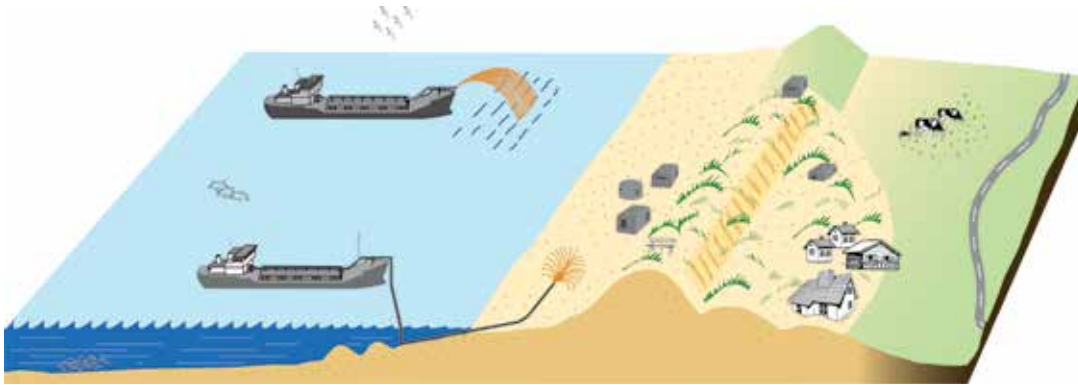
Figure 5: Schematic representation of the living laboratory at Krogen.

The illustration in Figure 5 conceptualizes some of the important elements of the system at Krogen. Both shoreface and beach nourishment have been undertaken, dune enhancements have been performed, and vegetation has been established. Fully and partly exposed wartime bunkers are found along the beach and in the dunes. In the dunes and just behind them there are vacation houses. In the following, the geological setting, the coastal system, the land use and the infrastructure are described.

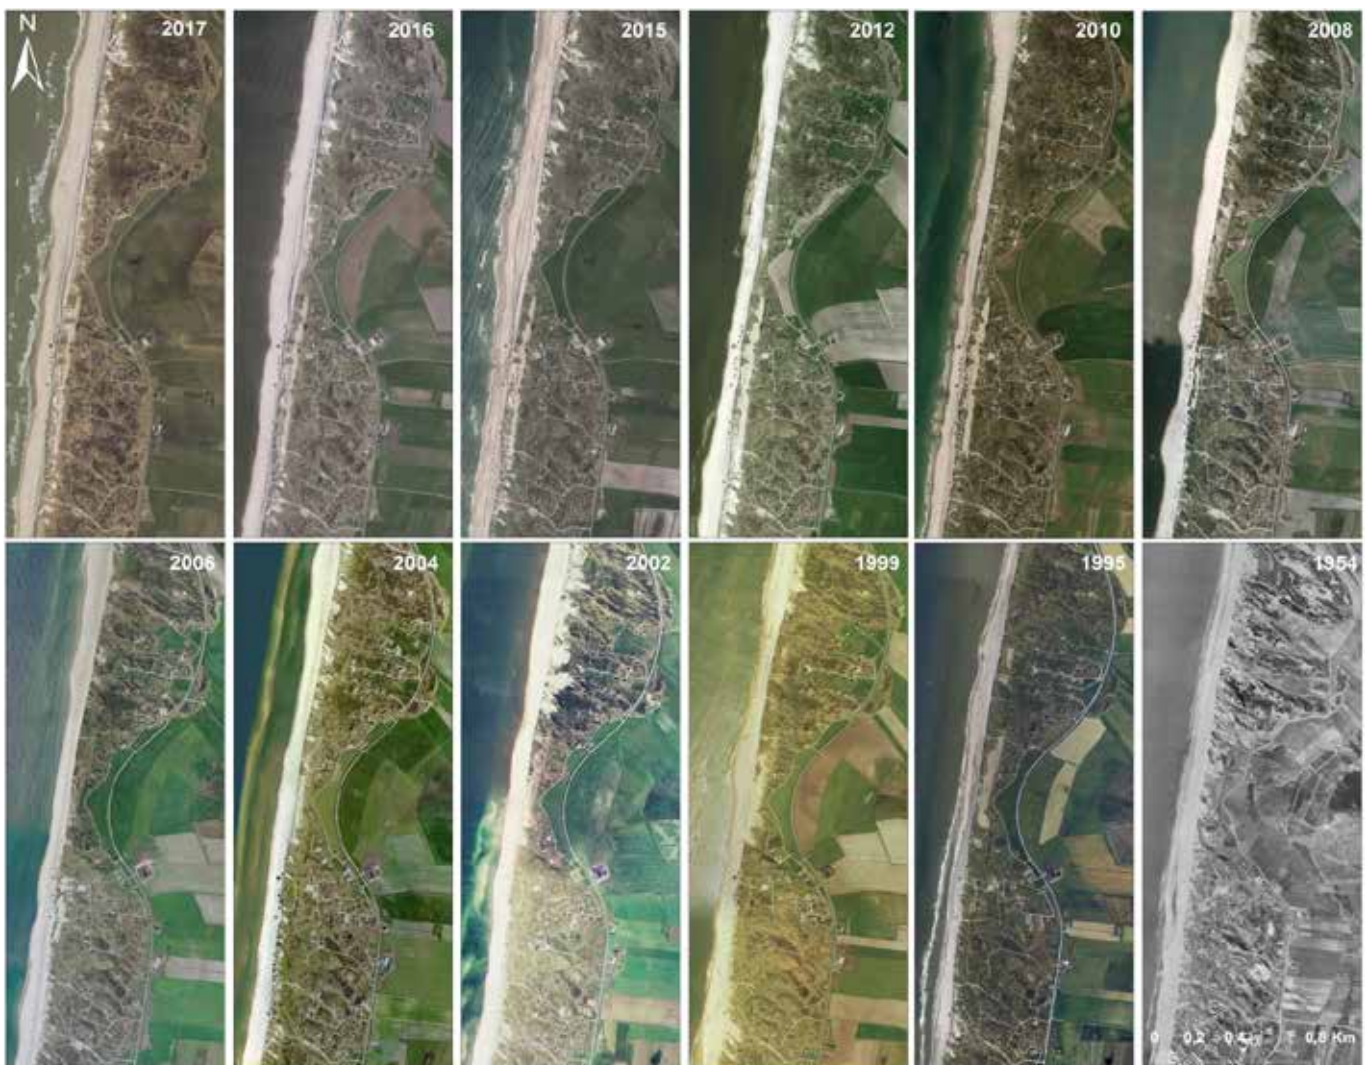
Figure 7 Aerial photos covering Krogen from (© DDO 1954-2012, COWI), (© DDO 2015-2017, Geodanmark, SDFE).

At Krogen the morphodynamic changes are evident when comparing aerial photos. The variations in beach width, and the bar evolution are apparent in the photos from 1995, 2002, 2004, 2006, 2010, 2015 and 2017. The above described alongshore variations in coastline and bars are observed, as well, especially in 2008 and 2017. In 2010 a nearshore bar with relatively rhythmic rip currents is observed (Figure 7).

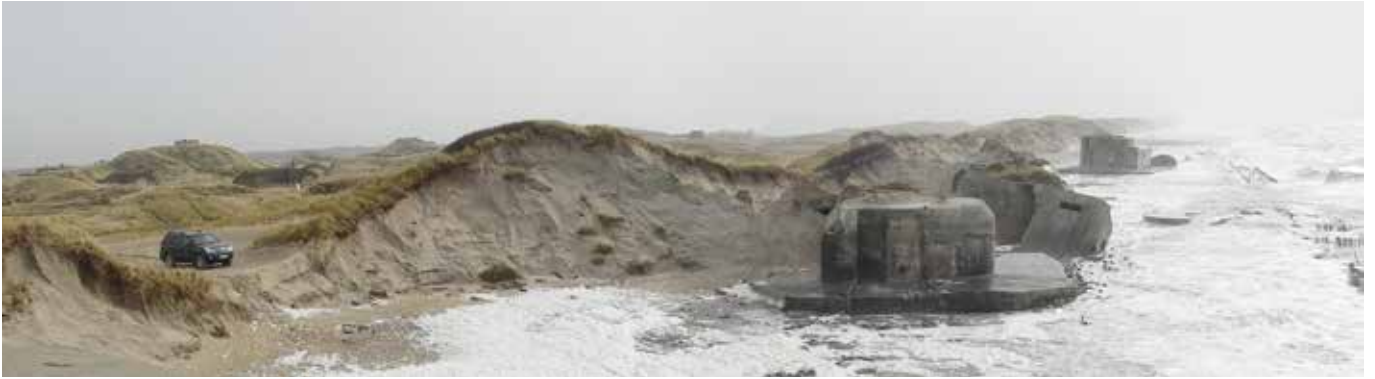
Figure 9 Picture from Krogen/Krylen right after an acute erosion event in March 2008.

Erosion can be categorized as either chronic or acute. Chronic erosion is long term and is often induced by alongshore gradients of the sediment transport; along coastlines where, as sediment transport rates increase, a sediment deficiency occurs leading to erosion of the coastal profile and a gradual landside displacement of the coastline. Acute erosion is temporary and occurs during storms with high water levels and high wave energy conditions (Acute erosion is part of the chronic erosion). The higher water levels and waves displace the erosional processes onshore leading to erosion of sediment on the back of the beach and the dunes. The Danish North Sea coast is recognized as an erosional coast which is subjected to chronic erosion caused by the southbound alongshore drift but furthermore, large acute erosion events will take place during storms, Figures 9 and 10.

Acute erosion at Krogen has previously influenced long stretches of dune, thus gradually exposing the bunkers which have been hidden in the dunes since they were built during World War II. Figures 9 and 10 show severe dune erosion at Krogen. The wave action during storms affects the dunes, eroding dune bases, which causes the dunes to collapse and makes erosion worse. In some areas the erosion was facilitated due to the presence of bunkers. The maximum recorded dune retreat at the Danish North Sea coast was 60 meters at Thyborøn and a retreat of 46 m was recorded at Vedersø in 1981 just 10 km north of Krogen. This indicates the scale of potential erosion at Krogen.

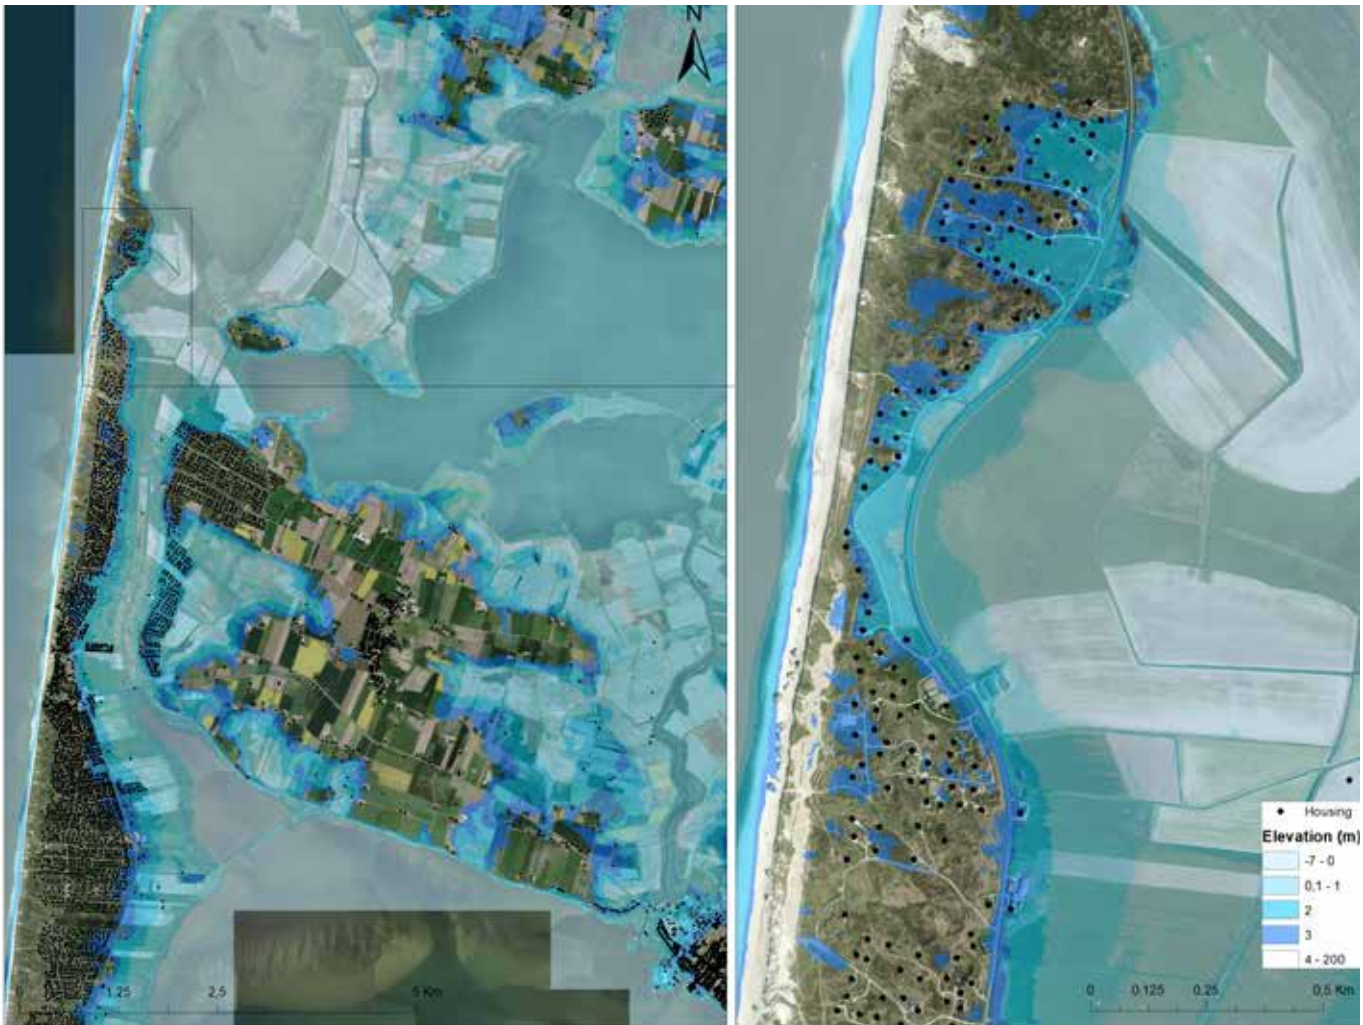
Figure 11: The maps show a flood risk analysis based on the national elevation model including houses. Left: Krogen, West Stadil Fjord, Stadil Fjord, and the most Northern part of Ringkøbing Fjord. Right: The local flood challenges at Krogen, especially to the vacation homes located in the dunes and along Houvig Klitvej (© Digital Elevation Model, 2014, SDFE).

The hinterland at Krogen is very flat and low; about 1 meter above sea-level with Vest Stadil Fjord to the north, Stadil Fjord to the east and Ringkøbing Fjord to the south. The 1 yr. and 100 yr. storm return periods are respectively; 2.02 and 3.11 meter above daily normal. In Figure 11 the national digital elevation model has been used to do a simple bucket fill analysis showing the area at risk in case of dune breach and subsequent flooding with a water level reaching as high as 3 meters above normal.

This means that in the case of dune breach the water could spread far inland affecting vacation homes, farmland, infrastructure and protected nature (Stadil Fjord and Vest Stadil Fjord are governed by Natura 2000 legislation), and a potential flood might eventually reach Ringkøbing Fjord and the town of Ringkøbing. This scenario is mainly due to a connection between Stadil Fjord and Ringkøbing Fjord which means that if the dunes break at Krogen and water flows into Stadil Fjord the potential for flooding and damage is extensive. The potential damage could be economically significant due to valuable buildings and infrastructure in Ringkøbing. The inland barriers between Stadil Fjord and Ringkøbing Fjord are not fully capable of delaying the water, even though the dike height of 1.80 m is considered adequate.

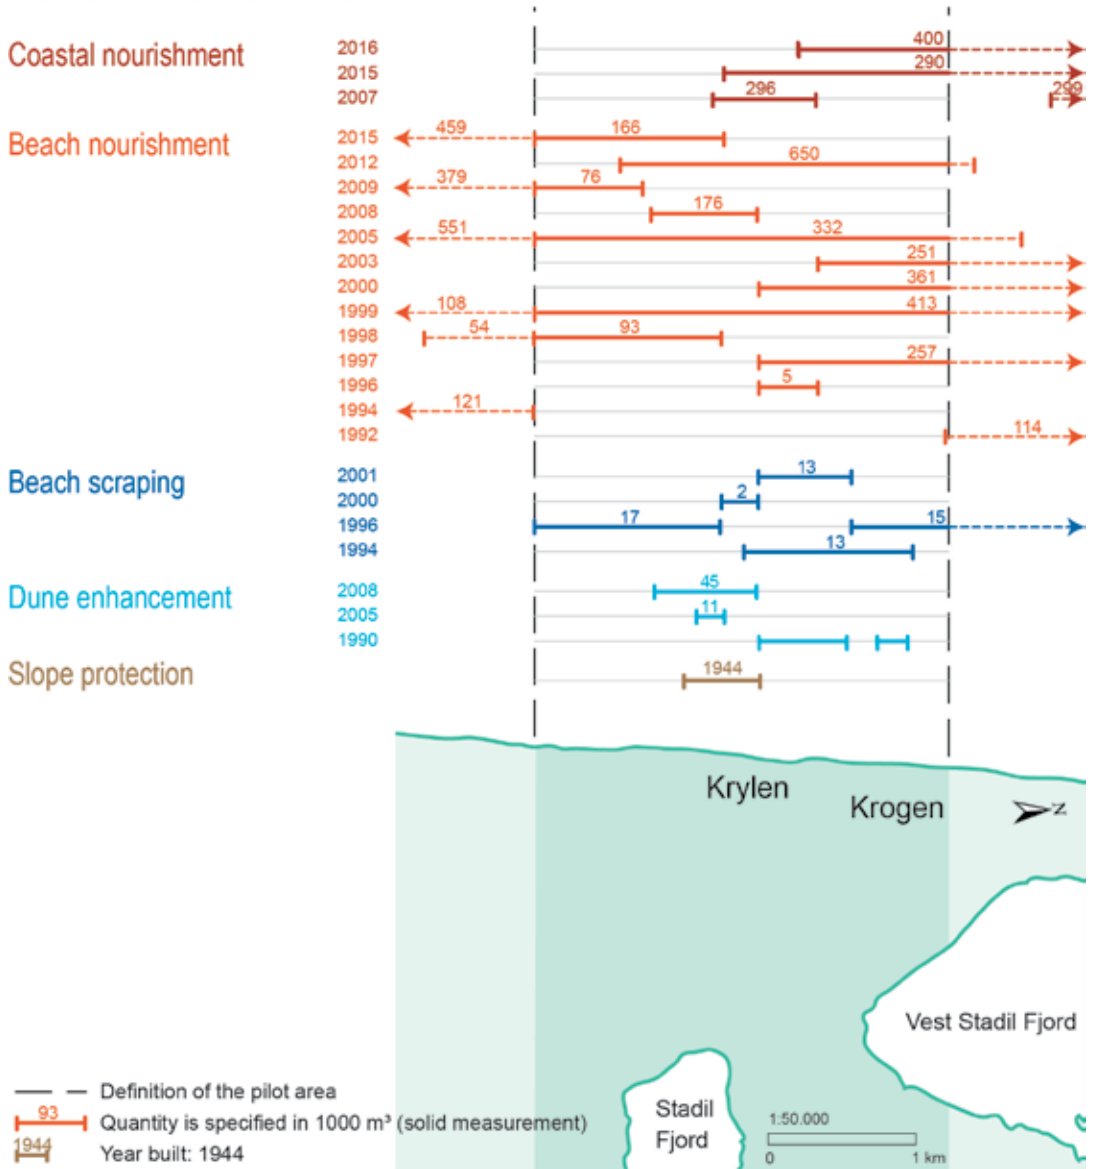
Performed measures since 1980

Figure 12: Performed measures at Krogen since 1980.

At Krogen both shoreface nourishment and beach nourishment have been undertaken, as illustrated in Figure 12. These were performed every year from 1996 to 2000 and then in 2003, 2005, 2007, 2008, 2009, 2012, 2015 and 2016 each to varying extent. In 1994, 1996, 2000 and 2001 scraping of the beach took place to better distribute the sediment that is deposited in the berm during calm weather. The Danish Coastal Authority no longer performs beach scraping, as this method has several disadvantages such as heavy machinery on the beach and interference with the natural distribution of sediment along the Danish North Sea coast.

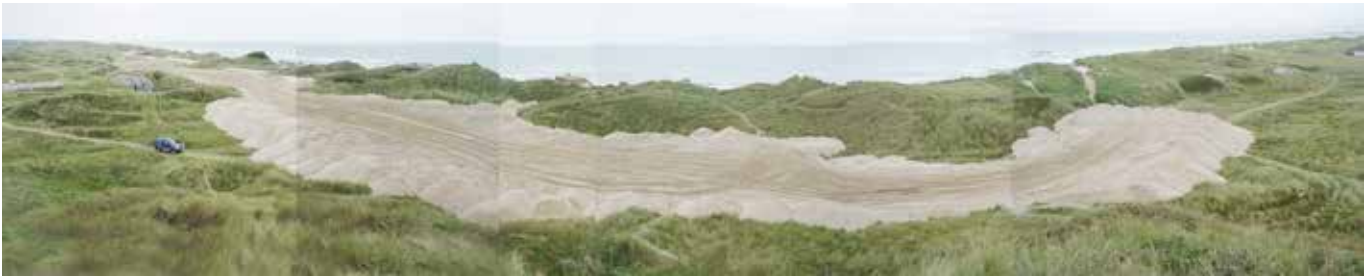
Figure 13 Dune reinforcement performed in September 2008.

At Krogen extensive work to enhance the dunes has been conducted to minimize the risk of erosion and flooding. Strengthening of the dunes has taken place in 1990, 2005 and 2008. The exact amount of sand, deposited as an enhancement in 1990, is unknown. Following the erosion event in March 2008 shown in Figure 12, the dunes were reinforced using 45,000 m³ of sand and the beach nourished with 176,000 m³ of sediment. The Danish Coastal Authority uses dead conifers, lyme grass and marram grass as a mean of stabilizing the newly established dunes. The final reinforcement and the nourishment process were photo documented which provides insight into the scale and placement of the beach nourishment and the reinforcement, see Figure 13 and Figure 14. The remodelled beach a year after nourishment is shown in Figure 15.

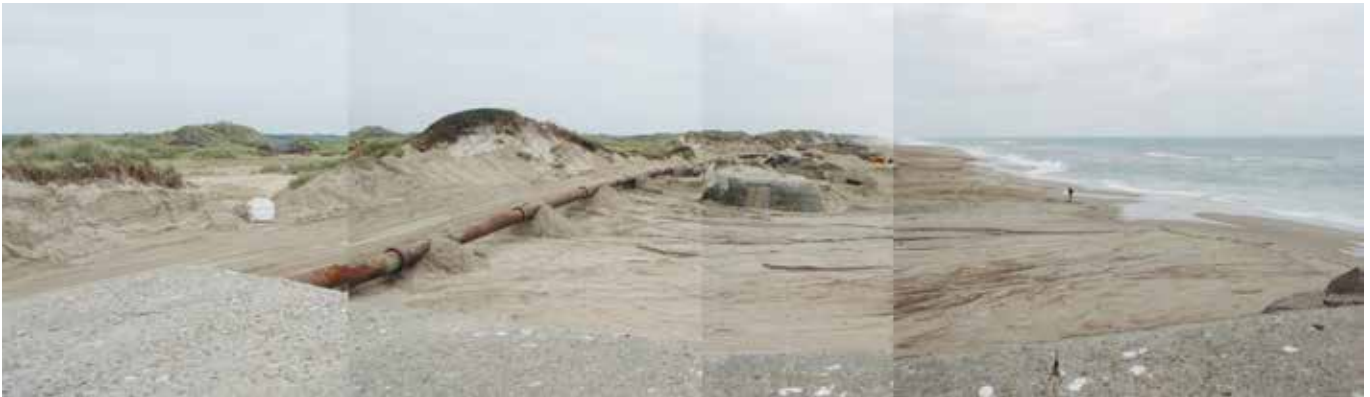
Figure 14 Beach nourishment performed at Krogen/Krylen in September 2008.

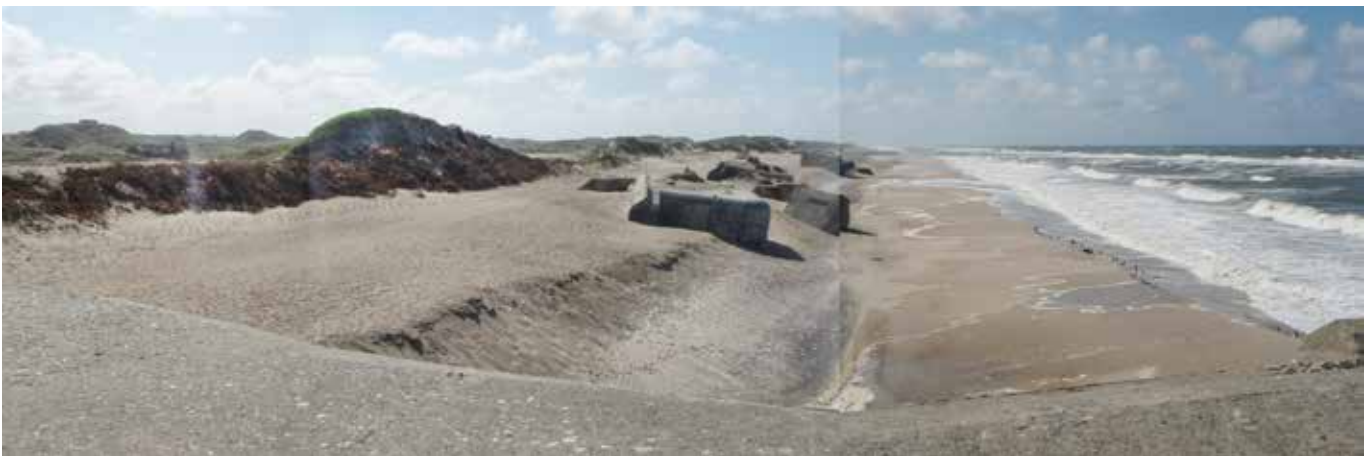
Figure 15 Beach nourishment at Krogen/Krylen photographed in May 2009, a year after nourishment.

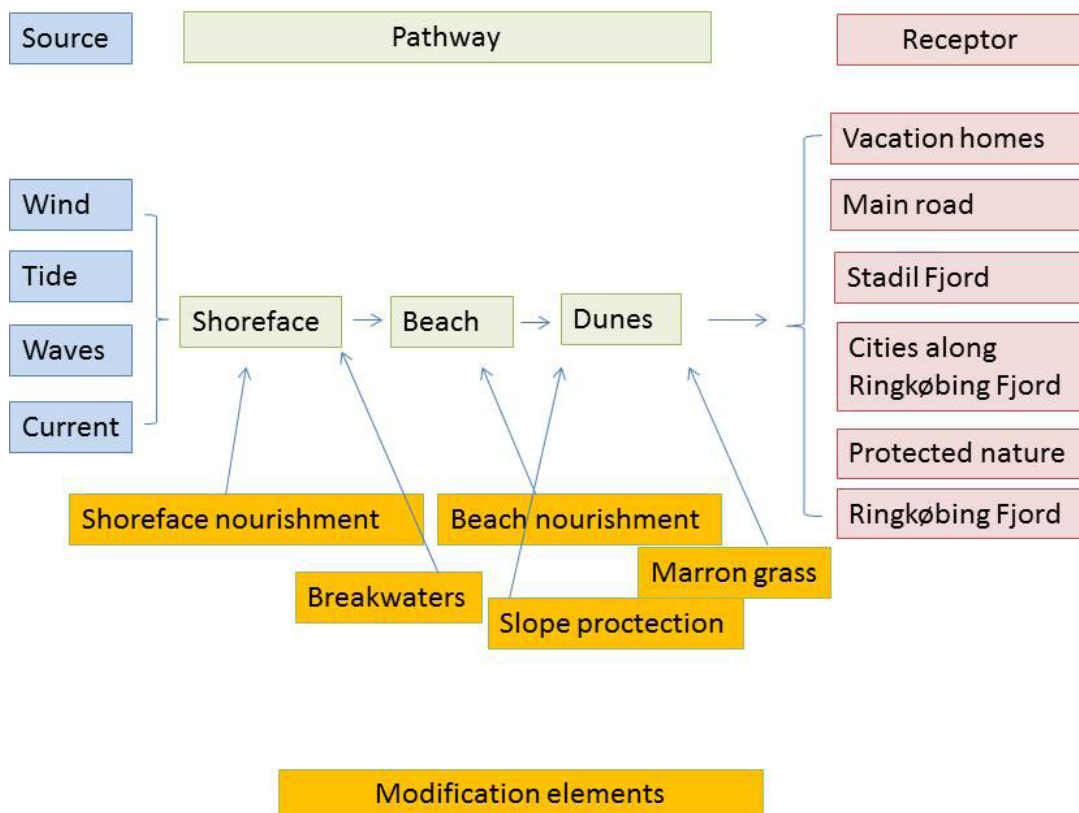
Figure 17: Shows the source, pathway and receptor model

In the Krogen system the sources are wind, waves, tide, marine surge and current. The model pathway is the coastal profile from the shoreface over the beach to the dunes. While the receptors are the infrastructure, vacation homes, Stadil Fjord, Ringkøbing Fjord, the towns along the two fjords and the protected nature around the Ringkøbing Fjord.

The consequence of the source action is erosion and retreat of the pathway (shoreface, beach, dunes) which can cause flooding at the receptor or erosion of the receptor. To prevent the sources from causing retreat and flooding, the pathway is strengthened with modifications such as nourishment, different kinds of hard coastal protection and planting of vegetation on the dunes. The BWN project focuses on modification of the pathway by using solutions based on nature.

Figure 11 shows the source-pathway-receptor-model in a schematic form.
