Ministry of Environment
and Food of Denmark
Coastal Authority

Building with Nature: Systems Description of Skodbjerg

August 2018

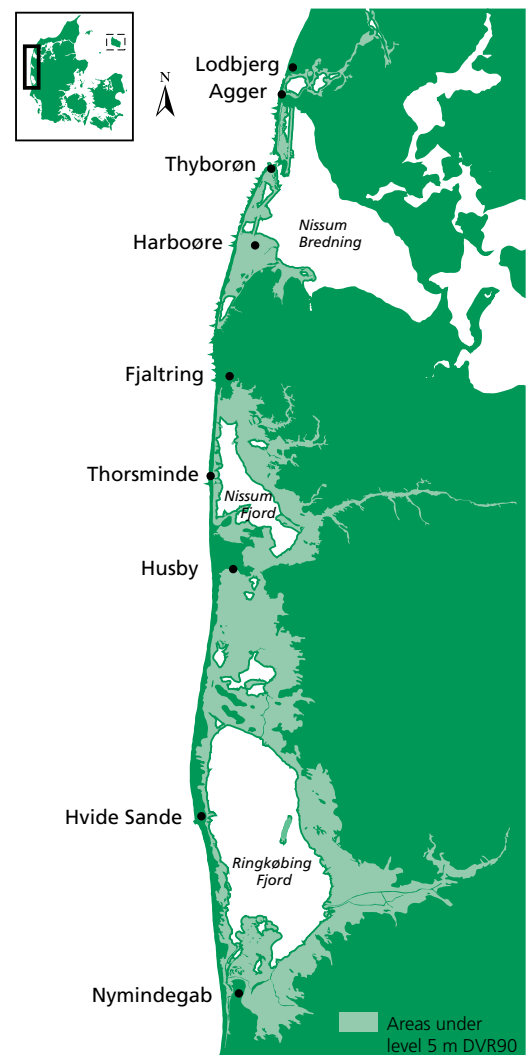
Figure 2 The 110 km stretch from Lodbjerg to Nymindegab. The map shows areas below 5 m DVR90.

After a severe storm in 1981 it became apparent that the structural coastal protection established, mainly consisting of groins and dikes were not enough to safeguard the Danish North Sea coast. This is due to the fact that the coast line is subject to chronic erosion, which means that the natural retreat of the active coastal profile will vary between one and eight meters per year, see Figure 3. In this area, the combination of substantial natural coastal retreat, a relatively high water level during storms, a narrow dune belt and low hinterlands along long stretches of the coast create a serious flooding hazard; and in case of dune penetration homes and property would be destroyed. See Figure 2.

Since 1982, thanks to these agreements, protection of the 110 km stretch of coast from Lodbjerg to Nymindegab has been carried out as a joint effort by the local municipalities and the Danish government, see Figure 2. The basis for the agreement is a safety level objective as expressed in the average volume of sediment in the coastal profile.

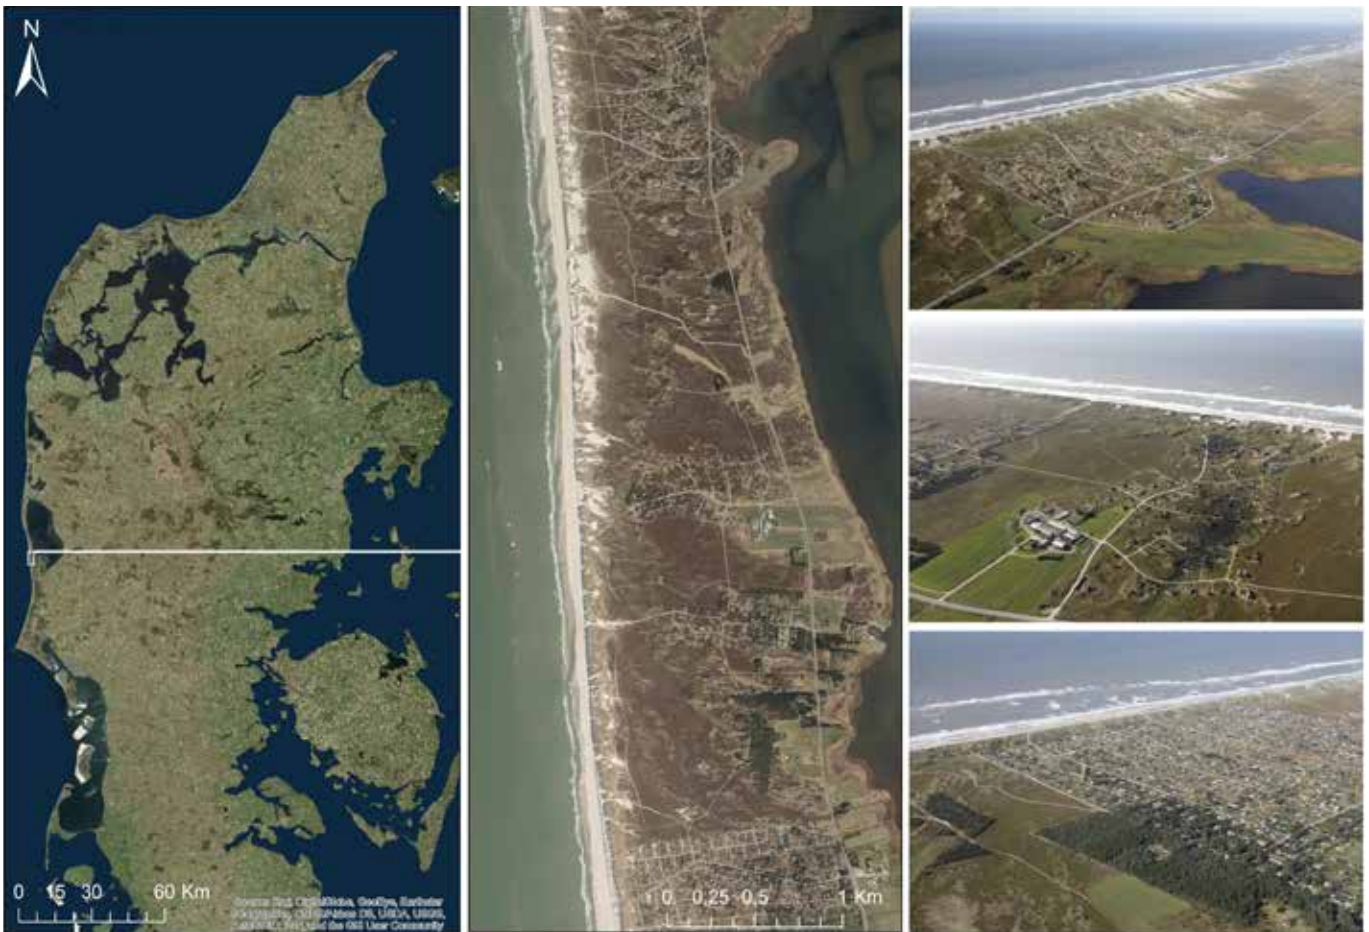
Figure 4: Location and photos of the living laboratory Skodbjerg (© SDFE).

Skodbjerg is located on the southern part of the narrow spit Holmsland tange which encloses Ringkøbing Fjord, Figure 4. The main road, Sønder Klitvej, is the only road connecting the southern part of the spit with the northern Holmsland Tange at Hvide Sande. Along Sønder Klitvej there are several areas with vacation homes in the dunes; as is also the case in Skodbjerg. The road runs parallel to the coast only about 1 km inland, which makes it important to maintain the safety level and safeguard the coastline position. The dunes are generally steep and the naturally developing dunes are backed by a plateau formed by a dune enhancement. The hinterland is protected by dunes and a dune enhancement. The dunes at Skodbjerg have several wind-scoured blowouts resulting in increased sand drift inland.

At Skodbjerg the main road, Sønder Klitvej, is about 700 meters from the dune front. Behind the dunes, approximately 300 meters from the dune front but in some areas as close as 150 meters to the dune front, vacation homes have been built, see Figure 4. Along the lagoon coast there are areas used for grazing. Large parts of the area are governed by Natura 2000 legislation because of their great importance to migrating and nesting birds.

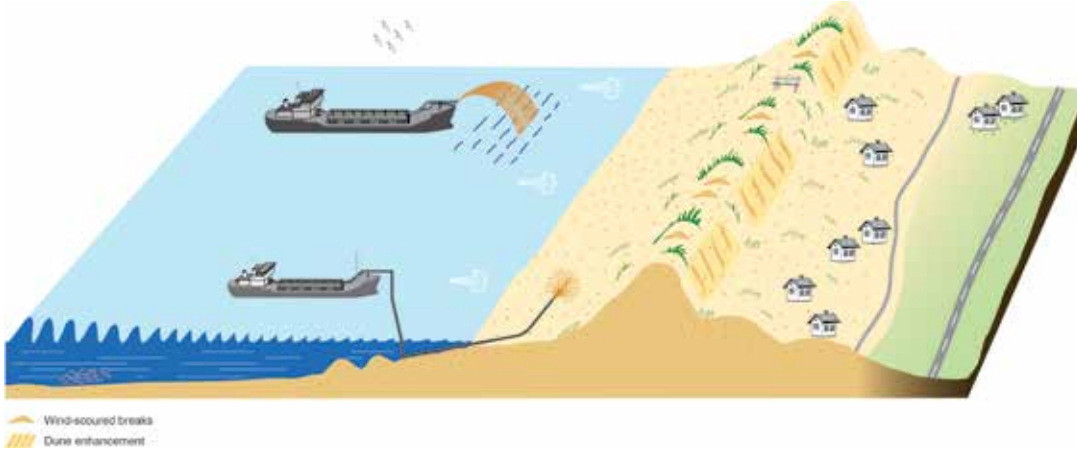
Figure 5: Schematic representation of the living laboratory at Skodbjerg

The illustration in Figure 5 conceptualizes some of the important elements in the system at Skodbjerg. During the last decades, The Danish Coastal Authority have performed dune enhancements, as well as beach and shoreface nourishments. In the following the geological setting, the coastal system, the land use and the infrastructure are described.

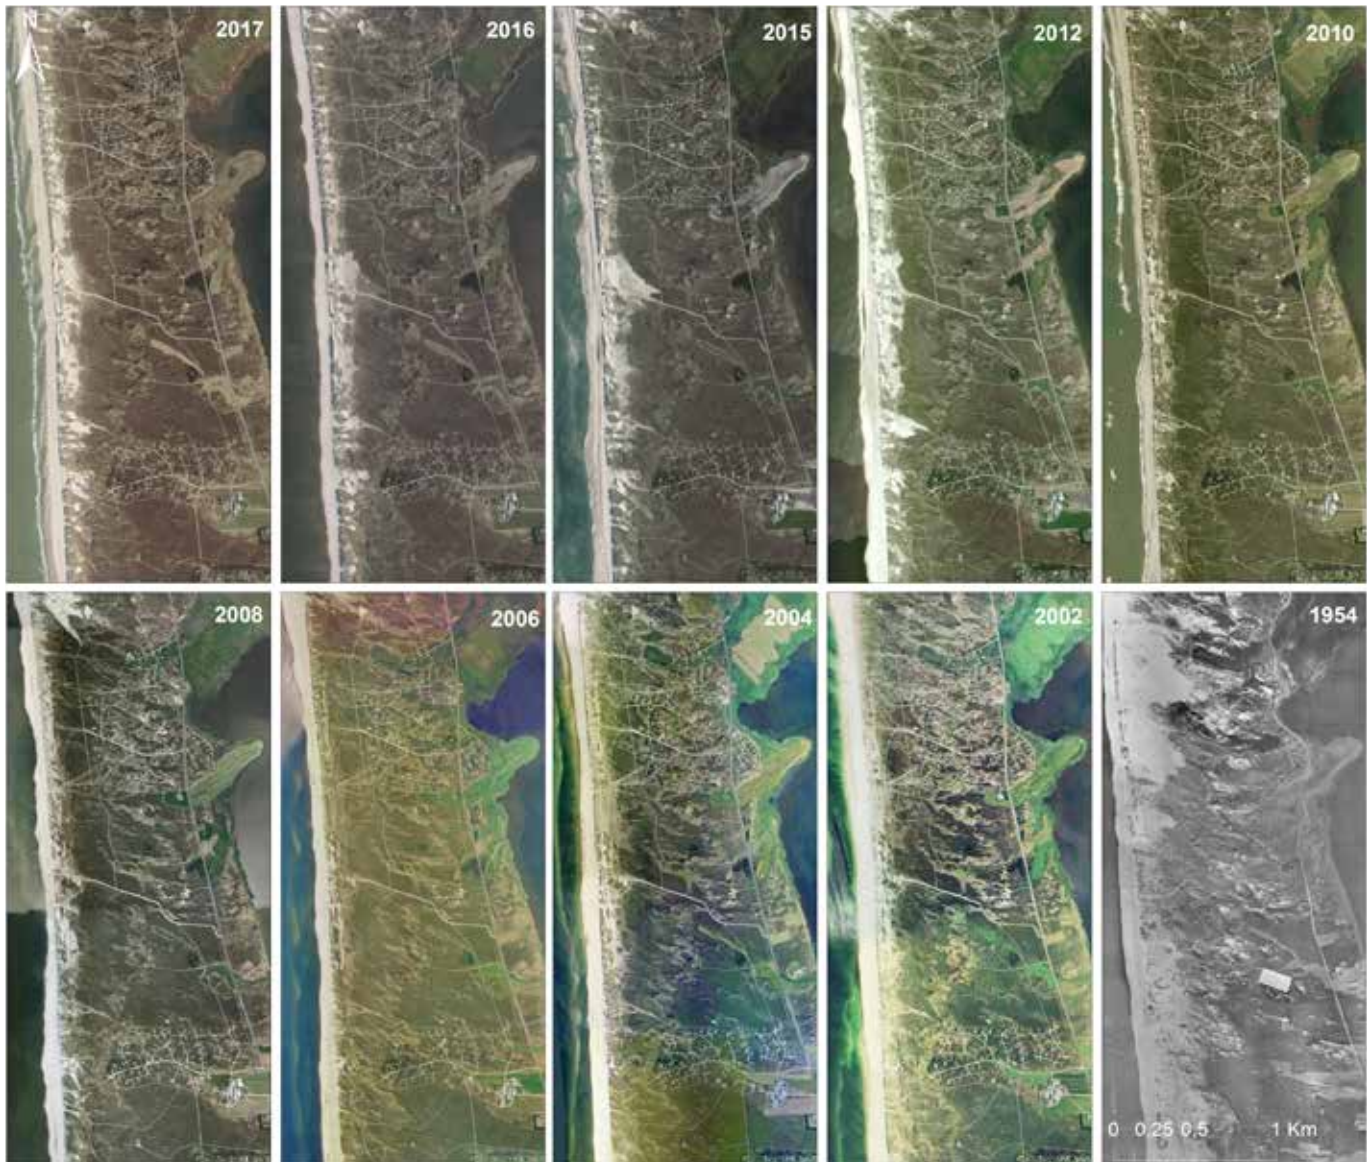
Figure 7: Aerial photos covering Skodbjerg from (© DDO 1954-2012, COWI), (© DDO 2015-2017, Geodanmark, SDFE).

The west coast of Denmark is generally flat, particularly around the area of Ringkøbing Fjord. The differences in elevation in the landscape are minor and the coast and hinterland are at risk of flooding. The morphodynamic changes on the exposed coastline are observed when comparing aerial photos, see Figure 7. The alongshore variations described above in coastline and bars are observed especially when comparing the photos from 2010-2015. In 2010 it seems that a bar is coming from the north and

ending in the middle of the map section. Just south of the bar there is an indentation in the coastline. The observed bar system is not visible two years later in 2012 when the coastline is more meandering. In 2015 a nearshore bar is present and it seems to have almost welded on to the beach creating a transverse bar and a beach system with rip channels. In 2006 it is possible to identify a rhythmic bar along most of the coastline section.

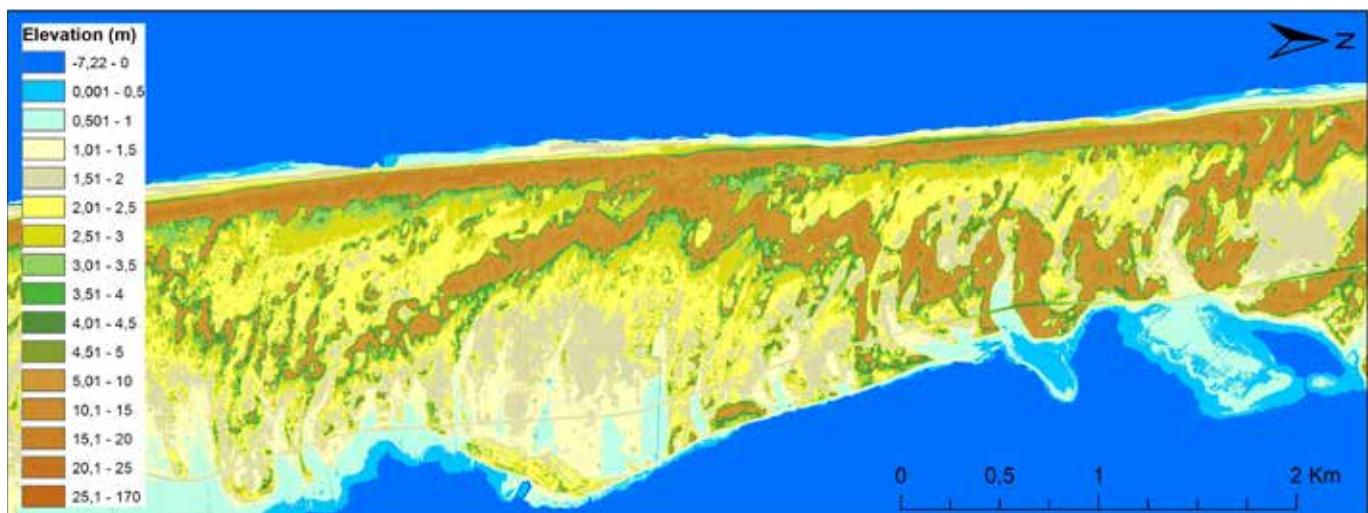
Figure 8 Map showing the elevation at Skodbjerg (© Digital Elevation Model, 2014, SDFE).

Storm surges are recurrent in the winter season at Skodbjerg. A storm surge can be defined by the resulting water level during a storm. There is a connection between high water level due to storm surges and large waves generated by strong onshore wind. The combination of these effects will have a particularly strong impact on the dunes, with risk of overtopping, erosion, breaches of dikes and dunes and subsequently flooding of the hinterland. The vulnerability of the area at Skodbjerg is apparent when examining the local elevation. The LIDAR scan from 2017 shows the narrow dune ridge which borders on a more low-lying area which is then followed by a new dune system consisting of dunes as high as 16 meters, see Figure 8.

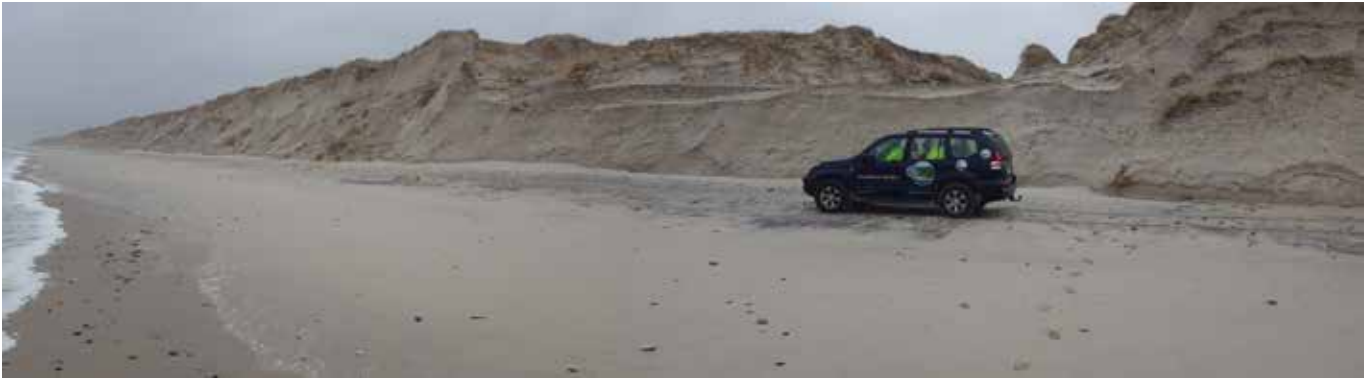
Figure 9 Photo from Skodbjerge on January 12 2015 after the storm, Egon. The front of the dune has eroded back and is rendered almost vertical.

Erosion can be categorized as either chronic or acute. Chronic erosion is long term and is often induced by alongshore gradients of the sediment transport; along coastlines where, as sediment transport rates increase, a sediment deficiency occurs leading to erosion of the coastal profile and a gradual landside displacement of the coastline. Acute erosion is temporary and occurs during storms with high water levels and high wave energy conditions (Acute erosion is part of the chronic erosion). The higher water levels and waves displace the erosional processes onshore leading to erosion of sediment on the back of the beach and the dunes. The Danish North Sea coast is recognized as an erosional coast which is subjected to chronic erosion caused by the southbound alongshore drift but furthermore, large acute erosion events will take place during storms, see Figures 9 and 10.

The chronic erosion at Skodbjerge is about 2m/yr. As such, this erosion rate is not high compared to other sections of the Danish North Sea coast, see Figure 3, but serious, in the light of the risk of acute erosion. At Skodbjerge large blowouts are scouring the dunes, see Figures 9 and 10.

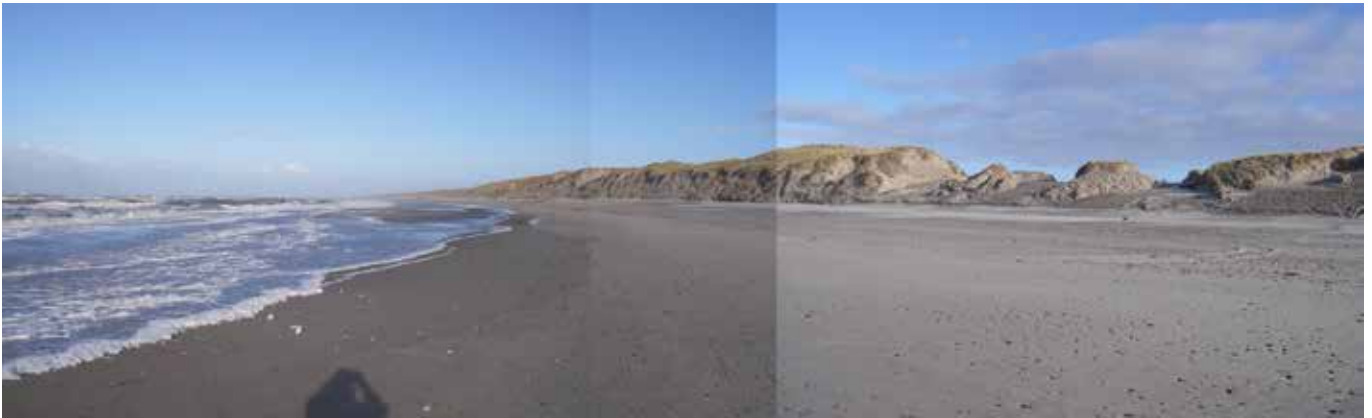
Figure 10 Photo from Skodbjerge on January 7 2007. The dune front is eroded over a long stretch and there is a local breach.

Acute erosion has previously eroded long stretches of dunes at Skodbjerge. In 2007 part of the dunes in Skodbjerge retreated 10 meters during a storm in January. The maximum recorded dune retreat at the Danish North Sea coast was 60 meters at Thyborøn and a retreat of 46 meters was recorded at Vedersø in 1981; this indicates the scale of potential erosion along the Danish North Sea coast.

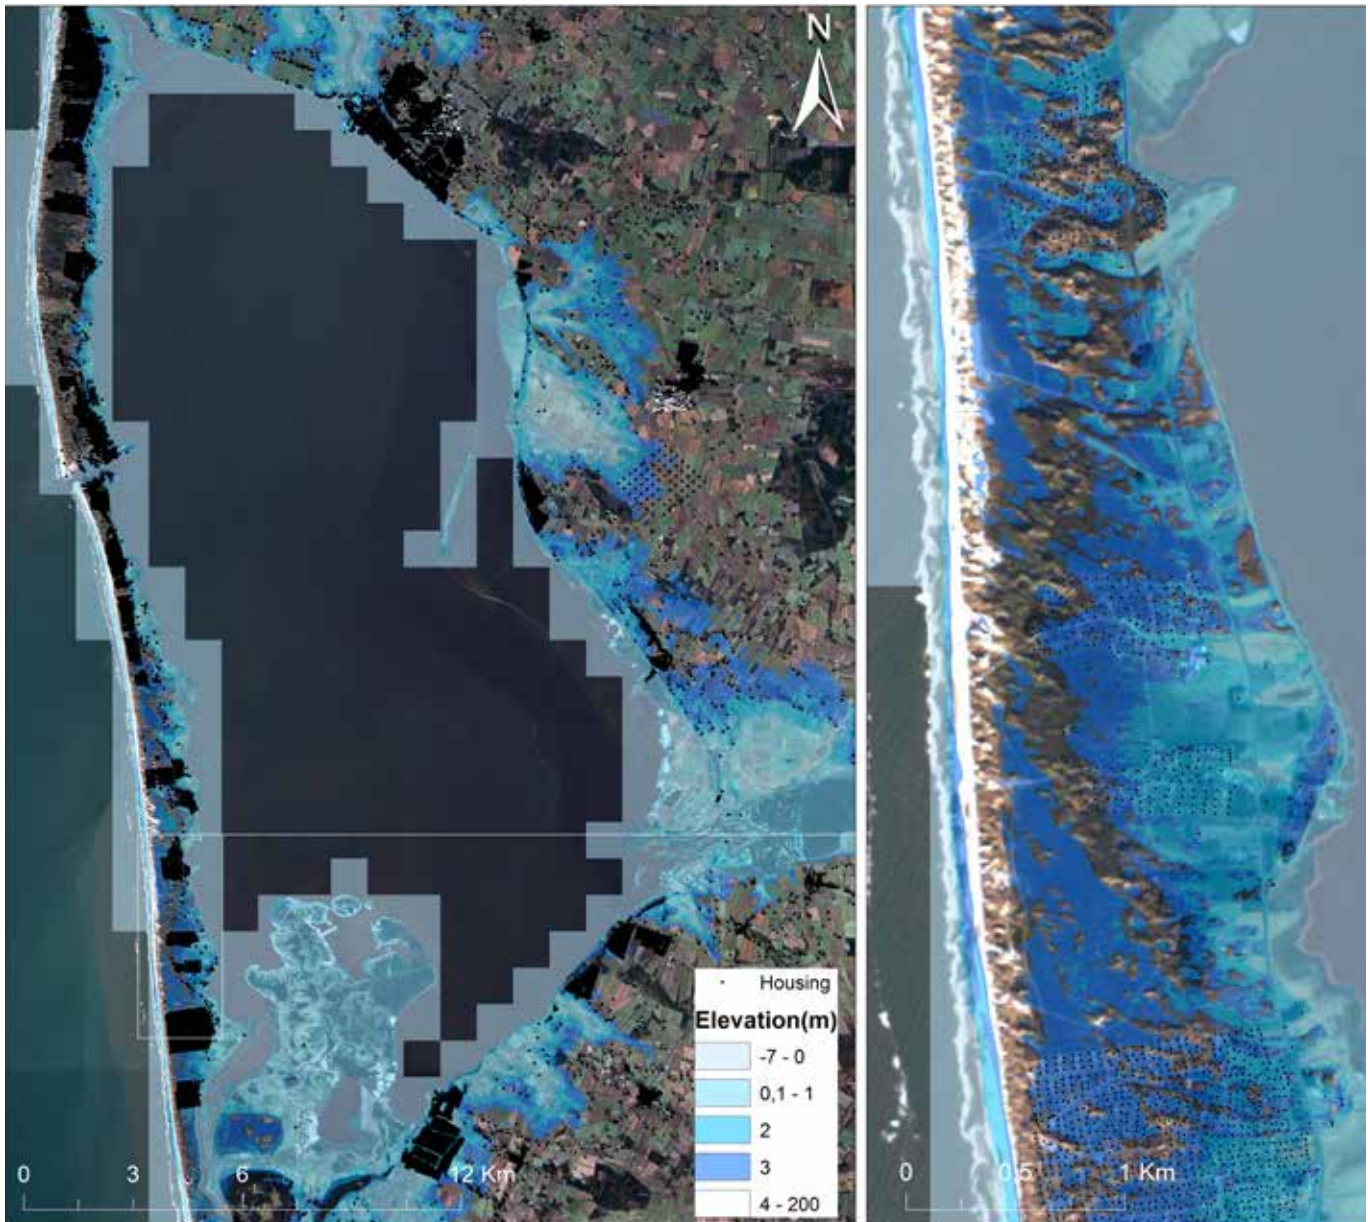
Figure 11: The maps show a flood risk analysis based on the national elevation model including housing. Left: Section of Ringkøbing Fjord. Right: Illustration of the local flood challenges, especially in relation to the vacation homes in the dune valleys (© Digital Elevation Model, 2014, SDFE).

The hinterland at Skodbjerge consists of Sønder Holmsland Tange, Ringkøbing Fjord and the surrounding towns which are all low-lying. The 20 year and 100 year storm return periods are 2.57 meter and 2.74 meter above daily normal at Hvide Sande, respectively. In Figure 11 the national digital elevation model has been used to do a simple bucket fill analysis showing the area at risk in case of dune breach and subsequent flooding with a water level reaching as high as 3 meters above normal.

As shown in Figure 11 (left part) flooding at Skodbjerge is a threat to the vacation homes, the main road and finally Ringkøbing Fjord and the surrounding towns. Extensive efforts to enhance the dunes and thus minimize the risk of flooding have been made at Skodbjerge. However, there are still challenges and flooding occurs locally, especially affecting vacation homes located in dune valleys, see Figure 11 (right part).

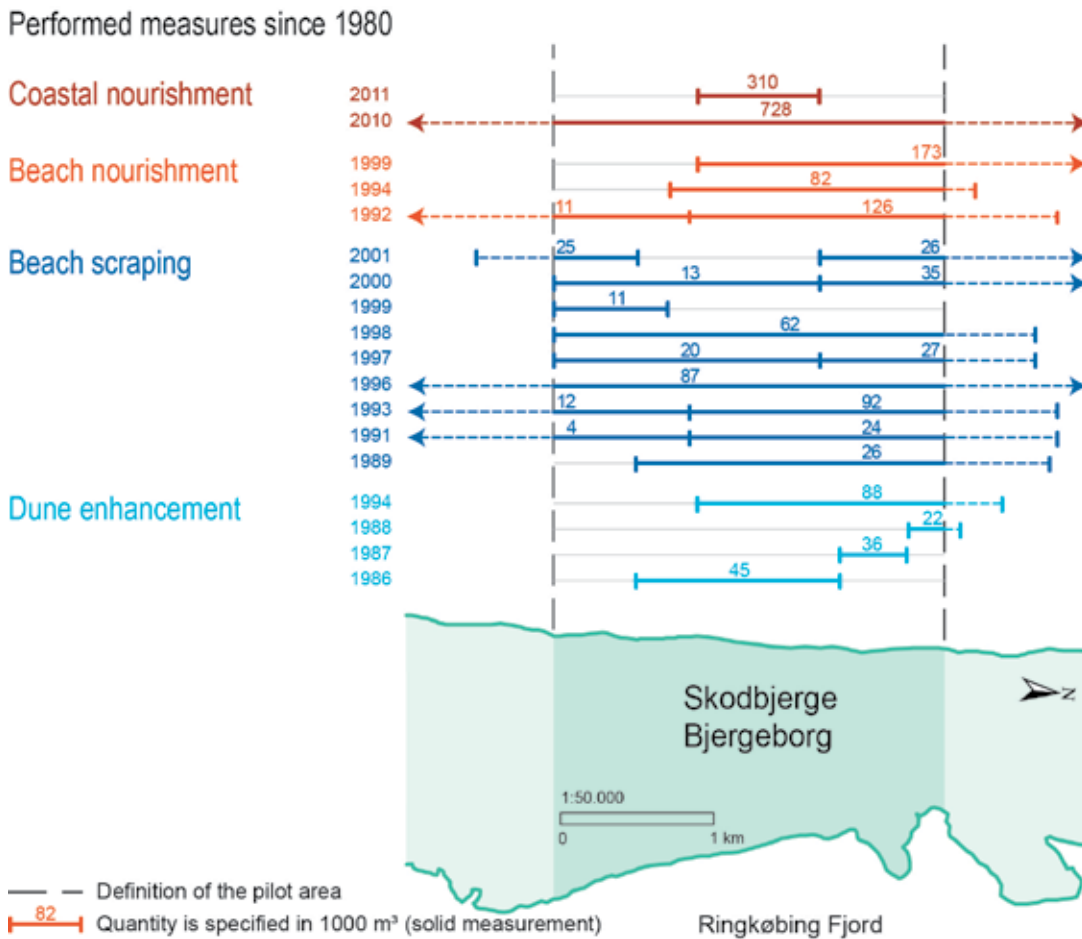
Figure 12: Coastal protection measurements implemented at Skodbjerge from 1980 until today.

At Skodbjerge both shoreface and beach nourishment have taken place, as illustrated by Figure 12. These were performed in the years 1992, 1994, 1999, 2010 and 2011. In 1989, 1990, 1993, 1996-2001 scraping of the beach took place to better distribute the sediment that is deposited in the berm during calm weather. However, The Danish Coastal Authority no longer performs beach scraping, as this method has several disadvantages such as heavy machinery on the beach and interference with the natural distribution of sediment along the Danish North Sea coast.

A series of dune enhancements were performed in 1986-1990, which is illustrated by the shaded area on the dunes in Figure 12. However, the exact amount of sand, deposited as an enhancement behind the existing dunes is unknown. The long series of dune reinforcements made in 1990 aimed to reduce the risk of flooding of the hinterland in case of a breach of the narrow dune zone.

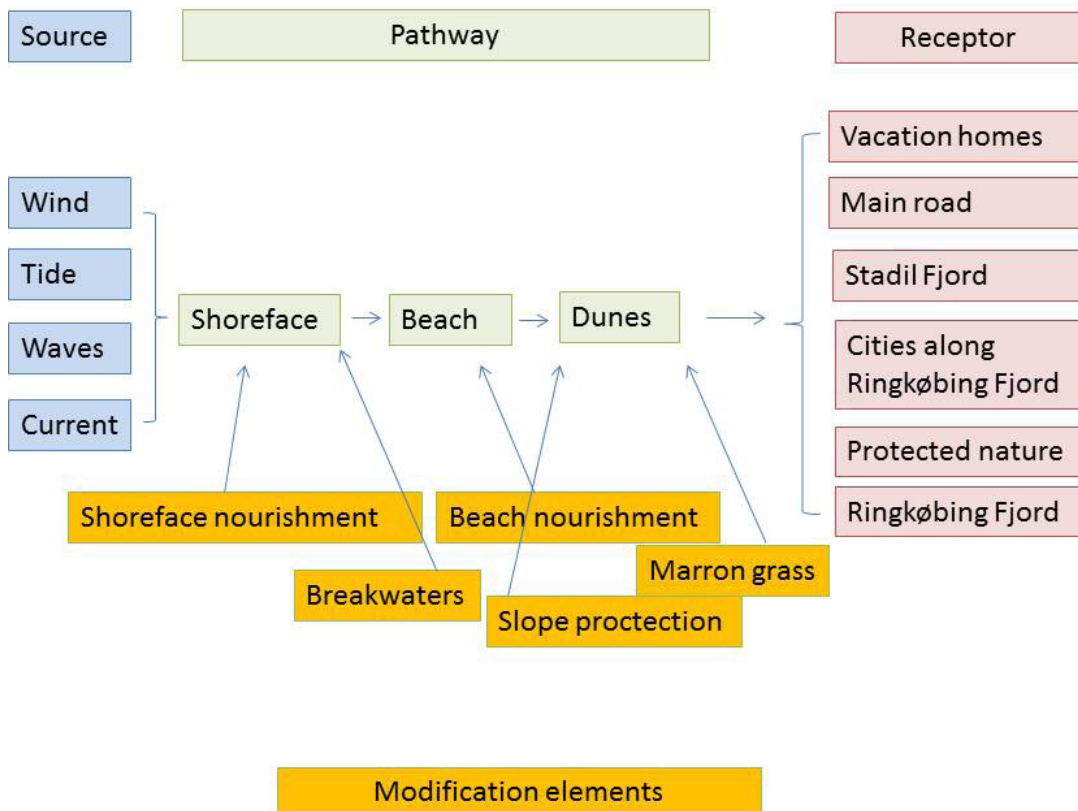
Figure 14: The source-pathway-receptor model.

In the Skodbjerg system the sources are wind, waves, tide, marine surge and current. The pathway is the coastal profile from the shoreface over the beach right to the dunes. While the receptors are the infrastructure, vacation homes, Ringkøbing Fjord, the towns bordering on Ringkøbing Fjord and the protected nature around Ringkøbing Fjord.

The consequence of the source action is erosion and retreat of the pathway (shoreface, beach and dunes) which can cause flooding at the receptor or erosion of the receptor. To prevent the sources from causing retreat and flooding, the pathway is strengthened with modification elements such as nourishment, different kinds of hard coastal protection and planting of vegetation in the dunes. The Building with Nature project focuses on modification of the pathway using nature based solutions.

Figure 14 shows the source-pathway-receptor model in a schematic form.
