# EVALUATION AND ASSESSMENT

TESTING OF THE WEBGIS TOOL FOR LANDSCAPE PROTECTION

Villa Ghigi Park / Italy

December 2021

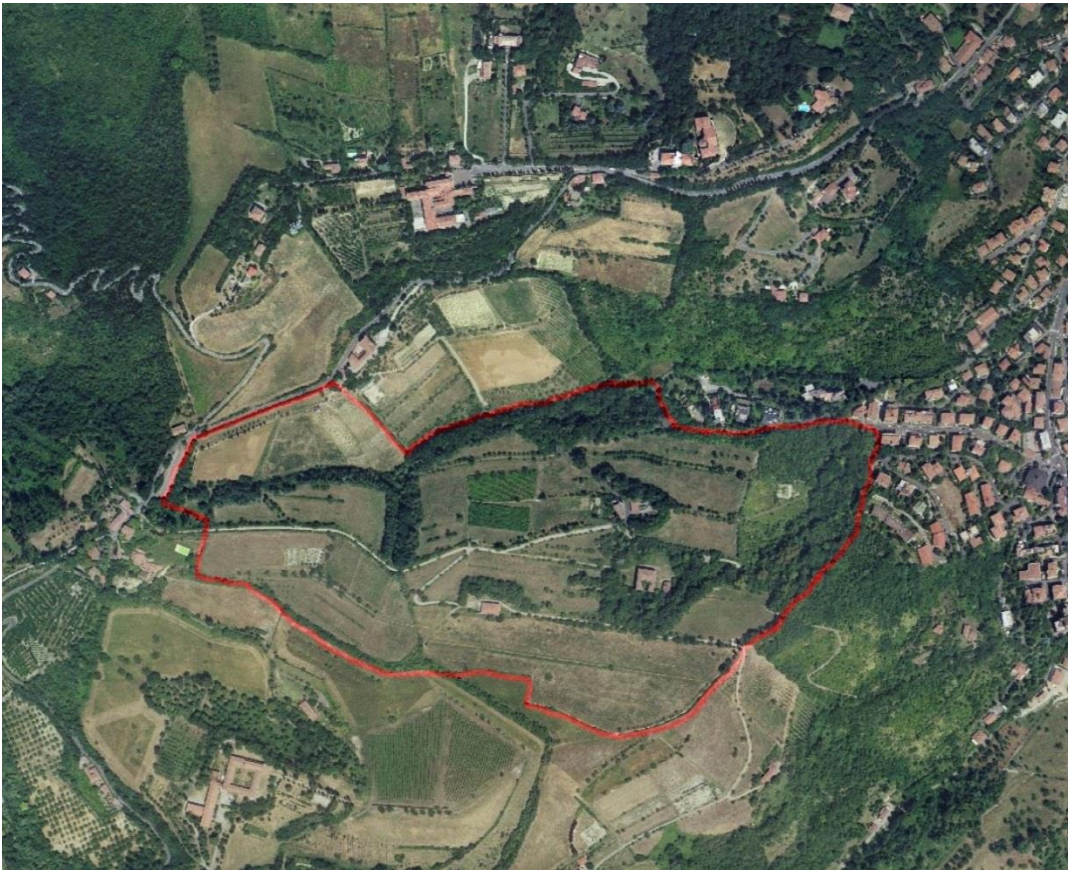
Aerial photo of the foothills of Bologna showing the boundaries of the park.

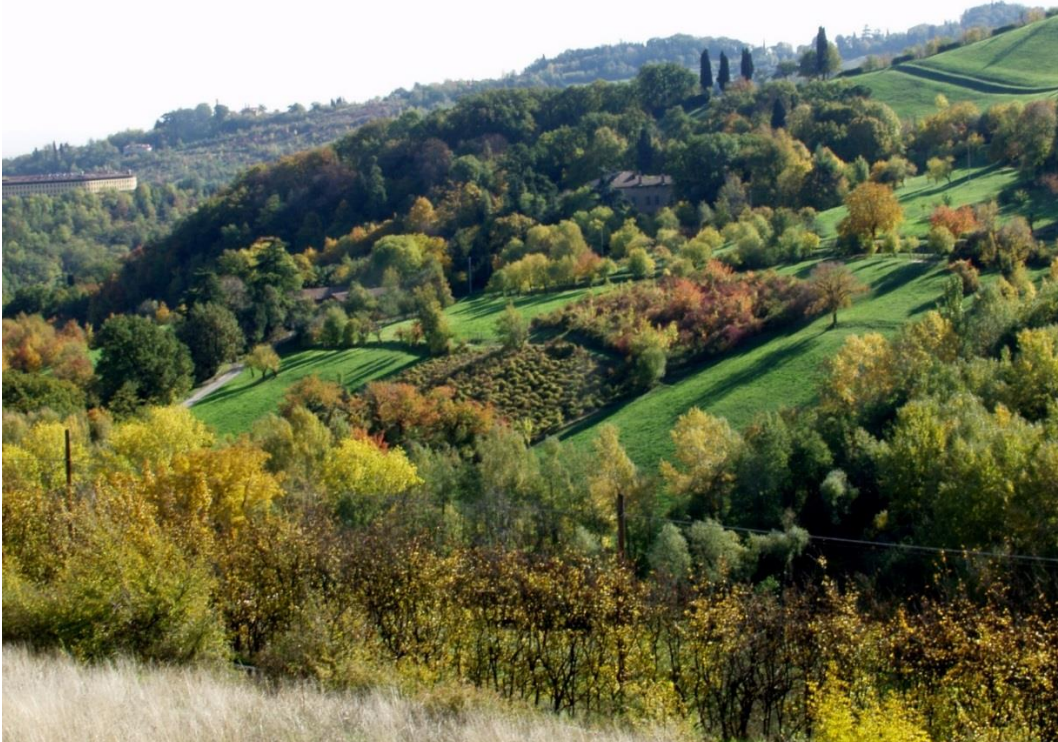
The mosaic of environments that characterises the Villa Ghigi Park.

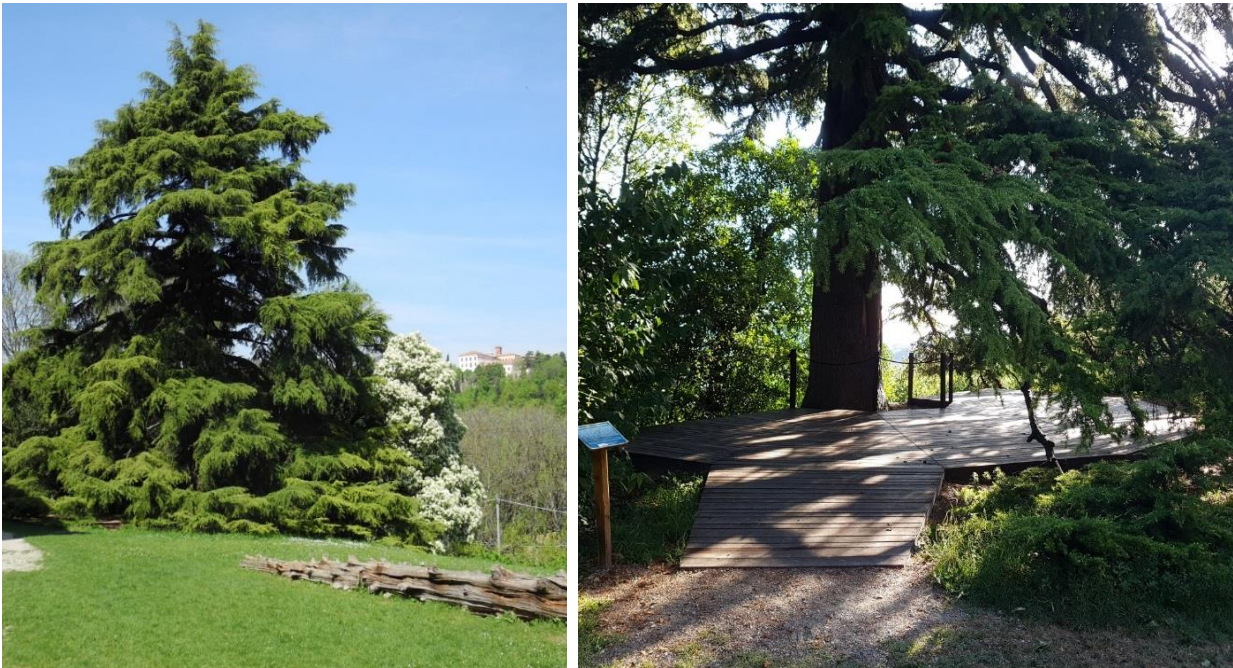
The great Himalayan cedar (*Cedrus deodara*) next to the building of Villa Ghigi, introduced in 1874 and recently included in the list of monumental trees in Italy (Ministerial Decree 5450 of 19.12.2017). The plant, about 30 years ago, was struck by lightning that cut off the top and left a long wound on the stem, triggering vegetative and phytosanitary problems. As part of the European HICAPS project, a wooden platform was created to welcome visitors, necessary to mitigate the negative effects of trampling under the tree.

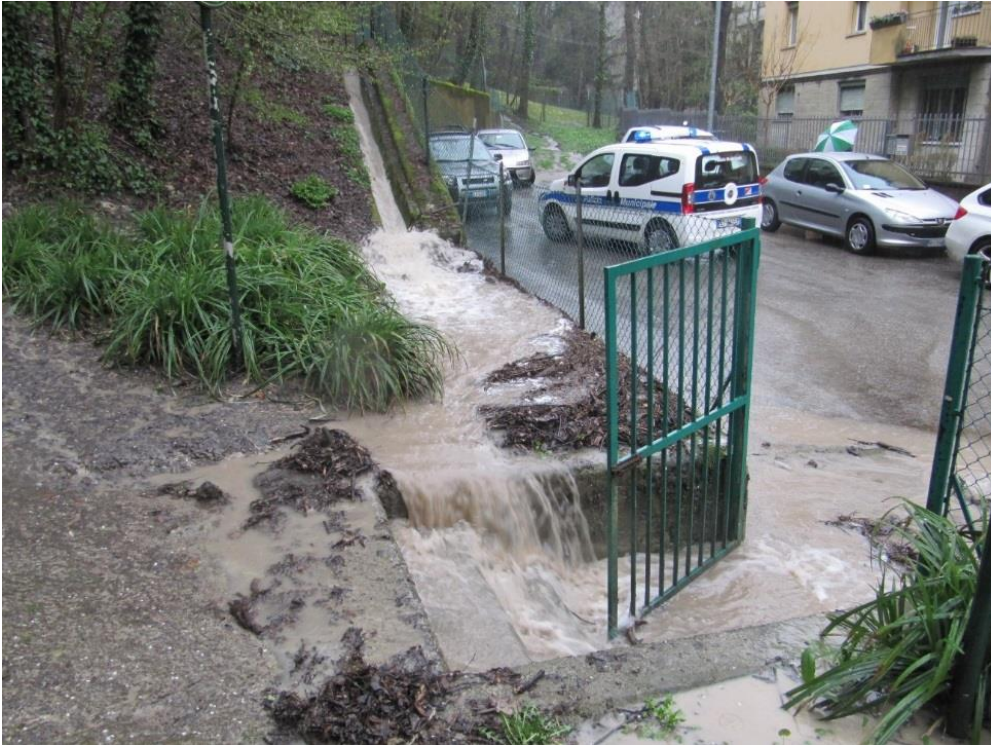
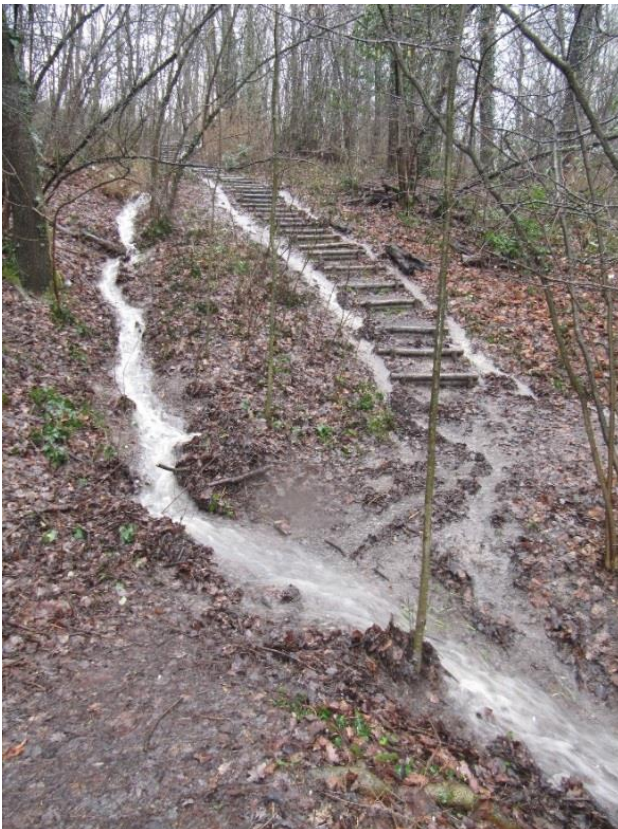
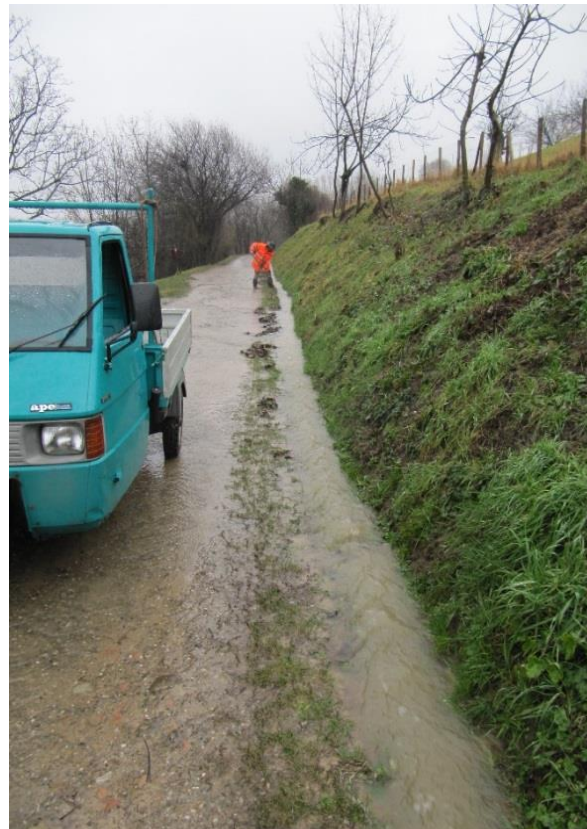
The more and more frequent and intense rains concentrated in a short time cause significant damage in the network of paths and in the regulation of surface water in parks and gardens. Some examples in the Park of Villa Ghigi in Bologna: one of the secondary entrances (upper picture) and two sections of the path network (lower pictures).

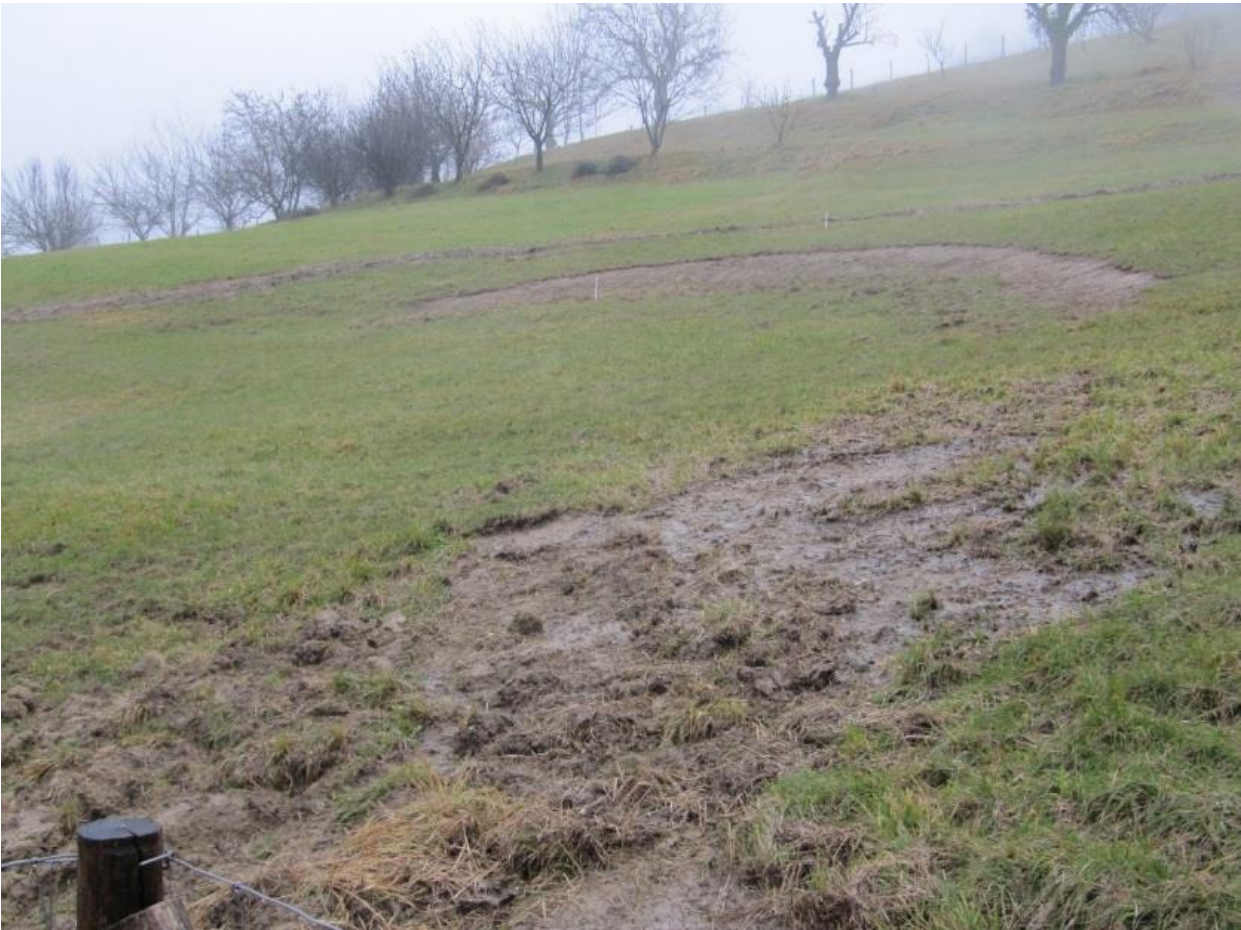
The landslide repair work took place in the park in the spring of 2013 following a prolonged period of rainfall. The restoration work, carried out promptly, has stopped the regularly monitored landslide movement for the time being.

The index showing the number of consecutive wet days (**CWD**) shows the highest peak coinciding with 2013, the year in which the last major landslide event occurred in the park (photo on page 8).

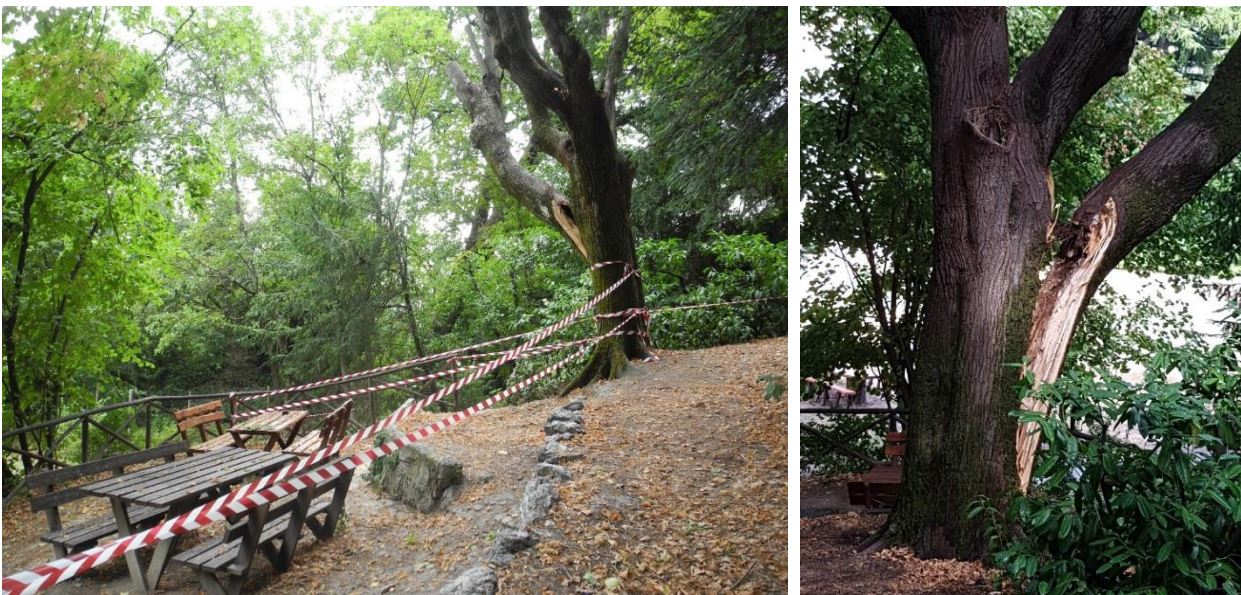
A rest area near a large linden tree was closed after a branch of the tree collapsed during a summer storm (left). The crushed branch of the lime tree did not crash to the ground because it was held to the rest of the foliage by a system of cables; consolidation work was carried out following instrumental surveys that had revealed the plant's precarious structural condition.

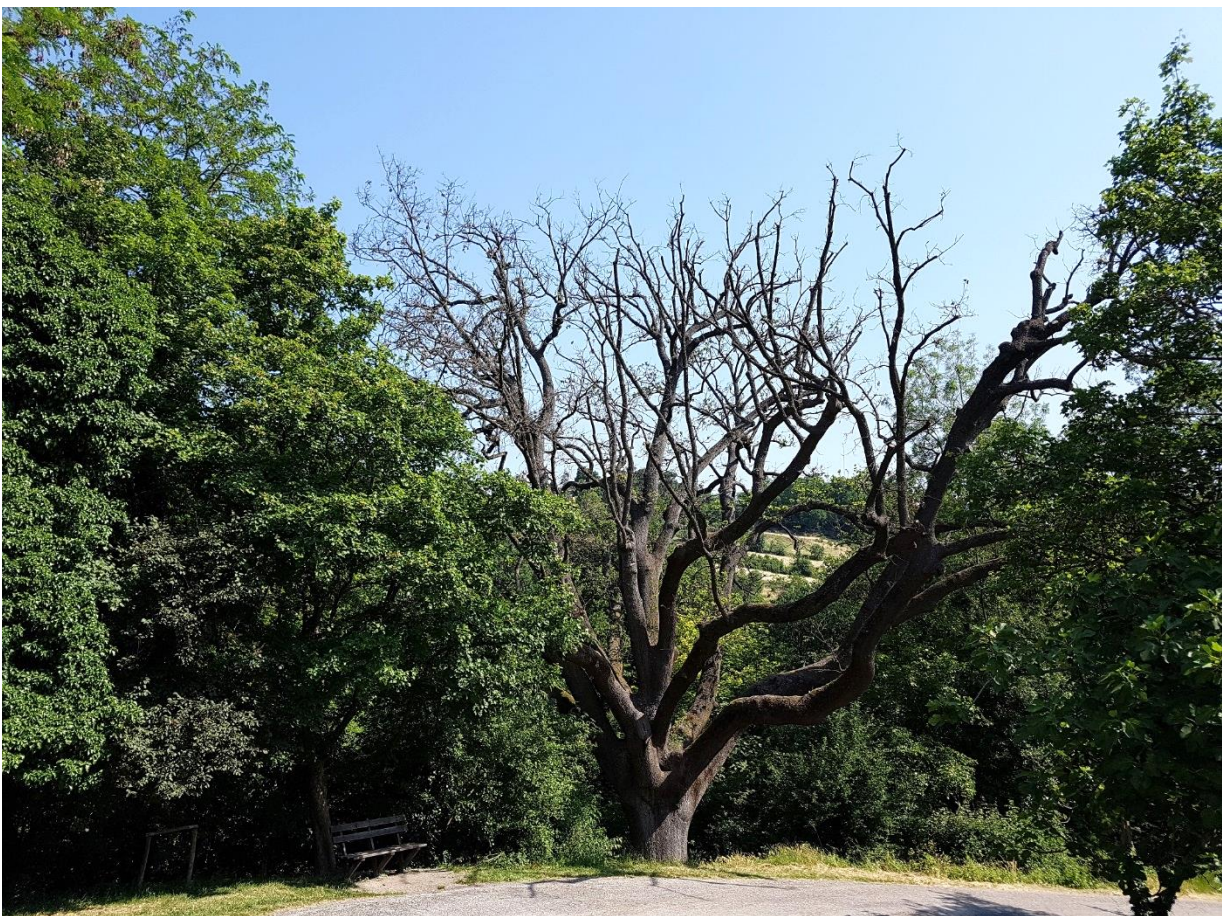
The majestic specimen of oak (*Quercus pubescens*) inside the Villa Ghigi Park subject to a progressive decline starting from 2011 that led to drying up; the decay phase of the plant lasted for about ten years but, despite the analyses and treatments undertaken, the oak dried up in 2018.

The graph of the **Extremely warm days** index (Tx99p) shows the highest peaks after 2000. Year 2011 was the one with the highest value of 35 days. In that year there was a long dry period with important consequences for the park's tree population: 2011 marks the beginning of the decline of one of the largest oaks (photo on page 13) and other old trees in the park. In the case of the oak, the death of the plant became apparent after the subsequent peak in 2017.

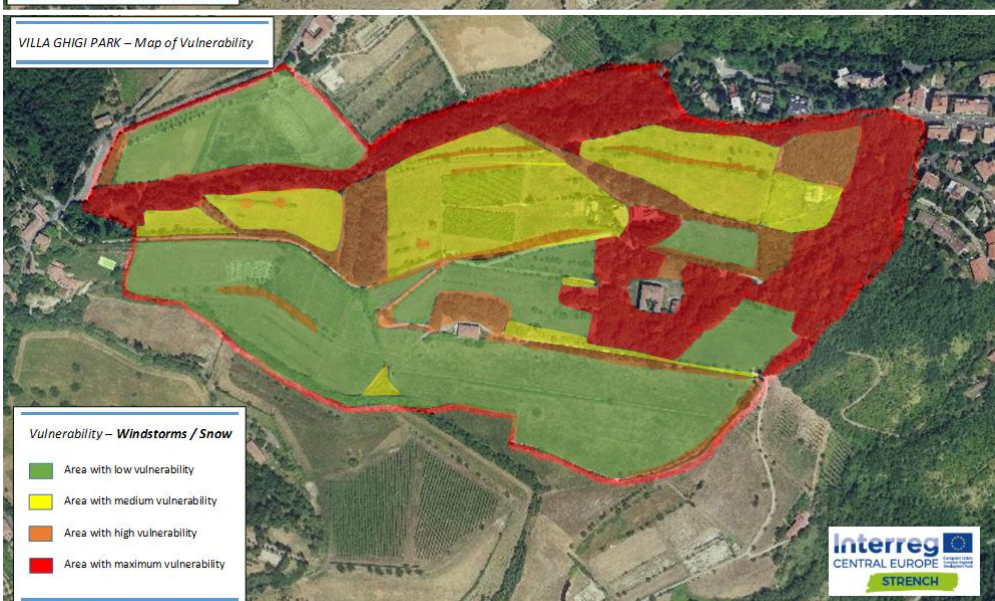
As part of the Park Management Plan, the area of the Villa Ghigi Park pilot site was zoned according to the main vulnerabilities identified in order to improve management and set up pre- and post-event contingency plans.

More attention has been paid to areas that may be subject to flash floods (top map), those at risk of landslides (side map) and areas of the park that may be subject to damage in the event of high winds or snowstorms (bottom map).

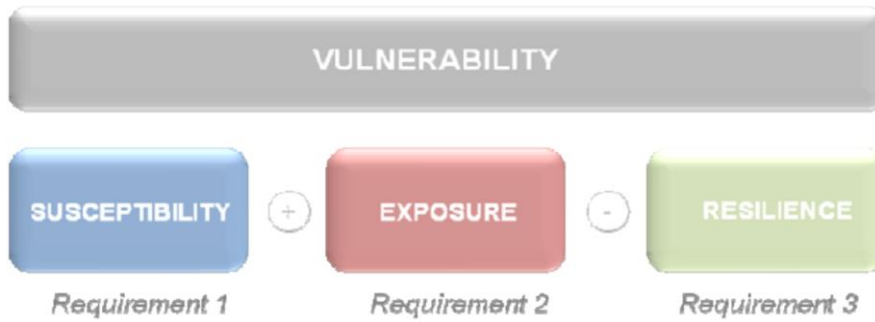
Particular attention was given in the calculation to the sub-criteria related to the tree heritage (such as CR1.3a Trees), which represent for the pilot site Villa Ghigi Park one of the most important elements and more prone to damage in case of extreme events.

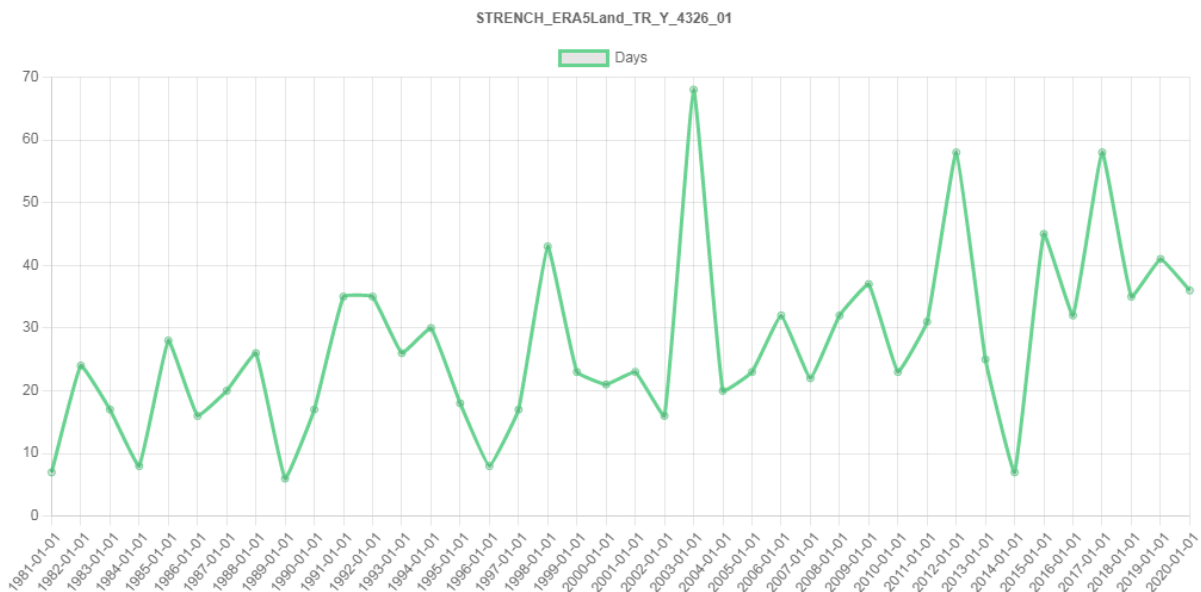
The **Tropical nights (TR)** index confirms the trend of the previous graph: there are five peaks corresponding to five years with more than 40 days concentrated in the most recent period (after 1998) and the year 2011 is among them; the peaks showing the years with the lowest number of tropical nights are mainly concentrated in the least recent period: before 1998 there are four years with less than 10 days compared to only one in the last twenty years.

The projections show a clear climate change, some of which is probably already occurring if one looks at the historical data for the last forty years regarding the increase in tropical nights (TR) shown in the graph on page 15.

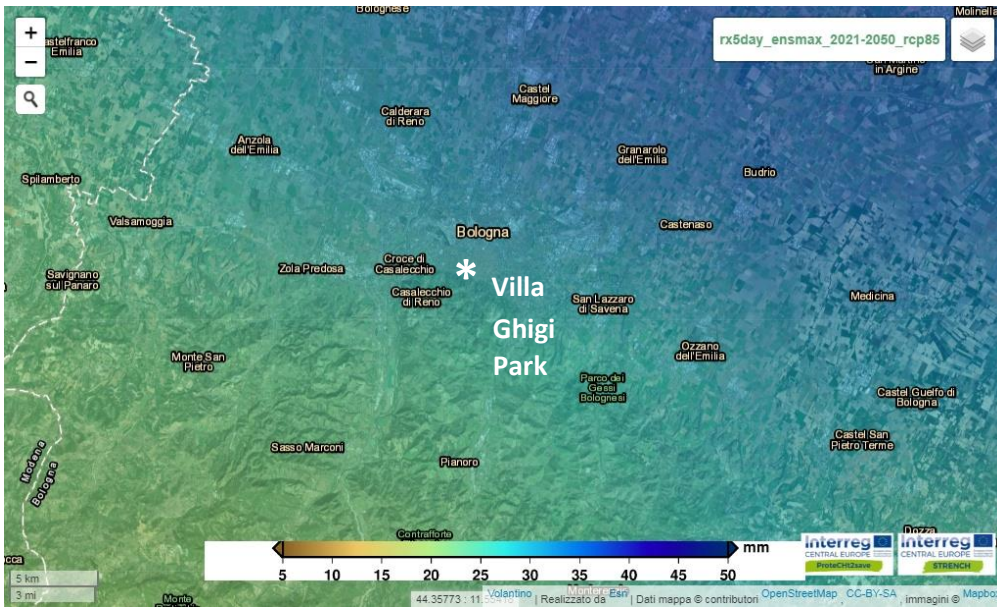
Map for the historic dataset on Rx5day

Map for the near future dataset on Rx5day in the rcp45 scenario

Map for the far future dataset on Rx5day in the rcp45 scenario

Map for the near future dataset on Rx5day in the rcp85 scenario

Map for the far future dataset on Rx5day in the rcp85 scenario

The figure for the maximum amount of precipitation in five days (Rx5day) is also increasing compared to the historical data available for both scenarios. Values vary between 20-30 mm increase up to about 30-40 mm. This index is particularly significant with regard to the risk of landslides in view of past events (graph on page 14), which have seen landslides trigger in the park precisely when there has been prolonged rainfall.
