DELIVERABLE D.T1.2.1

**RISK ASSESSMENT OF CULTURAL
HERITAGE IN CENTRAL EUROPE IN FACING
EXTREME EVENTS**

**Version 1
08 2018**

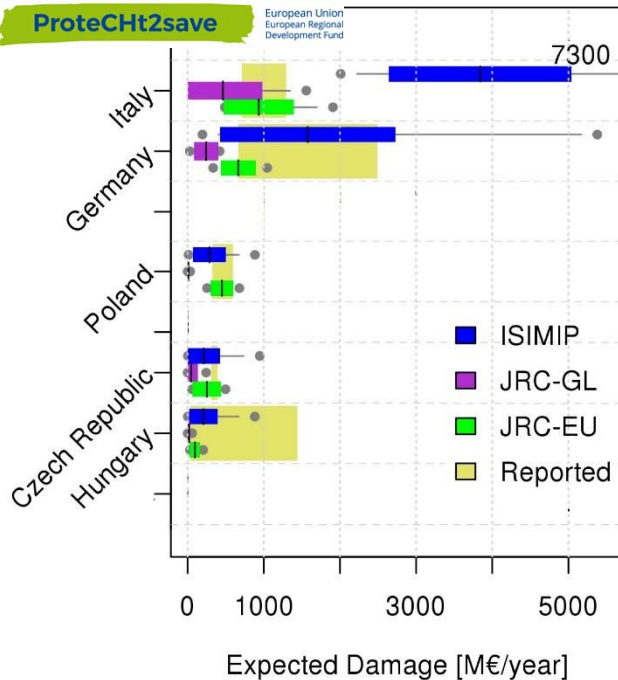
Figure 2. Modified from Fig. 2, Alfieri et al. (2018), extracting only the countries belonging to Central Europe. The figure compares the simulated impact of the three ensemble estimates for the baseline period 1976-2005, with the range of available reference datasets including data from the GAR, EM-DAT, and Munich RE for recorded losses and only EM-DAT for reported population affected. “Economic damage computed for the baseline period for each country by the ensembles of the three case studies (a,b). Plots show the average (black dash), ± 1 standard deviation (colored bar), and minimum and maximum values (whiskers) of each ensemble. The gold bars show the range of reported impact values (minimum and maximum).”

Another contemporary study, always concerning the projections and impact of this extreme events (Alfieri et al., 2018), compared estimates of river flood risk in Europe (Fig. 1), calculating economic damages for several economic sectors (residential, commercial, industrial, infrastructure, and agriculture). By combining inundation depth with damage functions³, Gross Domestic Product and land use maps, the research work highlights as **“most of the Central and Western Europe is consistently projected to experience substantial increase in flood risk, with the magnitude of the change increasing for higher levels of warming”**. Although results generally demonstrate a correlation between global warming and flood impacts, the authors also add that a “considerable increase in flood risk is predicted in Europe even under the most optimistic scenario of 1.5°C warming as compared to pre-industrial levels”.

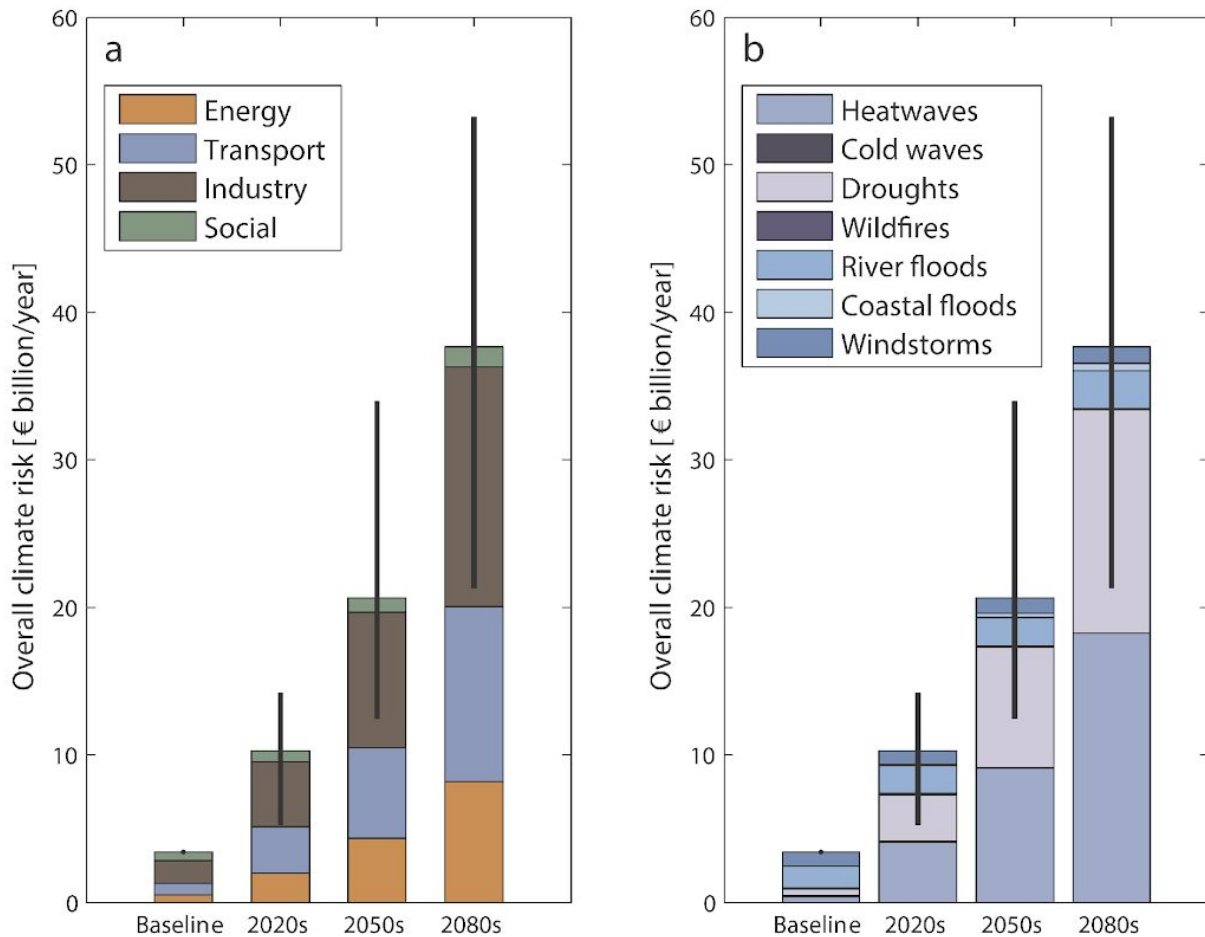
Figure 3. Overall climate hazard risk to critical infrastructures aggregated at European level (EU+) for each time period: a) distribution of damage by sector; b) distribution of damage over the seven hazards. For wind, projections of hazard are not available for 2020 s and 2050s; damage for these periods was obtained by linearly interpolating between the baseline and the 2080s. Whiskers reflect the inter-model climate variability (from Forzieri et al. 2018).

Always considering the possible damages due to climate extremes, another recent study (Forzieri et al. 2018) analysed the damage from climate hazards (heat and cold waves, river and coastal floods, droughts, wildfires, and windstorms). These are derived for 1981-2010 (baseline), 2011-2040 (referred to as the 2020s for short), 2041-2070 (2050s) and 2071-2100 (2080s), for an ensemble of bias-corrected climate projections under the A1B emissions scenario. The damages are referred to critical infrastructures, namely energy, transport, industry and social sector (Fig. 3).

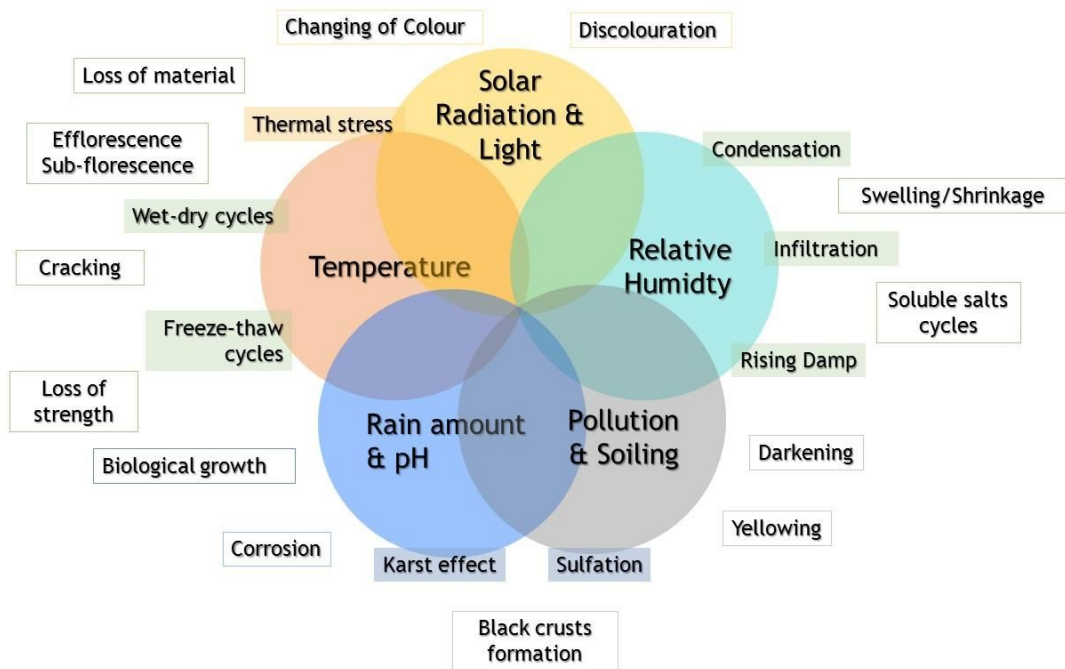
Figure 4. Scheme representing environmental parameters (coloured circles) responsible of processes (in coloured rectangles) that cause materials deterioration phenomena.

According to the EwaGlos (Weyer et al., 2016), several deterioration sources can affect historical architectural surfaces and wall paintings, and they can cause consequently deterioration phenomena as summed up in Figure 4 (for the definitions of stone deterioration patterns see also ICOMOS-ISCS, 2008).

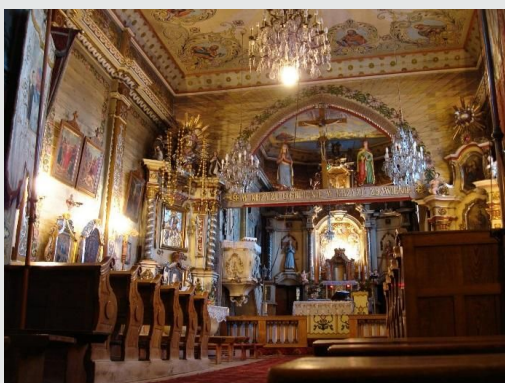
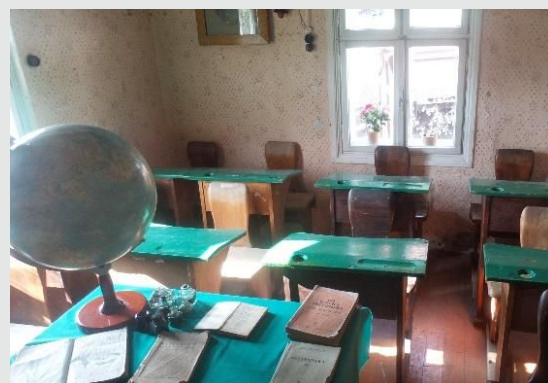
The inner decorations of the church are (Fig.7):

- Renaissance polychrome paintings of ceilings;
- Baroque polychrome wall paintings and movable paintings;
- Wooden, richly decorated and painted, baroque altars of the 14th and 15th centuries;
- Wooden, baroque pulpit and baptismal font;
- A Rococo organ;
- Statues;
- A historic confessional;
- A parchment reporting the act of consecration of the church;
- A bell in the belfry dates to 18th century.

Figure 7. Inner views of: on the left, the Roman Catholic Church of the Exaltation of the Holy Cross, while, on the right, the parish school.

In conclusion, the site shows a predominance of wood structure, but the two buildings can be considered polymateric structures as a whole.

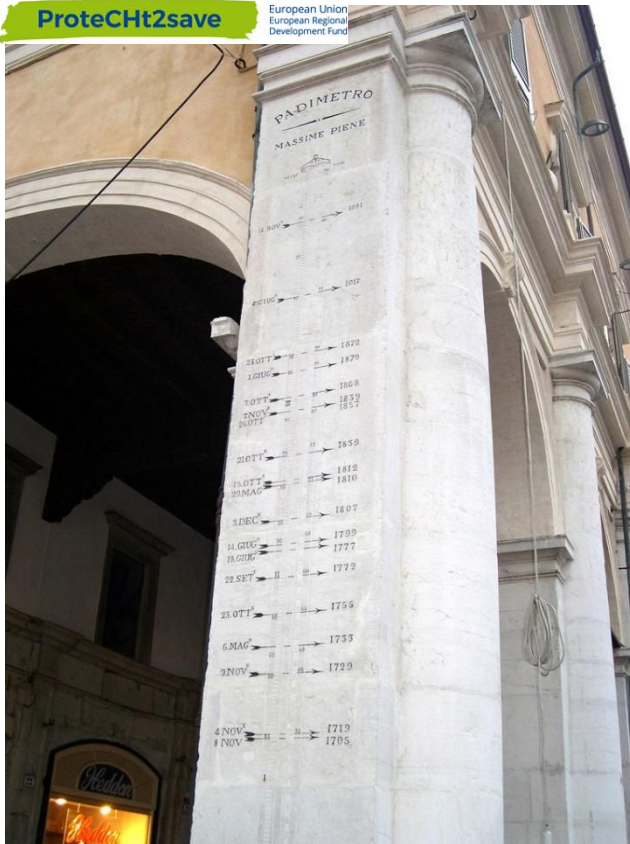
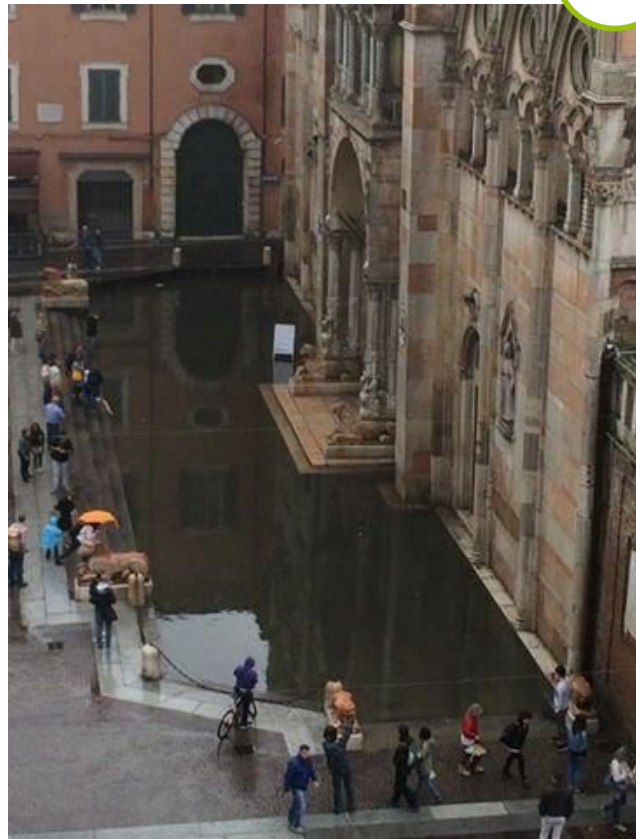
Figure 11. On the left: “Padimetro” of Ferrara. This monumental water gauge indicates the different heights and corresponding years of Po River level at Pontelagoscuro, a locality few kilometers distant from Ferrara city center. It is showed on a coloumn near the Cathedral square. On the right: the flooded area in front of Ferrara Cathedral.

Ferrara is taken into account as a case study for the heavy rain phenomena that affect the town. Furthermore, in the past the area underwent to flood events, in particular the area in front of the Cathedral Façade after heavy rains events result flooded (Fig.11). Even if no specific damages occurred to the cathedral after the flood, it has to be considered.

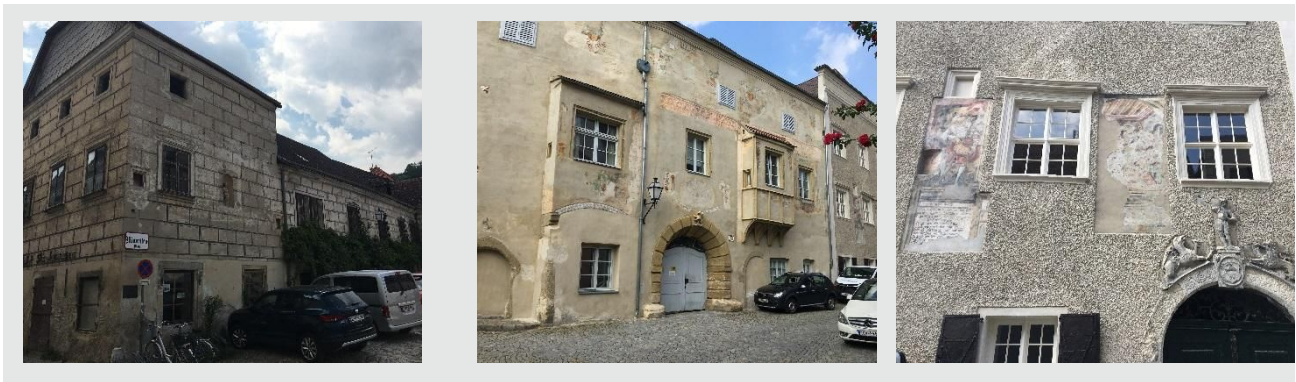
Figure 20. Buildings' facades with adornment and *sgraffito* articulation.

In particular, the district of Stein, a “long-stretched-out area of the medieval town, rectangular delimitation in the east, acute-angled in the west, which includes vineyard terraces in the north and is traversed on the narrow embankment strip by one single settlement axis.e., the Landstrasse connecting the two town gates” (Fig. 19). Furthermore, it is characterized by medieval and renaissance burghers’ and craftsmen’s houses. In particular, “the smooth facades of the building period prevail, in some places enlivened by late-Gothic window jambs, oriels, or cantilevered upper storeys, and partly with traces of former sgraffito articulation, or, mainly in the squares, adorned with late-Baroque and Josephine facades in accordance with new standards of representation set in the 18th century”(Fig. 20). (Bundesdenkmalamt/ REPUBLIC OF AUSTRIA, 1999).

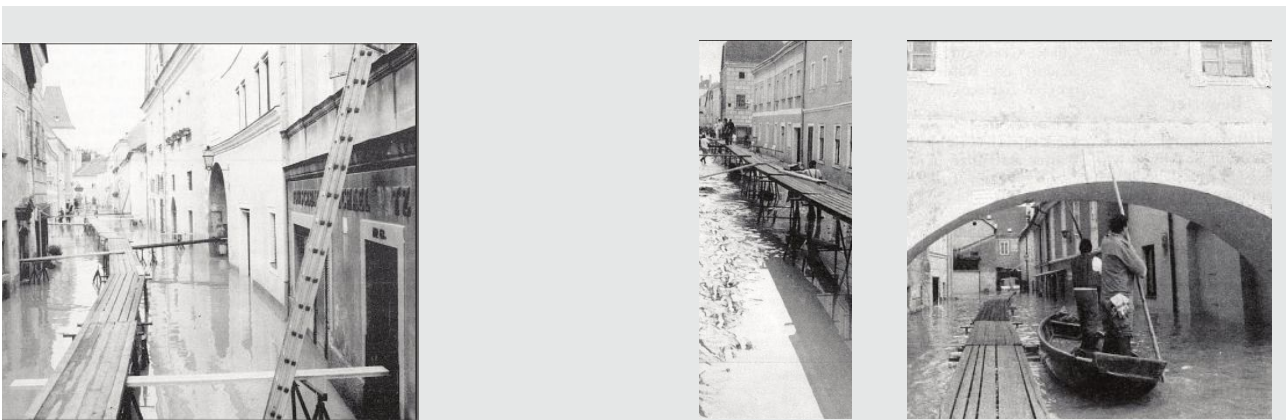
ictures taken during the flood in 1991 in Stein, also along the Landstrasse. During the more recent floods the protection was already developed and high enough to prevent flooding in Stein.

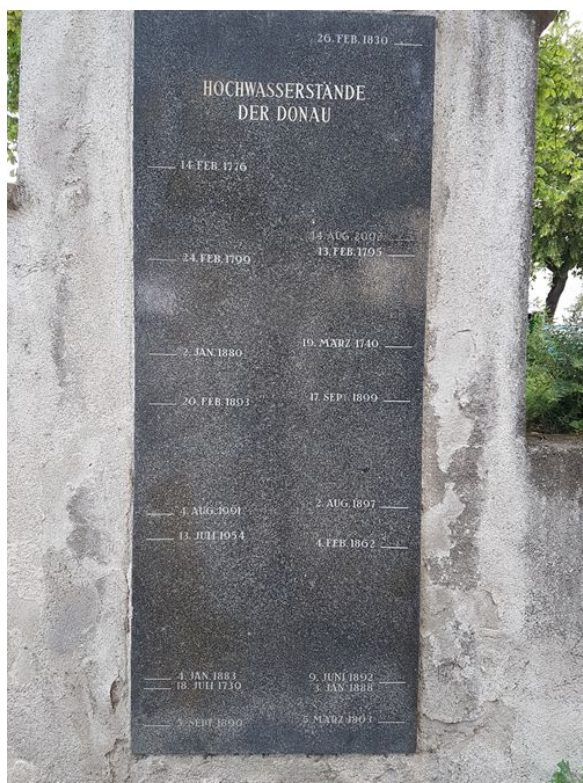
Figure 23. Flood marks of past flood events in Krems-Stein, represented from the highest to the lowest on the marker.

The main risks posed to Krems and Stein are floods by the river Danube and rivers and rivulets flowing into the Danube. In fact, in the past Krems and Stein have been affected by floods several times (Fig. 22), as shown in a monumental water gauge (Fig. 23), reporting their dates: 1830, 1776, 2002, 1795, 1799, 1740, 1880, 1899, 1893, 1897, 1991, 1954, 1862, 1883, 1892, 1888, 1730, 1803 and 1890 (listed from the highest to the lowest). Furthermore, a more recent flood event was registered in 1954.

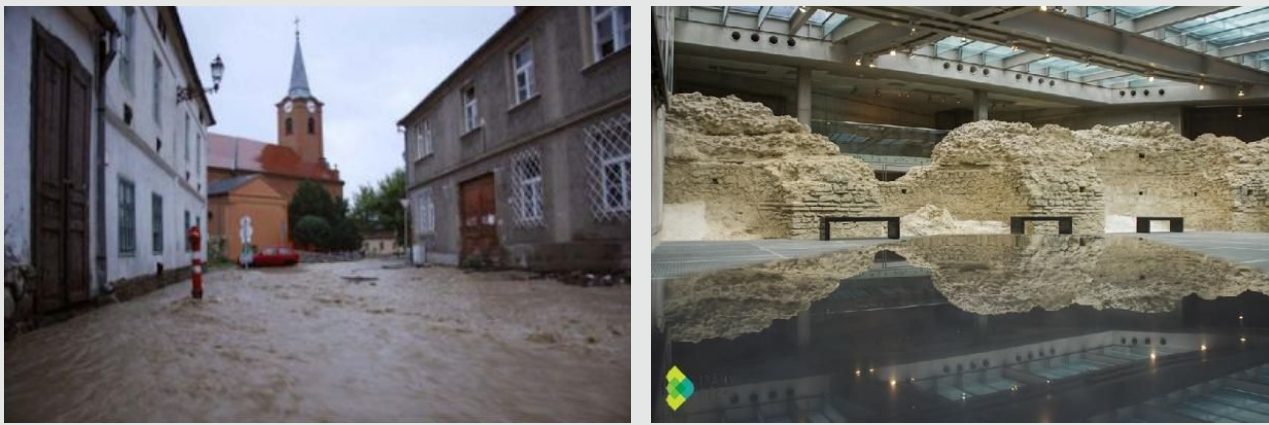
Figure 26. On the left: Pécs during a flood event; On the right: the underground burial chambers called *Cella Septichora*.

While, considering the possible risks to which this site can be exposed to, we have to consider heavy rain and rarely fire. Concerning the first one, heavy rains have caused damages in hilly area, because the drainage system was not able to manage the water amount. Furthermore, the UNESCO site *Cella Septichora* was being flooded with water in case of heavy rain, therefore, in order to avoid these events prevention and renovation works have been performed (Fig. 26).

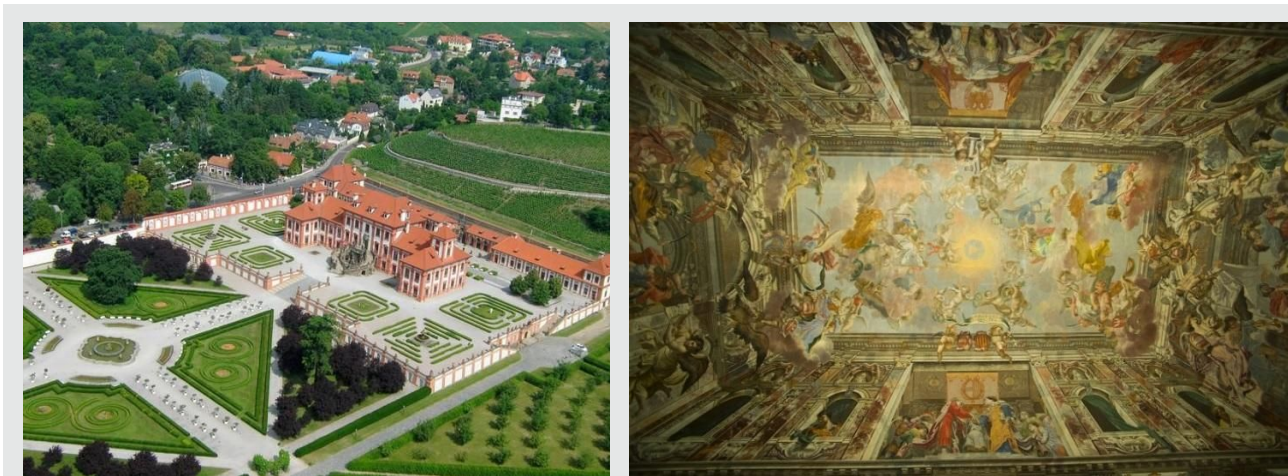
Figure 28. Early Baroque Chateau Troja, built in 1679-1691. On the left, aerial view; on the right internal ceiling richly decorated.

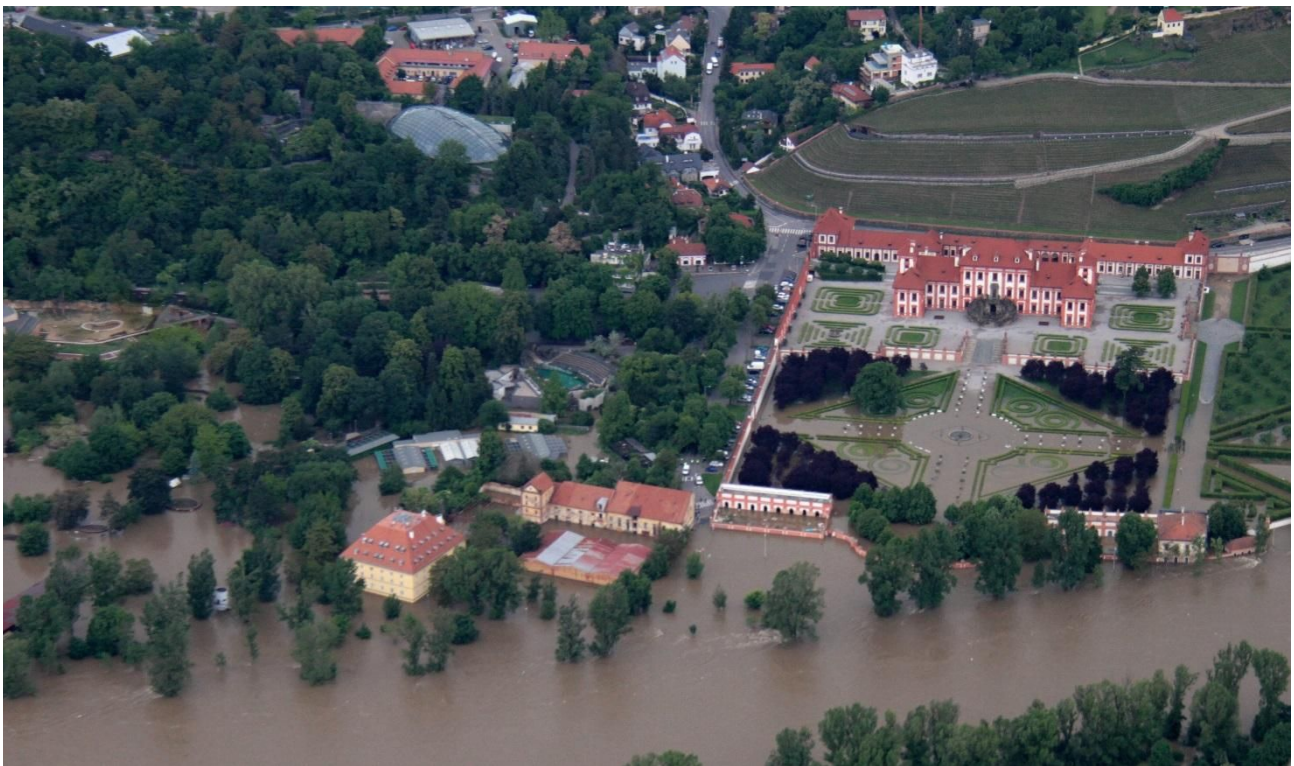
Figure 29. Flood in Troja in 2013.

River flood represents the most important risk in the area, experiencing in recent times a higher frequency of major floods, similar to the medieval period with intervals of about ten years repetitions. The devastating flood in 2002 accelerated the construction of combined permanent- temporary protection barriers, which proved a successful protection of an important part of the territory during the recent flood in 2013 (Fig. 29). However, a substantial part of the urbanized area is still unprotected and under a river flood risk. Minor risk is associated with wind storms which are dangerous namely for large trees in the historic gardens and natural areas of the district.
