Project Water Bodies Without Borders (EstLat 66)

Description of water bodies in the project area

Activity T1. Compilation of existing data and identification of gaps

REPORT

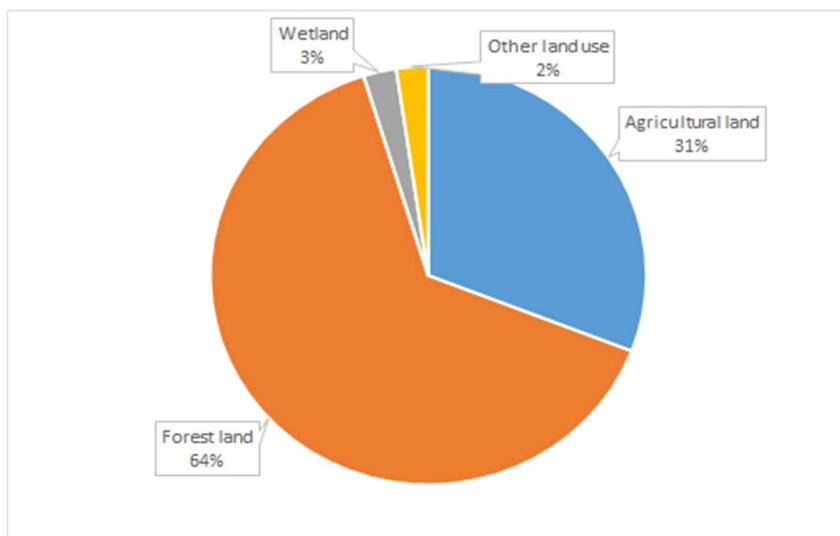
Figure 2. Main land use types in the project territory.

In total 4718 km² of WBWB project area is forest land (64,3 % of the project territory), 2266 km² are agricultural lands (30, 9 % of the project territory), 179 km² are wetlands (2,4% of the project territory) and other land use types account for 173 km² (2,4 % of the project territory), Figure 2.

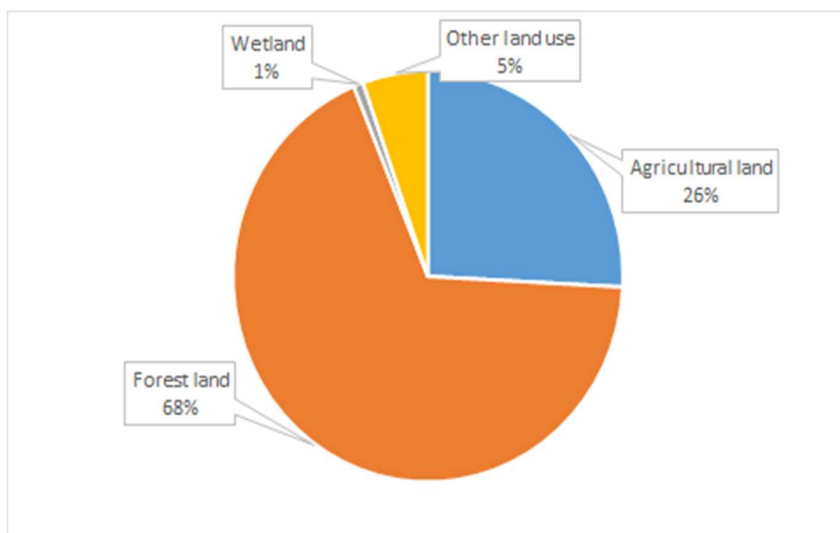
Figure 3. Main land use types in the project territory in Estonia.

In Estonia agricultural lands cover 473 km² (25,8%) of the project territory (Figure 3). Forest in Estonia covers 1144, km² (67,9%) of the project territory. Wetlands cover 18 km² (0,81 %) of the Estonian project territory. Other land use types account for 44 km² (5,4%) of the Estonian project area.

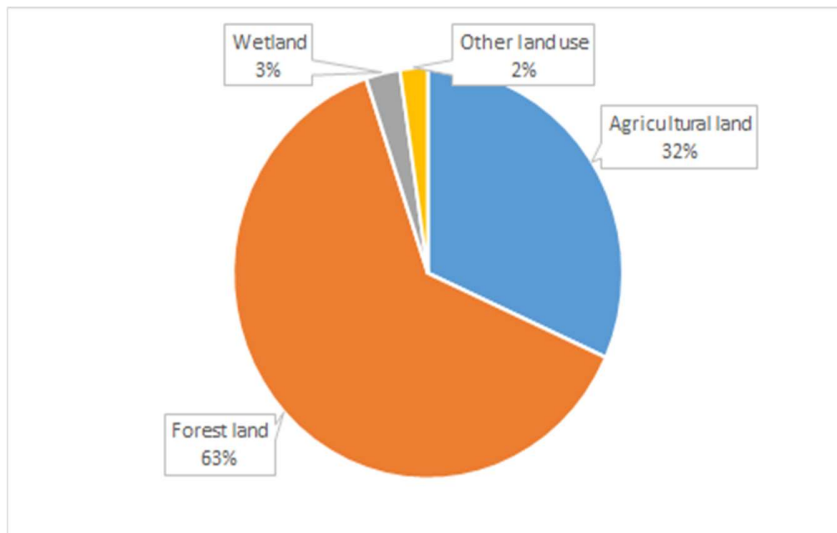
Figure 4. Main land use types in the project territory in Latvia.

In Latvia forest covers 3574 km² (63,1%) of the Latvian project territory (Figure 4). Agricultural lands in Latvia cover 1793 km² (31,7%) of the project territory. Wetlands

cover 161 km² (2,85%) of the Latvian project territory. Other land use types account for 129 km² (2,3%) of the Latvian project territory.

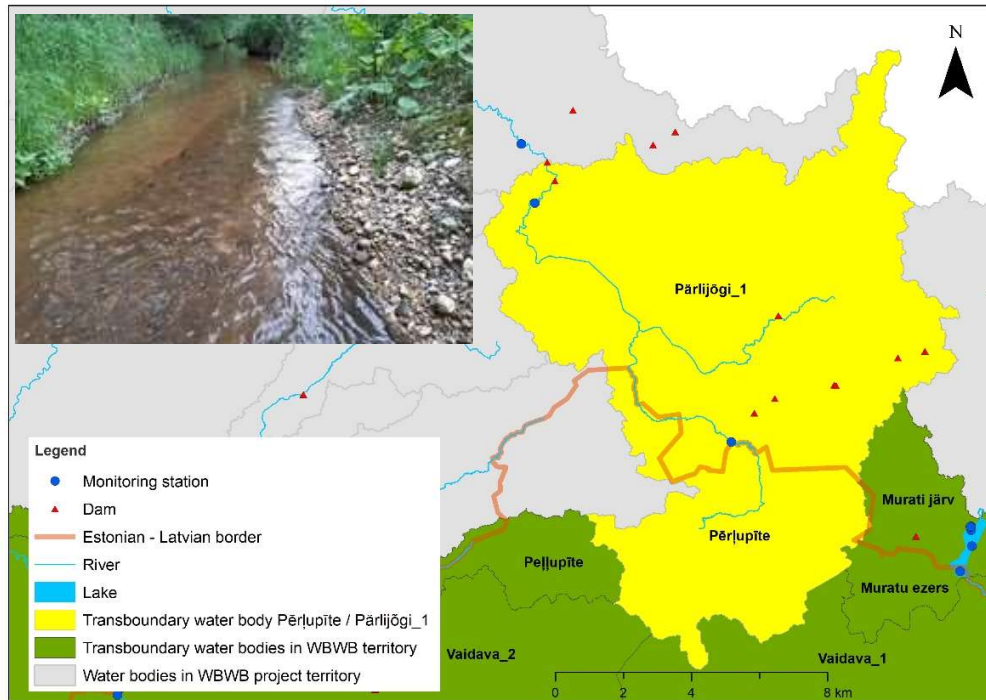
Figure 18. Transboundary water body Pērļupīte / Pärlijõgi_1. In photo – Pērļupīte in Latvia, straightened part (2019).

An existing water body Pärlijõgi_1 (1155700_1), from Latvian-Estonian border to Saarlase dam. The catchment area in Estonia is 95.7 km² and length of the water body is 26.3 km. Water body type is V1A. The catchment area is covered in forest - 64.2% and agricultural land - 31.6%. Water body is located in 3 protected areas: Pärlijõgi meadow limited-conservation area, Luhasoo conservation area and Pärlijõgi limited-conservation area.

Water body has no monitoring station. General physico-chemical quality is likely to be good, but biological quality elements are affected by hydromorphological modifications. There are 3 dams on the water body: Mustahamba, Saarlāsõ and Pärlijõe. Hydromorphological status of the water body is moderate because of the obstacles - dams. There are no good solutions available to construct a fish pass.

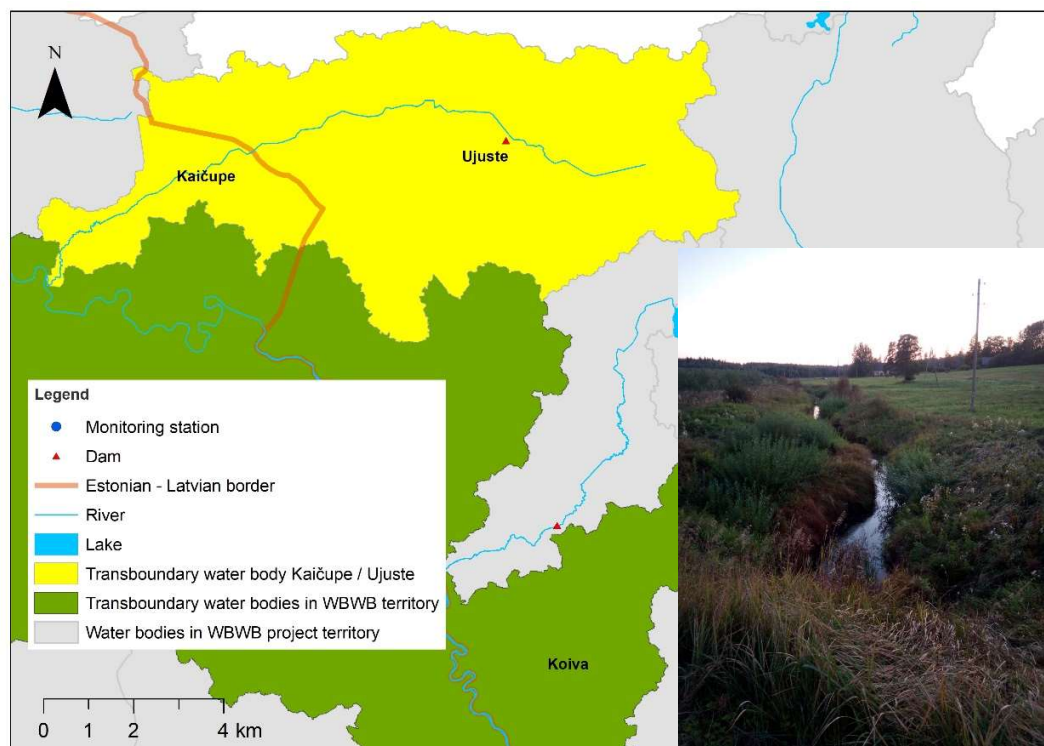
Figure 23. Transboundary water body Kaičupe / Ujuste. In photo – Kaičupe in Latvia (2019).

type is V1A-KaVo. The catchment area is covered in forests - 43.7% and agricultural lands - 55.7%. The water body is entirely in a straight artificial bed, but there are no other significant pressures. According to the monitoring results of 2012, the status of the water body is good.

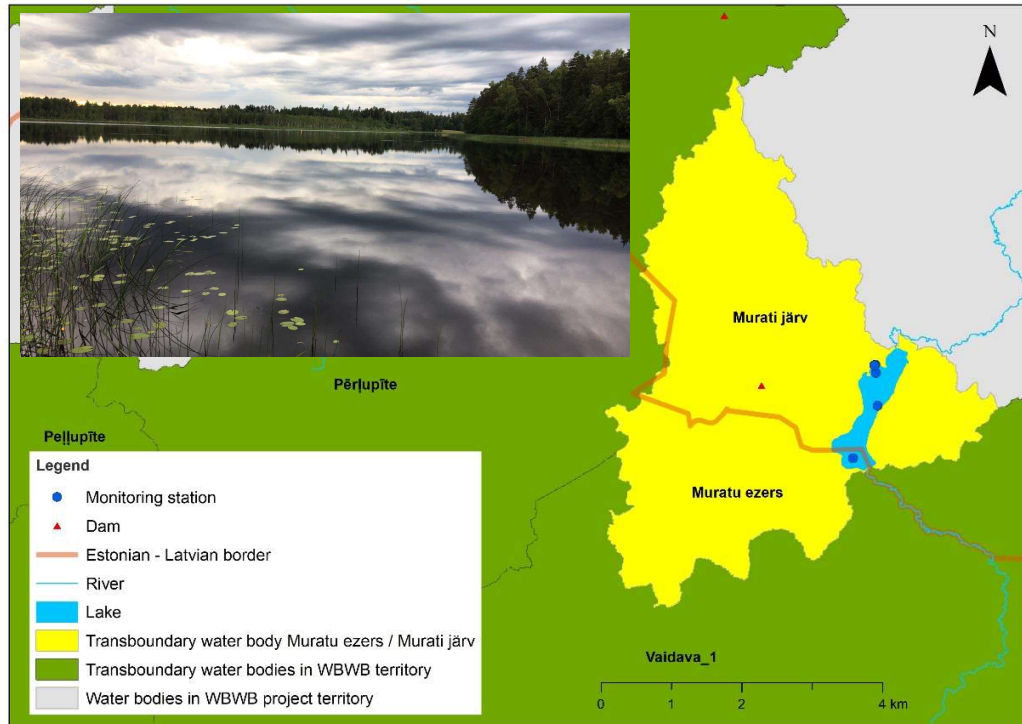
Figure 31. Transboundary water body Murati järv / Muratu ezers. In photo – lake Murati in Latvia (2019).

of local pollution. Water body has an existing monitoring station (last monitored in 2017). Ecological status is good. Water body is located in the specially protected nature territory “Murati loodusala”.
