**Project „Water bodies without borders” (EstLat 66)**

## **ACTION PLAN**

# **Pressures and impacts on water quality, economical analysis and programme of measures**

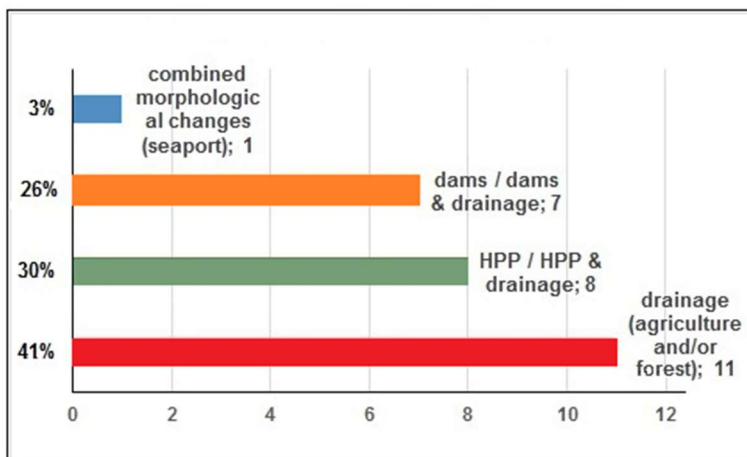
**Figure 8.** HYMO pressures in water bodies under risk.

- land drainage in agricultural area and in forests that causes, as changes in the river morphology (reduction of length of river bed), as hydrological regime;
- water regulations by HPPs and sluices which cause significant changes in hydrological regime of river;
- dams for hydropower production and other water use that interrupt the continuity of stream flow and create barriers for sediment transport and biota migration;
- seaport operation in Salaca river mouth is a combination of HYMO alterations (e.g. bed dredging, changes in sediment regime, bank stabilization, bank erosion).

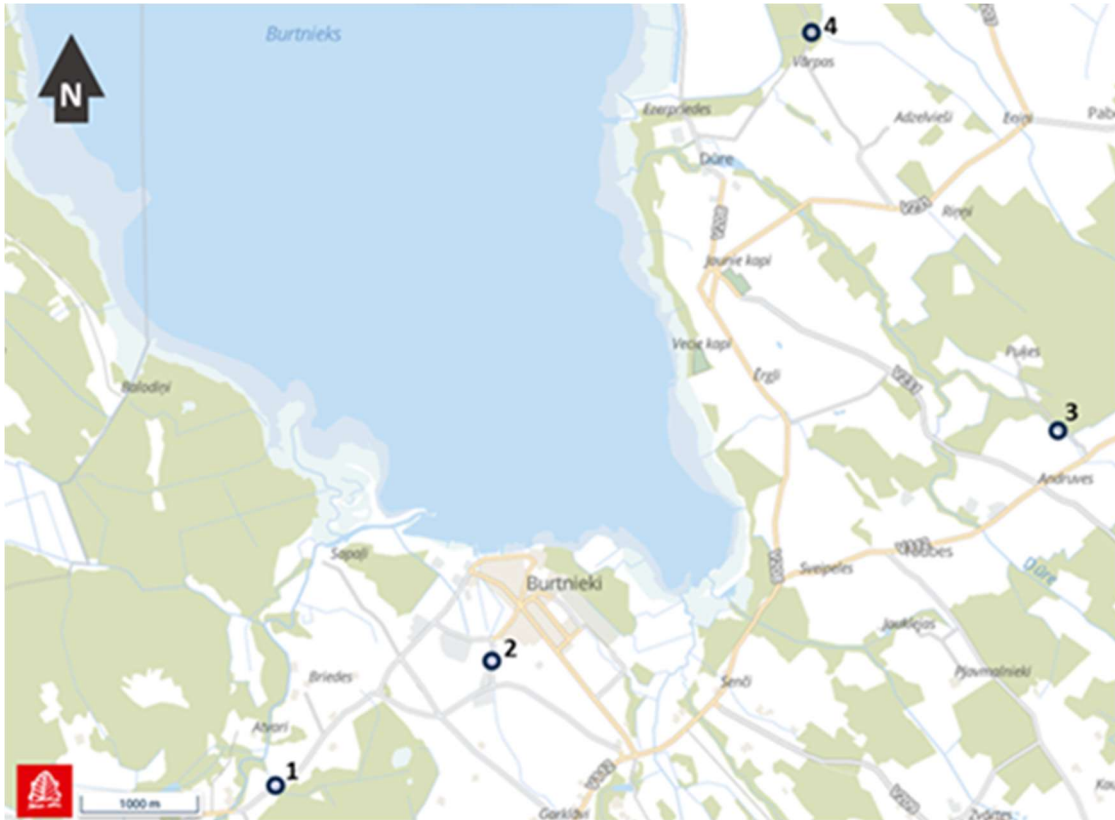
*Figure 14. Locations of watercourses chosen for filter construction*

Figure 14 shows the watercourses chosen for filter construction. These areas, around the watercourses, are active in economic activities (agriculture, animal husbandry, forestry), their size and stream speed are suitable for the installation and successful operation of the filters (small predicted runoff in spring floods) and have sufficient total phosphorus ( $\geq 0.1$  mg L<sup>-1</sup>).

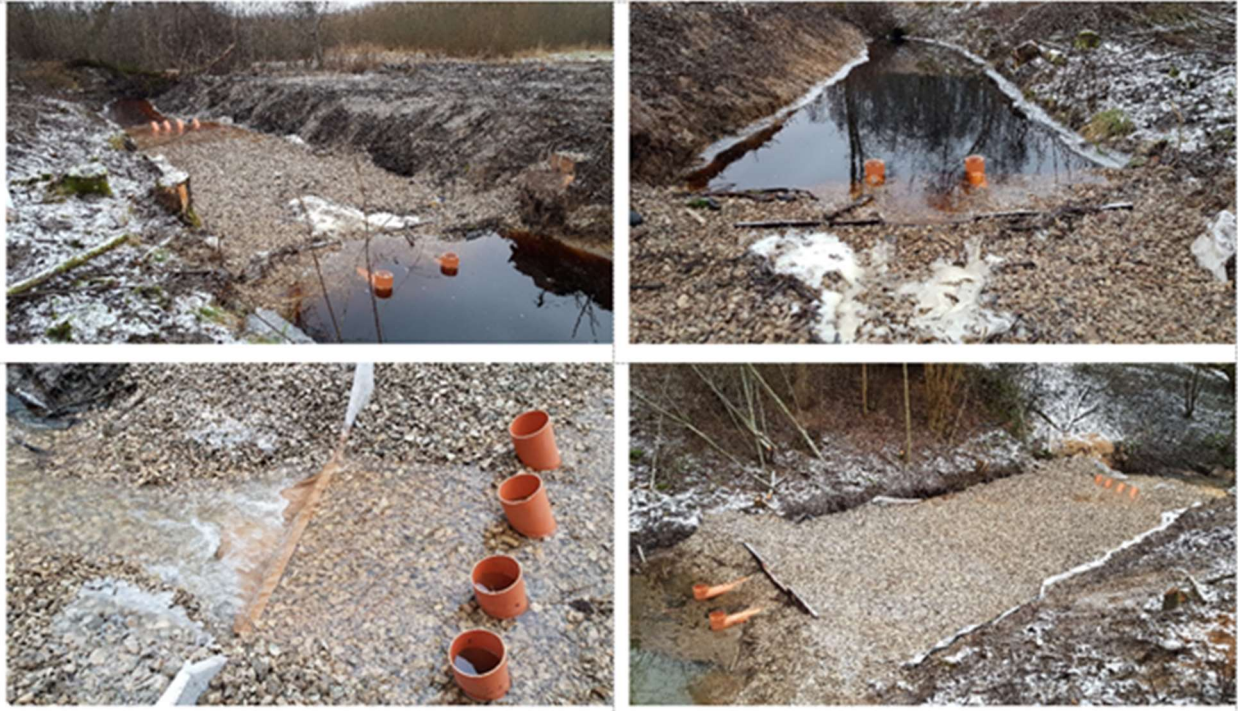
**Figure 16.** Phosphorus filters on small ditches around Lake Burtnieks

Filters installed in the ditches discharging into Burtnieks are 10 m long, 3 m wide and 1 m deep. A 50 m long water sedimentation basin is formed in front of the filter where suspended particles (mainly sand and organic matter) settles. This prevents rapid filter clogging.

The filter fill is calcium-containing material. All installed filters are filled with dolomite ( $\text{CaMg}(\text{CO}_3)_2$ ) chips. Two filters built in the ditch with the highest water flow rate, filled with  $30 \text{ m}^2$  dolomite chips of 16 - 32 mm fraction. Filters built into ditches with lower water flow rate are filled with 12 - 16 mm fraction dolomite chips and  $2 \text{ m}^2$  of Nordkalk<sup>TM</sup> calcium hydroxide ( $\text{Ca}(\text{OH})_2$ ) granules added. After contact with the calcium P dissolved in water precipitates and forms insoluble compound. The simplified phosphorus precipitation reaction is illustrated as follows:

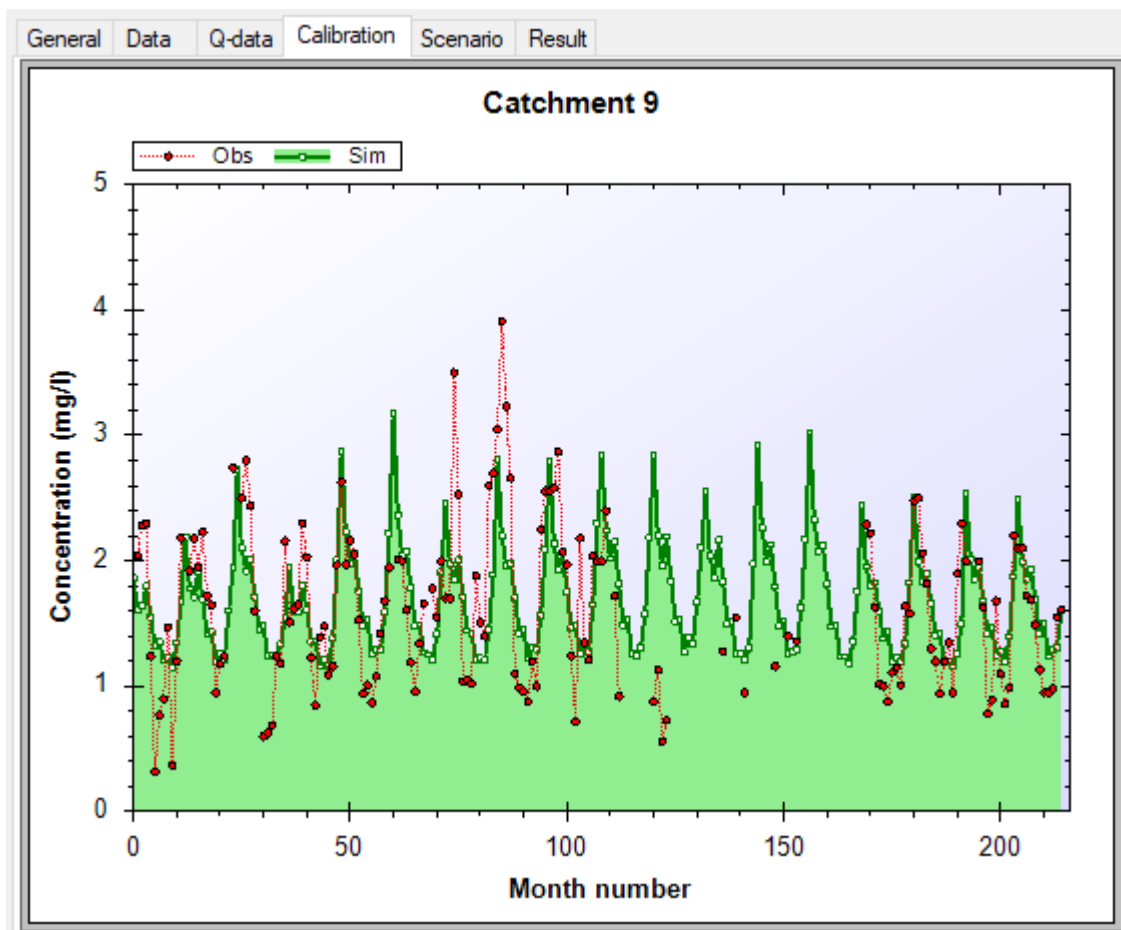
*Figure 1. Calibration result (observed values and simulated for WB G306 Salaca).*

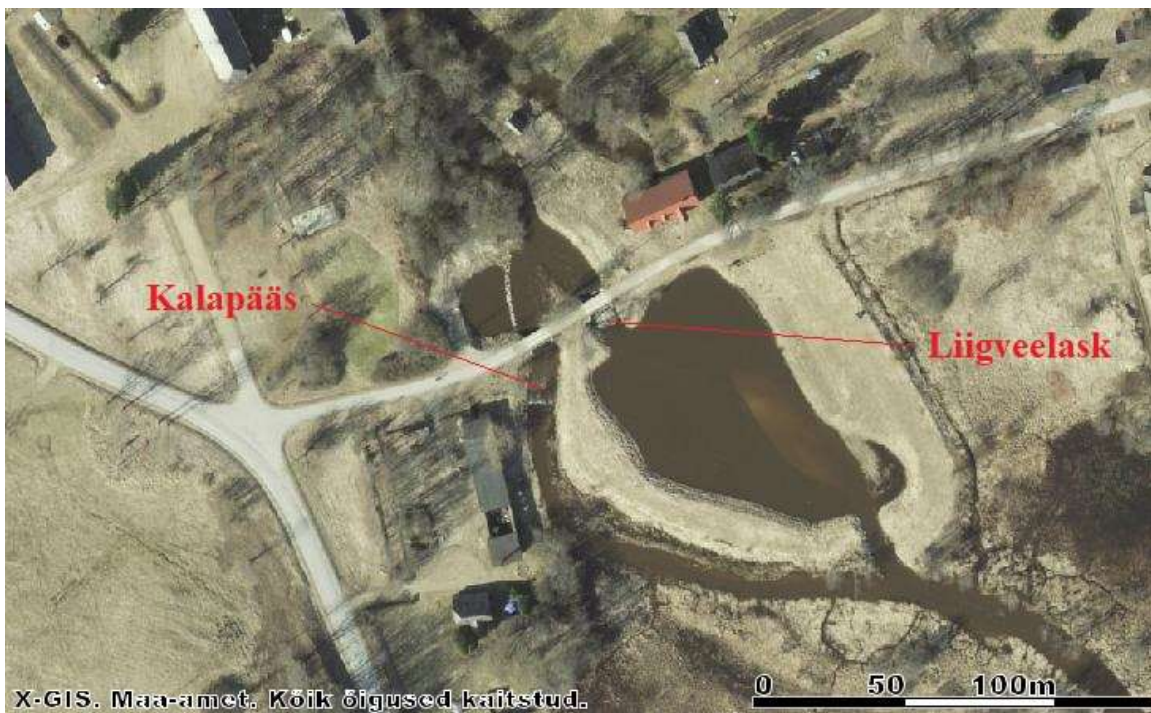
Joonis 2. Sänna Alaveski paisu kalapääs asub jõe vasakul harul, liigveelask paremal harul.

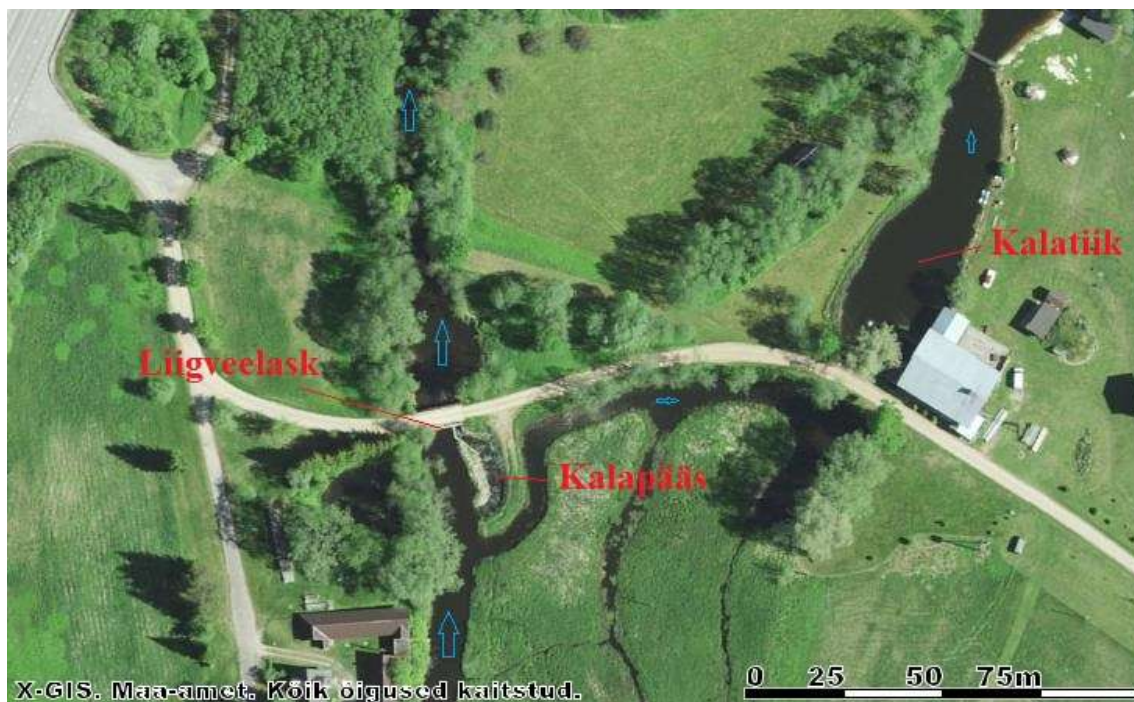
Joonis 4. Sanna Mäeveski paisu kalapääs on rajatud jõe paremale kaldale paisust ülesvoolu.

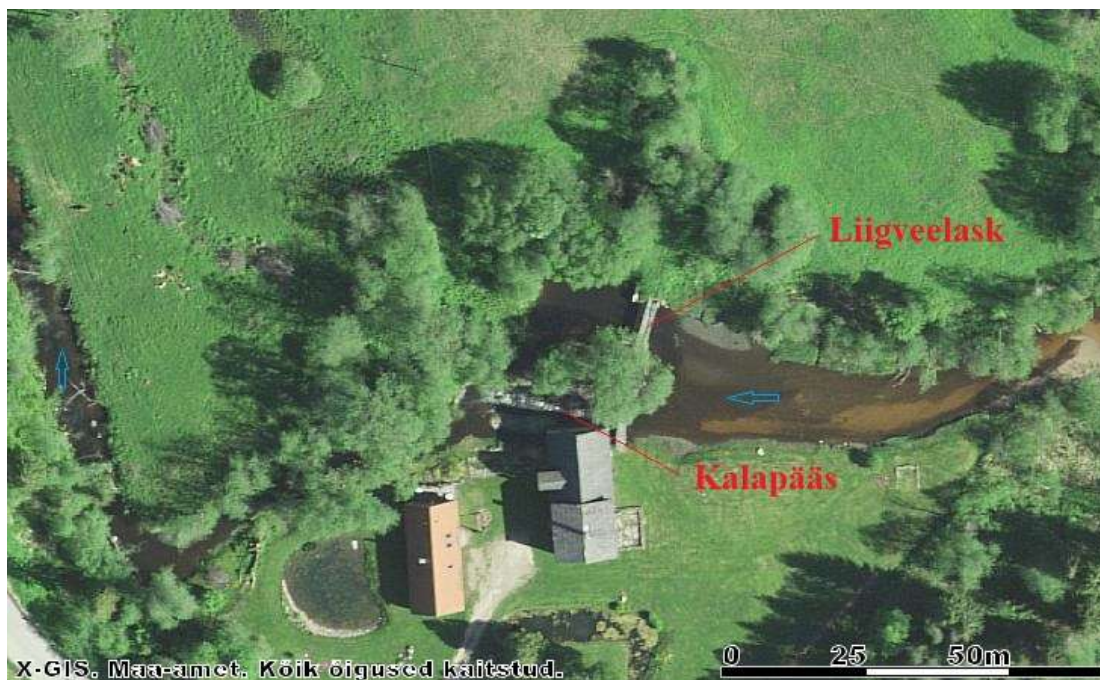
Joonis 6. Ala-Raudsepa paisu kalapääs asub jõe vasakul kaldal vana veskihoone kõrval.

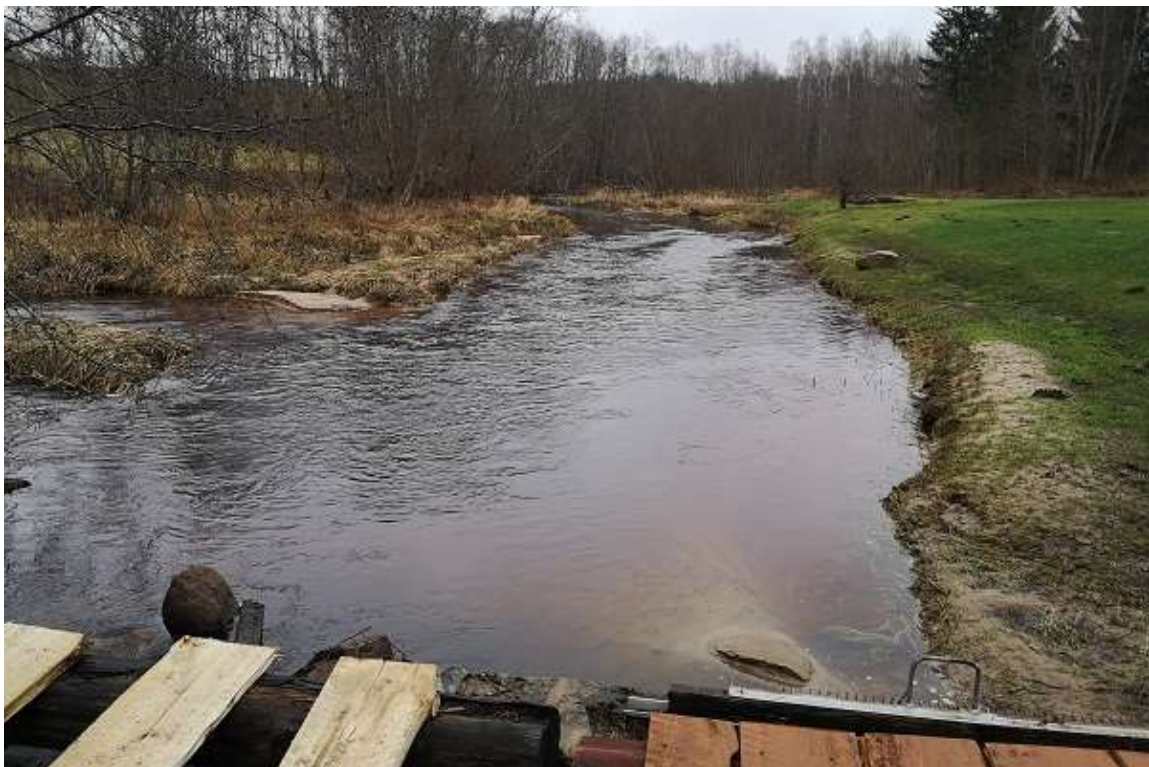
Foto 10. Vaade paisult ülesvoolu paisutusosalale. Kaldavööndi järgi on näha, et tavapäraselt on veetase olnud ca 0,5 m kõrgemal vaatluspäeva omast. Paisutusala ilmet see aga oluliselt ei muuda. Paisjärve pole, on vaid paisutatud jõe osa (R. Järvekülg, 10.12.2019).

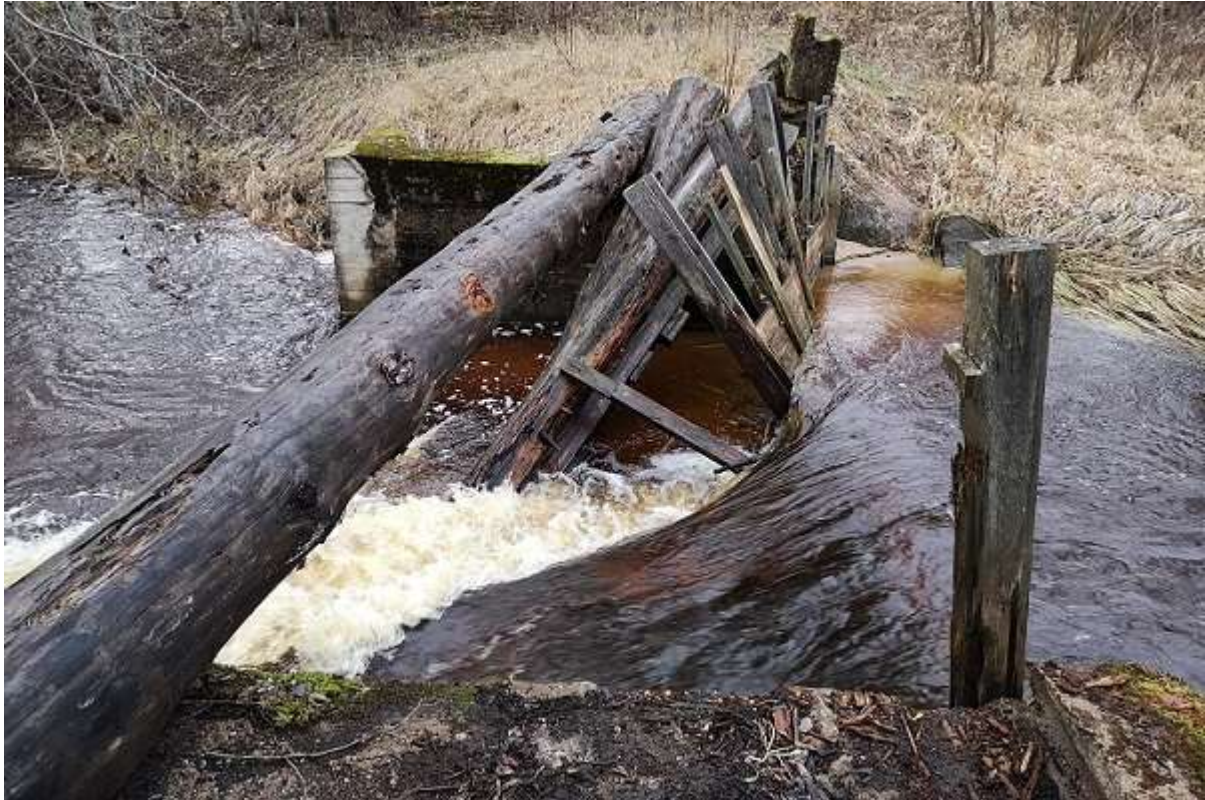
Foto 11. Paisu liigveelask on lagunenenud. Lip-lipi, lap-lapi peal konstruktsioon pole vee survele vastu pidanud. Tõenäoliselt on paisu omanik jäänud hiljaks paisu varjade eemaldamisega jõe veetaseme kerkides (R. Järvekülg, 10.12.2019).

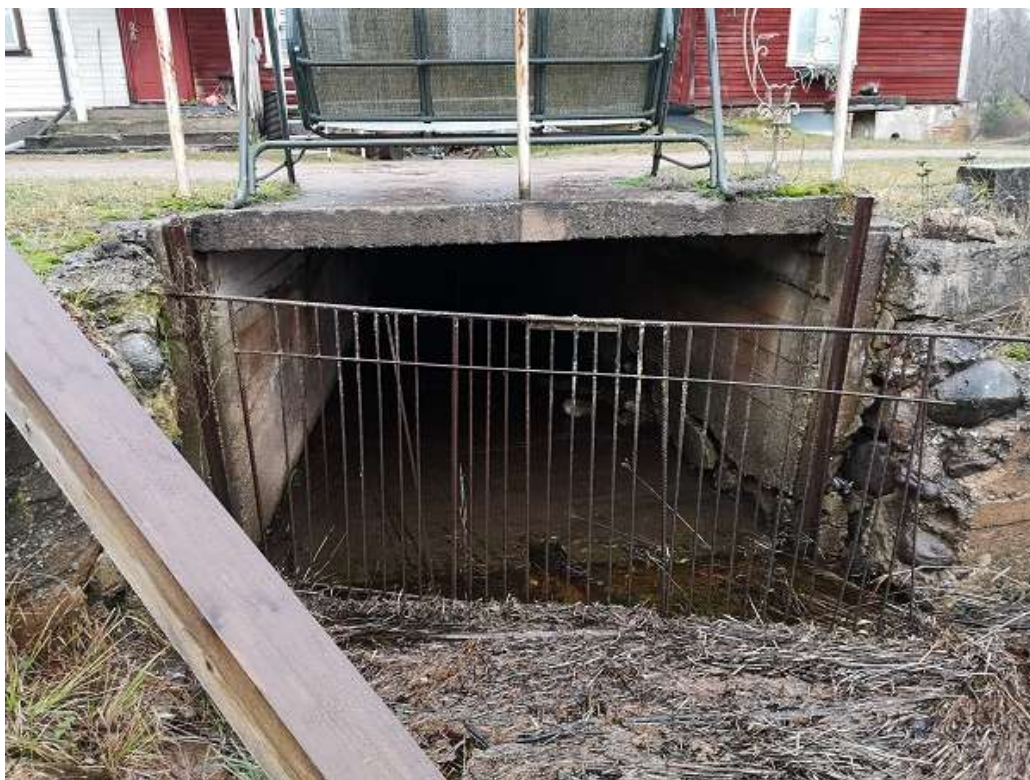
Foto 18. Varem on Saarlase paisu juures töötanud HEJ turbiini veetarbega ca 0,8 m<sup>3</sup>/s. Omaniku sõnul rikkus turbiini sinna sattunud puunott. Turbiini sissevoolu ees on võre, mille algsed avad on olnud 5...7 cm, pärast loodusjõudude toimet on aga avad suurenenud kuni 15 cm-ni. On selge, et selline võre ei takistanud turbiini sattumast mitte ühtki kala, ega toimunud kuigi efektiivselt ka prahitökkena (R. Järvekülg, 10.12.2019).

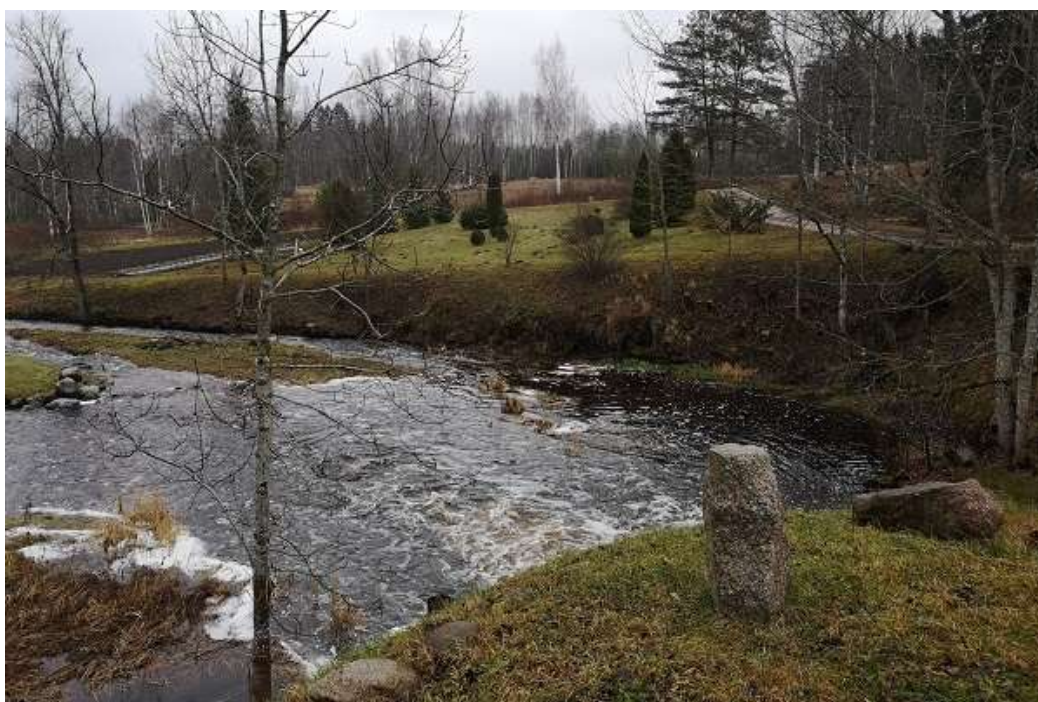
Foto 19. Kalapääsu rajamise teeb keeruliseks see, et jõe kaldad on paisu juures kõrged ning järsud. Vaade paisult jõe paremale kaldale. Kalapääsu rajamine on võimalik, kui alandada ülavee taset 3 m-lt 2 m-le. Paisu omanik on oma sõnul toimiva kalapääsu lahenduse leidmisest huvitatud ning valmis alandama praegust paisutustaset (R. Järvekülg, 10.12.2019).

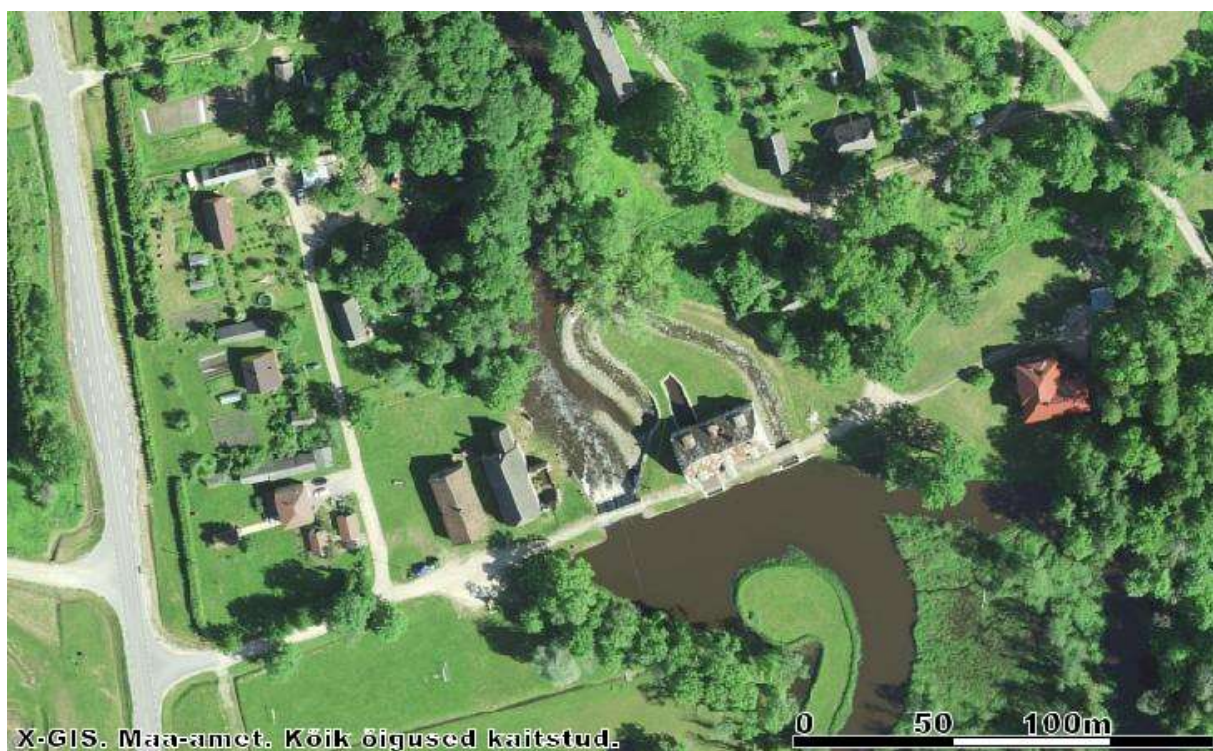
Joonis 2. Vastse-Roosa pais ortofotol. Vasakul laiema harul asub liigveelask, keskel HEJ hoone kohal turbiinikanali sisse- ja väljavool (väljavoolukanal jätkub pärast ca 15 m maa-aluse toruna kuni jõeni) ning paremal kitsama haruna on kalapääs, mis suubub jõkke parkümmend m allpool liigveelasku.

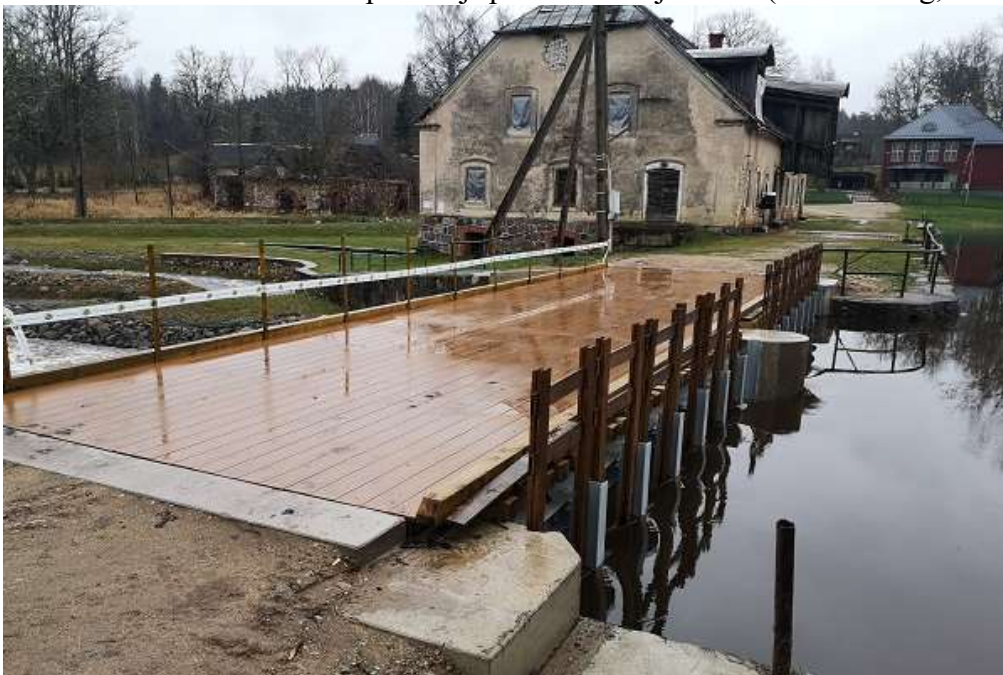
Foto 2. Vastse-Roosa paisu liigveelask (R. Järvekülg, 10.12.2019).

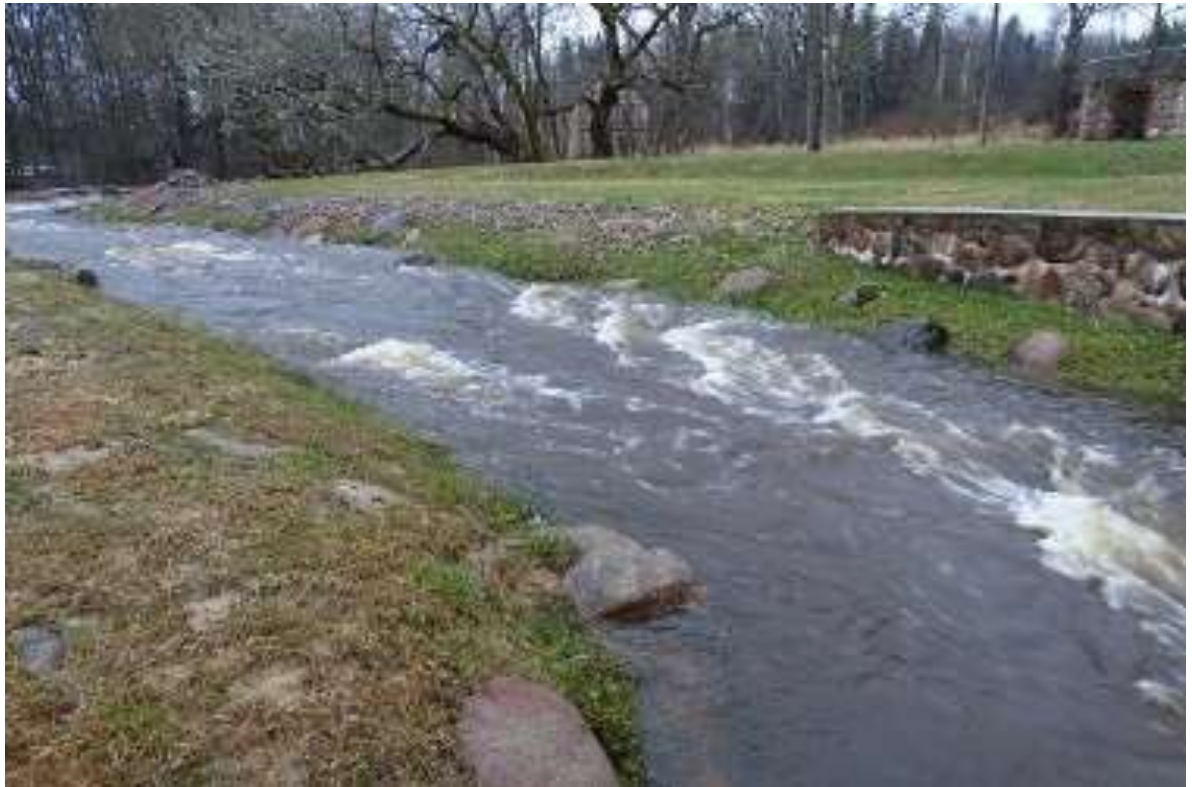
Foto 5. Kalapääsu alumises osas on paiguti voolurahustuskive liiga vähe ning vool seetõttu väga kiire. Puuduvad kalade varjupaigad (R. Järvekülg, 10.12.2019).

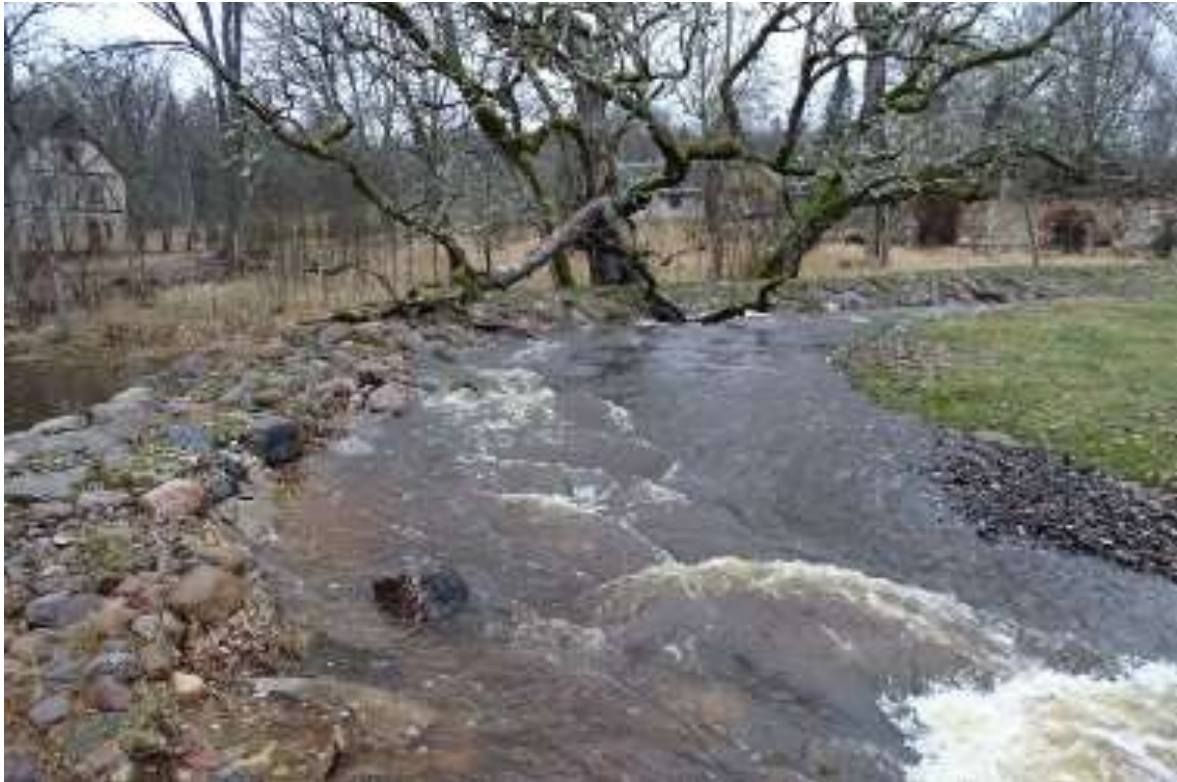
Foto 6. Lokaalselt suurema languga ning väheste voolurahustuskividega on ka kalapääsu lõik, kus kalapääsu säng teeb tagasipöörde paisu poole (R. Järvekülg, 10.12.2019).

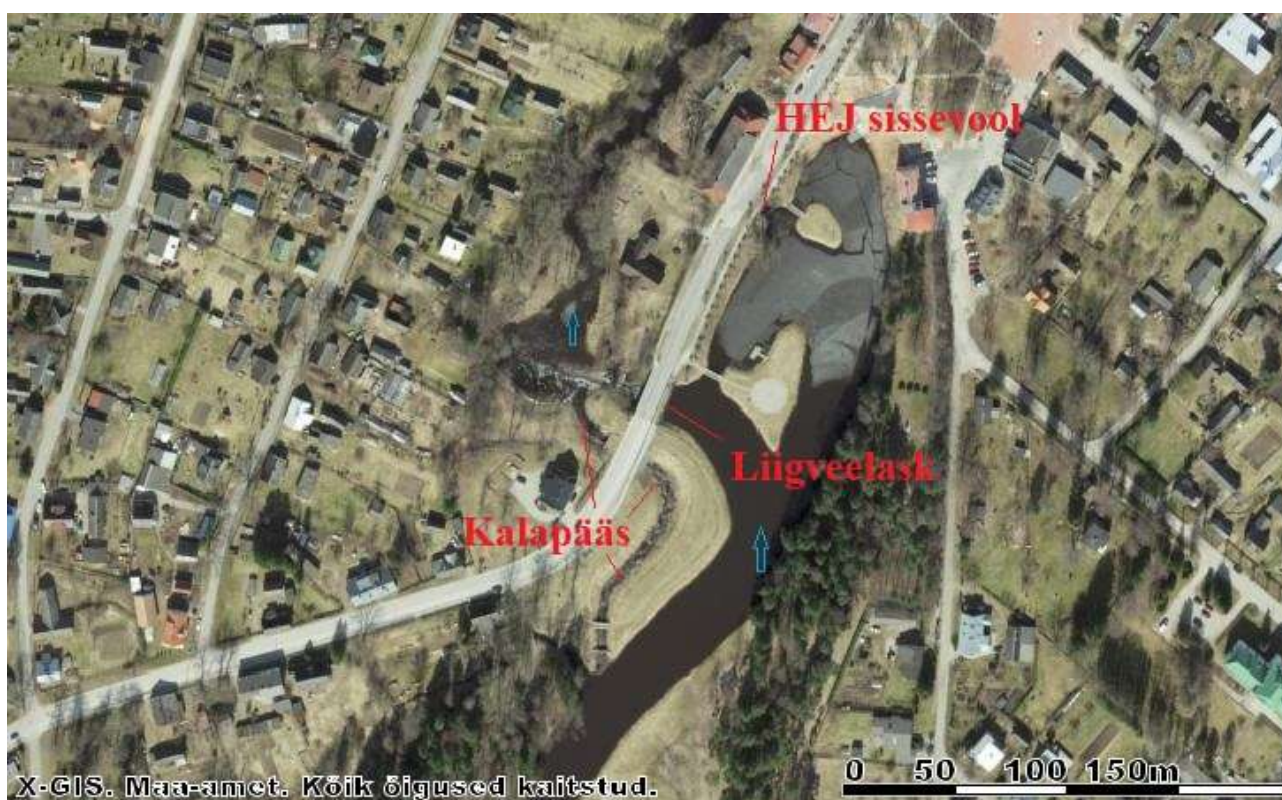
Joonis 2. Tõrva paisu kalapääsu, liigveelasu ja HEJ sissevoolude paiknemine ortofotol.

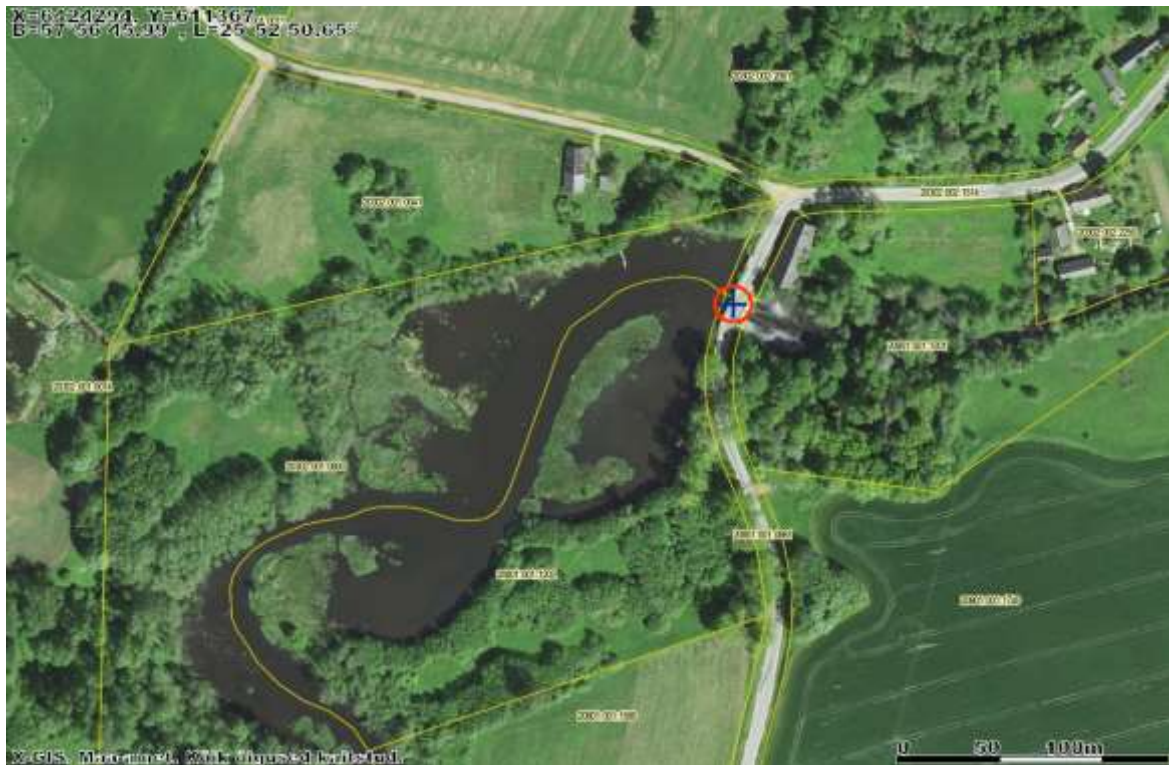
Joonis 4. Paisjärve madalamad osad on tegelikult kinni kasvanud, osaliselt maastunud ja kaetud mättilise rohttaimestikuga. Seda näitab ka ortofoto.

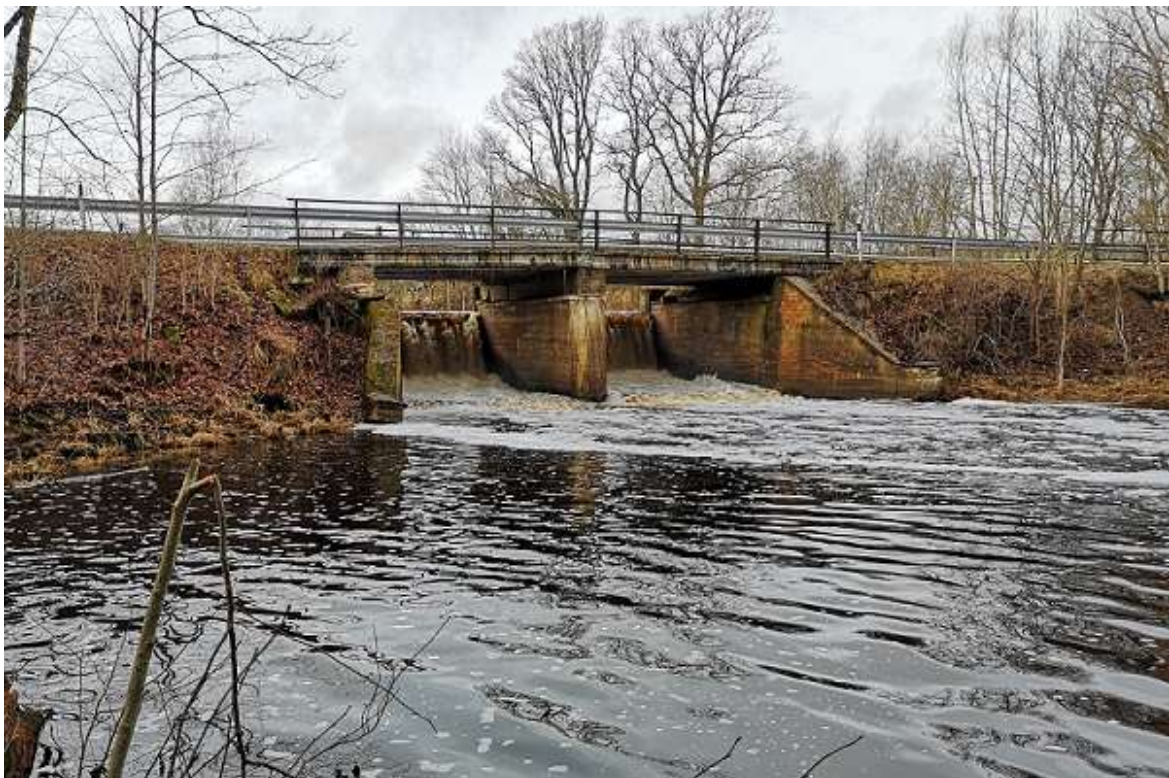
Foto 12. Vaade Koorküla paisule alavee poolt. Paisu kõrgus on ca 2,7 m. Praeguse paisutustaseme juures on kalapääsu rajamine äärmiselt keeruline, töömahukas ja kallid. Mõistlikeks lahendusteks oleks kas paisu lammutamine või paisutuskõrguse alandamine 1,5 m-le ning seejärel kärestikulise möödaviikpääsu rajamine jõe vasakule või paremale kaldale (R. Järvekül, 08.12.-2019).

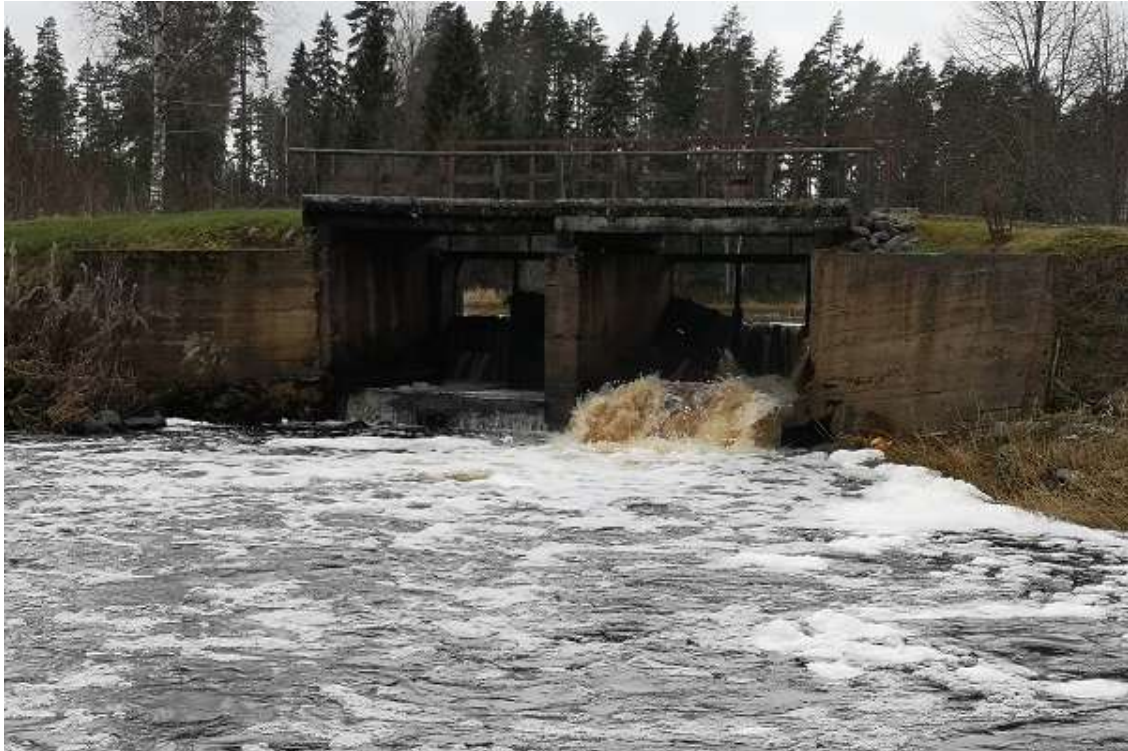
Foto 18. Dzirnavase paisu paisutuskõrgus on ca 2,1 m. Suurvee ajal on osa varjasid eemaldatud ja paisutustase madalam. Vaatluspäeval oli varjadega avatud vaid vasak liigveelaskme osa. Paisu omanikule on mureks ootamatud Holdre paisu avamised, misjärel Dzirnavase paisul tekib uputusohht (R. Järvekülg, 08.12.2019).

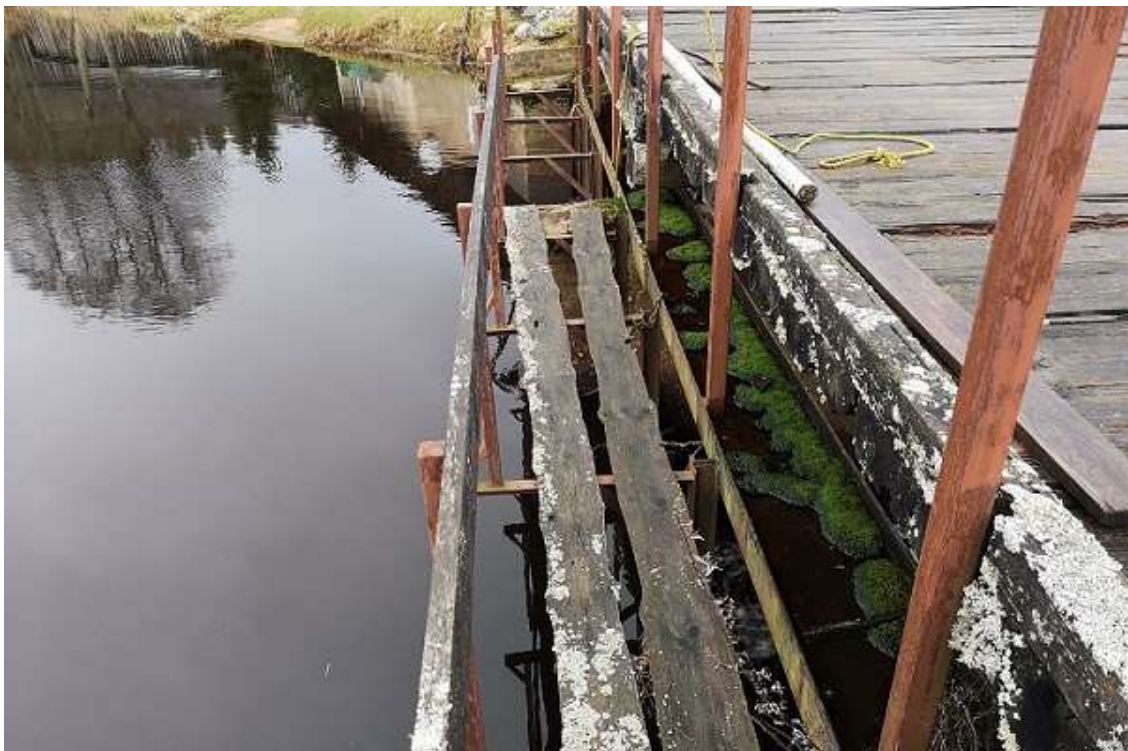
Foto 19. Liigveelaskmelt varjade eemaldamine on kaskadöörlik ettevõtmine, eriti talvel, kui lauad on jäised või lumised ja varjad on kõvasti kinni kiilunud. See on muide tavaline ka paljude Eesti paisude puhul – kui vaja kiiresti varju avada, siis pole seda sageli teha võimalik (R. Järvekülg, 08.12.2019).

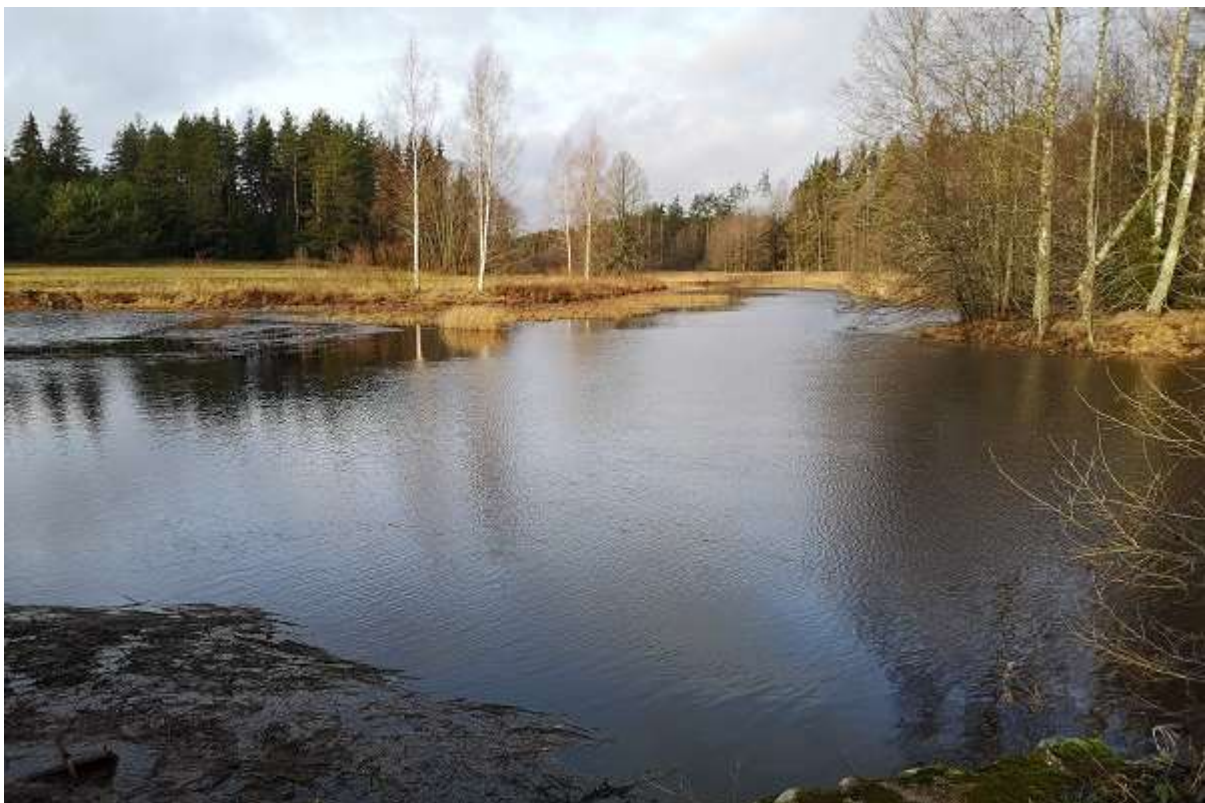
Foto 21. Holdre paisjärv on suurelt osalt kinnikasvanud madal veekogu, mis maastikulist väärtust ei oma. Elamised praegu paisjärve ääres puuduvad (R. Järvekülg, 08.12.2019).

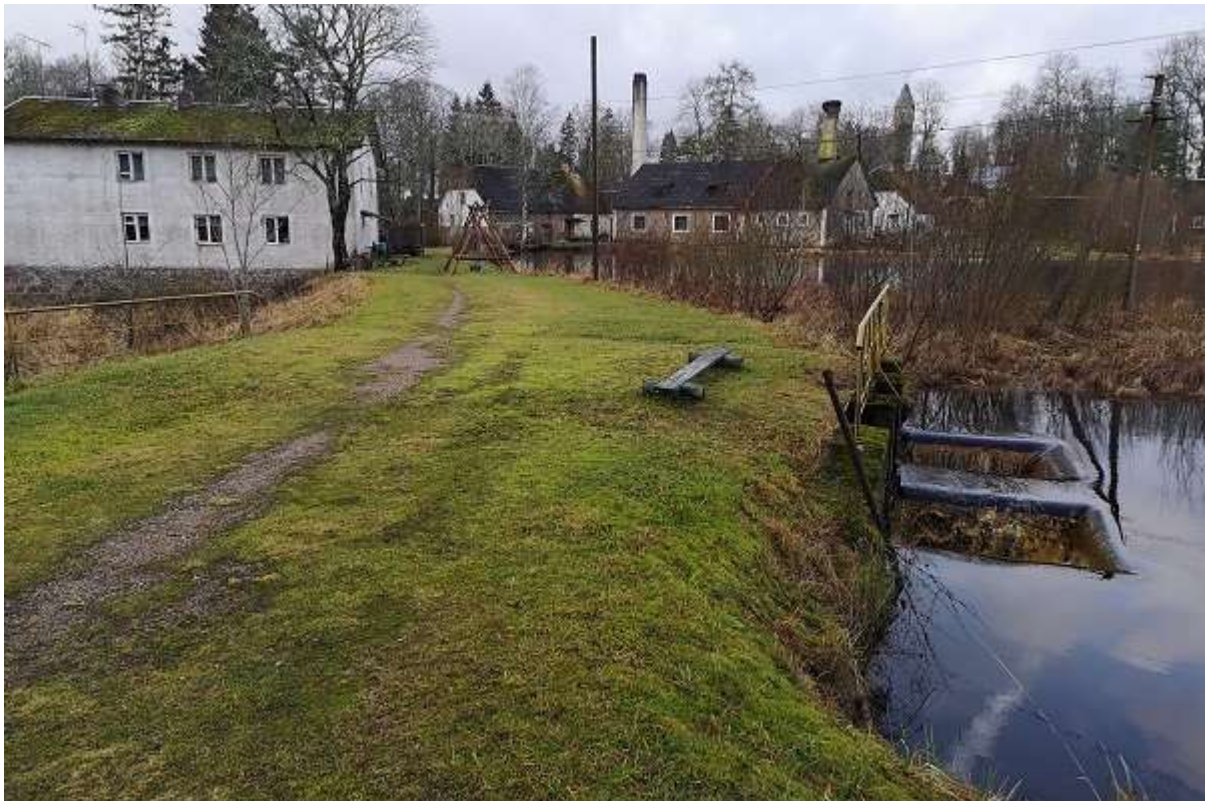
Foto 24. Taagepera paisu liigveelaskmeks on kaheosaline šahtkaev (R. Järvekülg, 08.12.2019).

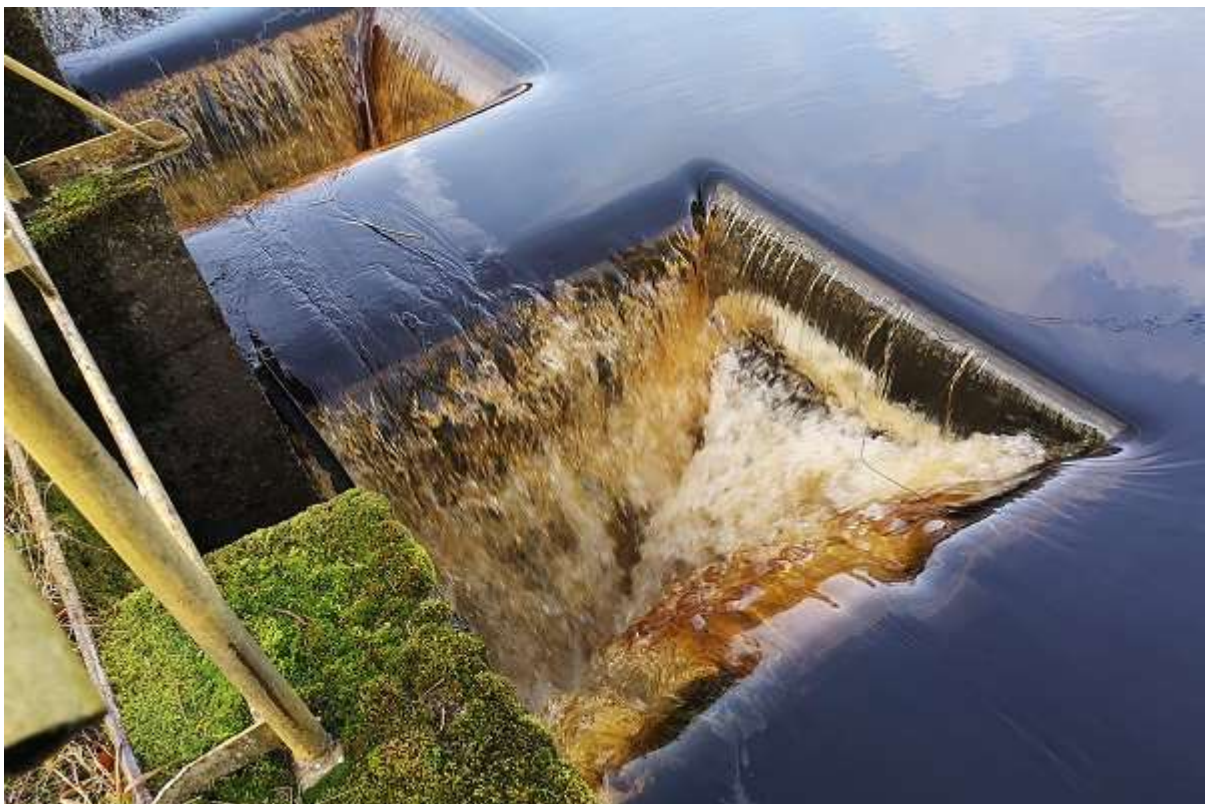
Foto 25. Vaade šahtkaevude sissevooludele (R. Järvekülg, 08.12.2019).

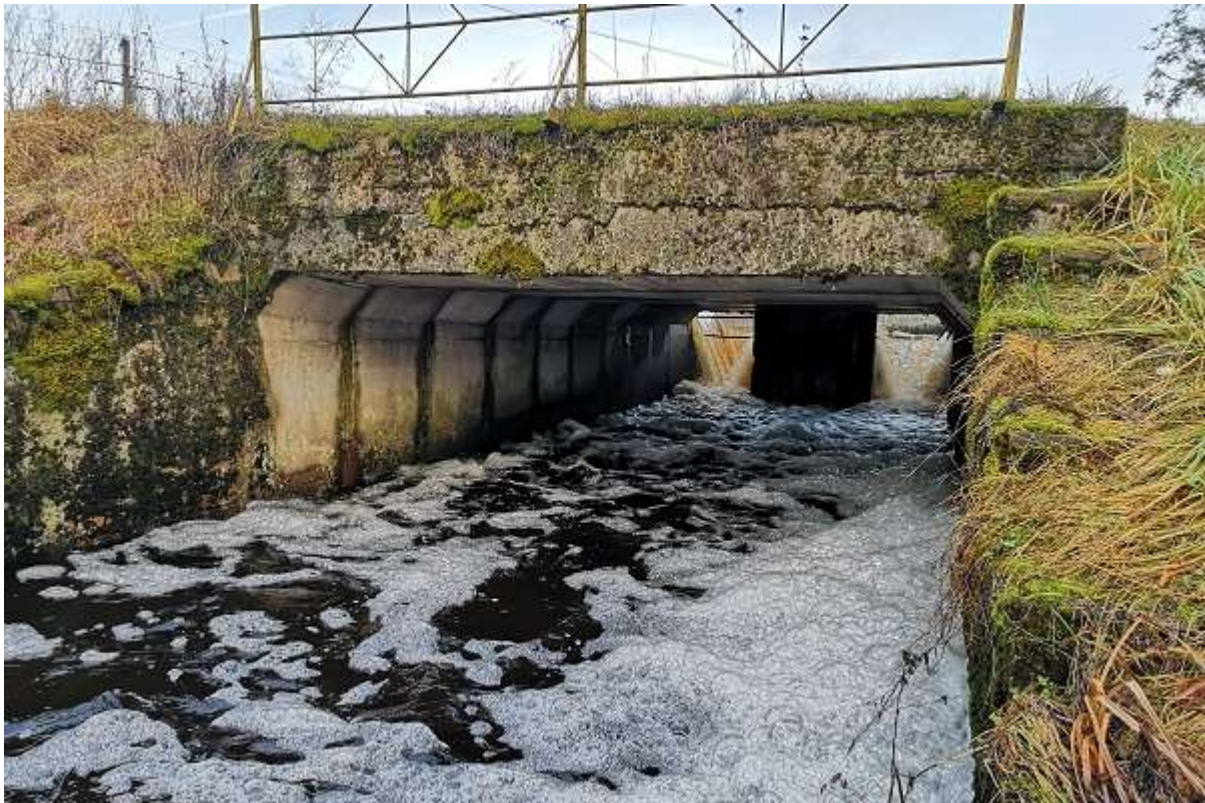
Foto 26. Vaade liigveelaskmele alavee poolt (R. Järvekülg, 08.12.2019).
