**Project „Water bodies without borders” (EstLat 66)**

## **ACTION PLAN**

# **Pressures and impacts on water quality, economical analysis and programme of measures**

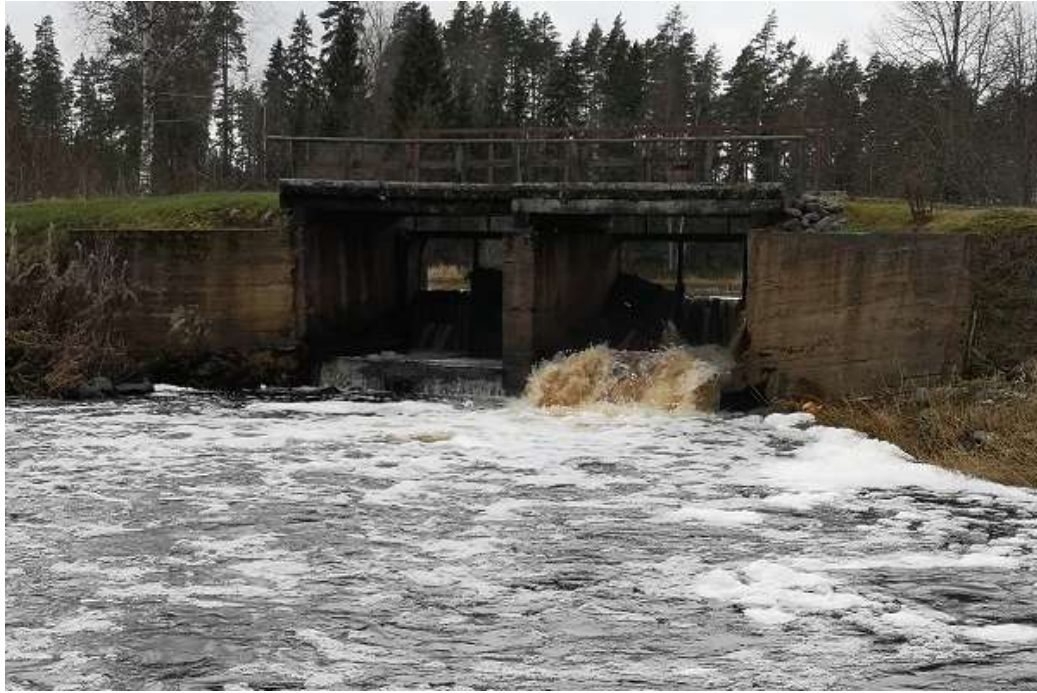
Photo 18. Dzirnavas dam's water level is raised by *ca* 2,1 meters. During high water some of the stoplogs are removed and therefore the expansion level is lower. On the day of the observation only the left excess water outlet was partly open which is achieved by removal of the stoplogs. Dam's owner is concerned with the unexpected openings of the Holdre dam, after which there is a risk of flooding in the Dzirnavas dam (R. Järvekülg, 08.12.2019).
