# SURFACE WATER STATUS ASSESSMENT ESTONIA 2016 WAY FORWARD?

### Surface water status 2016 assessment

• 2016. a status assessment – Estonia

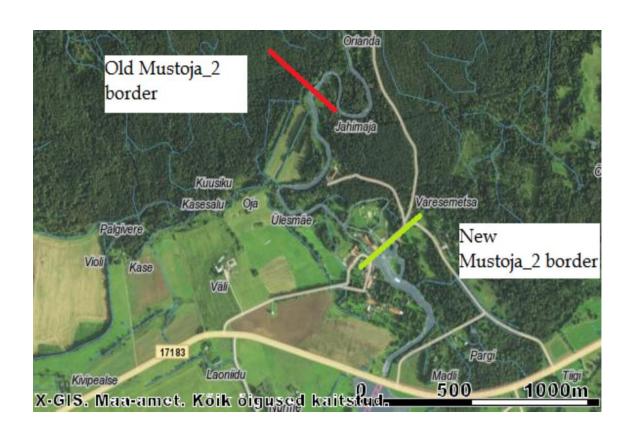
### River Mustoja at Vihula manor - important sea trout river

- One dam (red line) removed –
   6,7 km habitat is at GES for fish
- Vihula dam (green line) cannot be removed — landscape, wider environment, rural employment
- Vihula dam fishpass ? no feasible solution with significant positive impact to fish

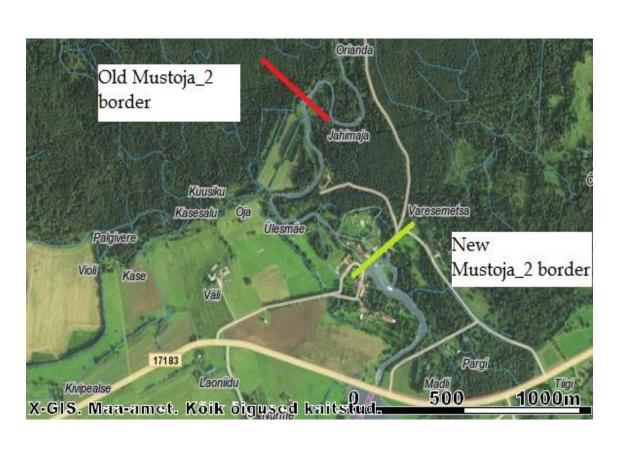
# Impact on wider environment, use and technical infeasibility – River Mustoja at Vihula manor

- Mustoja\_1 GES has SAEoE

(wider environment –cultural heritage, rural employment)
- Mustoja\_1 GES has SAEoU (recreational use)
- \* Fishpass in Vihula II infeasible
- \*Change the border of HMWB

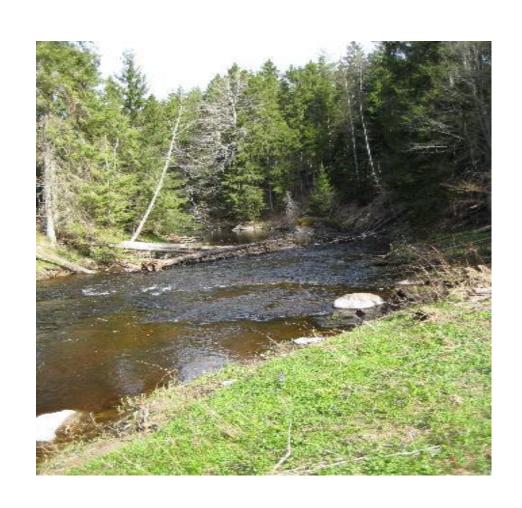
### River Mustoja natural part WB Mustoja\_2

6,7 km from the sea
Natural WB
GES is achieved
at all biological quality elements

Measures – remove beaver dams

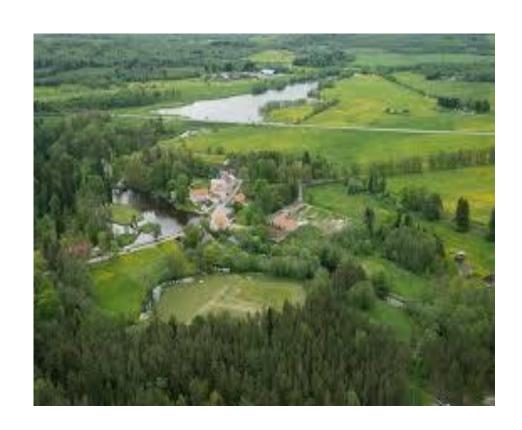
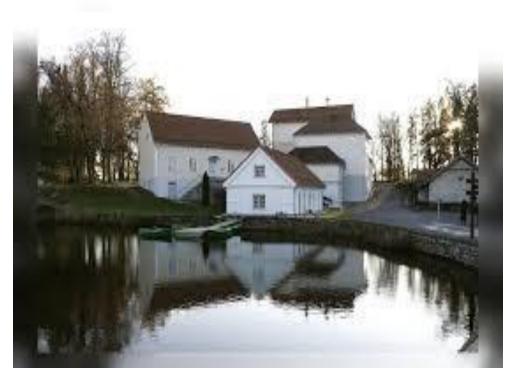
# River Mustoja WB Mustoja \_1 - heavily modified WB upstream from Vihula manor dam (Vihula II)

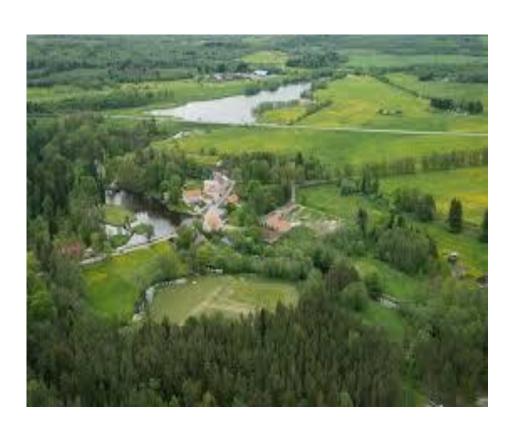
# River Mustoja WB Mustoja \_1 (heavily modified water body for fish) 36,54 km

- GES Fish is impossible GEP is possible
- SAEoE (wider environment –cultural heritage, rural employment)
   SAEoU (recreational use)
- Measures for Mustoja \_1 GEP
- regular removal of sediments, higher plants from impoundments;
- natural buffer zones at field areas,
- stones and gravel to the drainage system for ecosystem diversity

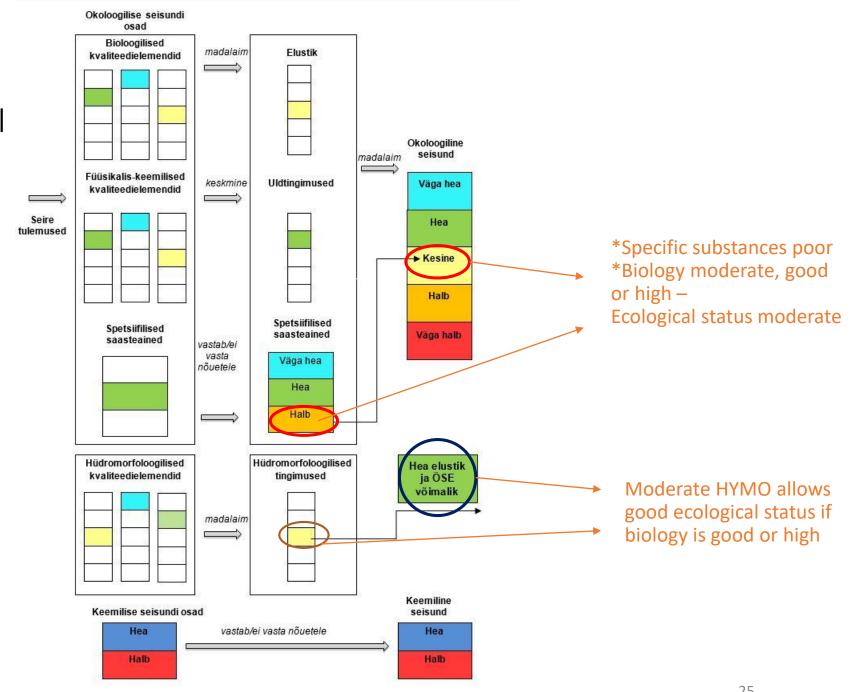
### Correction of combination rules 2017 I

Combination rules of Specific substances to generate Esological Status

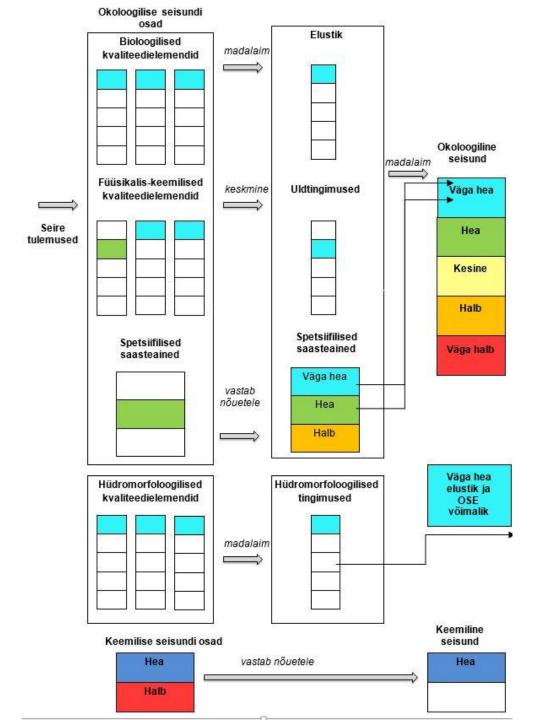
# Correction of combination rules 2017 II

For HIGH ecological status

- \*high biology,
- \*good or high specific substances and
- \*high HYMO is obligatory

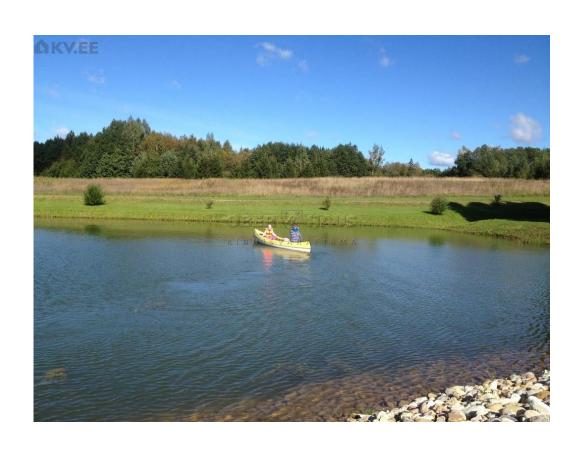
### Visela-Punde impounded WB at Visela river

- Fish farming
- Recreation
- Landscapes
- Upstream part unimportant fish habitat

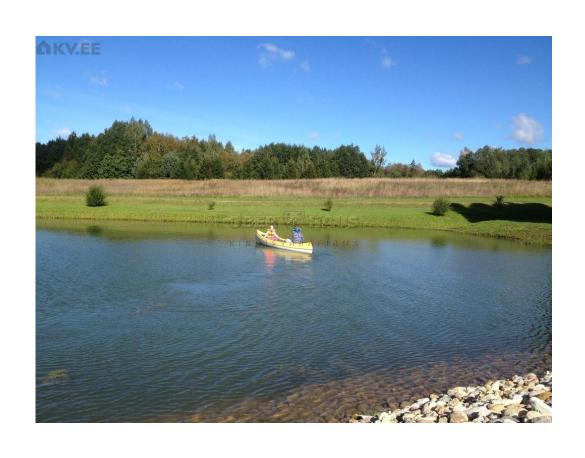
#### Visela-Punde impounded WB at Visela river

- ca 10 km from river mouth (Väike Emajõgi) 85 km from lake Võrtsjärv
- 10 km Natural WB Visela 2
- 9,5 km heavily modified WB Visela\_1

(ponded part 7,8 km + small stretch unimportant to fish 1,7 km)

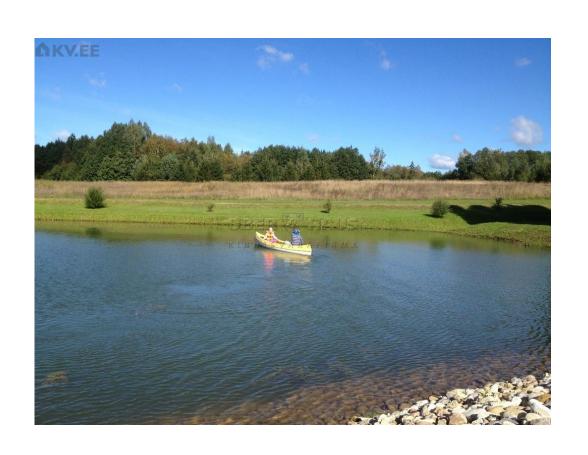
#### Visela-Punde impounded WB at Visela river GEP is achieved

- HYMO status poor
- Water quality -high
- Benthic diatomes -high
- Macrophytes –good
- Macroinverts –moderate
- Fish moderate (at stretch with naturally low quality for Fish)

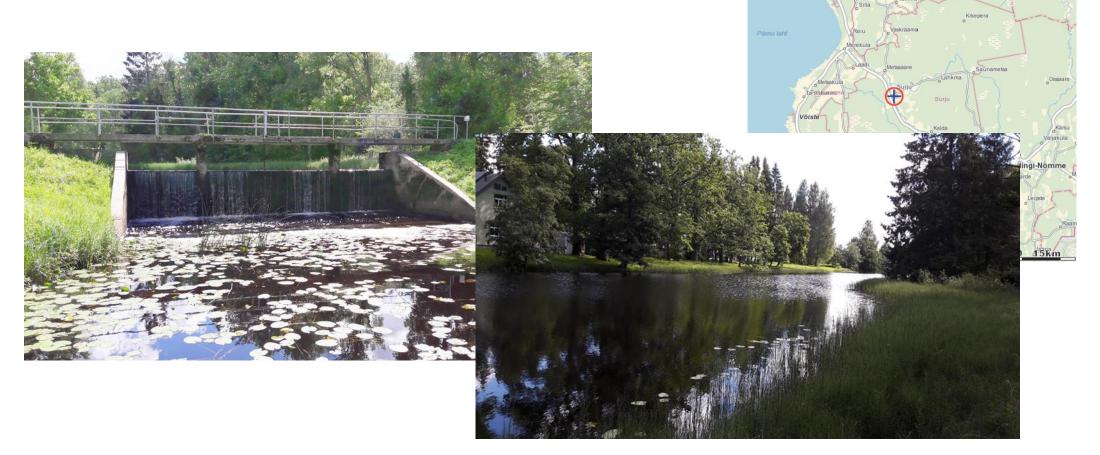
Surju impoundment at Surju stream (natural WB) 15 m from river mouth, total length 18 km, catchment 49 km2

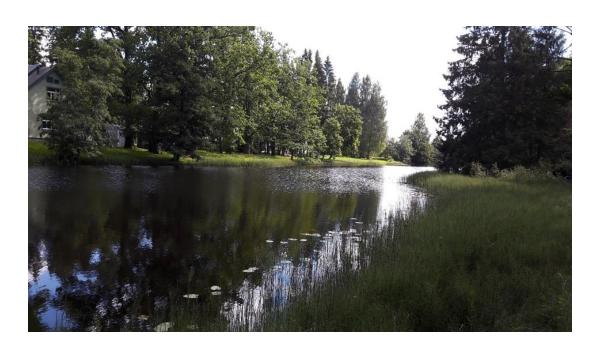
Surju impoundment at Surju stream (Natural WB) 15 m from river mouth, total length 18 km, catchment 49 km2

- Recreational use, landscapes
- Unimportant fish habitat
- Dam removal could damage landscape (SAEoE), bathing possibilities (SAEoU)
- Fish pass do not bring significant fish improvement

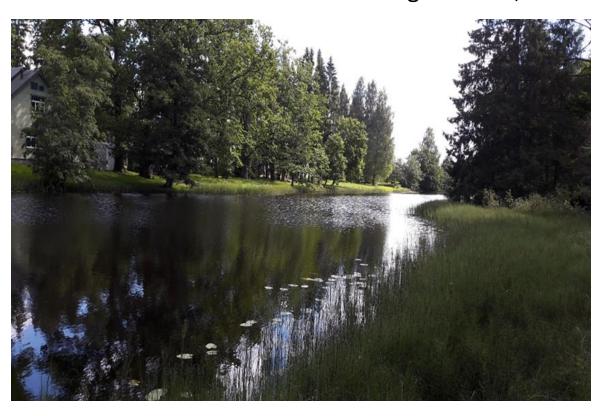
Surju impoundment at Surju streem (natural WB) 15 m from river mouth, total length 18 km, catchment 49 km2

- HYMO status poor
- Modelled water quality high
- Pressure group 2 very low pressure to water, dams
- Expert opinion unimportant Fish habitat
- Water permit no fishpass

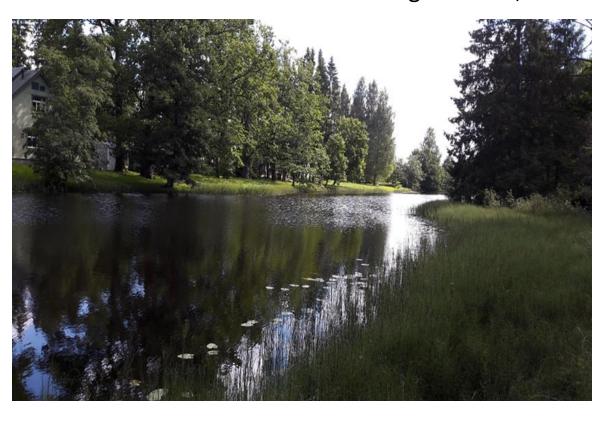
Surju impoundment at Surju stretch 15 m from river mouth, total length 18 km, catchment 49 km2

- Design as HMWB
- Main uses landscape, recreation
- Decision for III rd RMBP
- GEP is gained
- Moderate ES == Good EP
- Fish do not need achieve GES

sampling necessary at
   wadeable part
