SURFACE WATER QUALITY AND PRESSURE ASSESSMENT IN GAUJA/KOIVA AND SALACA/SALATSI RIVER BASIN, POTENTIAL MEASURES

FINAL SEMINAR

PARNU, ESTONIA, 26.02.2020.

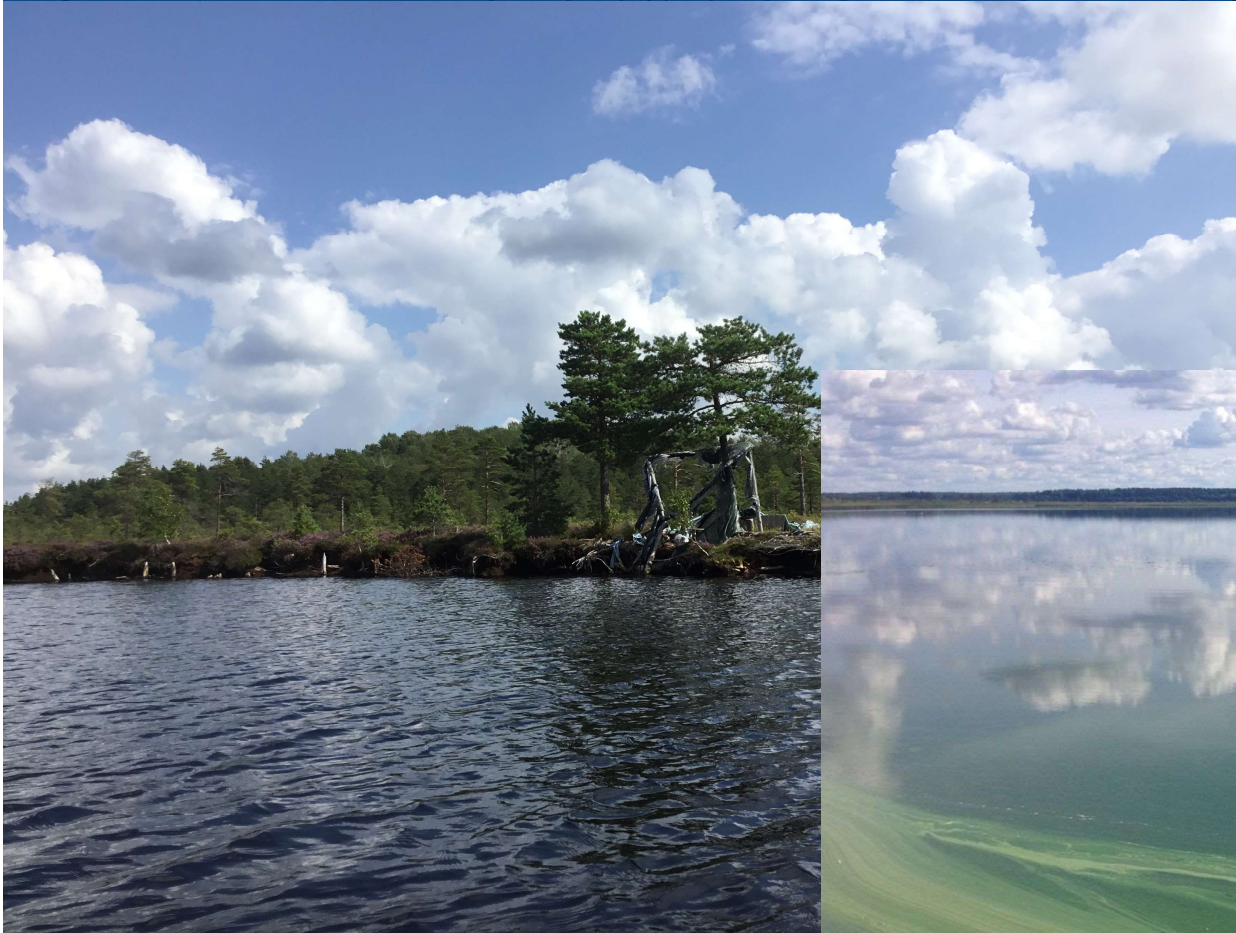
Natural, dystrophic
Lake Sokas

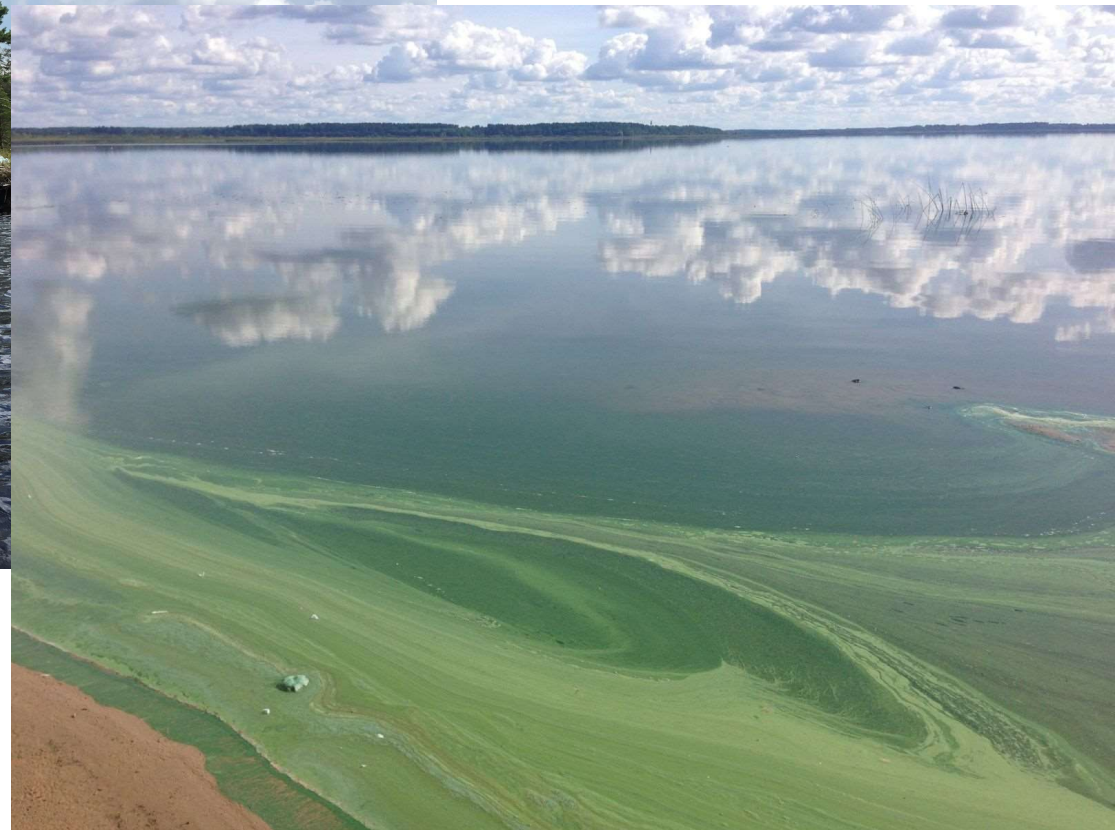
Hypereutrophic
Lake Burtnieku

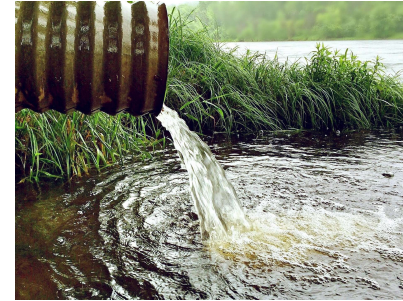
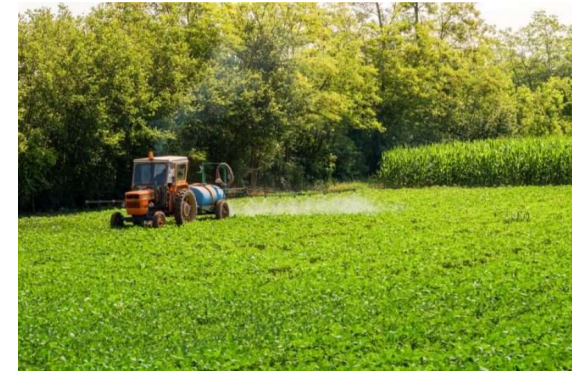
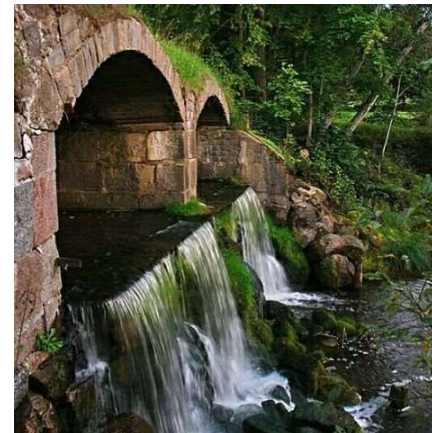
- Point source impact – wastewater treatment plants;
- Diffuse source impact – agricultural, forestry areas;
- Hydromorphological alterations – small hydropower plants, dams, drainage, culverts

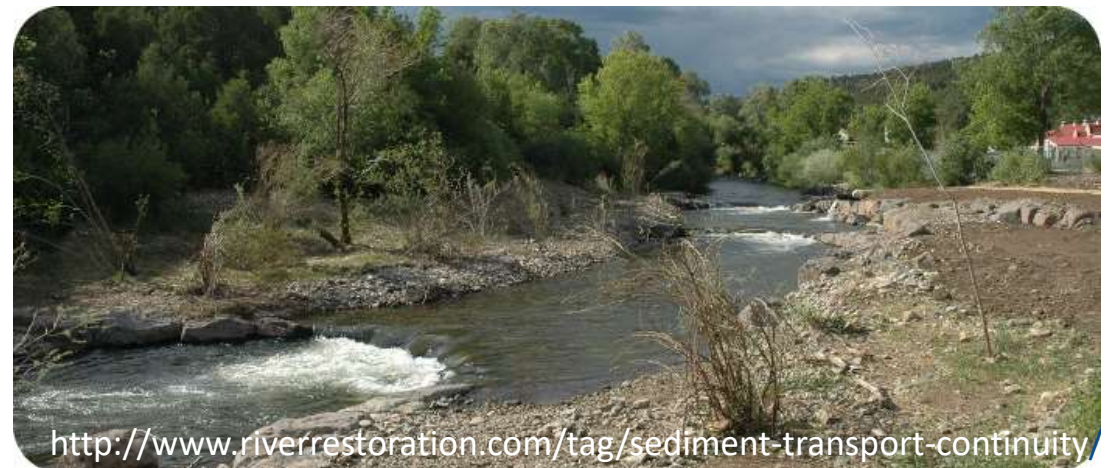
- Changes in natural flow regime;
- Interruption of river continuity;
- Decrease of water quality status;
- Disturbs fish migration, spawning, decrease available biotopes for fish;
- Decrease biological diversity;
- Decrease area of valuable biotopes.

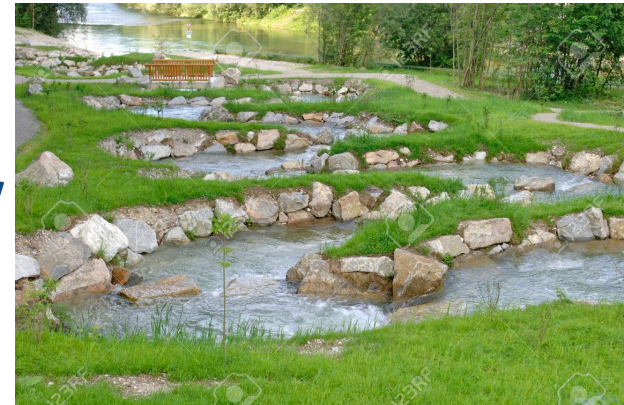
(P1) obstacle
(P2) rapids
(P3) E-flow

- Demolishing of dam
- Building of a fish pass
- Reconstruction or improvement of an existing fish pass
- Maintenance of an existing fish pass
- Environmentally friendly turbine
- Implementation of ecological flow
- Permanently lowering a dam
- Opening migration way during spawning period

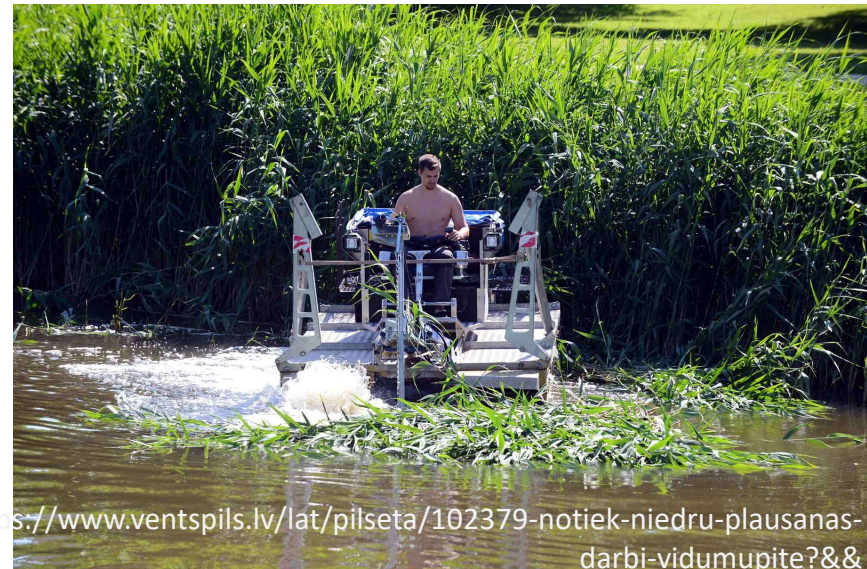
Lakes with accumulated nutrient pollution in sediments:

- Parameters for measuring «gap»:
 - (P1) Phosphorus amount (concentration) in water
- Measures:
 - Sediment dredging
 - Removal of macrophytes
 - Immobilization of phosphorus using chemical treatment
 - Artificial aeration and mixing
 - Biomanipulation
 - Hypolimnetic withdrawal
 - Artificial floating wetlands
