Joint action plan of measures for Gauja/Koiva and Salaca/Salatsi river basins

Transboundary waterbodies

Small HPP-s causing hydromorphological pressures

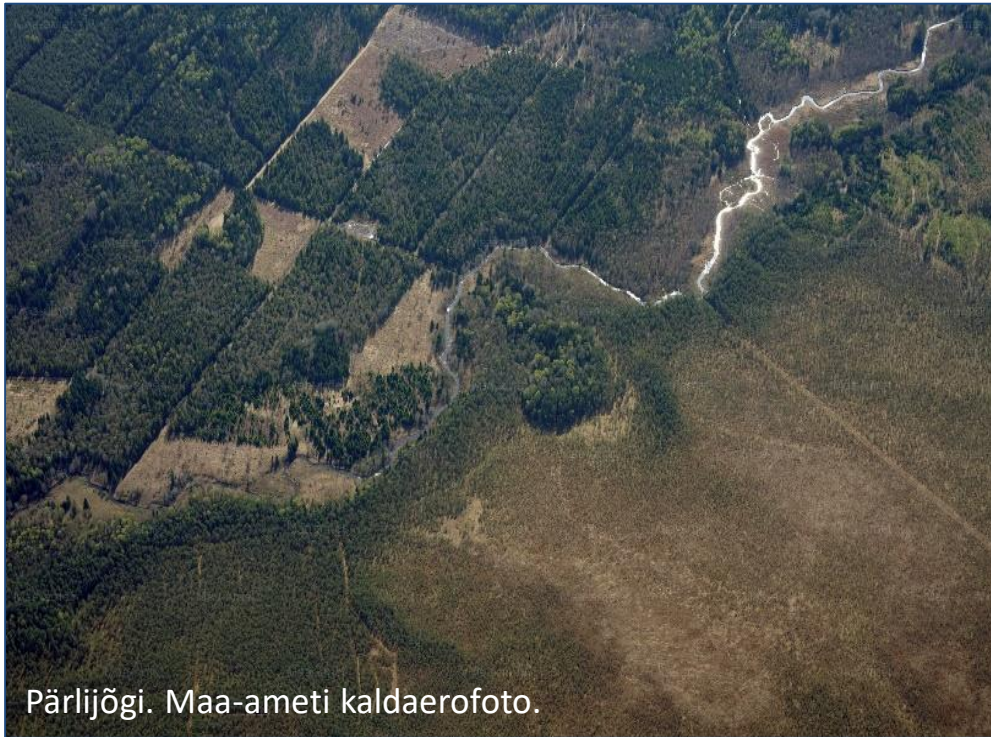
Pärlijõgi. Maa-ameti kaldaerofoto.

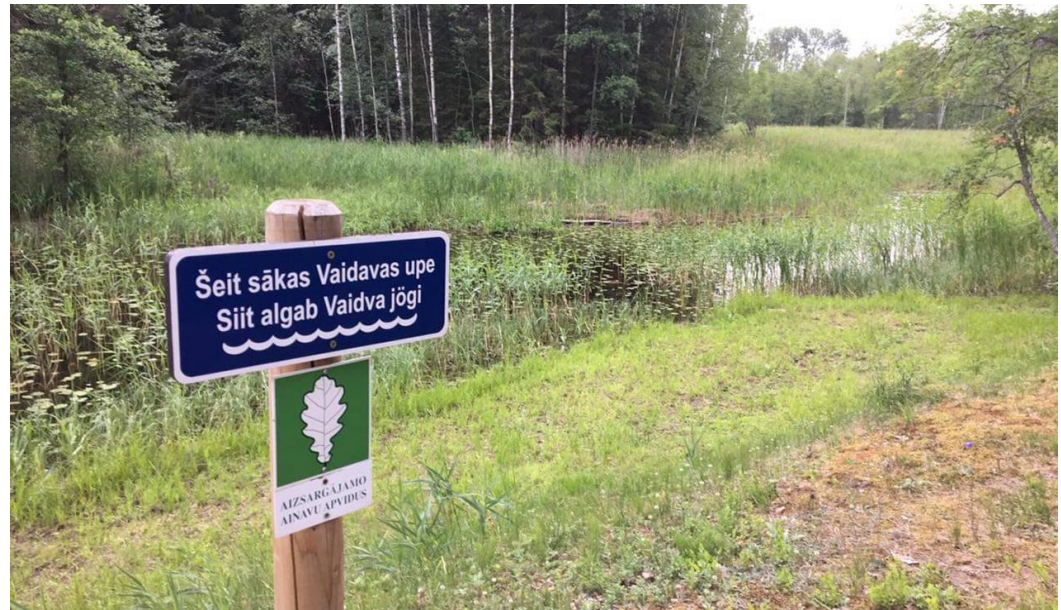
Vaidava_1 at the source (near lake Murati, 2019).
