Project Water Bodies Without Borders (EstLat 66)

JOINT MONITORING PROGRAM FOR KOIVA/GAUJA AND SALATSI/SALACA RIVER BASIN

**Activity T3. Joint monitoring program for
Gauja/Koiva and Salaca/Salatsi river basins**

Annex 1 PILOT STUDY

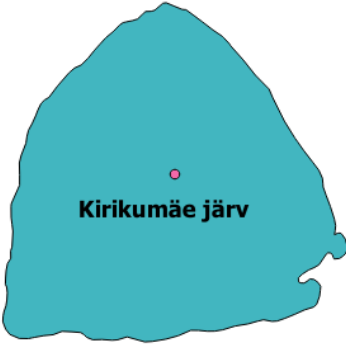
<p>Figure 3.12. Location of sampling stations from national monitoring programs</p>	<p>Figure 3.13. Transparency obtained from in-situ measurements and from Sentinel 2 data in national monitoring station</p>

The map of Lake and location of national monitoring station is shown on Fig. 3.12. Lake Kirikumäe has been classified to VRD type V. The lake water originates from the swan areas around the lake and therefore the colour of the lake is yellow and for this water class the good water transparency in 3-5 meters (table 3.1) which is more than the average mean depth of the lake (2.8 m). Lake Kirikumäe is yellow in color as the water in lake originates from swan areas surrounding the lake (Fig 3.14), therefore the reliability of the C2RCC algorithm can be low). In many satellite images we could also observe the mist or bottom reflectance on lake (3.14). From satellite images we could observe that the transparency of the lake was between 0.7-2.5 meters in national monitoring station, Secchi disk depth measured at national monitoring station in 2010 varied from 1-1.4 meter. The average transparency observed from satellite at national monitoring station showed slight increase in transparency (Fig 2) however the overall water type status class according to transparency is “boor”.

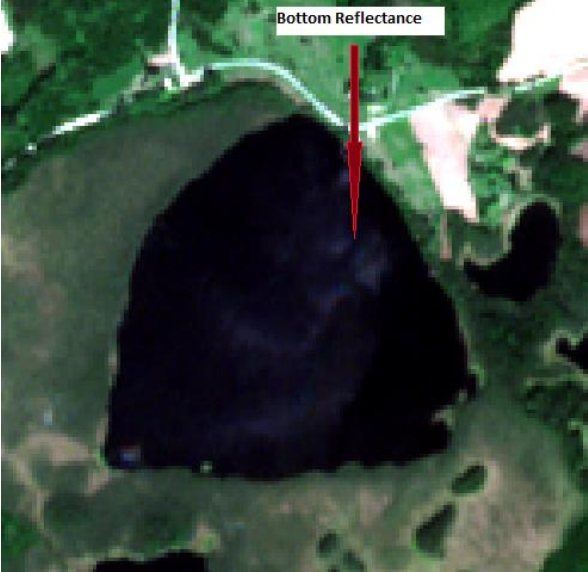
<p>Fig. 3.14. Sentinel 2 RGB image 20.05.2018</p>

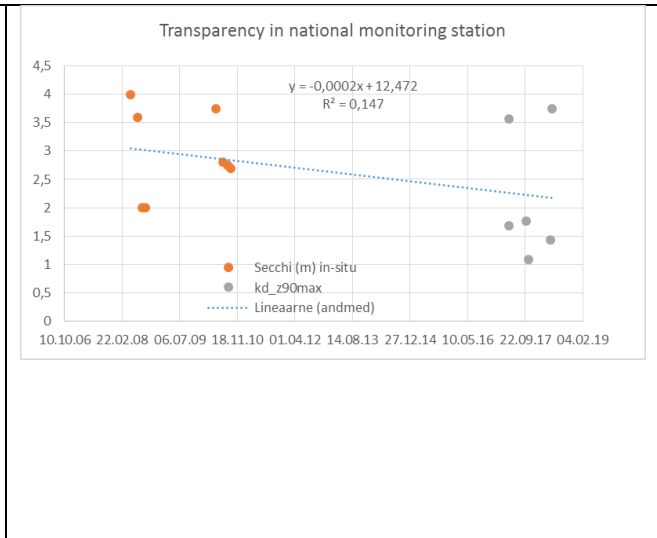
Figure 3.16. Transparency obtained from in-situ measurements and from Sentinel 2 data in national monitoring station

The map of Lake and location of national monitoring station is shown on Fig. 3.15. Lake Pulli järv has been classified to VRD type V. For this water type the good water transparency is 3-5 meters (table 3.1) been close to the average mean depth of the lake (3.8 m). From satellite imagery is seen that the lake is and later it seems very green in autumn (Fig 3.18) but on May images we often observed the mist or bottom reflectance on images (Fig. 3.17). In-situ measurements of lake water transparency (Secchi disk depth) has been performed between 8 times between the 2008 and 2010 it varied between 2.0 and 4.0 m (Fig 3.16). Satellite data showed water transparency between 1 to 3.7 meters (Fig 3.16) and there is seen slight decrease of water transparency in national monitoring station compared to in-situ measurements made in 2008 and 2010 (Fig 3.16). The transparency status at national monitoring station evaluated from satellite data in 2017 was “good” in two occasions and “boor” in 4 occasions (3.16). In average the transparency assigned in class “moderate”.

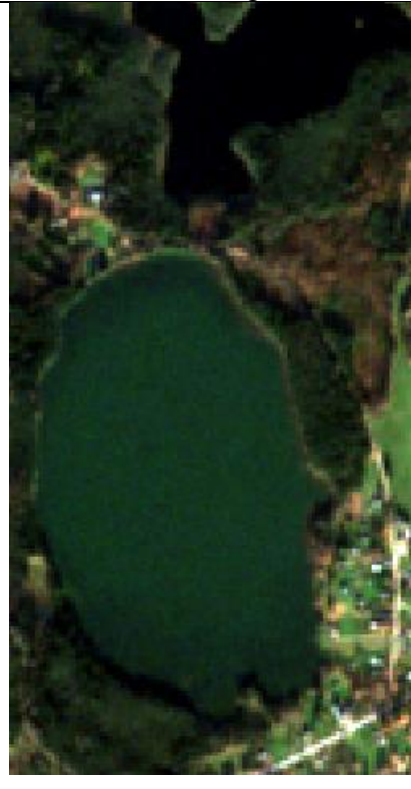
3.18. Sentinel 2 RGB image 22.10.2017

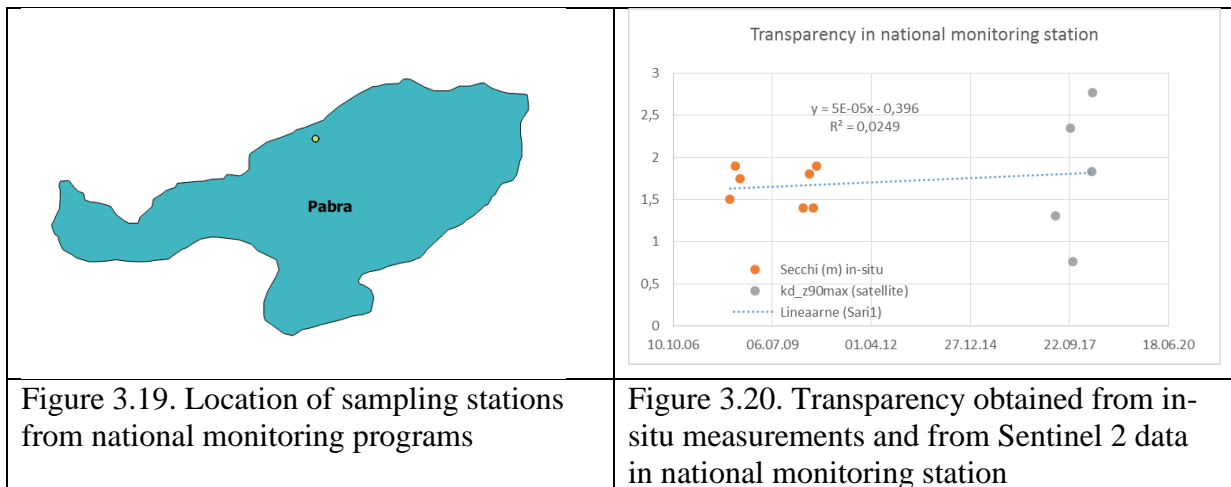
The map of lake and location of national monitoring station is shown on Fig. 3.19. Lake Pabra has been classified to VRD type V. For this water class the good water transparency is 3-5 meters (table 3.1) which is more than the average mean depth of the lake (2.8 m). On Fig 3.20 is shown Lake Pabra water transparency variations during 2008-2018. Field measurements of Secchi dick have been performed 7 times between the 2008 and 2010 and it varied between 1.4 and 1.9 m (Fig 3.20). Transparency observed from satellite data in national monitoring station

2017-2018 ranged from 0.8-2.7 m. The transparency status at national monitoring station evaluated from satellite data in 2017 was “moderate” in two occasions and “boor” in 3 occasions. According to previous in-situ measures the transparency of the water has been “boor”
