OIL SPILL Project

THE BALTIC CARRIER ACCIDENT IN DENMARK 2001

Kia Friis Petersen, Danish Civil Protection League

8 December 2020

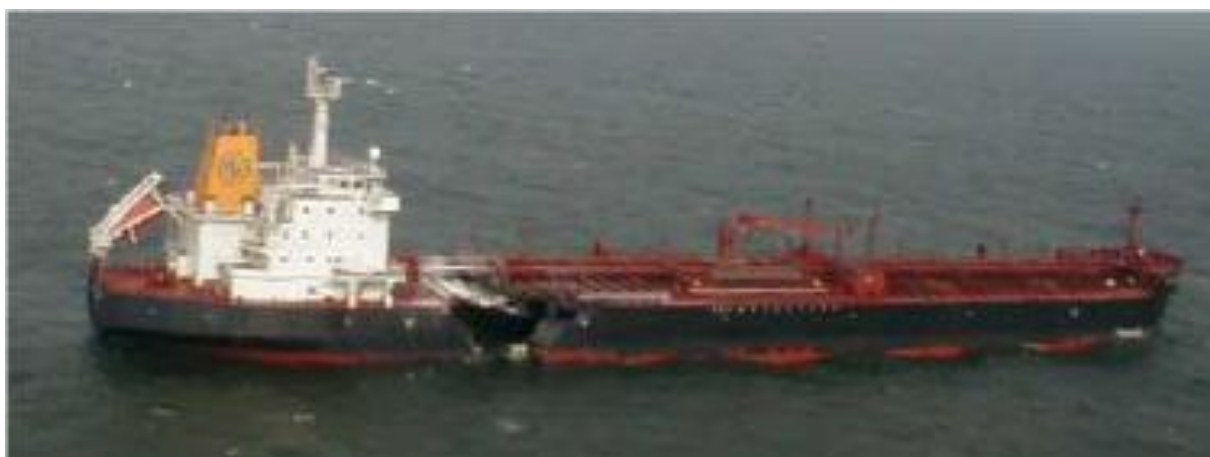
THE BALTIC CARRIER AFTER THE ACCIDENT [DEMA, DEVELOPMENT UNIT (2001). BEKÆMPELSE AF OLIEFORURENINGEN EFTER “BALTIC CARRIER” – EN TVÆRGÅENDE EVALUERING OG ERFARINGSOPSAMLING]
