Catchment area renovation instead of separate actions, success story of Hardombäcken in Loviisa, Finland

On the catchment of river Loviisanjoki was launched NUTRINFLOW-project, aiming to improve the condition of the river with catchment area renovations. The catchment of Hardombäcken was chosen to be the pilot object. It is one of the largest sub-catchments of the Loviisanjoki catchment area. There up to 60-80 hectares (about 20-25 % of the total field area) was suffering on drainage malfunction.

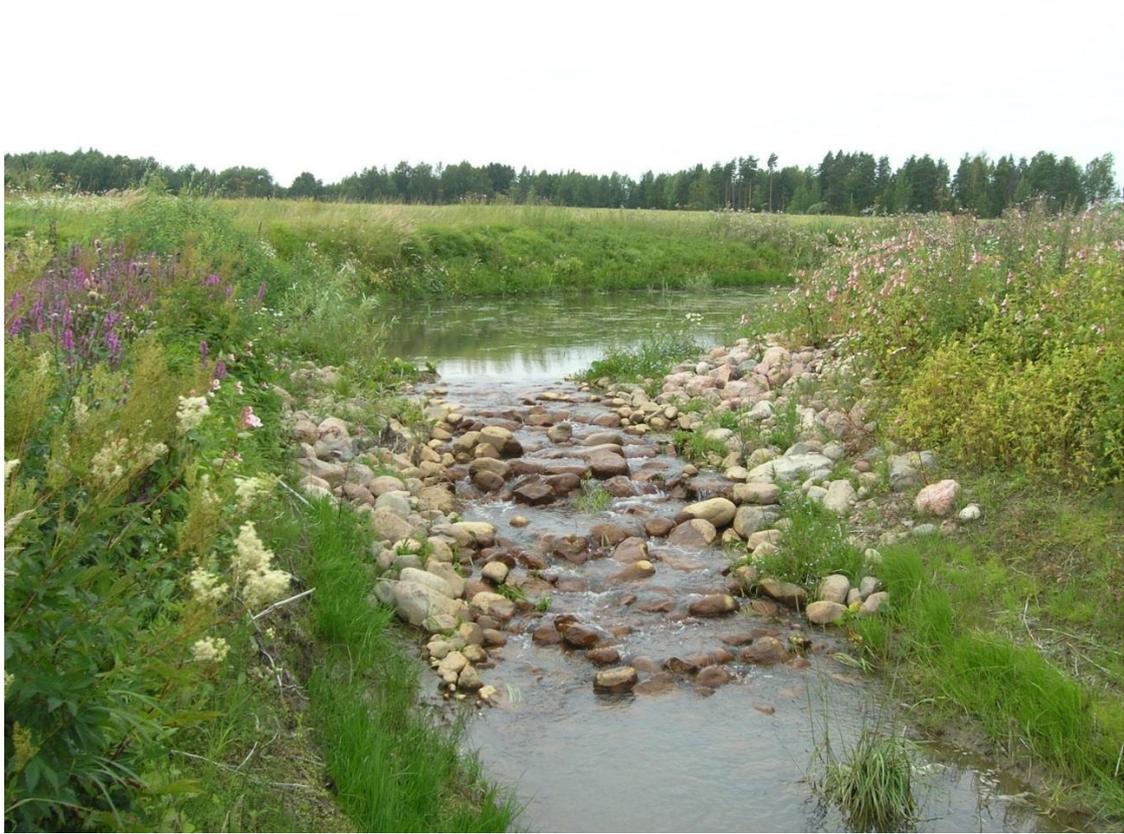
Pic.1 A bottom dam, allowing fish migration

At the Hardombäcken catchment was renovated about 10 km of the main channel, resulting water level decline up to 1,2 m. Prior to the renovation trees and bushes were cut off and to the downstream was built 100 m long flood plain section and two large sedimentation pond with bottom dams in order to catch the loading caused by the excavations. The last downstream section, 240 meters of meandering creek was left untouched. This was possible, because the field levels were sufficiently high above the water level. This downstream section might most possible be a habitat of sea trout, because the river Loviisanjoki has a natural sea trout population.

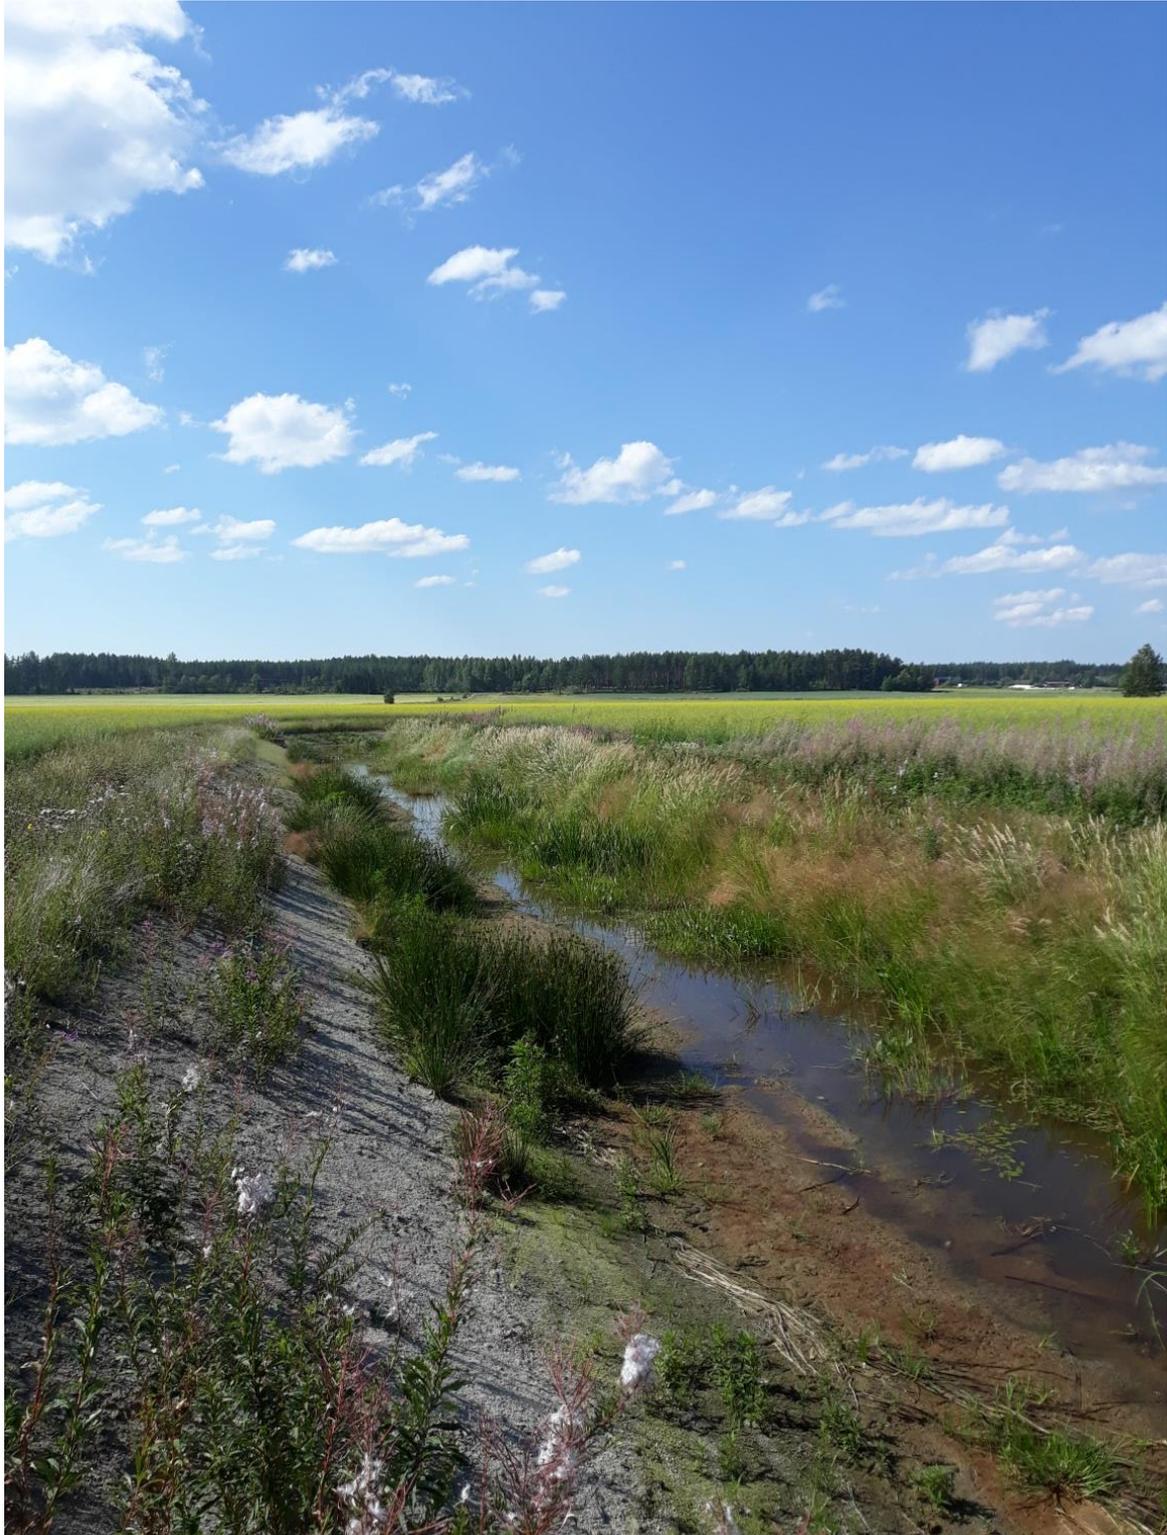
Pic. 2 A two-stage ditch, with one sided flood plain

Upstream was constructed 300 m long flood plain for better drainage of the lowest fields and for improvement of biodiversity. Water protection constructions were placed to waste land sections of the fields. Connected with the renovation was built three new culvers and renovated three old ones. The old culverts were damming the water flow, and after renewal the water level declined up to 80 cm. 658 m of open ditches flowing to Hardombäcken was transformed to subsurface tube channels.

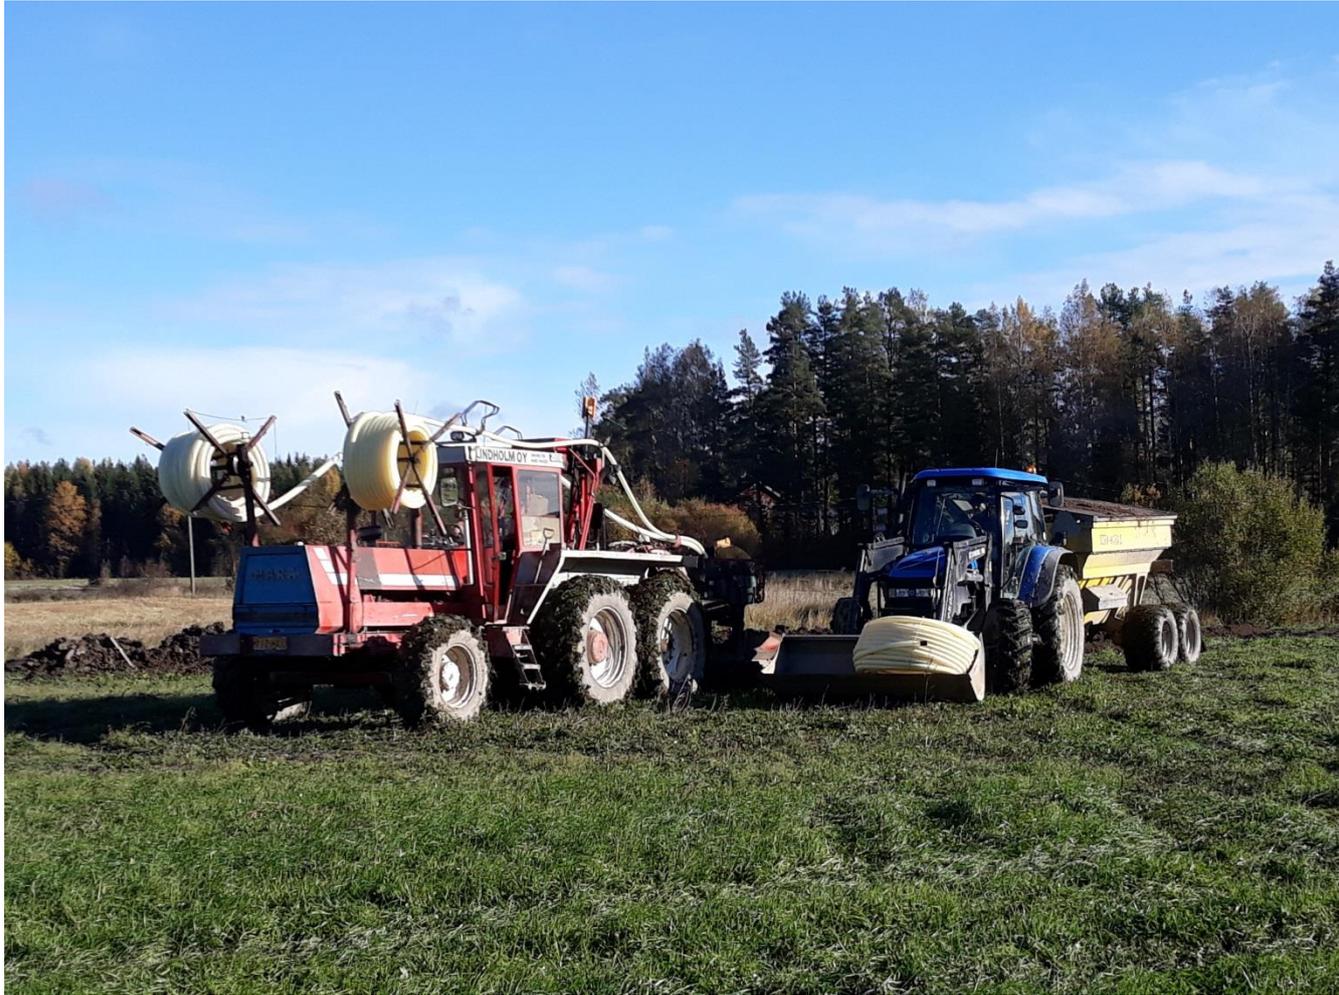
Pic. 3 Local sub surface drainage installation after renovation of the basic drainage

When the basic drainage was set into condition, it was possible to renovate the field plots which were suffering of wetness. Subsurface drainage was constructed to 21 hectares, of which 13 ha was new drainage and 8 ha supplementary drainage. Soil improvement substrates was spread to 180 ha of fields. Structural lime (Nordkalk Fostop) was spread 89 tn to 20 hectares and calcite (Nordkalk) 810 to 115 ha. Zero fiber of pulp industry (Soilfood) was spread total 1635 tn for better micro fauna and cultivation properties of soil. During the project was also constructed a 1,3 hectares multifunctional wetland to upstream of Loviisanjoki (Rutumi, Lapinjärvi).
