NORTHERN HERITAGE  
**CONFERENCE**  
05 & 06 MAY 2020

## Adapting historic places to climate change

*Proceedings of the international virtual conference  
of the project Adapt Northern Heritage*

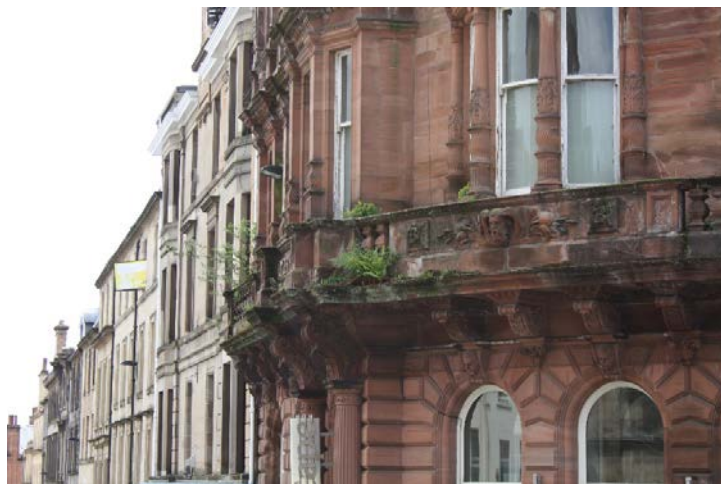
Figure 1. Many building owners ignore obvious signs of disrepair

Building owner behavior is a key contributing factor to high rates of disrepair. Many owners take a reactive approach to repairs; never thinking about or inspecting their buildings until problems arise. More serious repair issues, such as eroded chimney stacks or loose high-level masonry can go unnoticed for years as they are not easily visible or evident to building owners. Owners who do take a more proactive approach often lack the confidence and knowledge to commission the most appropriate repairs for their building and can be suspicious of contractor advice.

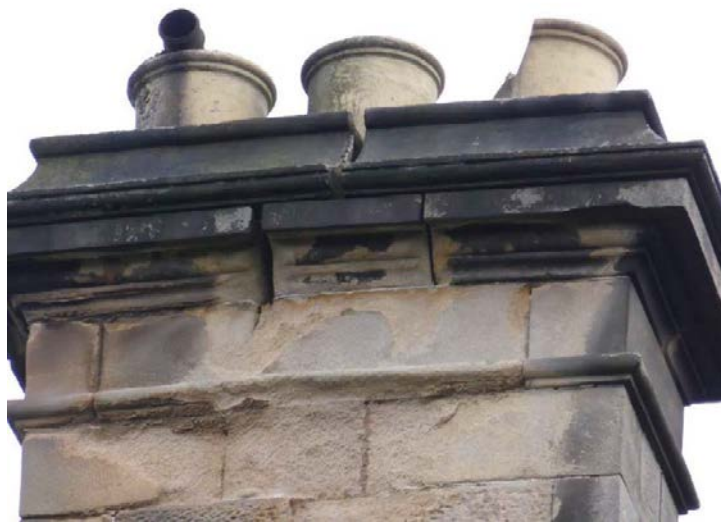
Figure 2. Serious high-level repair issues frequently go unnoticed and unchecked for years

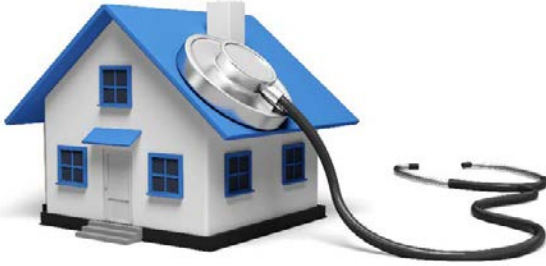
Ref	Element	Defects present & recommended repair priority

1.1.10	The part of the building in focus	Repairs, replacement or recommended investigations should be carried out at the first available opportunity and in less than 12 months. Failure to attend to these defects may cause further deterioration or damage elsewhere or create a safety hazard.	1
		Repairs, replacement or recommended investigations are required and works can be phased to make best use of resources and any access required. If not attended to these defects may be elevated to a higher priority.	2
		The condition of the building element is consistent with age. No repair or replacement is currently needed. The element should be regularly inspected and maintained as necessary to reduce the possibility of failure.	3

5.5.4	Facings	Paint to the facings on the two dormers is failing, D6 is also obscured by ivy growth. <a href="#">Pics 47, 57</a>	2
5.5.5	Windows	Most windows are replacement double glazed units. Window to the stairwell is timber sash and case, paint failure across the timber, but the timber is in fair condition. Window mastic failure and failure to the window putty. Window was not checked internally for functionality. <a href="#">Pics 62, 68, 72</a>	1

5.5.6	Doors	N/A

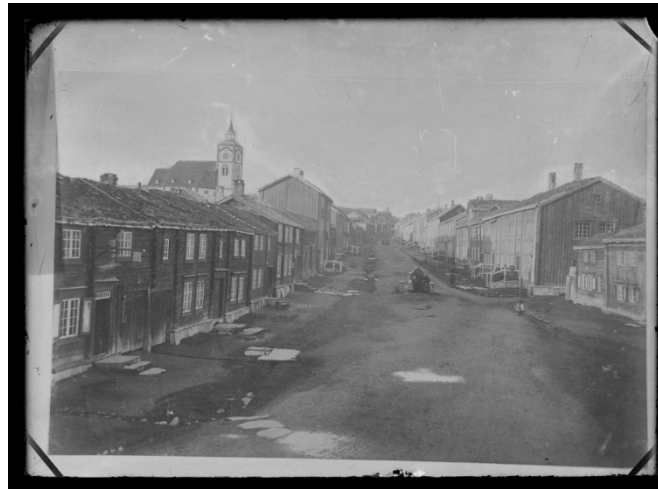
Figure 1 Røros about 1870

The Town houses are, in reality, clustered farming properties, where the main building faces the street (fig. 1). From the street a gate leads into a courtyard, where you find the different outbuildings required for animal husbandry, like stables, cowsheds and storage rooms for hay. Most of the buildings are made of wood. The residential houses and the buildings for animals, that needed insulation, were mostly timbered buildings. Other kind of storage buildings were half-timbered constructions. In the 1700s only a few buildings had panelling on the outside, but during the second half of the 19th century this became more common, especially with the introduction of the Swiss style. The traditional roof construction up to the second half of the 19th century, was sod roofing with layers of birch-bark underneath. In the late 19th century slate roofing became the most usual roof construction in the town.

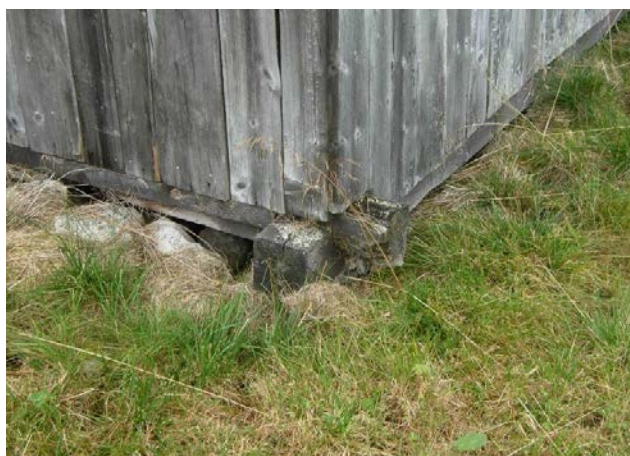
Figure 2 Damage caused by brown-rot.

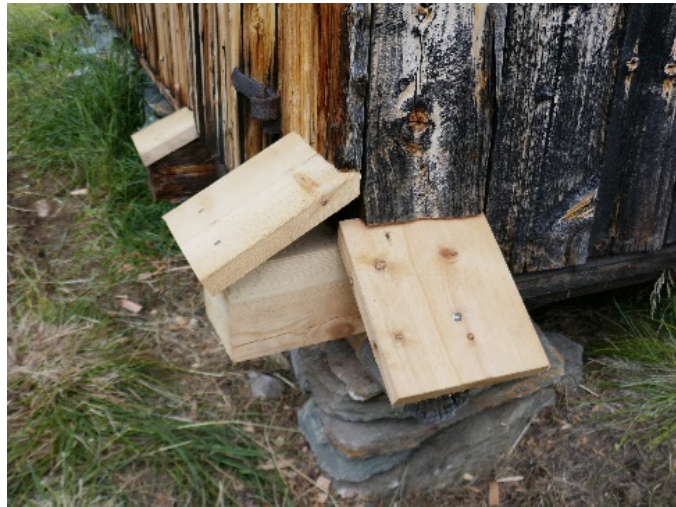
Figure 3 Solution to avoid rot damage.

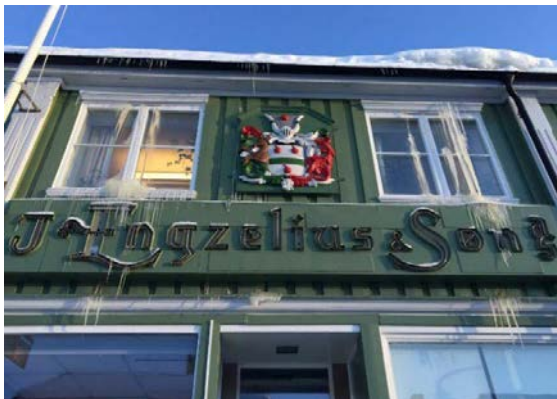
In the winter of 2018, there was discovered a huge number of icicles hanging from the roof, windows and upper parts of the wall on a building in the town (fig 4). The reason behind the problem was probably a combination of lack of enough ventilation in the roof construction, installation of a new ventilation system on the attic of the building, and a huge amount of snow melting on the roof. The solution was to extend the vents along the raft of the building to let more of the hot air to escape before coming up through the upper layers of the roof and cause the snow to melt (fig 5). The solution entailed only a small intervention in the façade of the building.

Figure 4 Icicles hanging from the roof and walls.

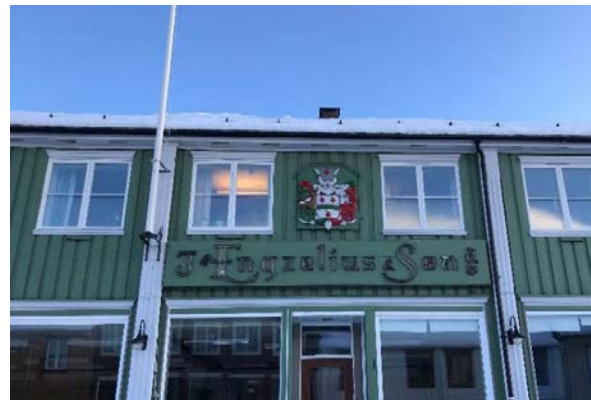
Figure 5 The vents have been extended.

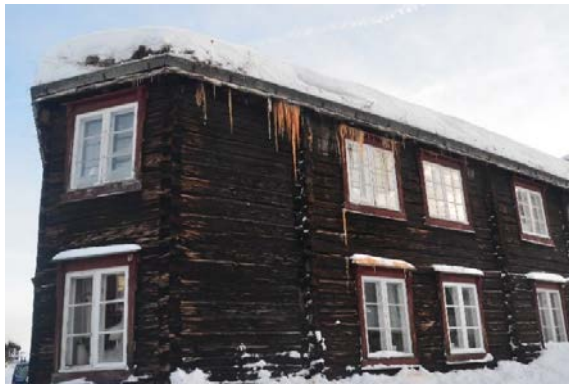
Figure 6 Icicles from the roof. Photo: Røros Museum

In 2018 there was discovered leakage from a traditional sod roof on a residential building in the town. Water was coming in through the ceiling by the walls and there were big icicles hanging from the roof (fig 6). The roof had been completely changed in 2005 and redone in the traditional way with several layers of birch-bark. The reason behind the leakage was probably hot air causing snow on the roof to melt. In 2019 the roof was repaired, and it was decided to replace the traditional roof construction with a modern form of sod roof that had been adapted to take into account the cultural heritage values of the building. The new

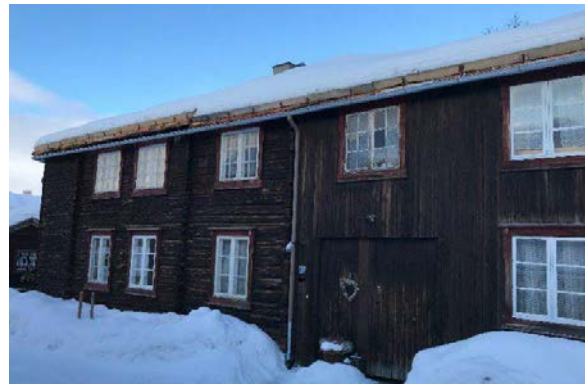
Figure 7 After restoration.

construction has a waterproof membrane instead of birch-bark and a layer of ventilation between the insulation and the membrane to get rid of the hot air from the rooms inside. The new construction seems to be working fine and it has only slightly altered the proportions of the building (fig 7).

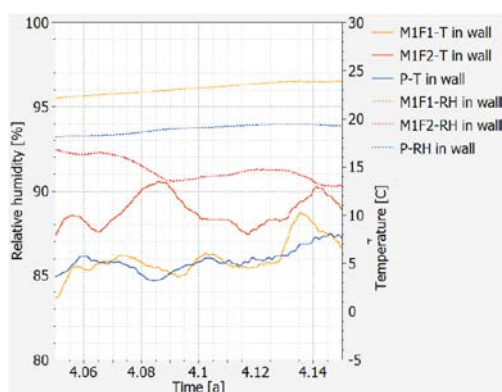
Figure 3 RH & T in retrofitted granite wall (VO) in Climate zone II during condensation period

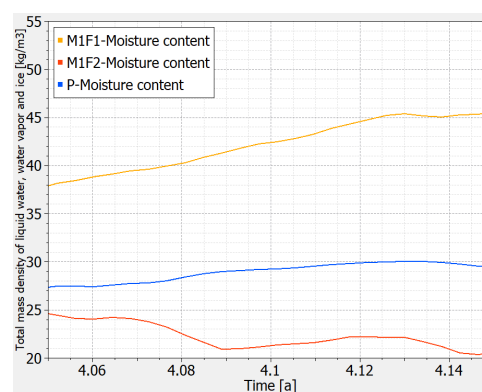
Figure 4 Moisture content in retrofitted granite wall (VO) in Climate zone II during condensation period

In Climate zone III, the RH in granite walls with a vapour-tight system remains under the critical threshold at P scenario, but it increases over time (Figure 4), and the moisture content accumulates as a consequence of the limited drying potential of the vapour-tight system (Figure 5). Although the accumulated moisture content slowly dries out in F1 and F2, the RH in wall exceeds regularly the safe threshold.

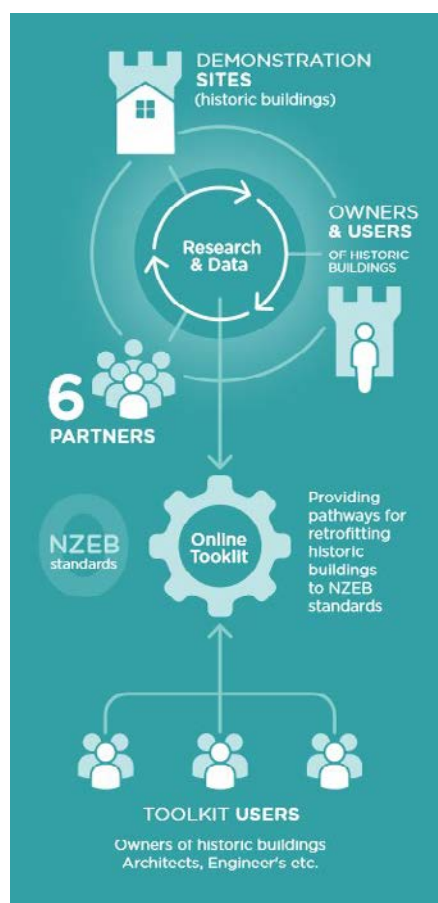
Figure 1. Diagram illustrating the components of the Energy Pathfinder Project.

owners and curators of historical buildings, through the confusing maze of techniques, technologies, principles, regulations and guidelines that must be considered when planning alterations to an historical building. The major components of the Energy Pathfinder project are illustrated in Fig. 1.

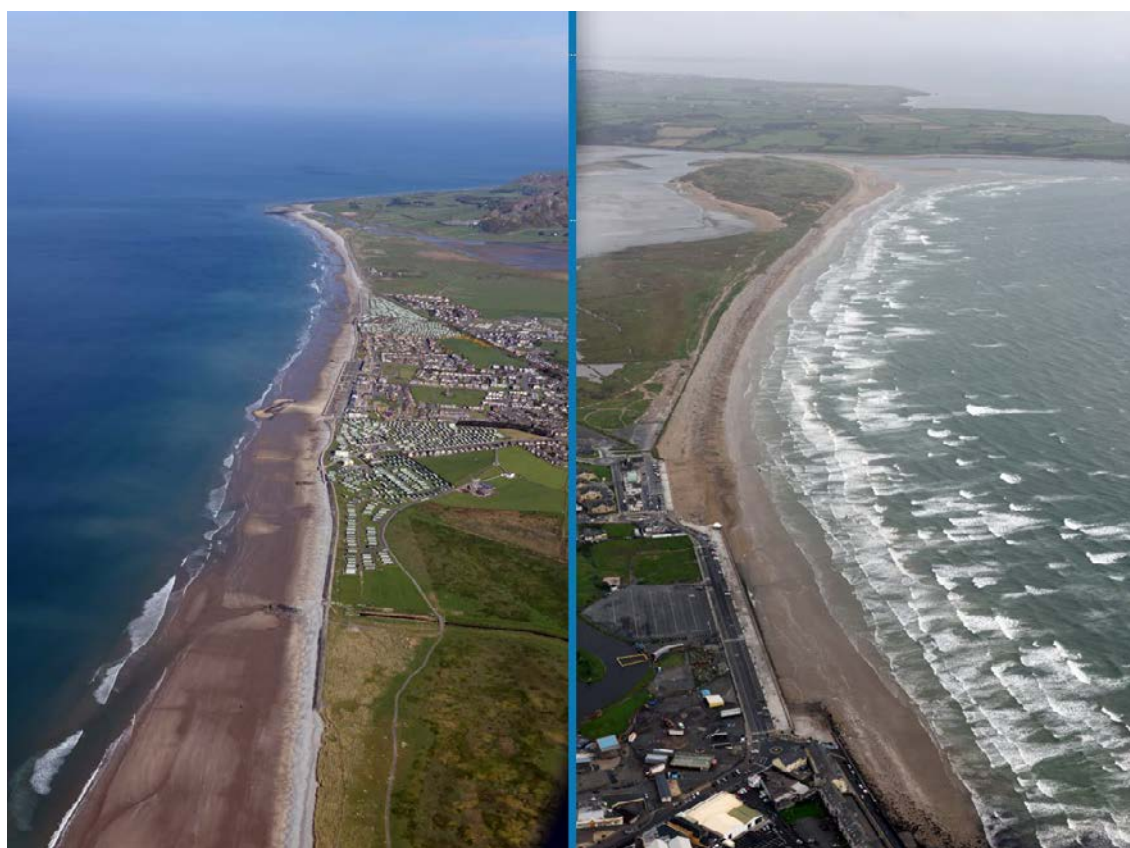
Figure 11. Baseline aerial survey over similar historic coastal resort towns with sand bars, coastal dune systems and inland lagoons in Wales and Ireland (Left) Tywyn, Gwynedd and (right) Tramore, Co. Waterford (Crown Copyright: CHERISH Project).

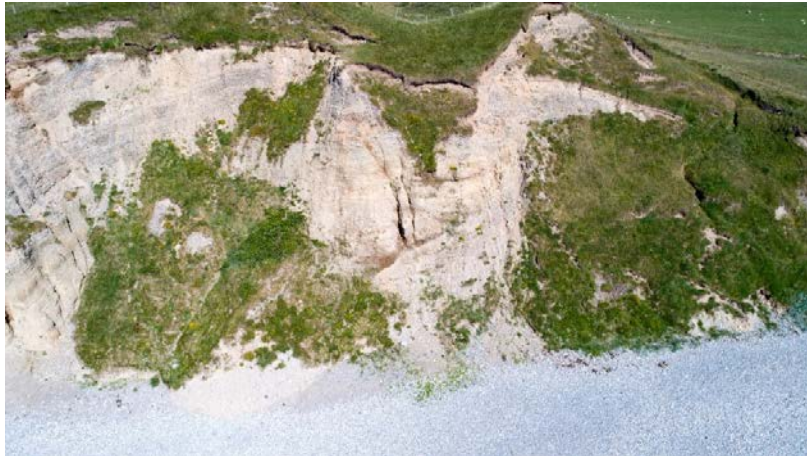
Figure 12 Dinas Dinlle. UAV images showing the cliff-face before and after the collapse in early 2019.  
Before collapse: 11 June 2018 (Crown Copyright: CHERISH Project)

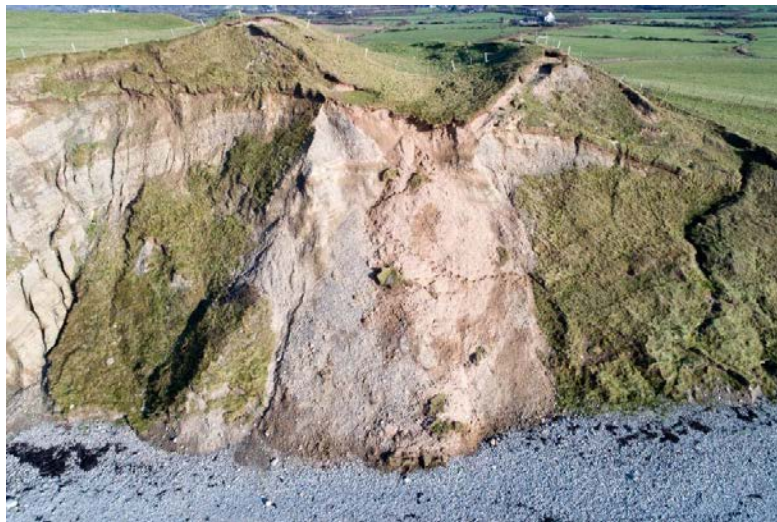
Figure 13 Dinas Dinlle. UAV images showing the cliff-face before and after the collapse in early 2019. This image taken after the collapse on 14 Feb 2019 revealed what appeared to be the clear edge / cut of the inner ditch and a previously unreported fill of sand (after Hunt et al. 2020, Figs. 9-10; Crown Copyright: CHERISH Project).

erode the softer sand sediments and leave behind a scoured 'shelf' or surface at the junction with the harder glacial sediments. Removal of the sand, which is also exacerbated by avian and mammal activity, then causes the overlying turf to slump and degrade. Rain is another pressure as water infiltrating the surface of the fort interior passes easily through the sand units but is restricted by the dense nature of the underlying glacial sediments. When saturated, particularly following periods of more intense rainfall, the water emerges from the cliff-face at the interface between the soft and hard sediments which promotes gravitational slumping and degradation of the softer sediments (Figure 6).

As with Dunbeg in Ireland it is the action of groundwater pushing off the cliff face from within, following periods of intense rainfall, which have caused at least some of the most extreme cliff erosion at these sites rather than wave action from the sea. The multidisciplinary team approach to work at Dinas Dinlle was the only way to study archaeological and geomorphological processes together; the presence of team members who have analysed similar sites and processes in Ireland has allowed specialists to compare scientific data in both nations.

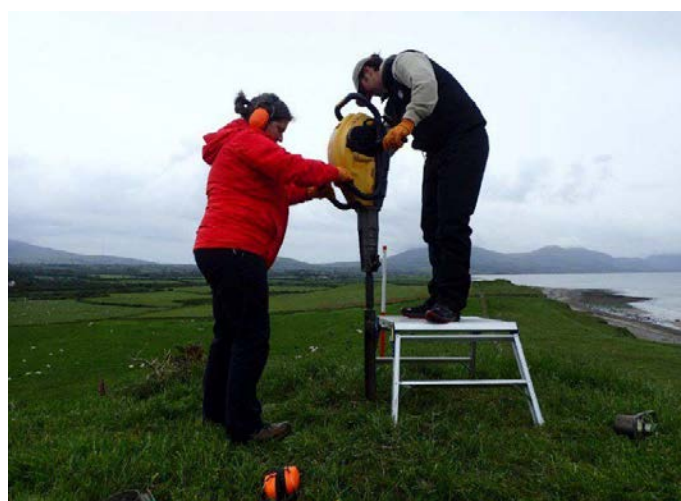
**Figure 14 Hywel Griffiths and Sarah Davies coring through the southern outer rampart (Crown Copyright: CHERISH Project).**

The investigation area was located towards the top of the cliff and comprised a 13m wide and maximum 4m deep section of vertical cliff-face. The best way to access the unstable sand and gravel cliff was via rope and harness (Figure 8). To enable the team to work in these challenging conditions they first participated in a two-day safe working at height course before employing Plas y Brenin outdoor centre in Snowdonia to supervise the rope work on site. Hand excavation by archaeologists allowed deposits to be carefully recorded, while the presence of geographers allowed the geomorphology of the cliff to be closely examined and sampled. Overlapping UAV imagery was captured to produce a Structure from Motion (SfM) 3D reconstruction and orthomosaic of the site for archiving. Five samples were also taken through the profile of the ditch from contexts for Optically Stimulated Luminescence (OSL) dating by Professor Helen Roberts (see Figure 9). The cliff-face investigation was augmented by a simultaneous core-transect of the hillfort's southern defences (Figure 7). The firm dry sediments of Dinas Dinlle are too compacted to be sampled with a hand-driven Russian or Livingstone corer, therefore an Atlas Copco Cobra percussion corer was employed. The Cobra uses a petrol driven engine to produce compressed air to hammer a 1m core barrel into the ground. The core is retrieved using a manual jacking system.

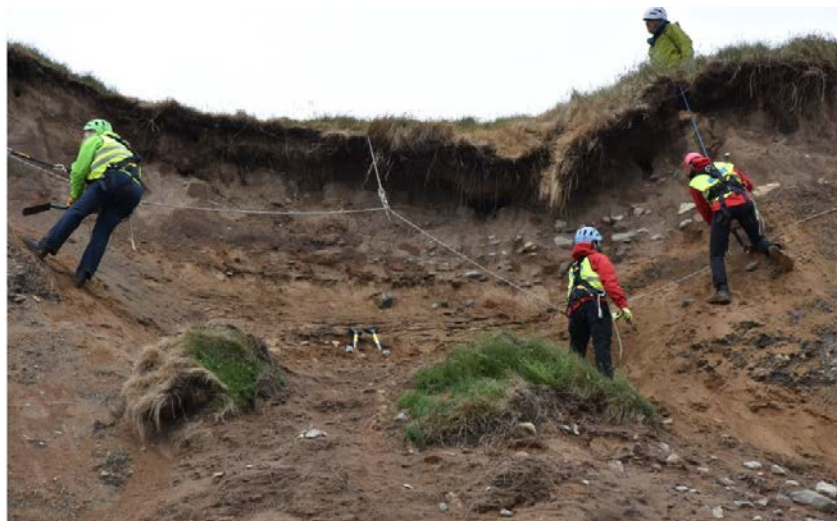
Figure 15 Using rope-access to investigate the silted ditch of Dinas Dinlle coastal promontory fort, Gwynedd, 2019. Geographers and archaeologists worked side by side in the excavation, allowing analysis both of archaeological deposits and also geomorphological and glacial processes revealed in section (Crown Copyright: CHERISH Project).

Between the 3-7 June 2019 the combined CHERISH team comprising archaeologists and geographers from the Royal Commission and Aberystwyth University undertook cliff-face investigations of archaeological and glacial deposits visible along the top of the eroding cliff-face of Dinas Dinlle coastal fort in north-west Gwynedd, and a core transect across its southern defences (Hunt *et al.*, 2020). These investigations formed part of wider archaeological and palaeoenvironmental investigations at Dinas Dinlle undertaken since 2017 by CHERISH. At such a heavily protected and designated coastal fort, the work took place with the full permission from the landowner, the National Trust, and with Scheduled Monument and Site of Special Scientific Interest (SSSI) consents from Cadw and Natural Resources Wales (NRW) respectively.

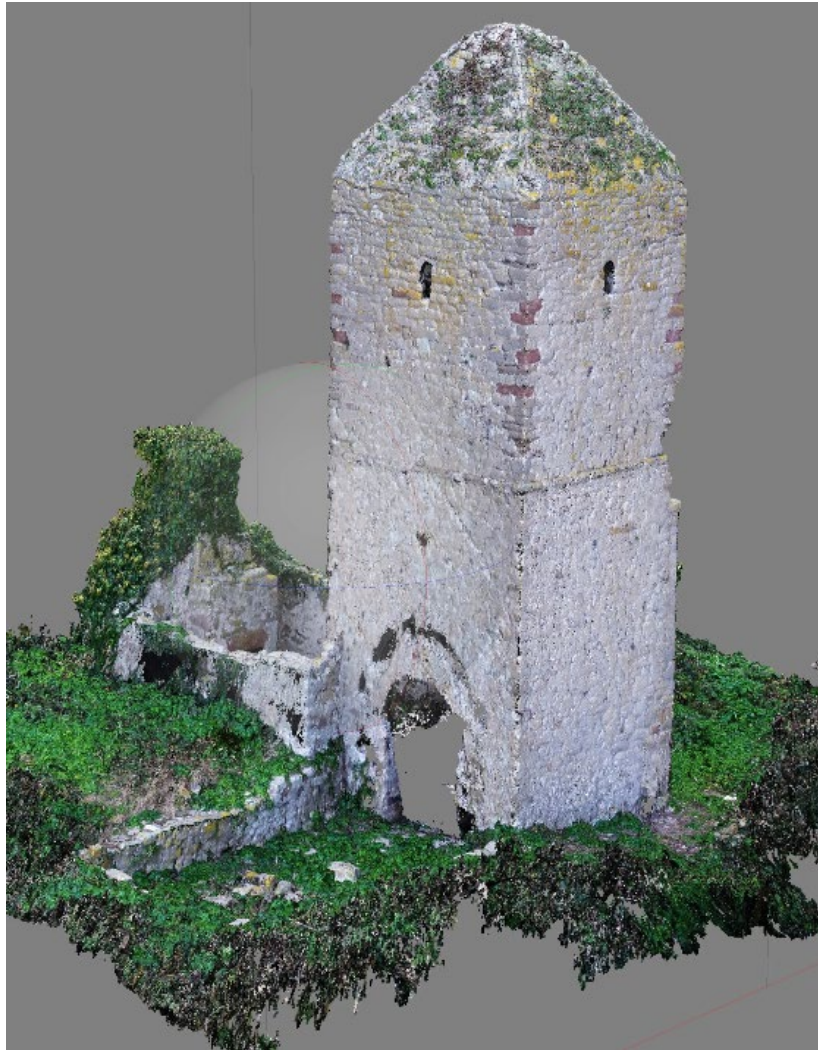
Figure 18 Puffin Island. Photogrammetric model of the twelfth century church tower seen from the north-east; dense point cloud produced using Agisoft metashape from 186 photographs flown by a UAV (Crown Copyright: CHERISH Project).

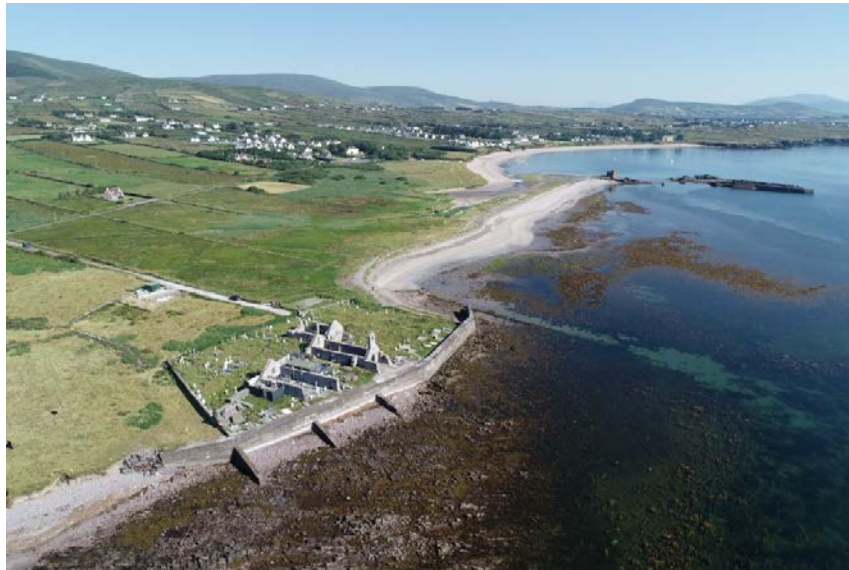
Figure 21: Unmanned Aerial Vehicle image of Ballinskelligs Abbey

In the mid-18<sup>th</sup> century, the erosion at the of the Priory is recorded as extensive (Smith, 1754, 103). The Office of Public Works (OPW) has undertaken construction of a substantial sea-wall, revetted by groynes. The first phase of seawall construction was at the turn of the 20<sup>th</sup> century. The priory buildings have been the subject of restoration projects by the OPW, which include substantial repairs and building works alongside repointing and general maintenance. In October 1962, erosion uncovered human remains on the sea-shore in front of the Priory.

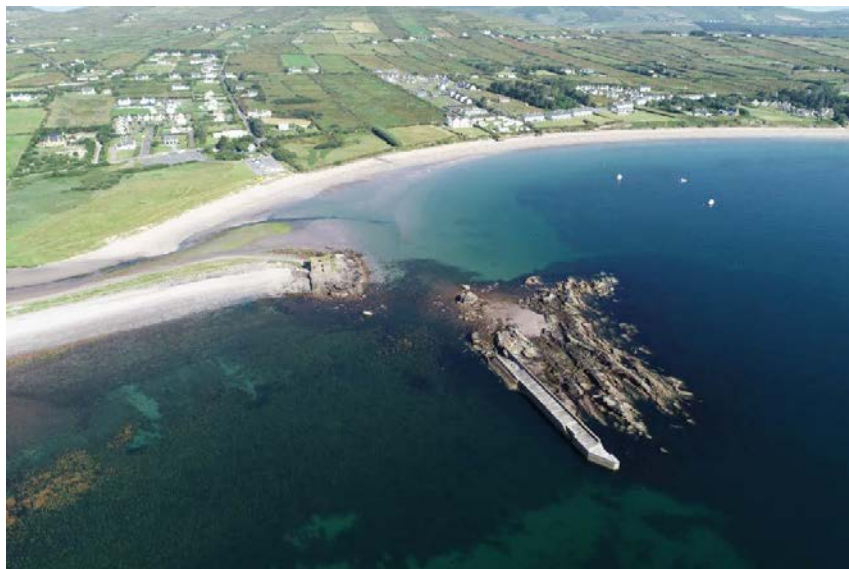
Figure 22: Unmanned Aerial Vehicle image of Ballinskelligs Castle and Harbour

(O'Sullivan & Sheehan, 1996). It may be identified as the manor that along with the Priory and associated lands were bestowed on the Sigerson family by Richard Harding in the early seventeenth century (Lynch, 1902, 352). This promontory suffers badly from erosion and has changed substantially in living memory. The tract of land that joined the 20<sup>th</sup> century concrete harbour (Fig. 3) to the Castle peninsula has been eroded resulting in the destruction of the harbour and its separation from the mainland. The harbour jutted out into the sea and its construction potentially accelerated this land erosion.

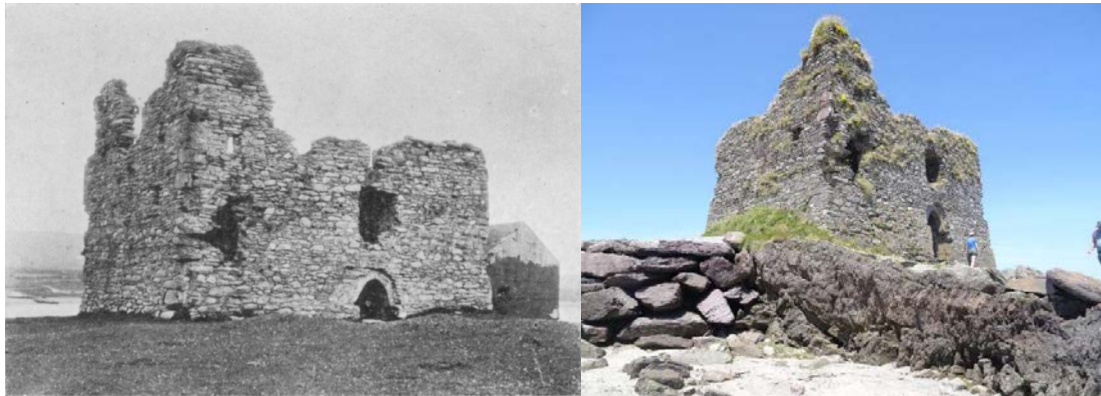
Figure 23: Left Image- Ballinskelligs Castle (Crawford, 1923); Right Image- Ballinskelligs Castle (CHERISH, 2018)

This three storey rectangular tower house rises from a battered base built on bedrock. Its walls are built of split stone laid in a strong, pebbly mortar with marine shell inclusions. The quoins, many of which are missing, are of dressed sandstone and are alternately face-bedded. At each floor level the plan of the building consists of a main chamber with an adjoining mural passageway. Access to the upper floors of the structure is gained by means of a mural stair, approached from the entrance lobby through a doorway which could be secured from within. The castle ruins remain largely intact; however, the southern corner is badly damaged with a breakthrough in the wall in this area. This is partly due to it being the location of an ope, exposure to the sea and the wall being thinner due to the mural stairs located in this corner of the tower house.

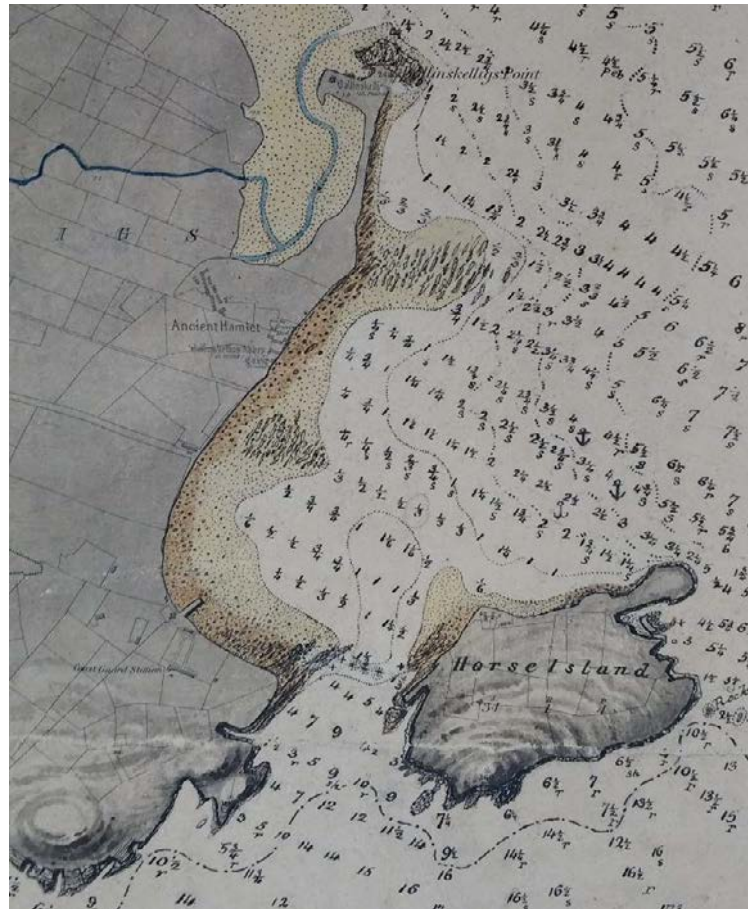
Figure 24: UKHO 1855 map showing west shore of Ballinskelligs & CHERISH sites: Ballinskelligs Priory, Castle and ancient Hamlet site are all visibly depicted on this navigational chart (© UKHO: D18460)

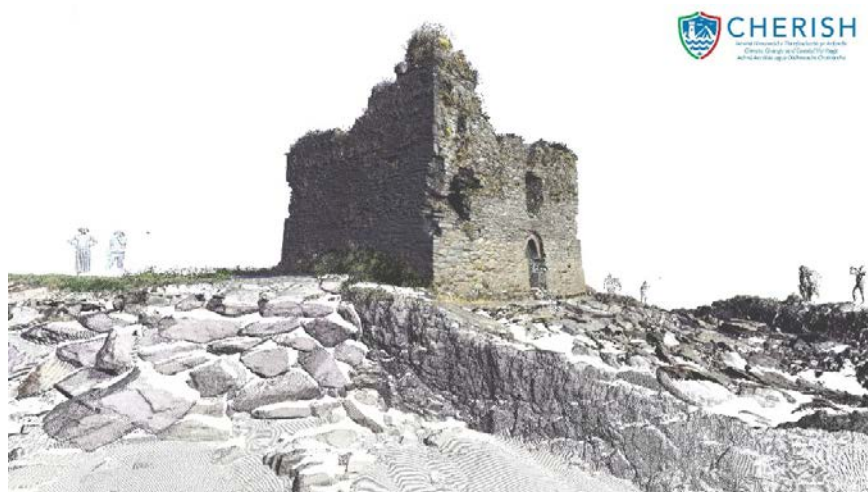
Figure 25: 3D point cloud captured using Faro Focus 120 Laser Scanner

In June 2018, the Discovery Programme (DP) team collected terrestrial laser scan data of McCarthy Castle. The laser scan system employed for the acquisition of data was a Faro Focus 120 phase-based laser scanner with spherical targets. The data was georeferenced using a Trimble 5800 real-time kinematic differential GPS system, using the VRS Now correction service. The coordinate system utilised was Irish Transverse Mercator (ITM). The pre-defined survey profile used was 'Outdoor - up to 20m', with the RGB values recorded. This defined a point-spacing of 7.67mm at 10m, with each scan taking less than 10 minutes to complete.

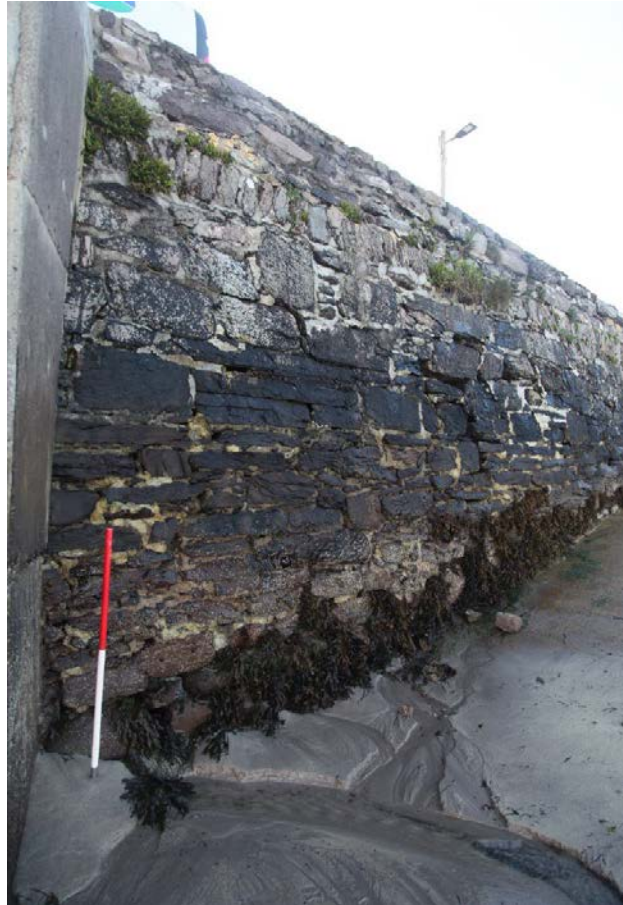
Figure 28: Walkover survey, Ballinskelligs Pier

approximately following transects 15m apart. Only finds at risk of being lost or moved out of context were to be recovered with locations logged. Sites of archaeological potential were identified, with a written record and positional data captured. Positional data is captured with a hand-held Garmin GPS with an accuracy of  $\pm 3\text{m}$ . The areas chosen for walk-over survey are influenced by historic and cartographic research.

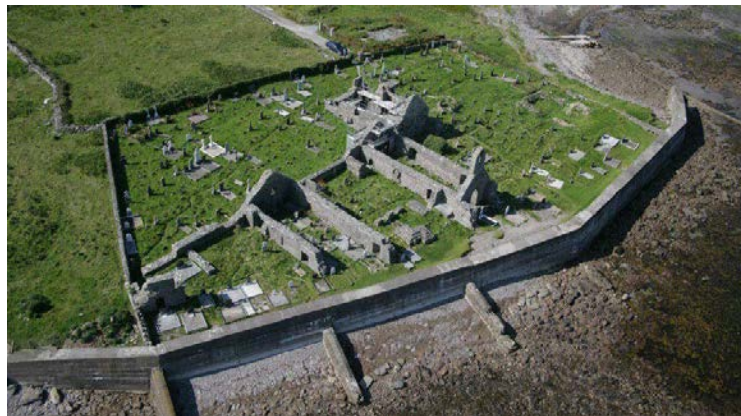
*Figure 2- Aerial view of Ballinskelligs Priory and the existing concrete sea wall (DCHG)*

bodies consulted consist of OPW architects, Kerry County Council, OPW Flood Risk Management section engineers, consultant structural engineers, DCHG and consultant archaeologists. The repair works to the sea wall will be technically challenging and expensive and have to be carefully discussed with all stakeholders. Any proposed methods for the enhancement and repair of the sea wall cannot compromise or damage the ecosystem of the bay. A foreshore license from Kerry County Council to carry out the works will be required. A Ministerial Consent for carrying out works to the National Monument will also be required from DCHG [6].

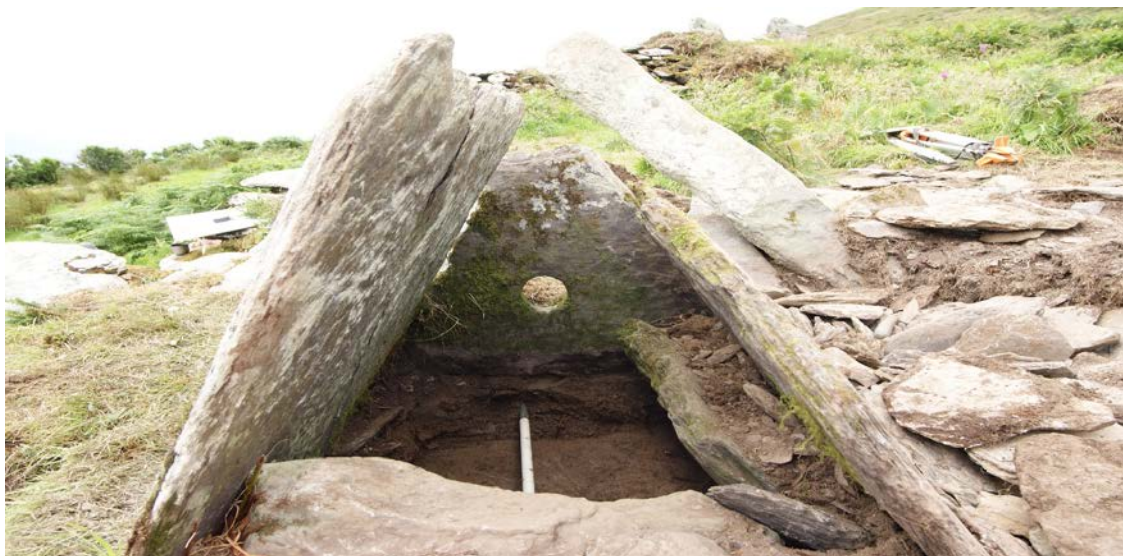
*Figure 1: Gable shrine at Cill Buaine during excavation showing the fenestella in western side slab through which the 'relics' of the saint would have been touched*

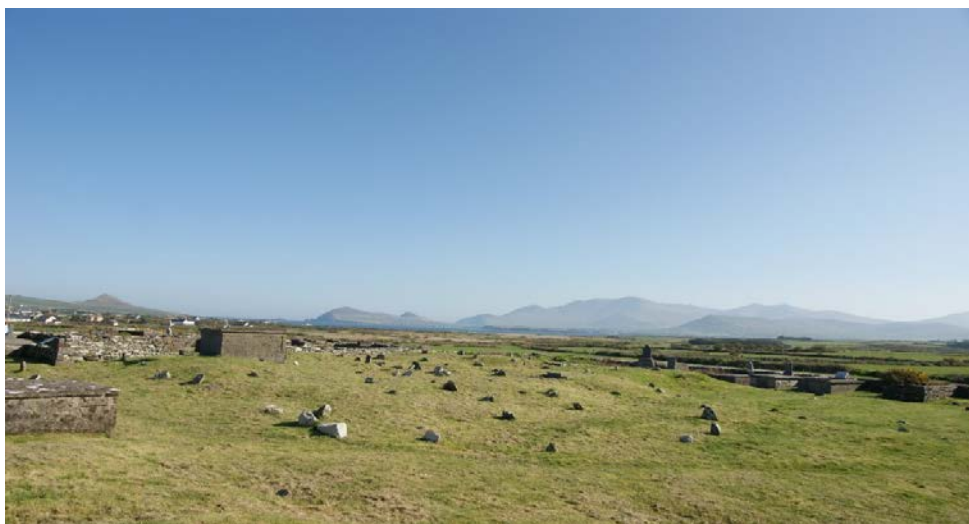
*Figure 3: Dún Urlann graveyard with medieval parish church on the left and mounded area of earlier grave markers indicating the likely location of the earlier oratory*

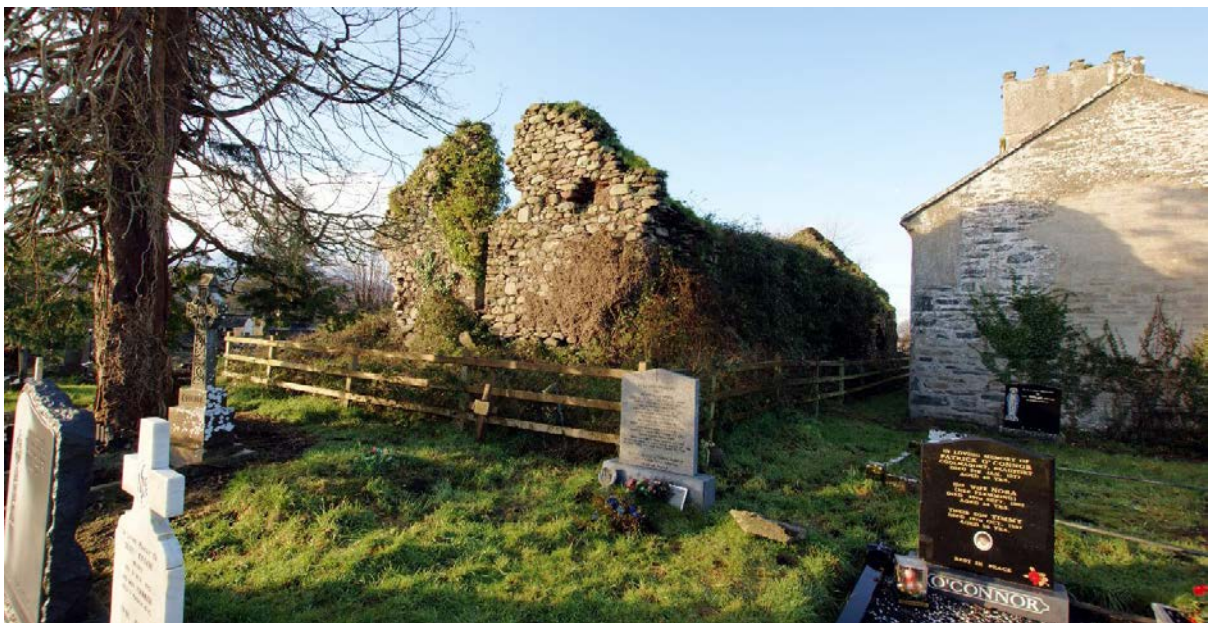
*Figure 4: Churchtown medieval church ruin. Here the corners and the dressed stone around the east window have been robbed for use in tombs while up to 10 burials have been inserted partly under the gable wall*

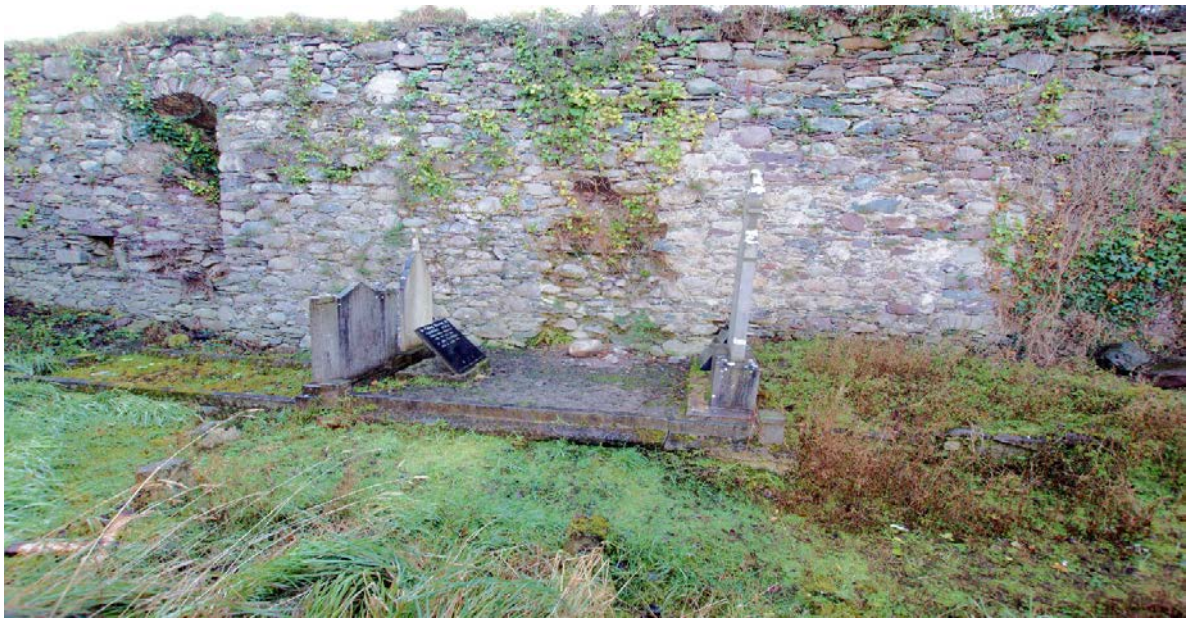
*Figure 5: Grave surround cut partly under side wall at Churchtown causing slumping and cracking of the wall. Note recently fallen stone from the wall face*

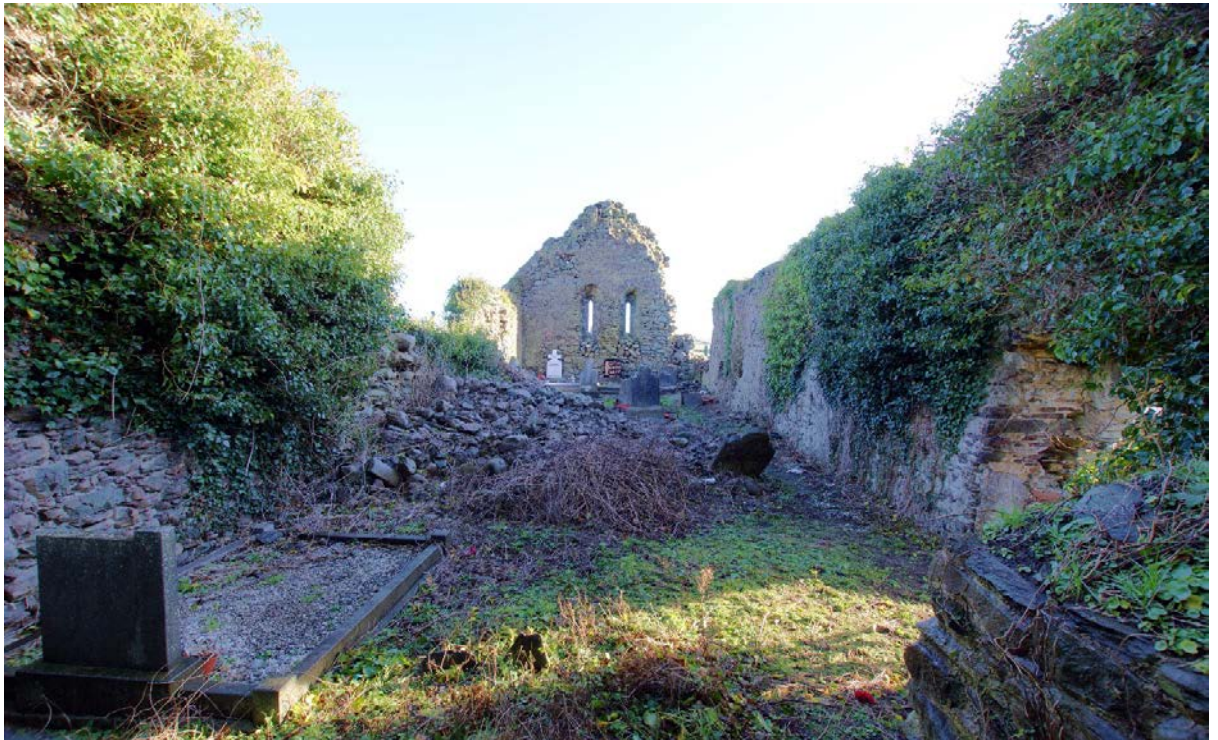
*Figure 5: Kilbonane Church which was structurally intact in 2009. The major collapses at this site occurred after an extended period of freezing weather in 2010 and heavy rainfall over the Autumn of 2012*

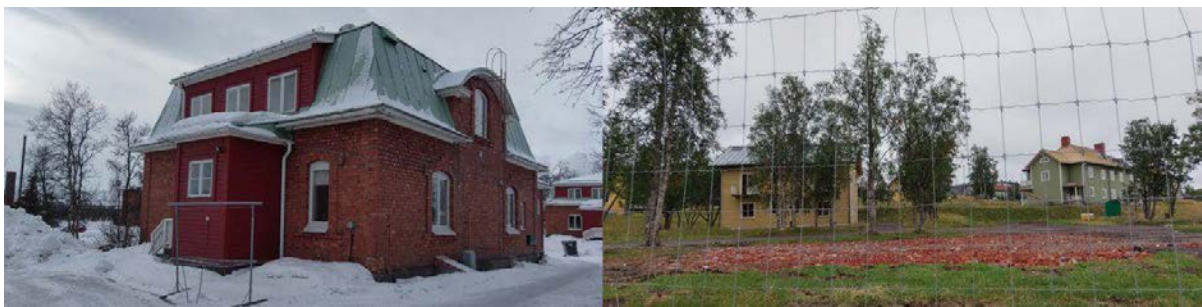
*Figures 1 and 2. A typical “Bläckhorn” house in Kiruna made in bricks before and after its demolition despite of its heritage value. Timber houses of the same typology were instead saved since the relocation was cheaper and easier.*

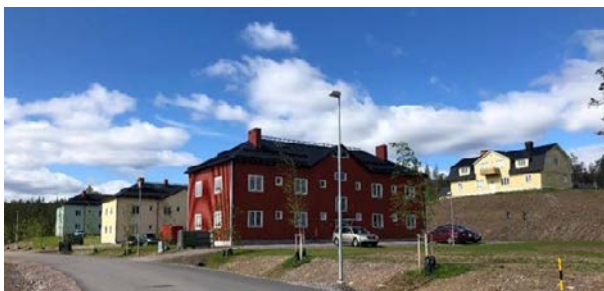
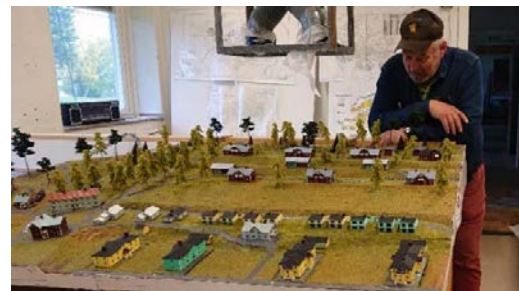
*Figures 3 and 4. Workers' houses from the company area of Malmberget relocated in Koskullskulle. The same houses reproduced in their original disposition by the artist T. Pettersson in his "Malmbergsmodellen".*

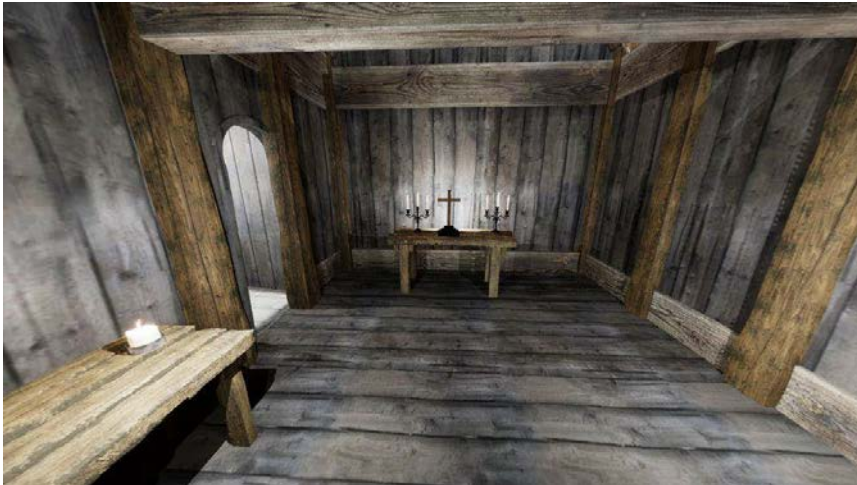
**Figure 4 Digital reconstruction of Skriduklauster monastery site accessible via Roundme, Facebook, Google Maps, VR App Museum Exhibit and Live Streaming.**

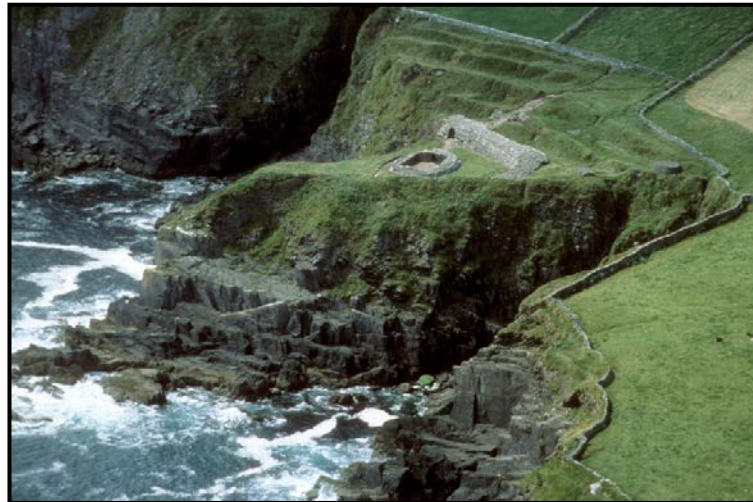
Figure 5. Aerial oblique view from southeast of Dunbeg Fort in the 1980s (© Walter Horn, courtesy of OPW)

The site consists of four outer defensive banks of stone and earth that were far more extensive when the site was occupied, but much of their western extent has been lost to the sea through time. In the interior a stone-built rampart provided protection to a single circular hut site or clochaun (clochán), which is located at the southernmost edge of the monument overlooking the sea. A flag-covered souterrain or underground passage runs from the innermost earthen defensive bank, beneath the rampart and leads to the clochaun. Other features include a defined pathway through the site flanked by upright stone flags and, prior to the 2017 collapse, an iconic lintelled entranceway with two side chambers was located within the western extent of the inner stone rampart.

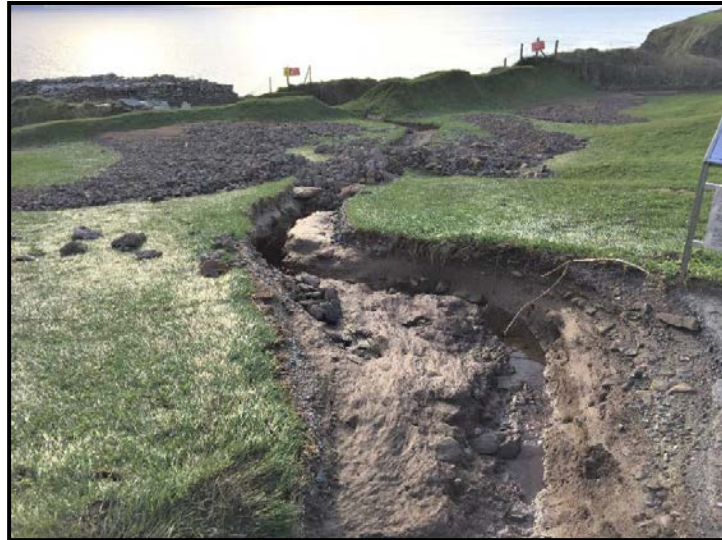
Figure 6. Flood damage at the site in 2017, with scoured areas and deposited heavy gravels (© NMS)

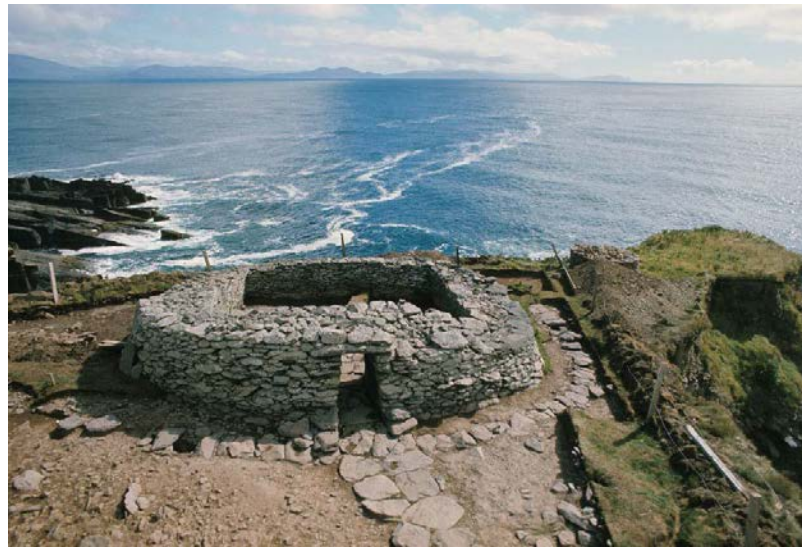
Figure 3. Excavation at the clochaun in 1977 with external drain and souterrain revealed (© NMS)

The NMS have been aware for some time of the site's vulnerability to coastal erosion, with an archive of material tracing impacts over the decades [2]. This has allowed for planned archaeological excavation ahead of potential loss and in the late 1970s extensive archaeological excavation was carried out by NMS at Dunbeg Fort. Three quarters of the site was archaeologically investigated at the time and revealed evidence of man-made construction dating from 580BC (a date from the lowest levels beneath the stone rampart), to the medieval period, with the excavation of the clochaun revealing evidence for occupation up to 1000AD [3].
