Baltic History Beneath Surface

Edited by Maili Roio

Tallinn 2019

Underwater documentation – is photogrammetry here to stay?

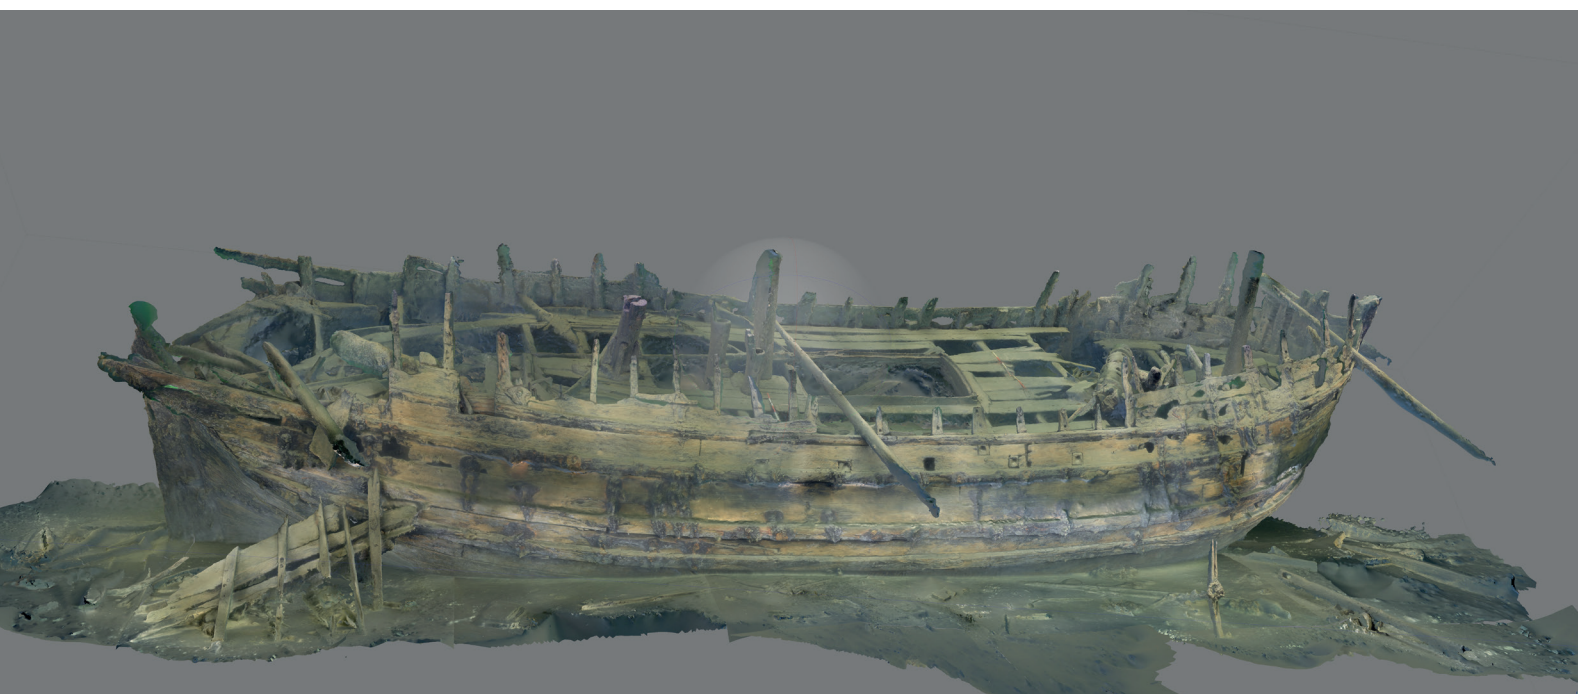
Figure 5. The result exceeded expectations. The result was highly detailed and mirrored the wreck at a whole new dimension.
Image: Jim Hansson. Source: SMTM.

In spite of this, the model was not complete, but lacked two masts that are still in place on the ship, as well as large parts of the seabed that there had been insufficient time for during the first week of dives. Additions were therefore made at the end of 2017, where the seabed sections that were missing were photographed. On this occasion, there was a lot of current in the water, mainly on the port side, which made it difficult to photograph with satisfactory results.

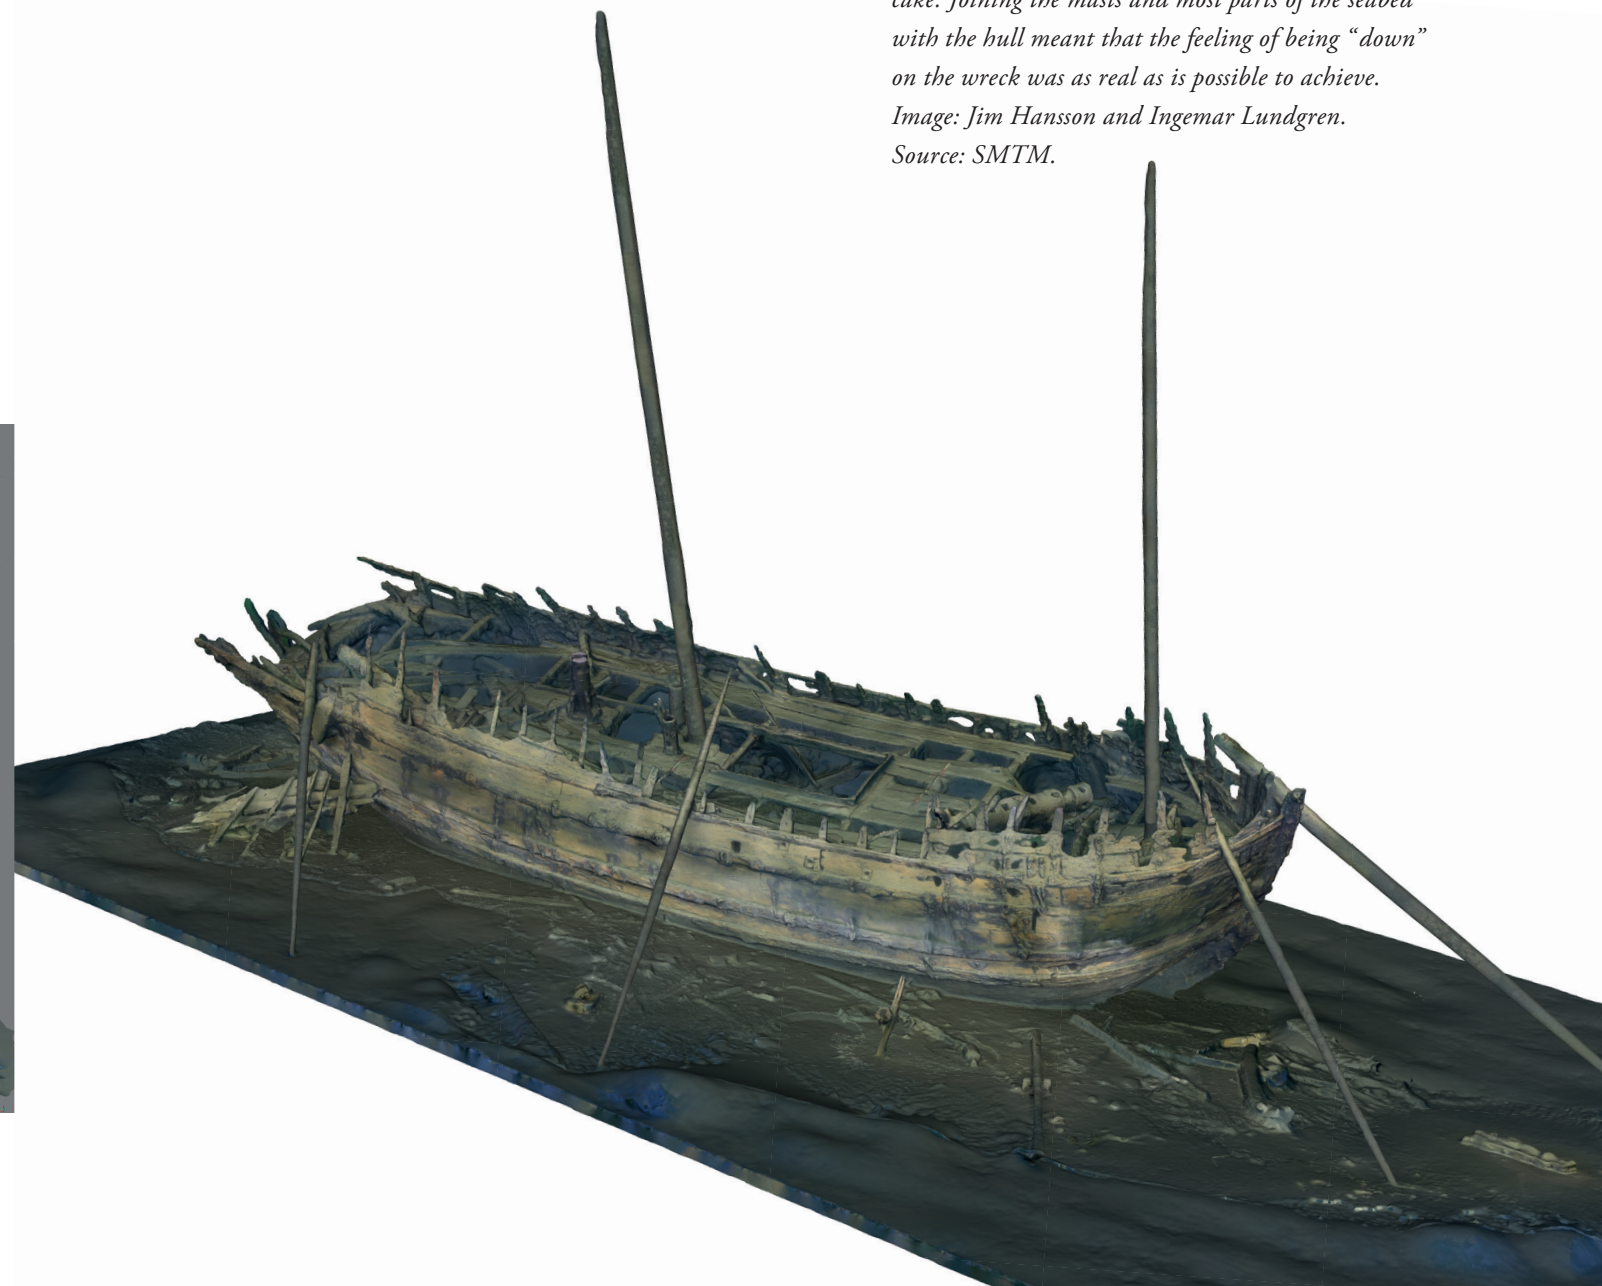
Figure 6. The complete model was the icing on the cake. Joining the masts and most parts of the seabed with the hull meant that the feeling of being "down" on the wreck was as real as is possible to achieve.
Image: Jim Hansson and Ingemar Lundgren.
Source: SMTM.

the starboard side, however, most of the seabed and loose wreck parts were successfully joined with the original model, among other things, the galleon lion. We obtained an almost complete picture of the entire wreck site and a model that truly reflects the experience of being at the seabed.

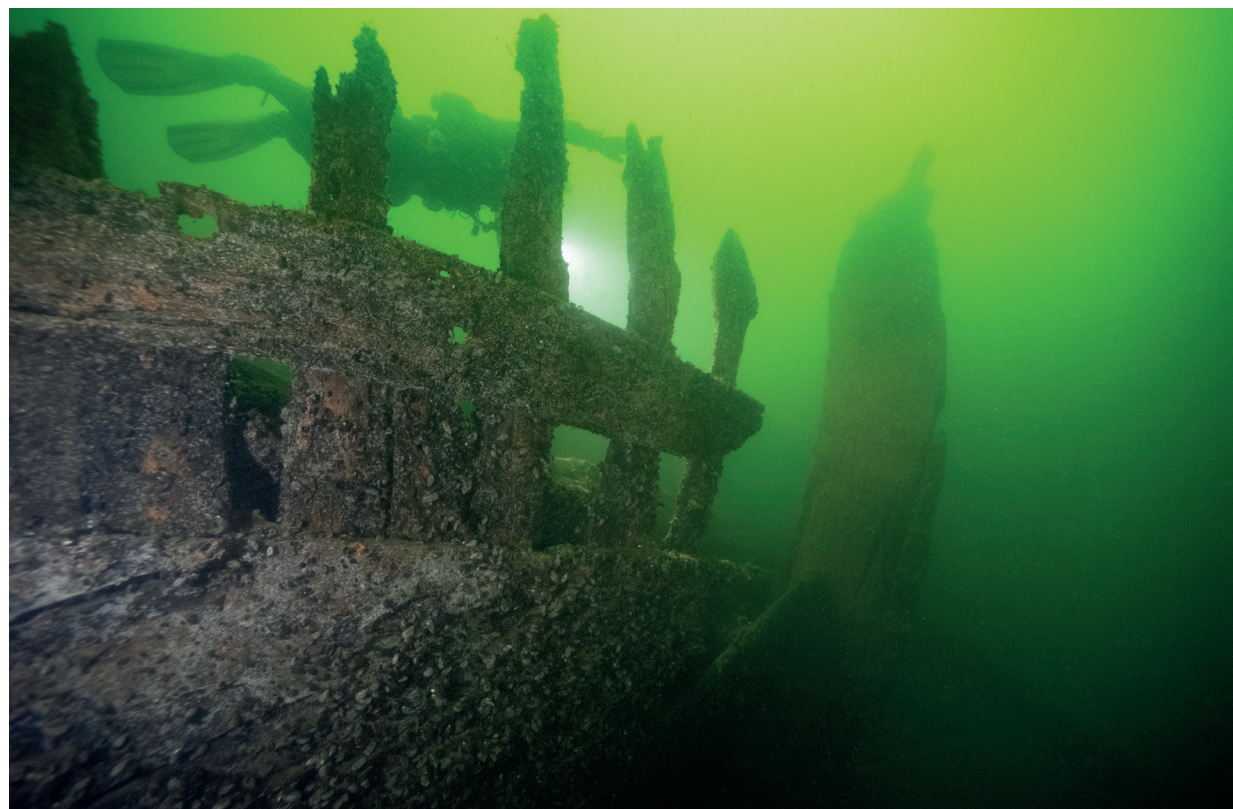
*Figure 7. The picture shows the high stern that rises almost 8 metres above the sea bed.
Photo: Jim Hansson, SMTM.*

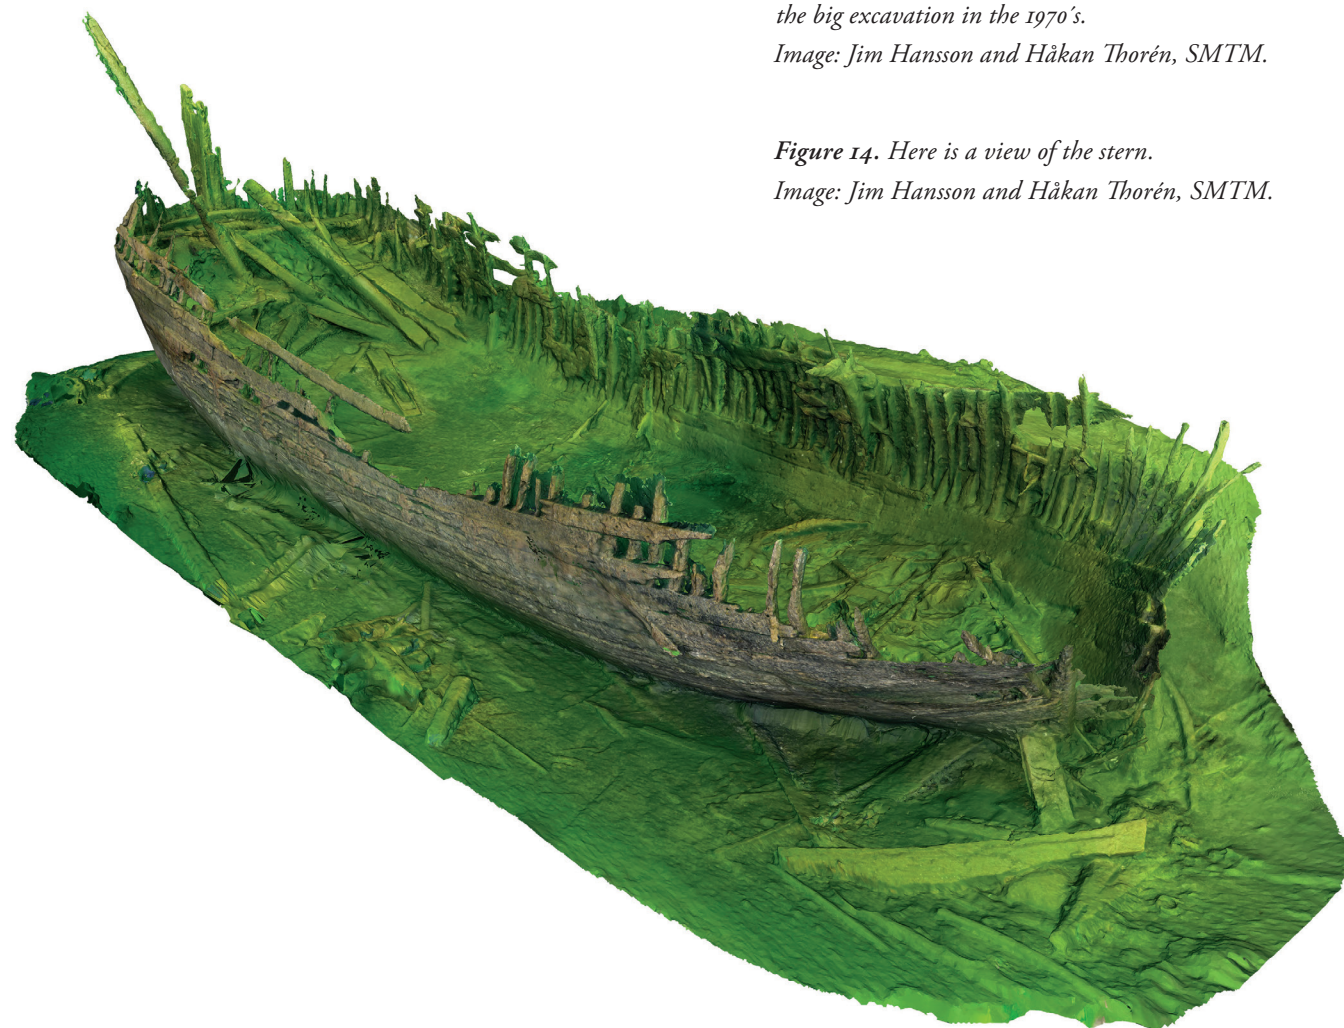
Figure 14. Here is a view of the stern.

One day's diving with four different photographers resulted in material that was not able to give an overall image of the ship. In December 2018, we had the opportunity to supplement the material with new pictures of areas on the wreck that had not turned out well. After testing other settings, the program aligned the wreck. This meant that we could get a complete model. In stage 2, Dense Cloud, it turned out that because of the higher settings in stage 1, particles and floating seaweed were also incorporated into the model. We returned to the point cloud where clearing these out was easier. The result was a genuinely nice model of the Jutholm wreck (Fig. 12–14).

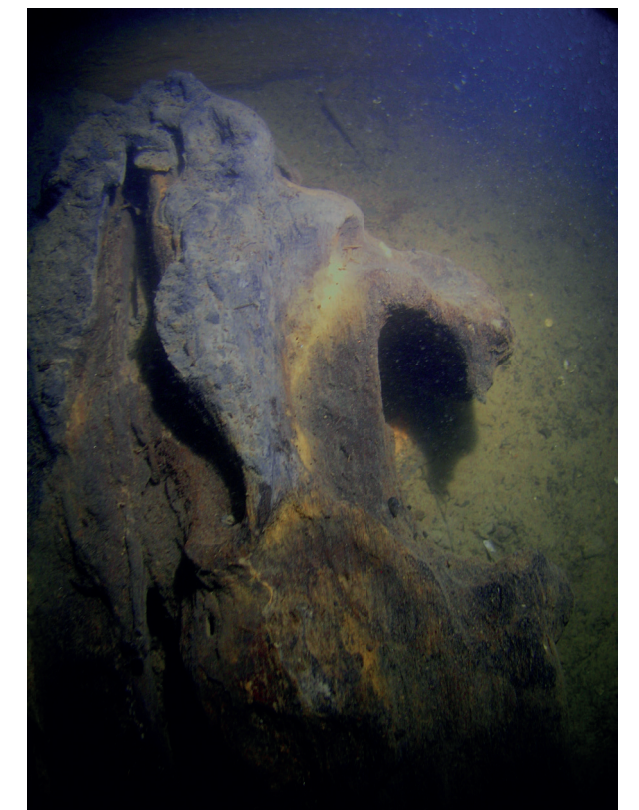
Figure 1. Lion figurehead. Photo: National Maritime Museums of Sweden (SMM) 2007.

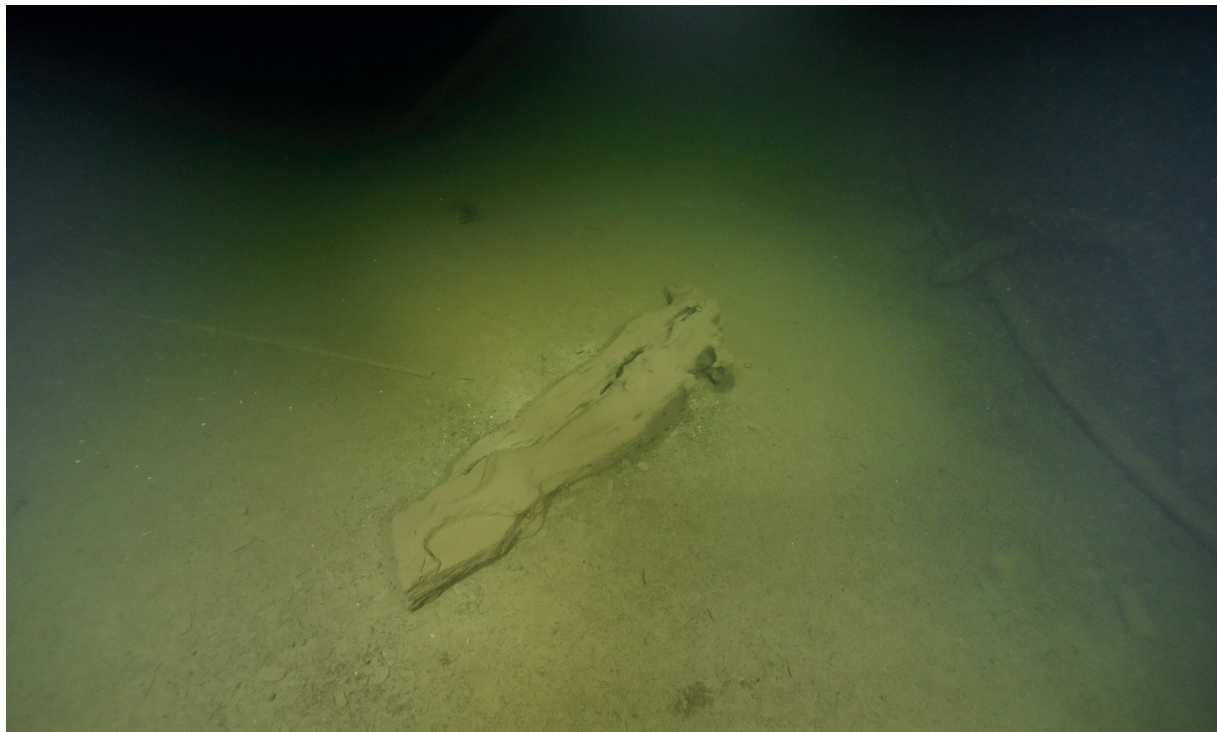
Figure 2. The lion figurehead at the sea floor in front of Bodekull. Photo: Mikael Fredholm 2018.

main mast and the main loading hatch. Towards the bow you can see the windlass and an anchor hanging on the port side of the wreck. If you then follow the bowsprit to the seafloor to the depth of around 31 metres, you will encounter the lion figurehead.

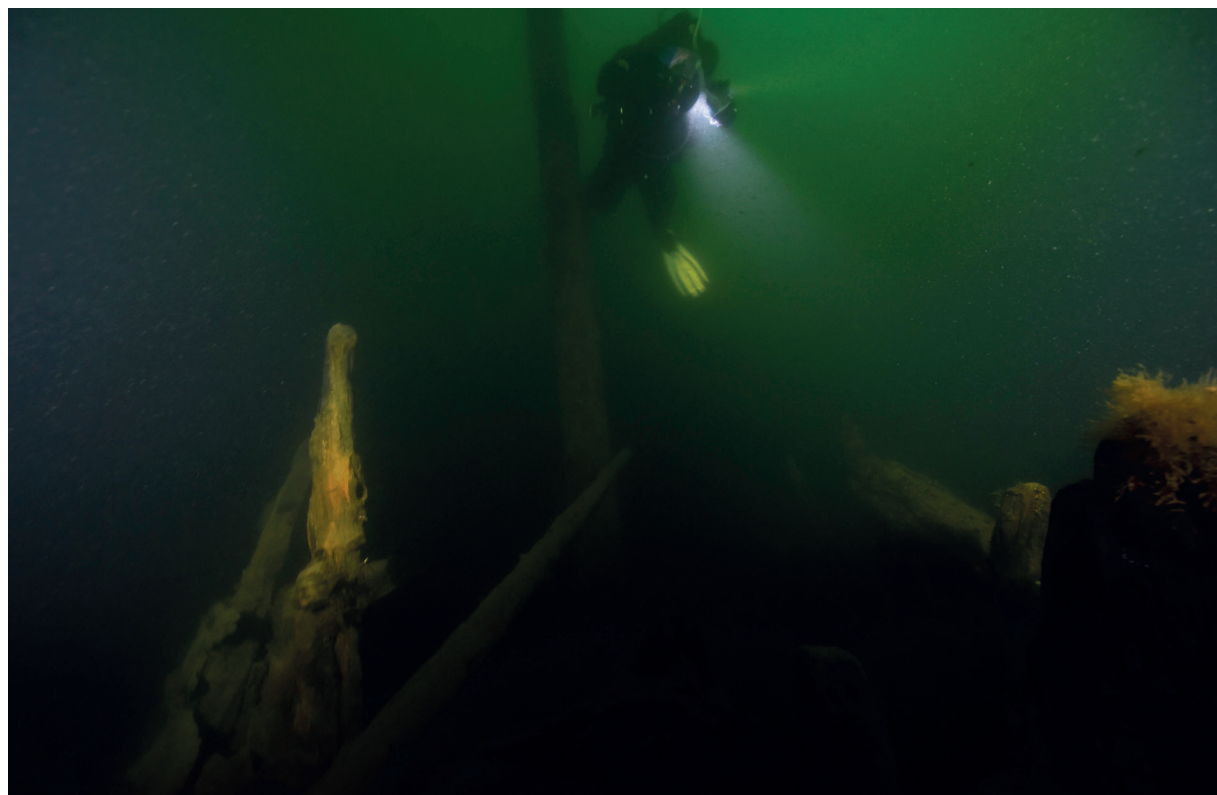
Figure 3. A diver by the bow at Bodekull. Photo: Jim Hansson 2017.

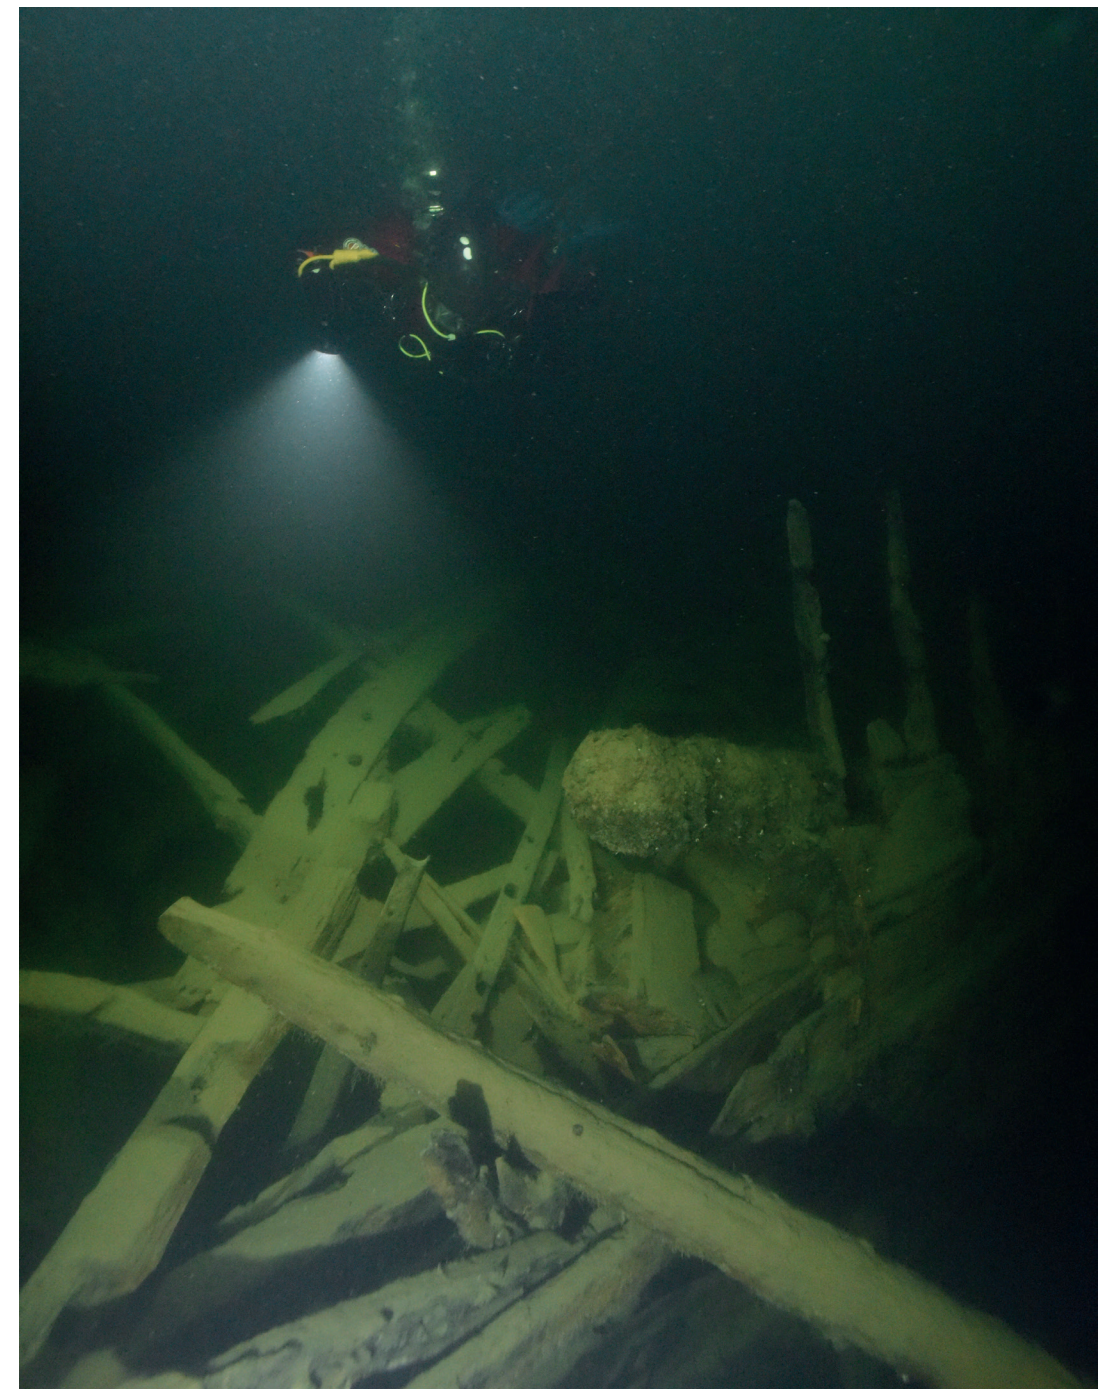
Figure 4. A diver above the cannon on the starboard side, to the aft. Mikael Fredholm 2018.

Turning back to the bow and along the starboard side there is an anchor standing on the seafloor. On the starboard side part of the rigging is sticking out and on the deck there is a grindstone. In the aft on the starboard side a cannon is easily visible. Just towards the aft of the cannon there are five Bartmann jugs. Continue around the stern and you will reach the small buoy and the line that takes you back to the mooring buoy and the ascending to the surface.

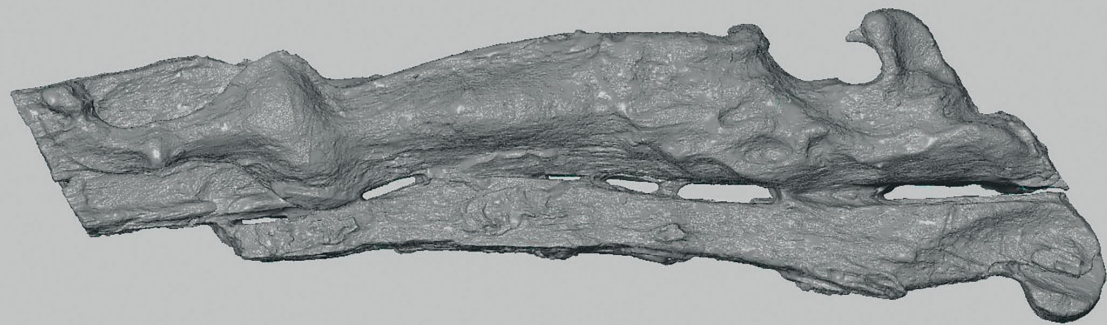
*Figure 6. Scanning of the Lion figure head.
Image: SMM 2007.*

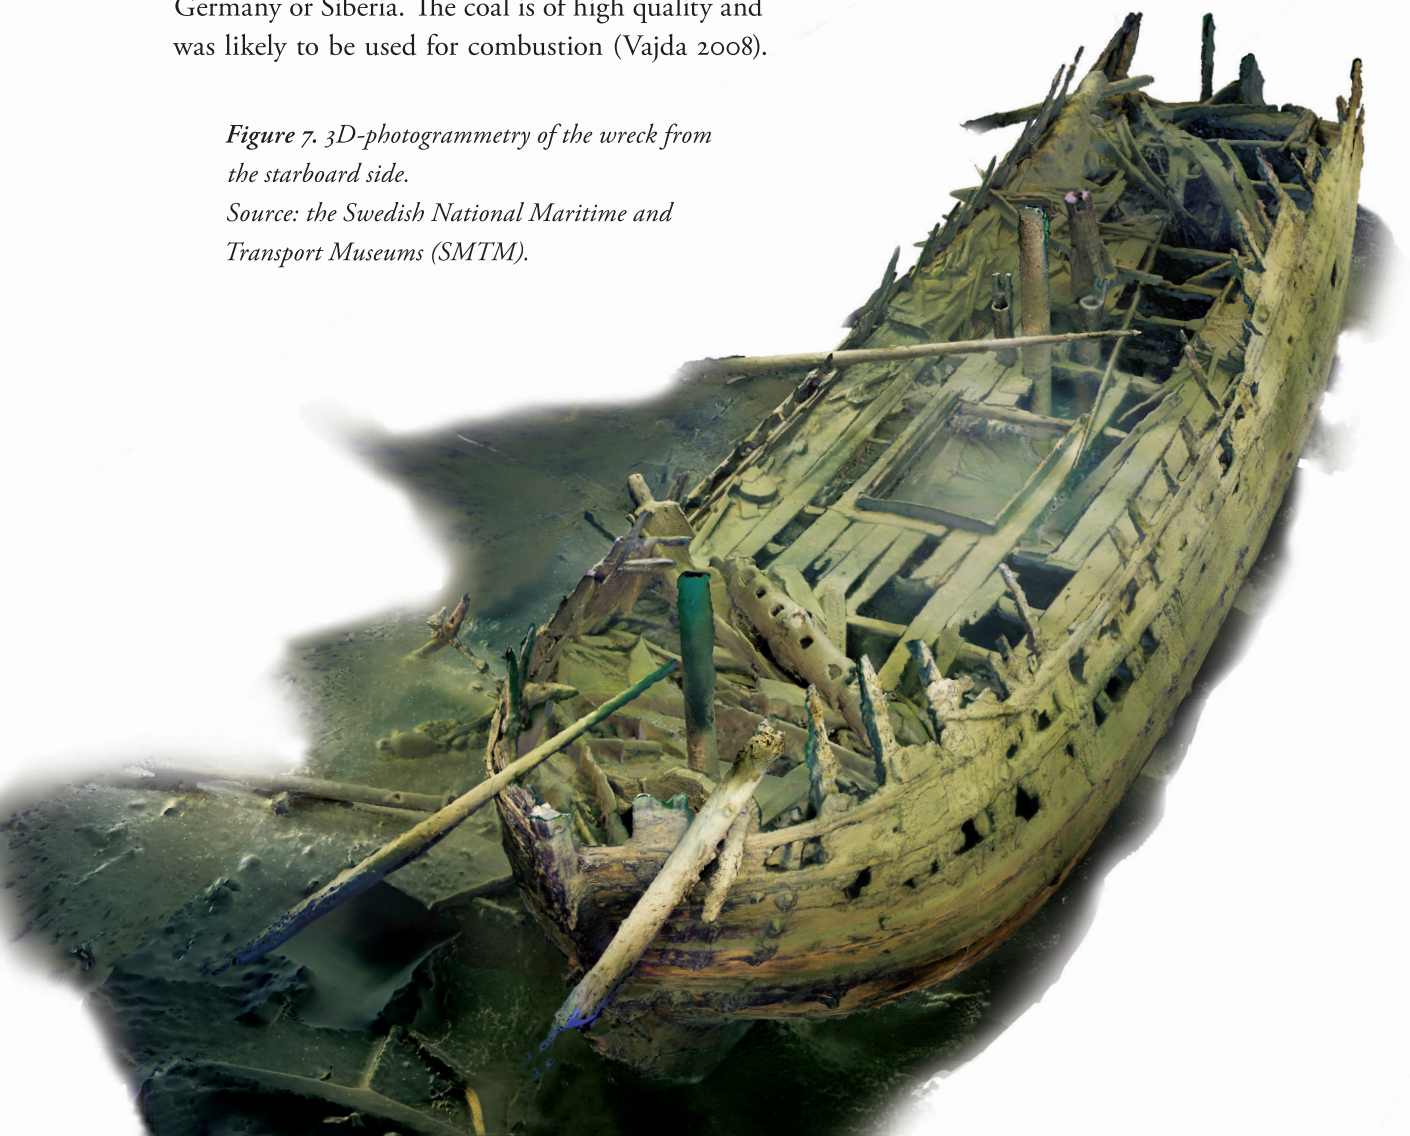
Figure 7. 3D-photogrammetry of the wreck from the starboard side.

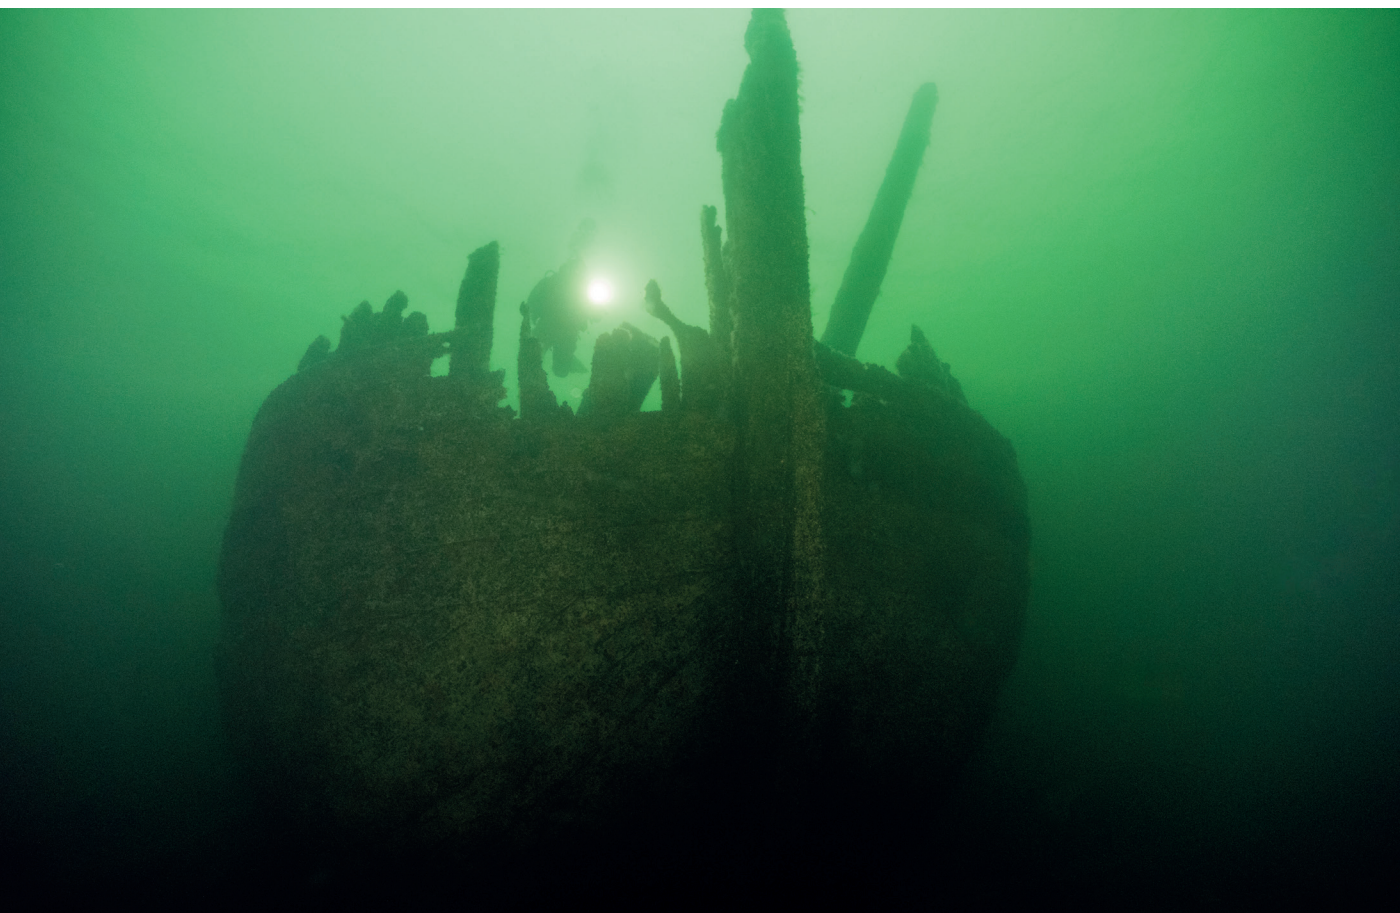
Figure 9. The Bow of the Jutholmen wreck is quite round and bulging, which was typical of Dutch ships. The fluyt (Dutch ship type), which was one of the most common cargo ships during this period, is characterized precisely by such stem sections. Photo: Jim Hansson, SMTM.

New dives were carried out in 2018 in connection with documentation for a 3D model. The shape of the ship has been interpreted as a typically Dutch construction. The stem is quite round and bulging which is typical of Dutch ships, this can be clearly seen on the most recent pictures from 2018 (Fig. 9).

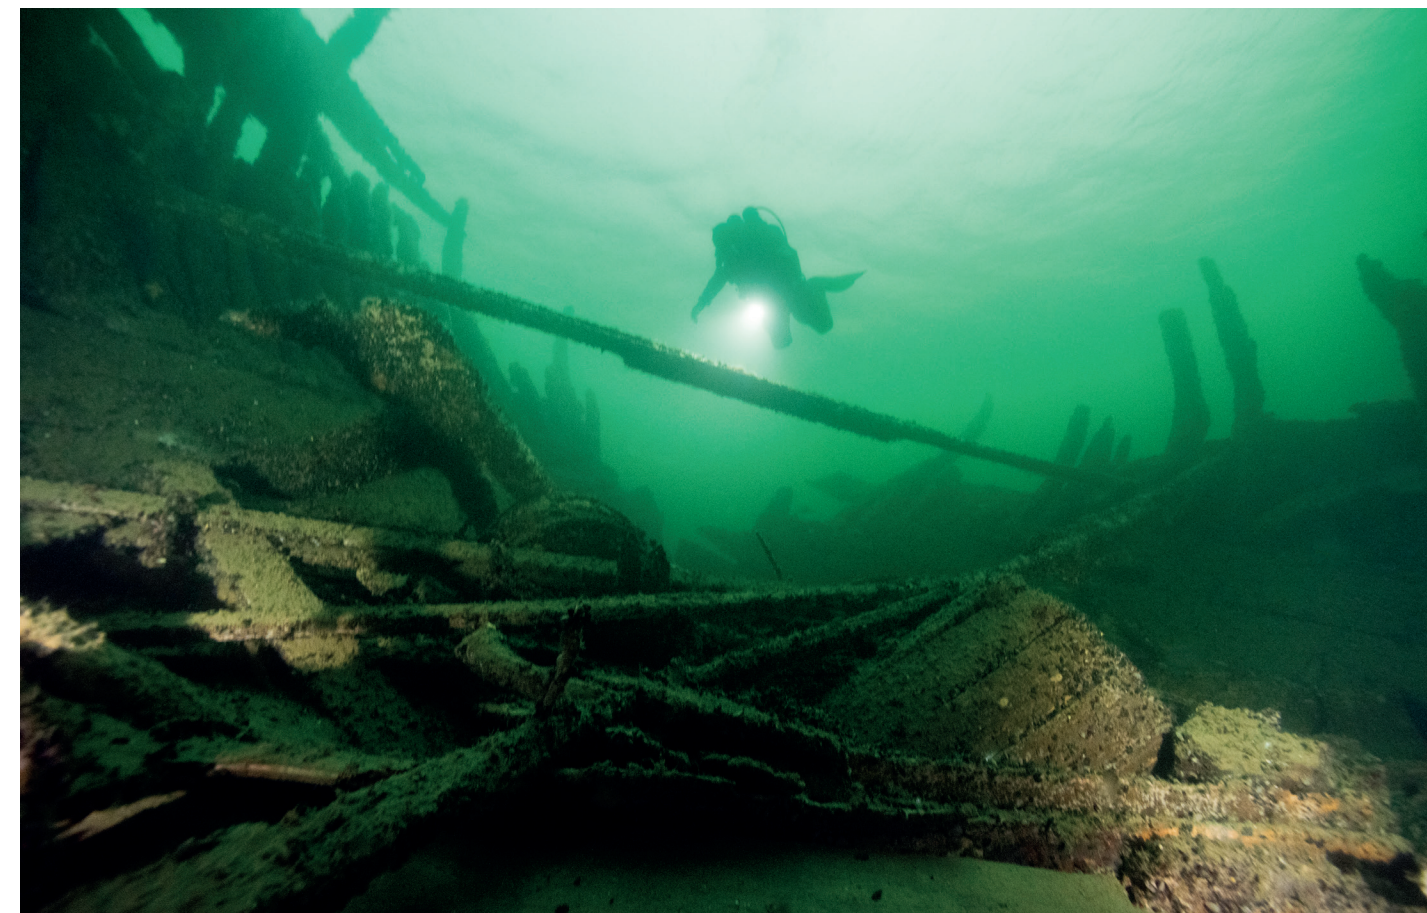
Figure 10. Several barrels remain in the cargo hold and one of the tension rods is still in place. Photo: Jim Hansson, SMTM.

Looking from the inside of the wreck towards the stern, parts of the cargo can still be witnessed in the form of barrels, as well as one of the remaining tension rods (Fig. 10).

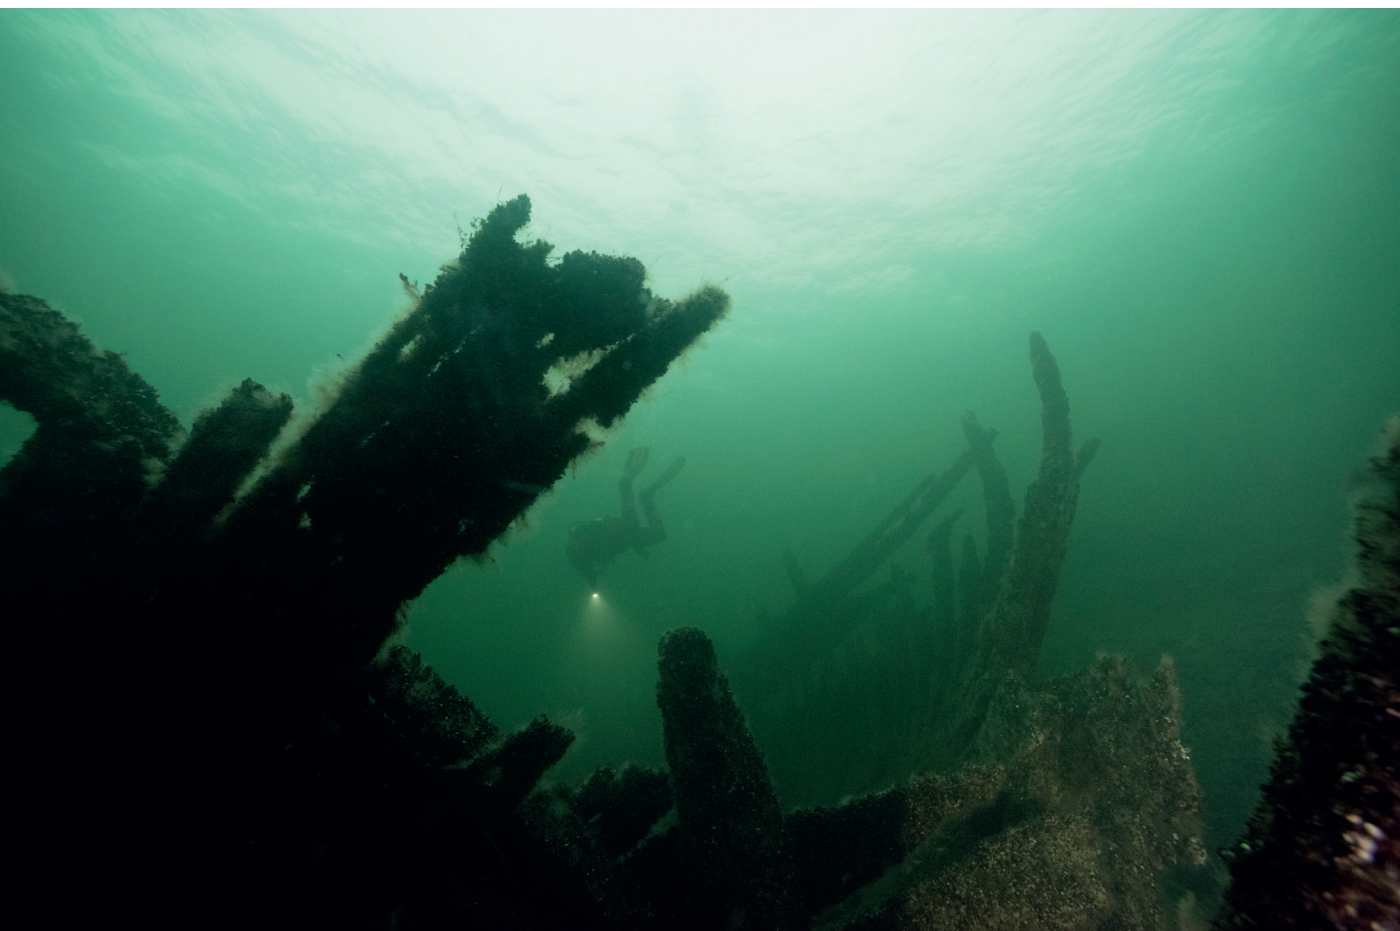
Figure 11. Here you can see straight into the stern. However, a few of the frames are still in place on the starboard side.
Photo: Jim Hansson, SMTM.

Comparing Sven Olov Johansson's sketches (Fig. 5 and Fig. 6) with the pictures from 2018 it is clearly visible how heavily eroded and damaged the stern is, possibly as a result of an anchoring (Fig. 11).

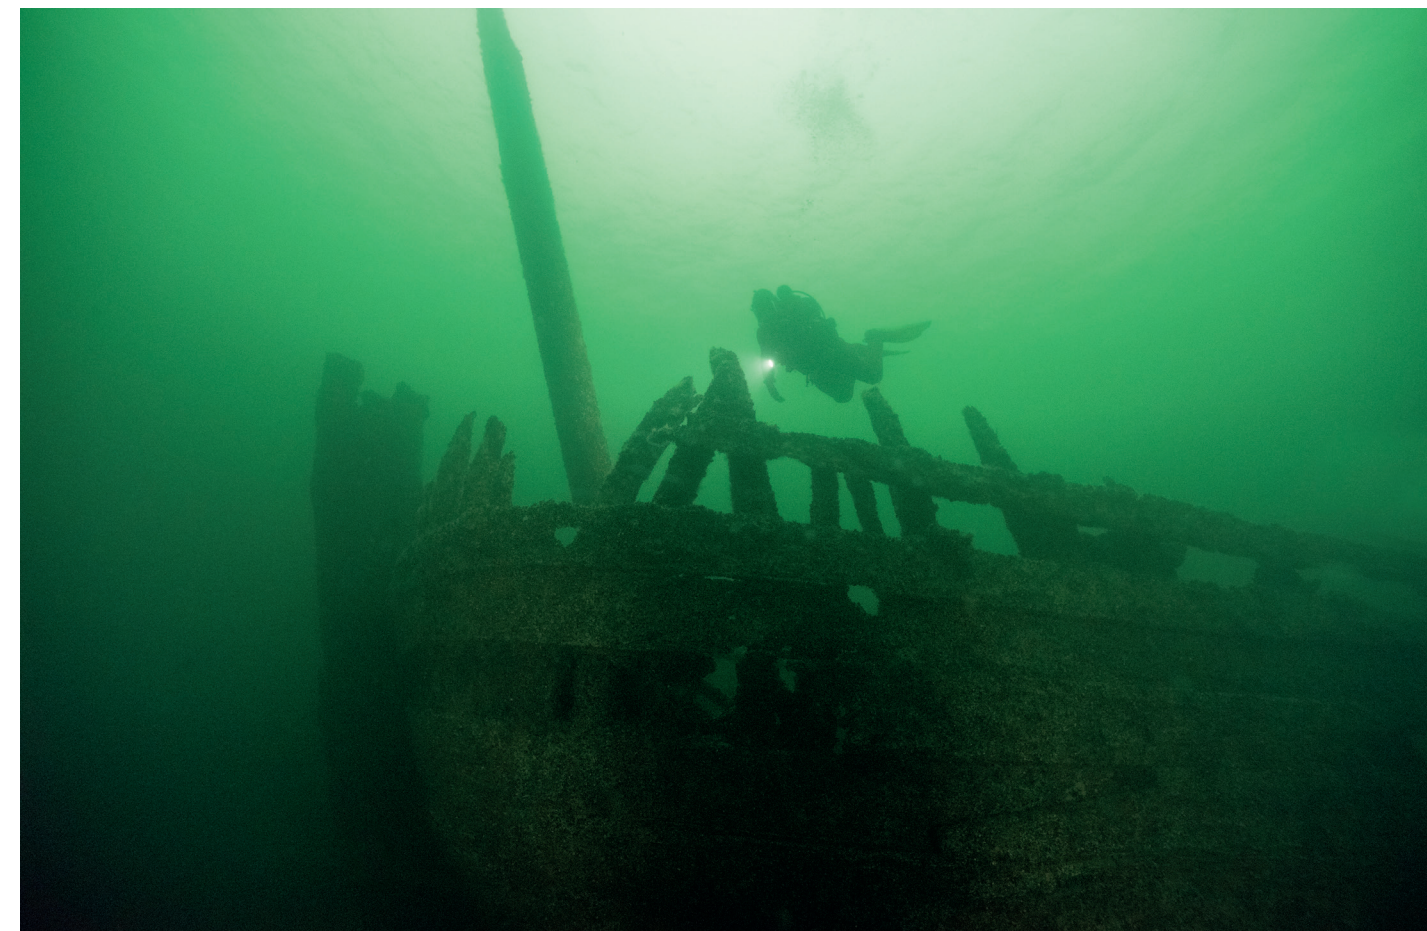
Figure 12. The powerful stem is virtually intact except for a few hull planks that have loosened. Note the mast that is also in its place.
Photo: Jim Hansson, SMTM.

At the front of the ship, the stem is still securely in place. Also, the foremast is visible, still in its position, albeit slightly inclining towards the stem (Fig. 12).

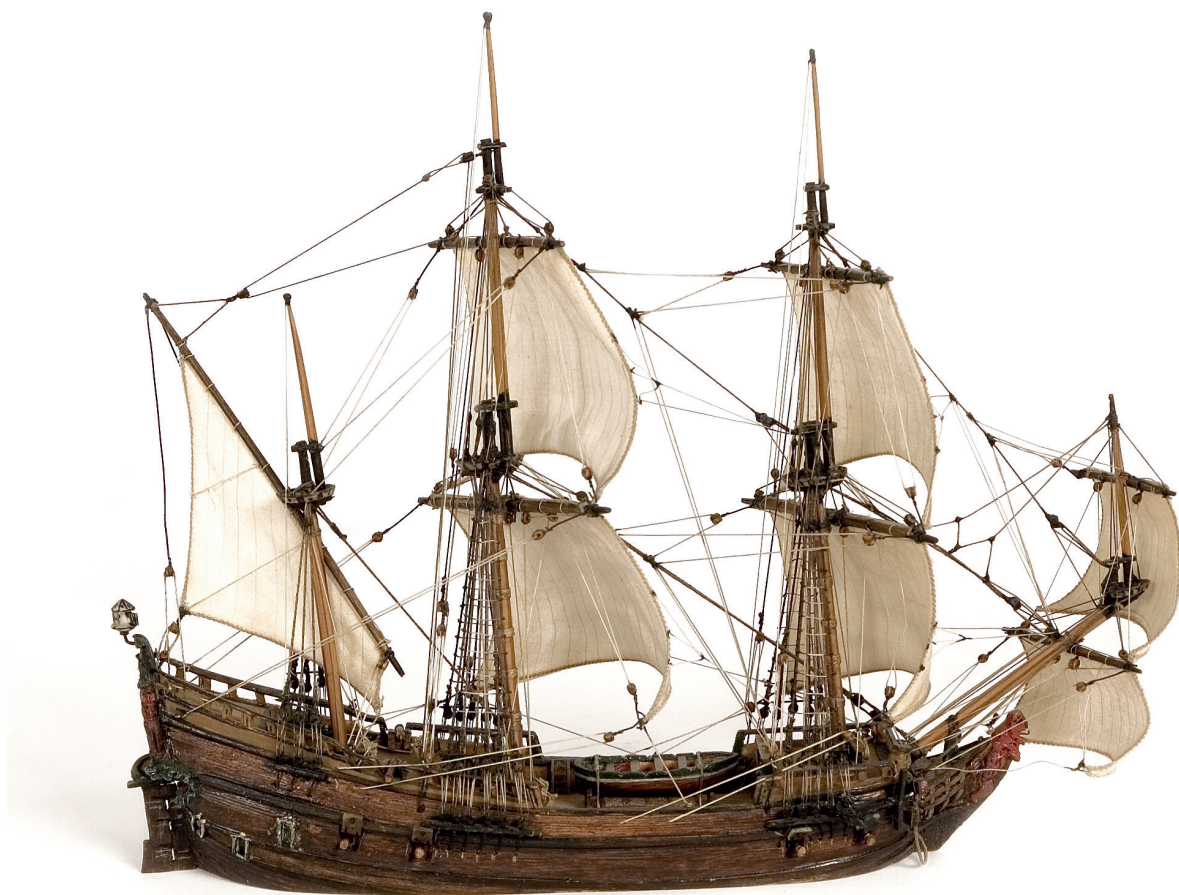
Figure 13. The model of a fluyt from the 17th century gives a good picture of what the wreck at Jutholmen might have looked like. These were very beautiful ships even if they were “only” cargo ships. Note the small windows in the stern, very similar to the positioning shown in Fig 5. Photo: Karolina Kristersson, SMTM.

What did the Jutholmen wreck look like? Categorizing ship types from the 17th and 18th centuries is a complicated matter, although much indicates that the Jutholmen wreck is a small fluyt, which was one of the most common cargo ships, particularly during the 17th century. The fluyt is characterized by its seaworthiness and vast cargo space. It could also be sailed with relatively few sailors, which was economical. Written sources indicate that only seven men were necessary on a ship like the Jutholmen wreck. Fluytes were built in different sizes. The most common were perhaps those that were built in Holland and were of the larger variant (35–40 metres long), which is represented by the Anna Maria. It was built to sail on the oceans. The Jutholmen wreck, on the other hand, is slightly smaller, 25 metres long, and is more suited for shipping on the Baltic Sea. The collections at the Swedish Maritime Museum contain a model of a fluyt which gives a good picture of what the Jutholmen wreck might have looked like (Fig. 13).

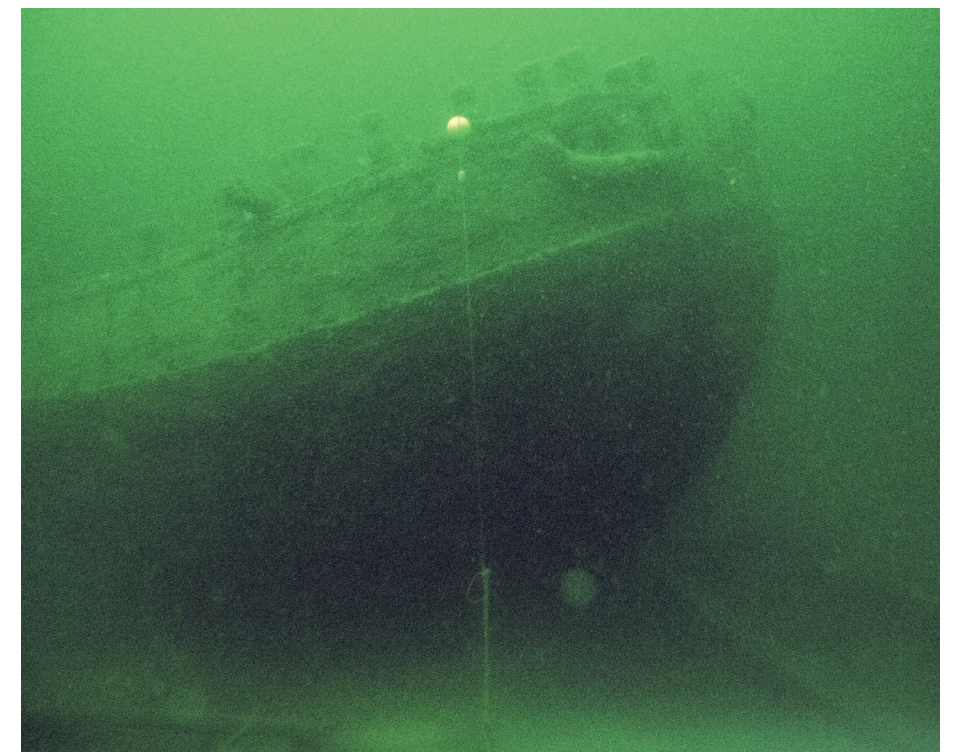
*Figure 1. The Koster wreck
in ideal visibility conditions.
Photo: Marco Ali 2018.*

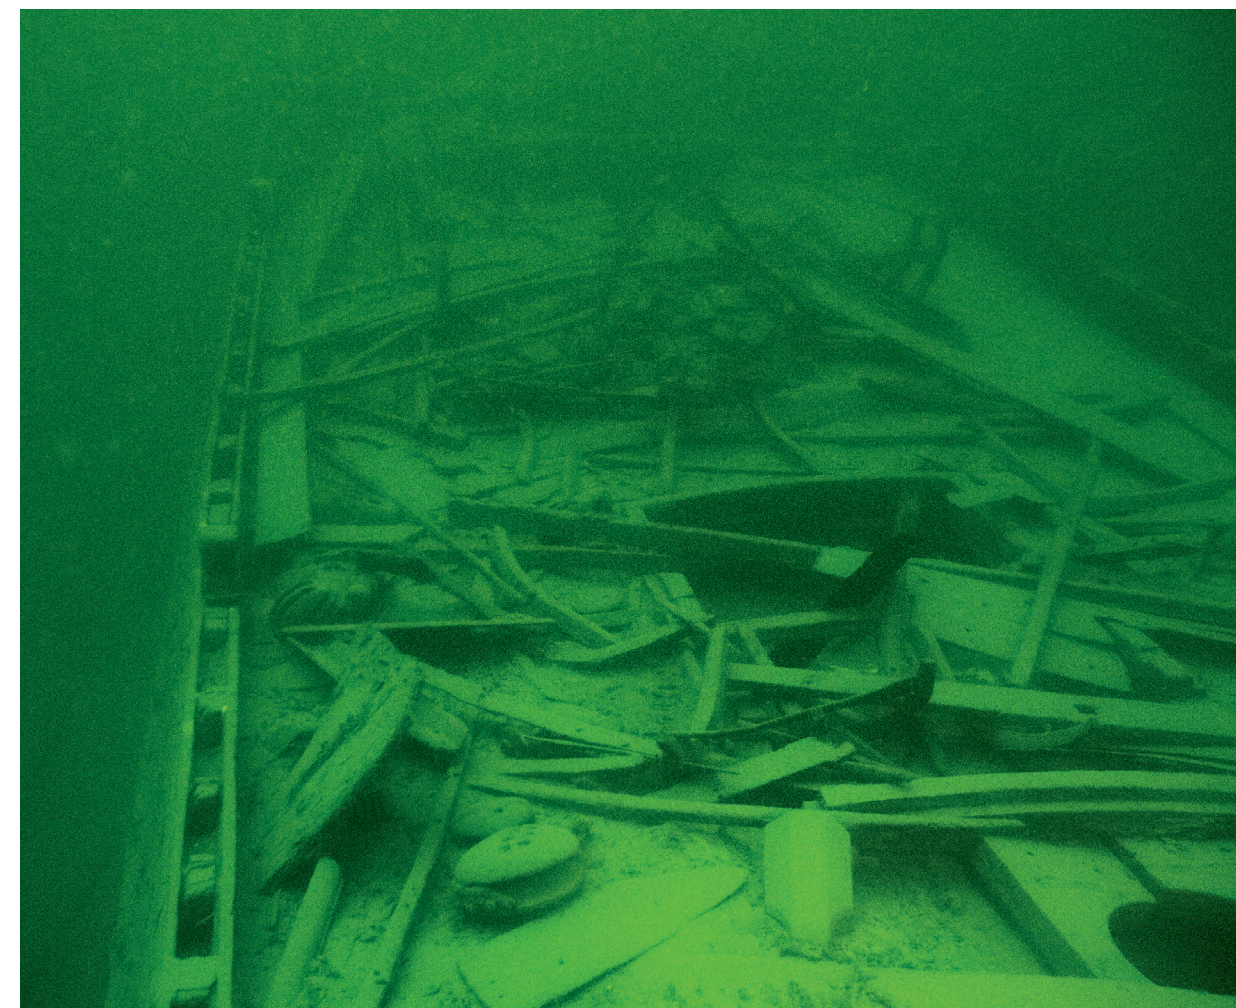
Figure 3. Cluttered deck. Photo: Marco Ali 2018.

I ascend to the height of the bulwark and glide slowly over the deck. An extensive mess is revealed. Blocks and rigging, planks and remains of barrels are scattered on deck. Beneath me lies a windlass, completely preserved, as if ready to hoist up the stock anchor that now rests on the sea bed underneath the cathead. I slowly swim astern over the deck. Beyond the mast hole I see a collection of small boat parts; floor timbers, broken strakes, a stem and a transom.

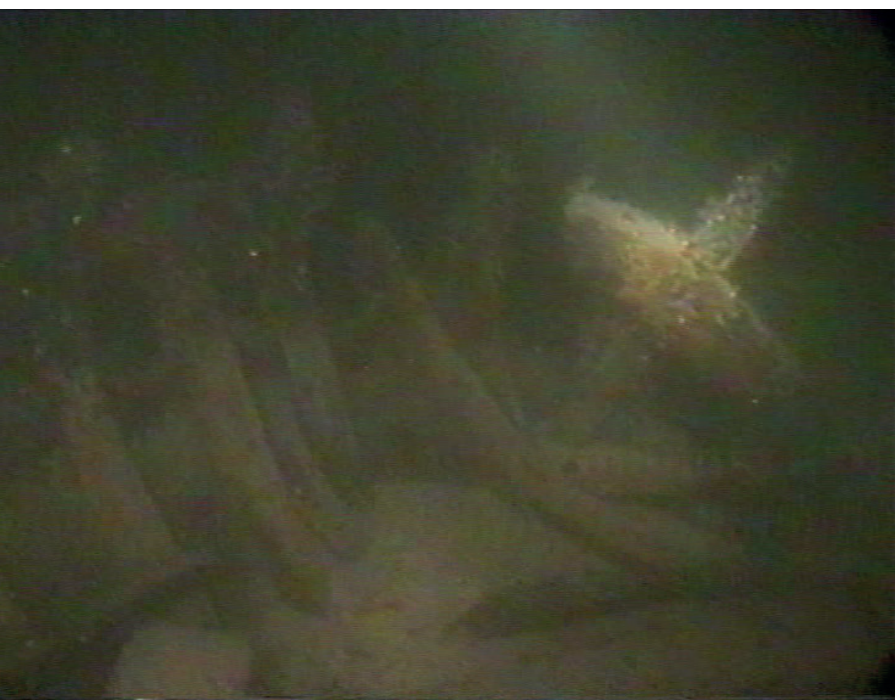
Figure 2. In film footage taken approximately twenty years ago you can see that the boards once constituted a skiff. The skiff, filmed during the second half of the 1990s. Photographer unknown, Sweden's Marine Archaeological Archive, the Swedish National Maritime and Transport Museums (SMTM).

In the first films are two large tackle blocks lying inside the ship's boat. Perhaps the crew had tried to launch the boat using the tackle in an effort to save themselves? Although diving requires presence and focus, I cannot avoid letting my thoughts drift away for a while because the lifeboat and the tackle together seem to somehow build a bridge of sentiment across the centuries, a message penetrating the dark waters of forgetfulness. Deep in thought, I hover over a scene that my imagination easily reconstructs in all its tragedy. Maybe the lifting tackle broke, maybe they just didn't have the time to launch the skiff before the ship went under? I shake off my thoughts. The tackle might just as well have belonged to the mainsail, and what really happened we will never know for sure.
