Baltic History Beneath Surface

Edited by Maili Roio

Tallinn 2019

Underwater documentation – is photogrammetry here to stay?

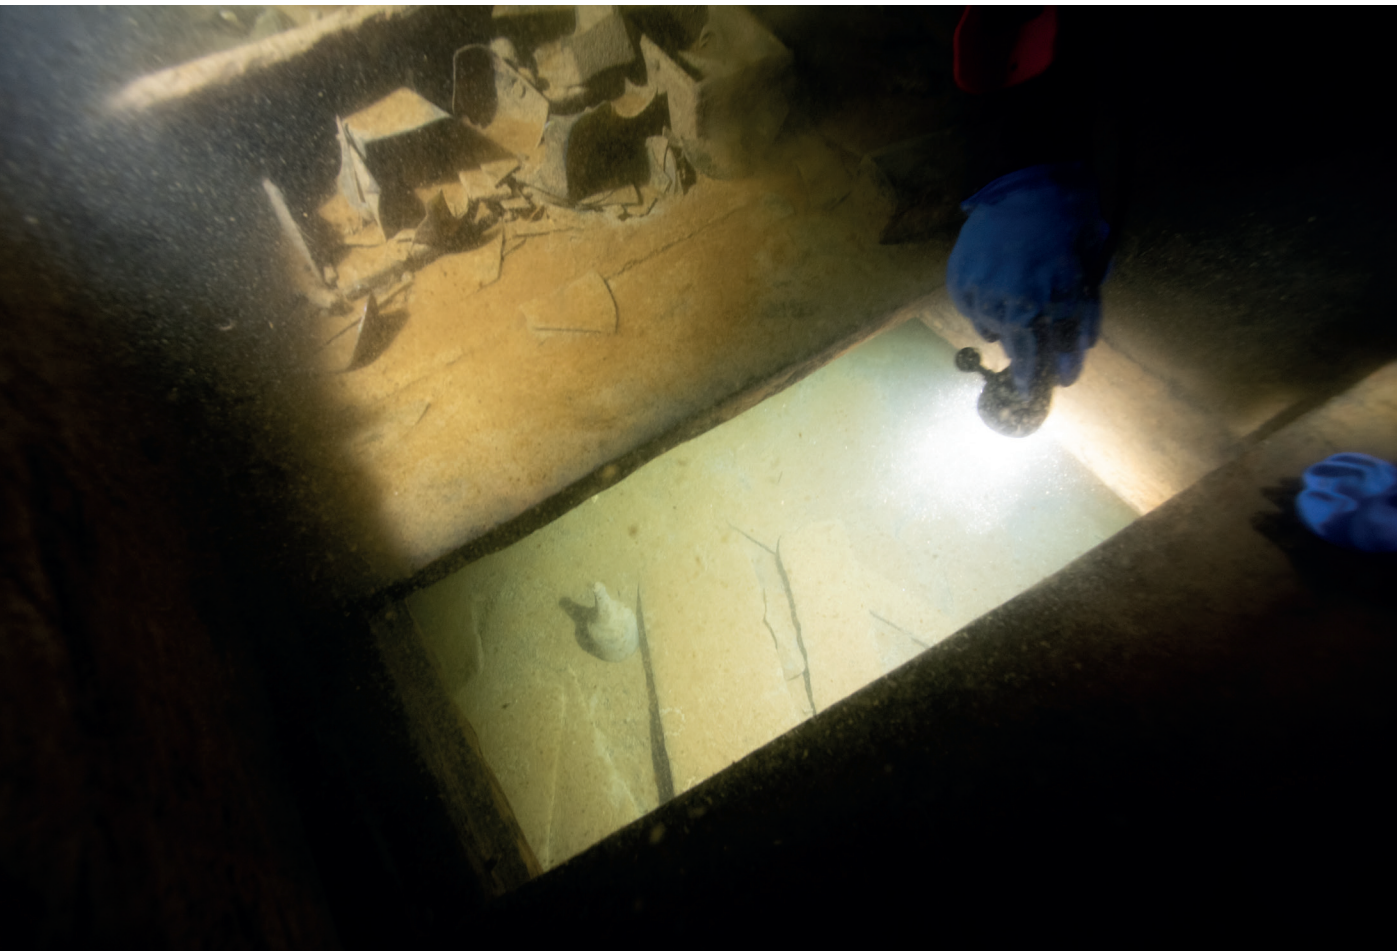
*Figure 4. A glimpse below the deck.
Photograph: Jim Hansson, SMTM.*

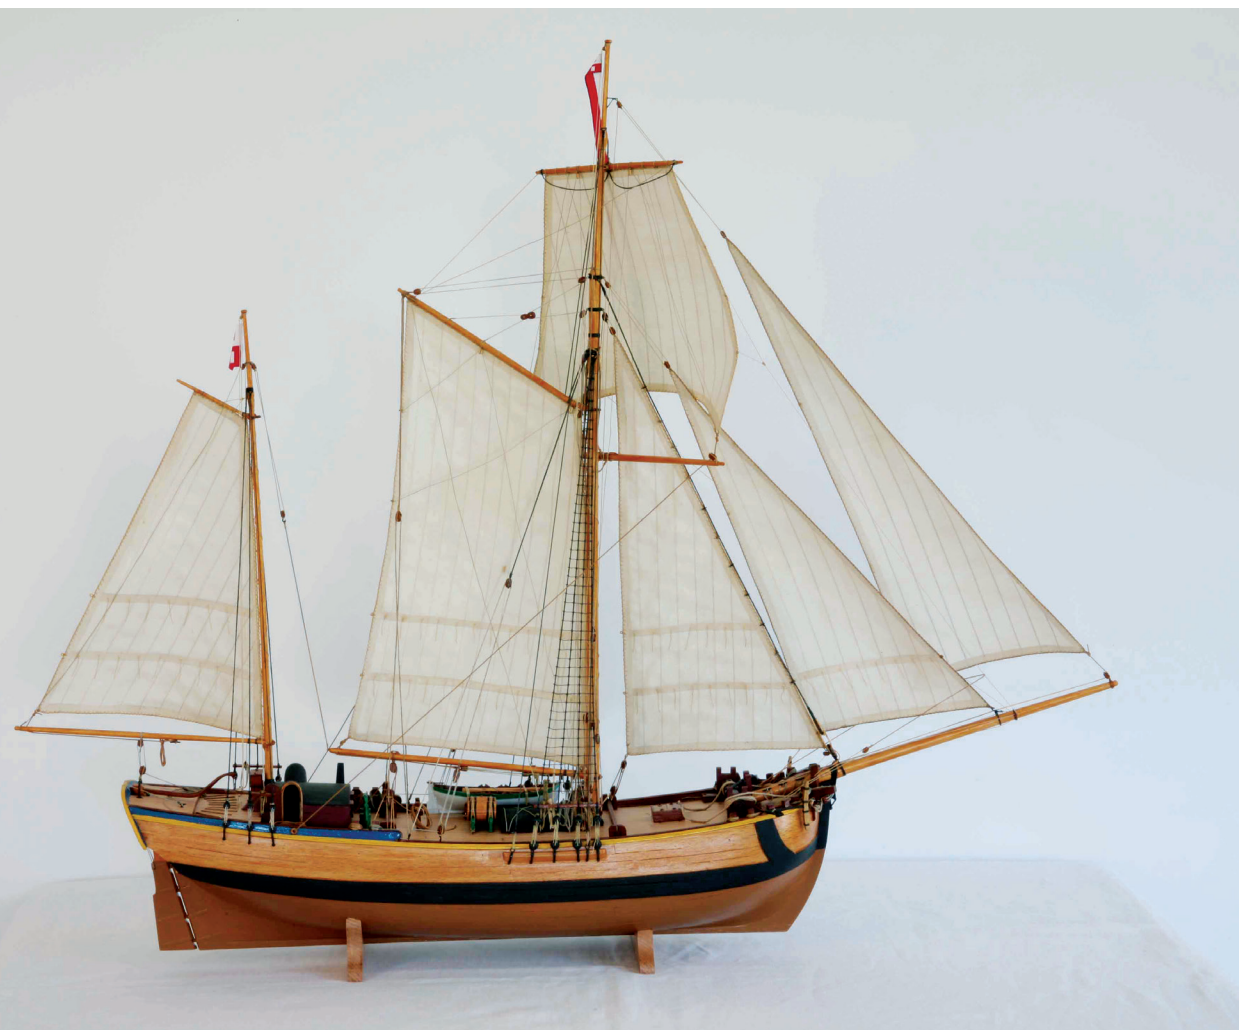
Figure 5. This is approximately what the Koster wreck might have looked like.

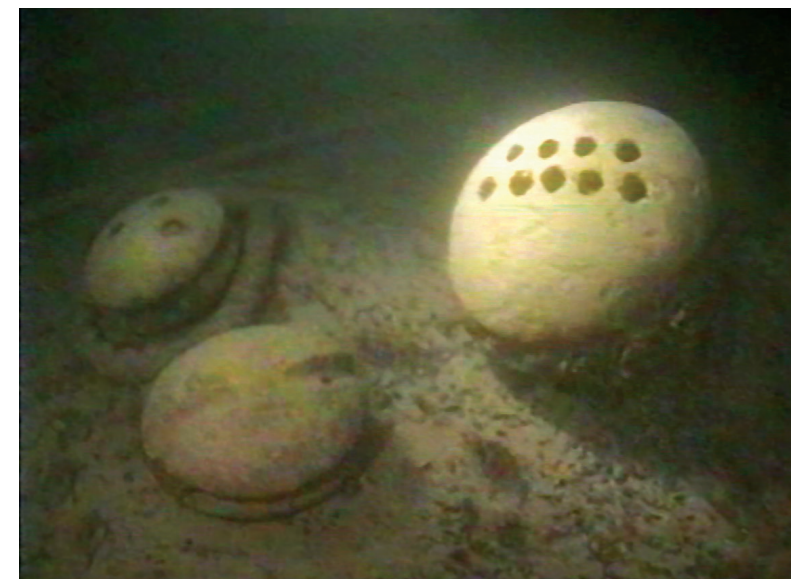
Figure 9. Dead eyes and a block 1990s.
Photographer unknown, SMTM.

Shortly after the shipwreck was discovered, further along on the portside, there lay a fallen mast, probably the mainmast, resting on the bulwark with its tip in the seabed. It is no longer visible on the film from 2009 and now probably rests on the bottom next to the ship – probably as a result of damage from anchoring or buoying. Contemplating, I swim on ahead. Next to the main mast hole, at the bulwark on the starboard side, I see three blocks and dead eyes that are some of the objects visible in all the film footage since 1995 when the shipwreck was found. Therefore, they are interesting objects for comparison. In the first films, the cordage around the dead eyes still remains. This has since disappeared, and the objects have been moved around.

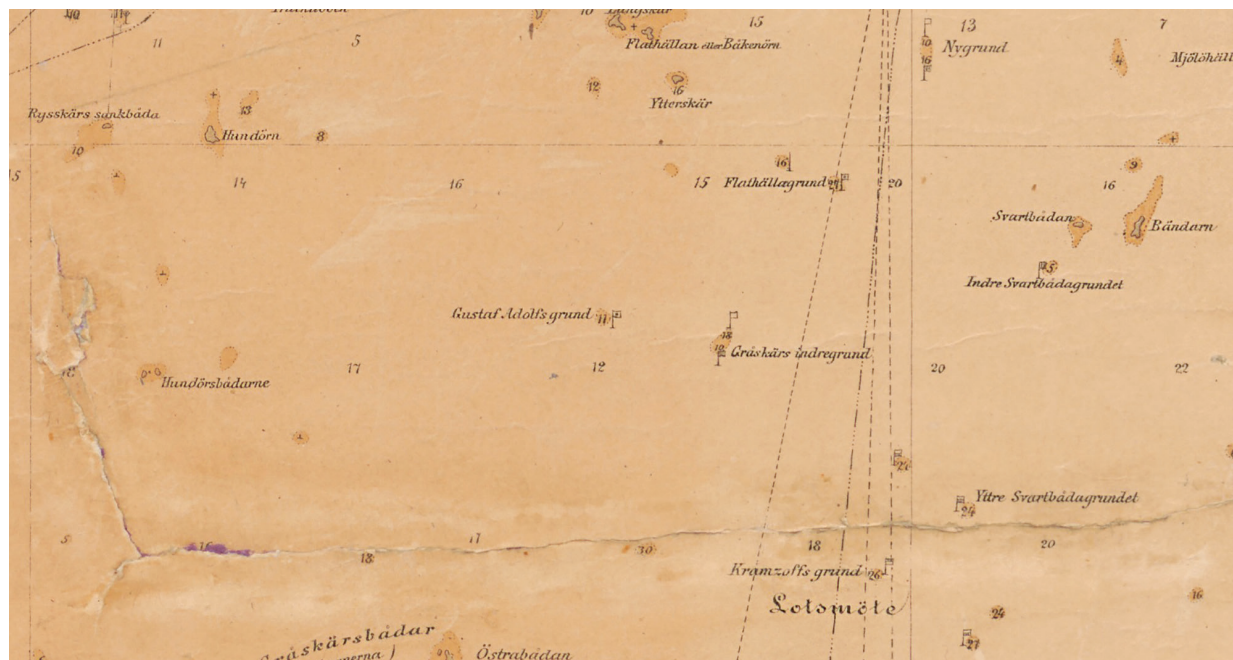
Figure 1. The shoal on which the Kronprins Gustav Adolf grounded. The chart from 1880. Map: The Karta öfver Finlands skärgård, Porkala-Helsingfors-Willinge, utgifven år 1880 af K.G.Ekebom. Meri- ja vesistökartat (Vesistökartta A 19/- -), Kansallisarkisto (The National Archives of Finland).

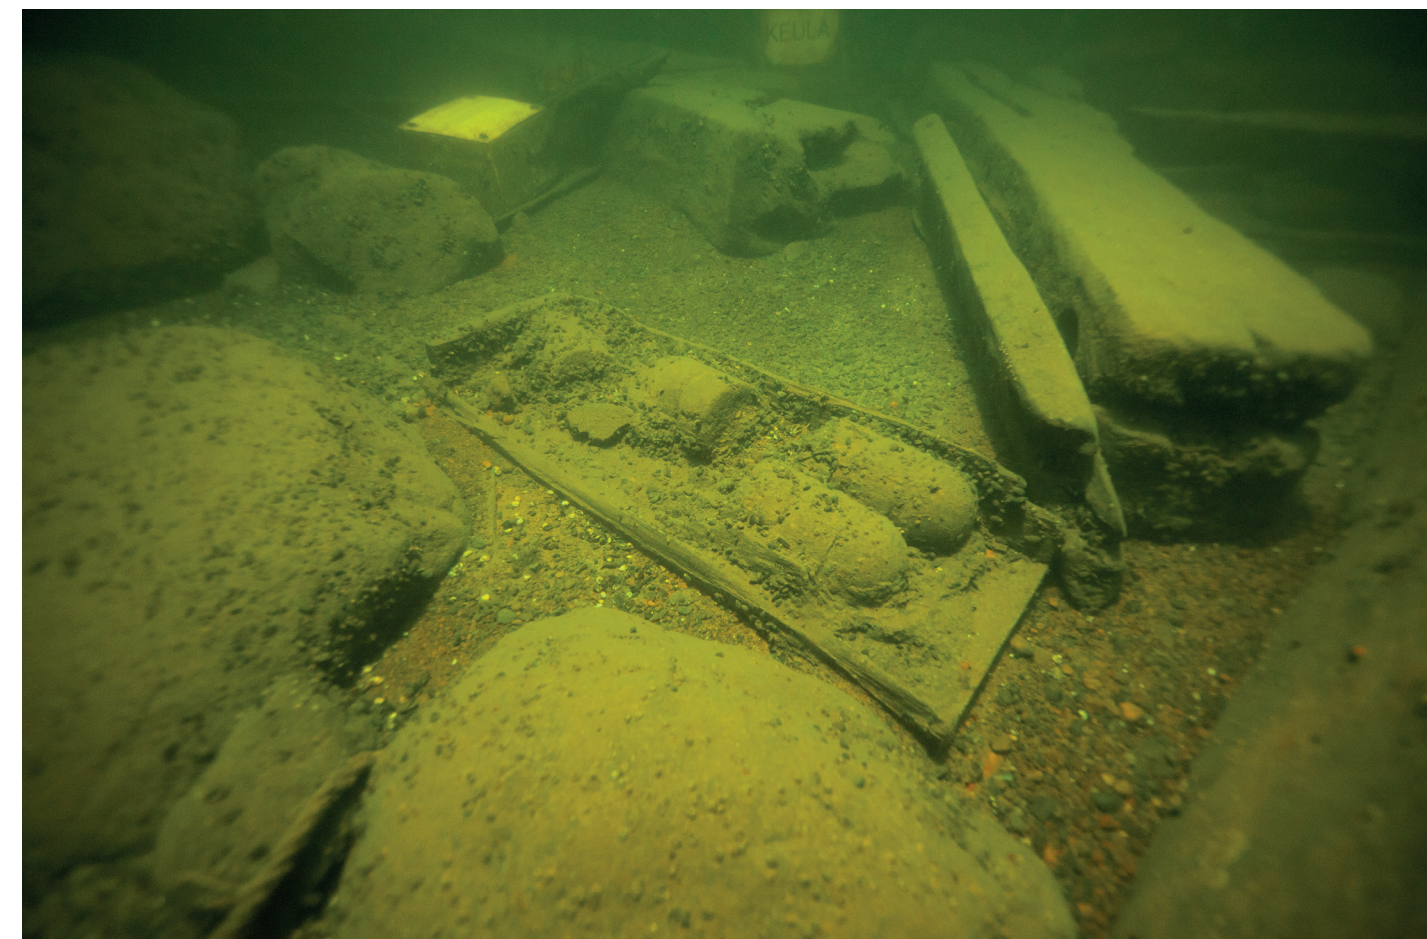
Figure 3. An ammunition chest. Photo: Jesse Jokinen.

other loose artefacts and ships equipment like ropes (Fig. 2 and 3). There is a large, bent iron anchor in the middle of the wreck (Fig. 4), and another anchor just outside the aft. The cast iron guns are covered by a thick layer of rust. The massive oak structures of the wreck are in good condition. Scattered around the wreck there are some large structural parts of the hull. The length of the wreck is nearly 40 metres and the width approximately 15–16 metres (Tikkanen *et al.* 1997).

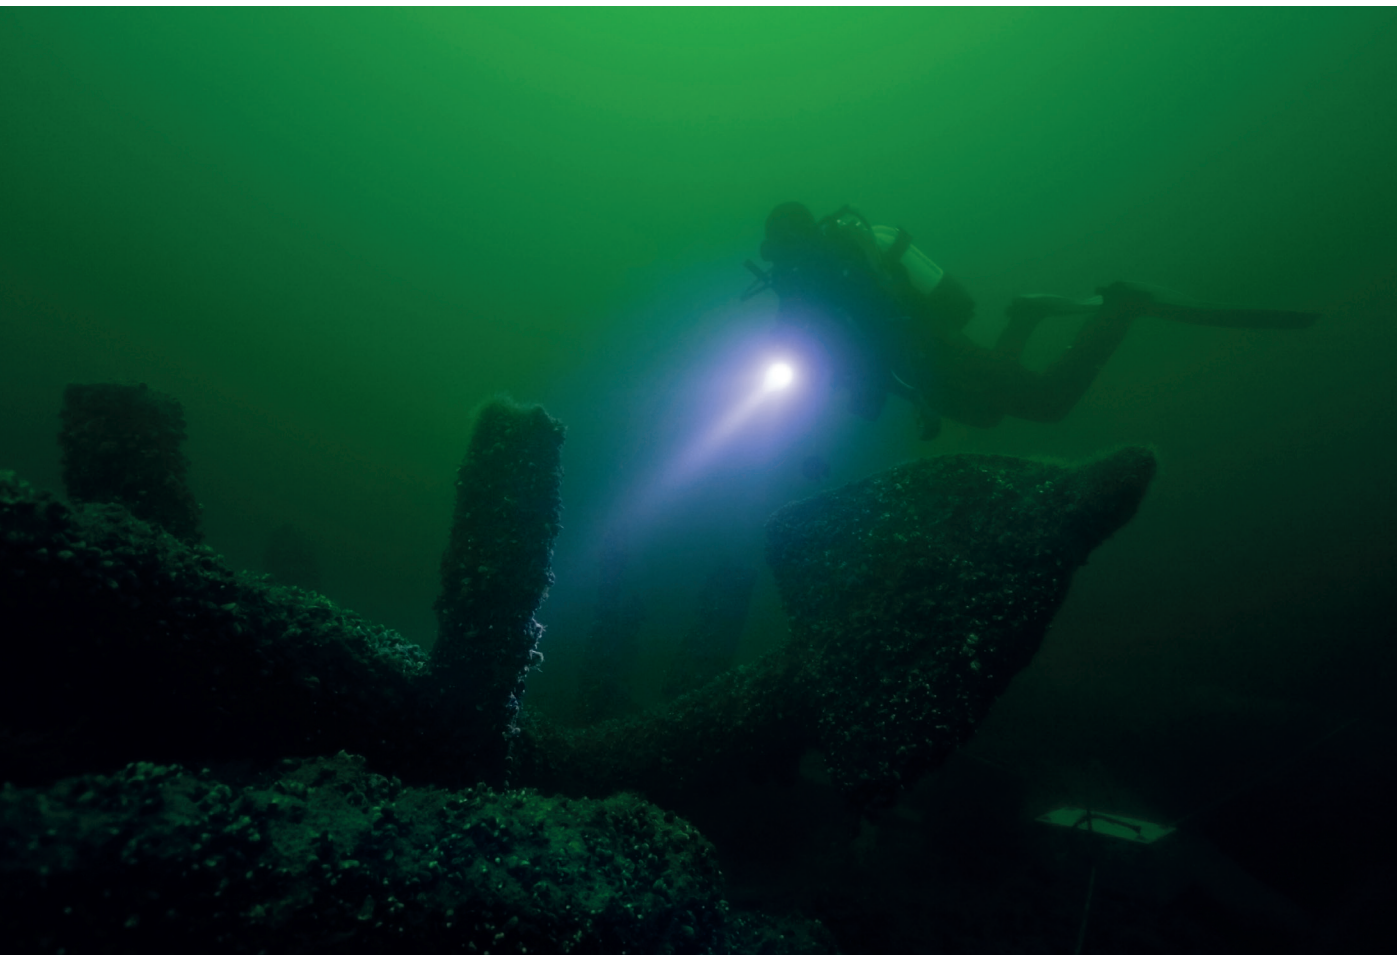
Figure 4. An anchor in the middle of the wreck Kronprins Gustav Adolf. Photo: Jesse Jokinen.

Two anchors have been found at the wreck site, one in the middle of the wreck and the other behind the stern. They are both stock anchors, the wooden stock of them both have been destroyed. A ship of the line had many heavy anchors. There were two anchors; the port side was called the "daily anchor" and the one on the starboard side "mooring anchor". The port anchor was normally used. There were two anchors in amidships also for emergencies. In addition to these, there was even a reserve anchor stored upside down in the hold. All the anchors were of the same weight, though some sources insist that the starboard emergency anchor and the one stored in the hold were the heaviest. There were also a sea anchor and a couple of kedge anchors on board (Webe 1986, 166; Färnström 1993, 68; Hägg 1941, 38; Harris 1998, 231; Stjerncreutz 1982, 19–22; Tikkanen 2000, 50; Chapman arkivet, SMM).

The arms of the anchor found at the middle of the wreck point aft; if it is the anchor stowed below decks it must have fallen towards the aft of the vessel. The shank of this anchor is 5,3 metres long and the width between the flukes is 3,30 metres. The anchor is bent in the middle of the shank. There are no inscriptions on the anchor. The anchor's arms are somewhat bent, which is typical for Scandinavian and Dutch anchors of the time as opposed of the to the British anchor with straight arms (Marx 1985, 52; Tikkanen *et al.* 1997). The anchor outside the wreck of Kronprins Gustav Adolf's wreck site has not been measured.

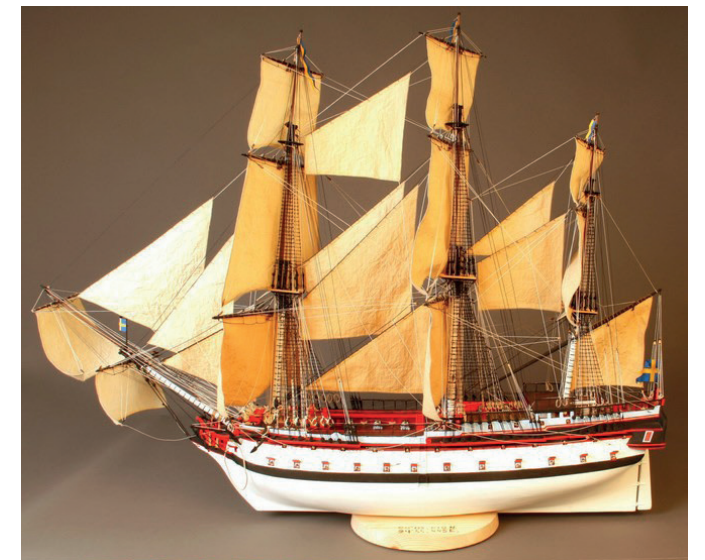
Figure 5. A model of Kronprins Gustav Adolf made by Marko and Anne Torvinen. Picture: Archives of Finnish Heritage Agency.

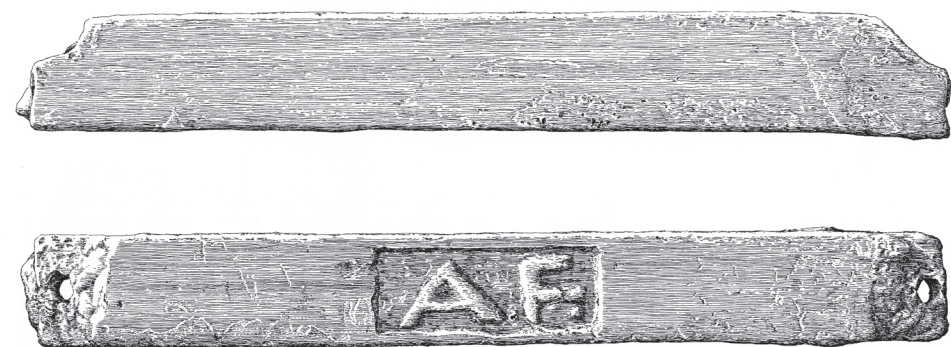
Figure 6. The iron bar used as ballast in the ship.

The letters AF mean most likely *Arméns flotta*, the coastal fleet of Sweden.

Ballast was used to stabilize the vessel. It was placed as low as possible in the hold. Traditionally the ballast consisted of sand or stones; using metal bars represented a modern trend. Iron bars had been used in Sweden since 1748. Iron bars were heavier than e.g. a stone of same dimensions and thus saved space. Bars were also easier to handle, when the ballast had to be moved. Chapman recommended using iron bars with a layer of washed gravel on top of them. Also pieces of cannons, anchors and old cannon balls were used as ballast. Chapman considered 1/10 or 1/11 part of the vessel's displacement as the required amount of ballast (Hägg 1941, 41, 114; Harris 1998, 232)²³.

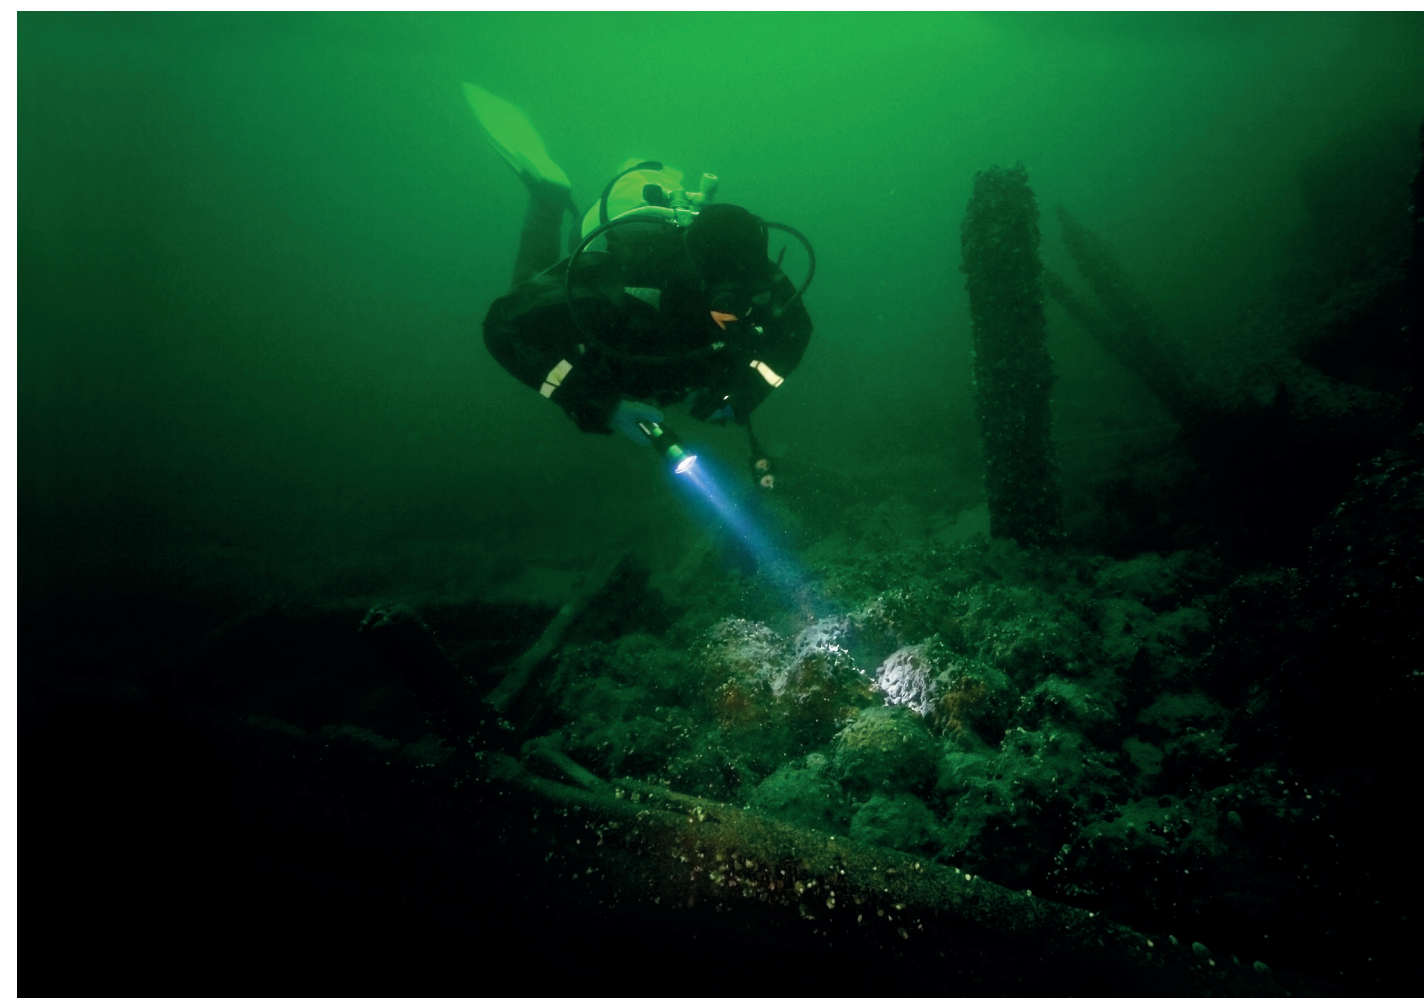
Figure 8. Remnants of cannonballs.

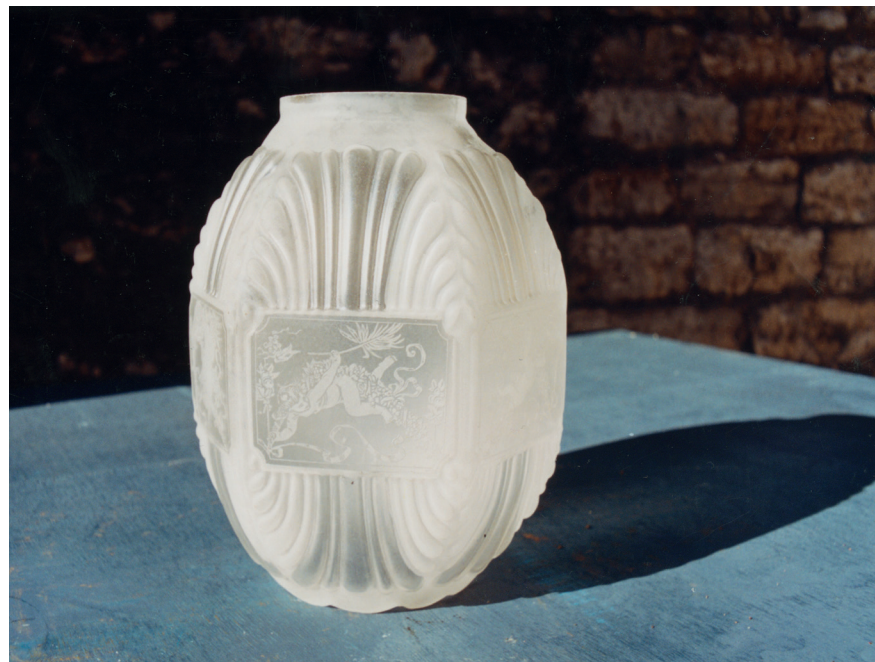
Figure 1. A lampshade was found on the wreck and retrieved by the Estonian Maritime Museum in 1997. Photo: Vello Mäss, MMF4163.

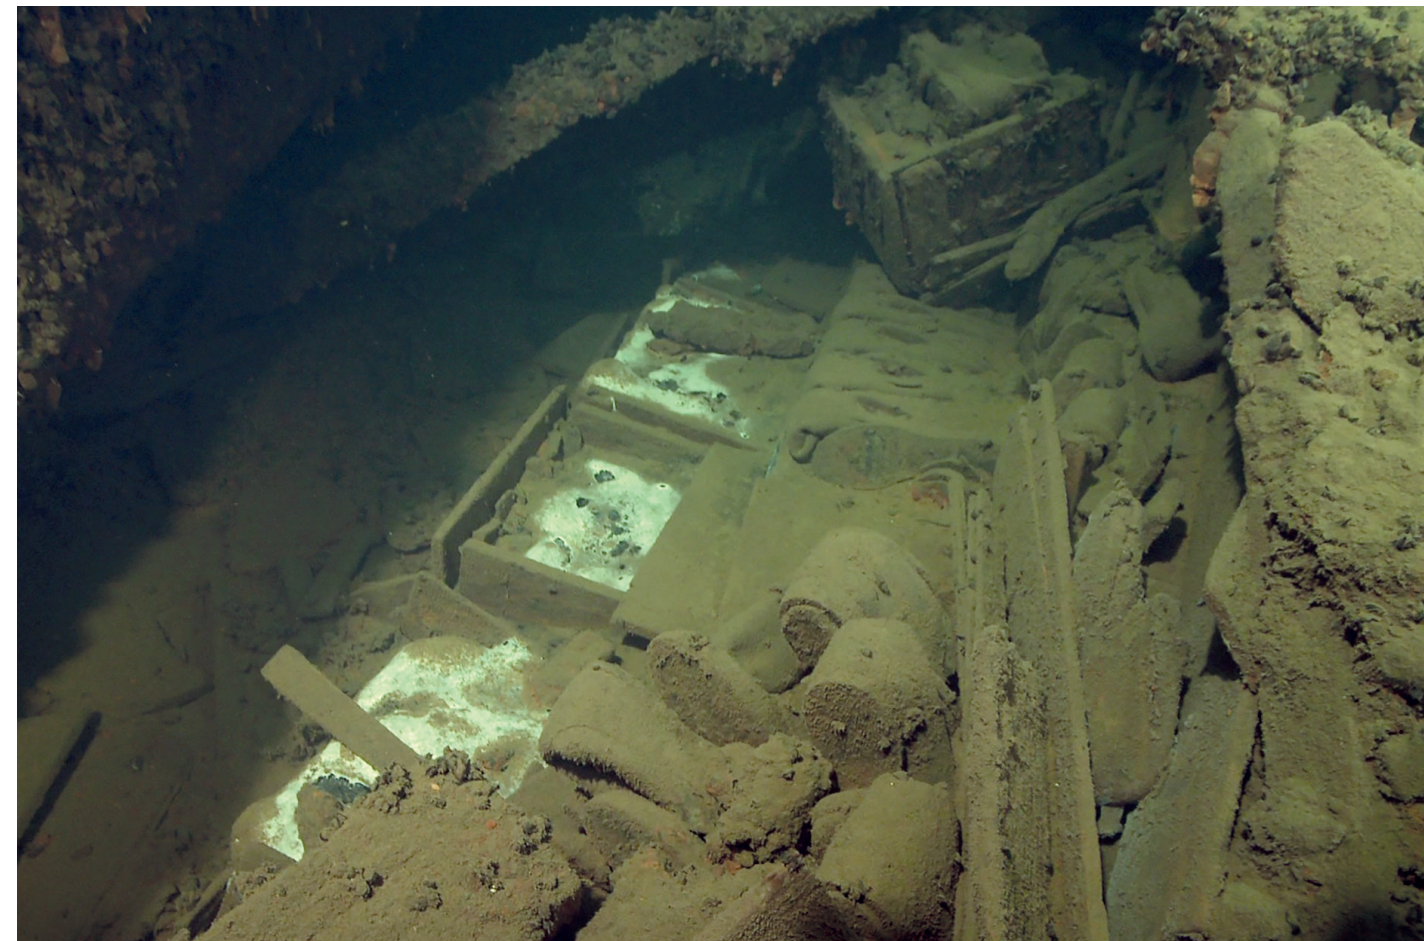
Figure 14. There were about 50 cars on board the E. Russ. Photo: Jouni Polkko 2013.

The E. Russ carried goods for almost 2 million dollars, incl. cars. In addition to this, it carried spare car parts and two motorcycles. The hold of the ship mainly contained food: salted meat, bacon, sardines, oleomargarine, vinegar, dried potatoes and carrots, turnips and onions, plums and bread, marmalade, condensed milk, coffee and tea. The ship also carried tobacco, cigarettes, candles, towels, boots, clothes, medication. 102 barrels of alcohol had been placed on the deck of the ship (ERA.73.1.614).
