# “Riverbanks: how to achieve a coexistence of biodiversity, recreation and flood retention”

Project Partner:  
**Kuldīga District Municipality**

2020

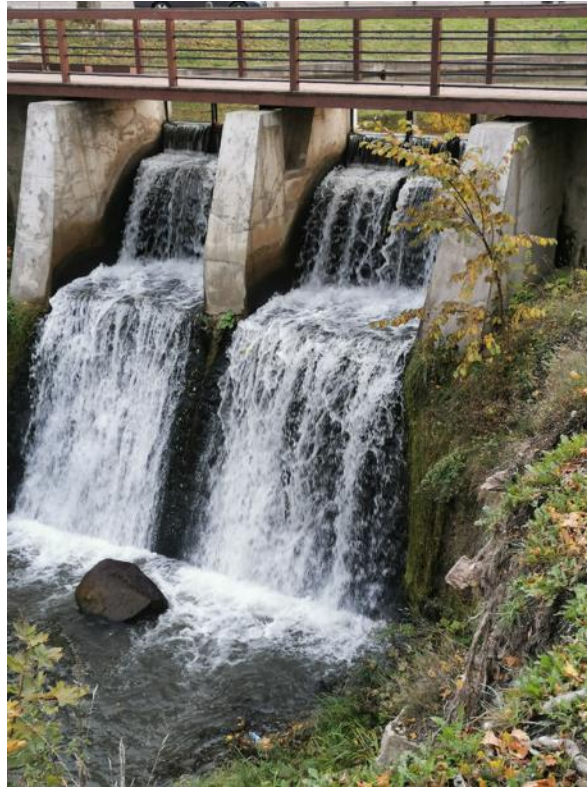
*Figure 22 Aleksūpīte waterfall and mill dam (photo I. Gavēna, 2019)*

There is an artificial float created on the river Alekšupīte - a former mill lake maintained by an existing dam (Figure 22). In general, the downstream area of Alekšupīte has been substantially transformed over time, both during the construction of the Order’s Kuldīga Castle and later by setting up the mill. An artificial spill and an artificial overhead has been created to ensur the operation of the mill. When installing a mill floodplain, the riverbed was artificially deepened below the floodplain, possibly by cutting the dolomite material and using it in construction. It is possible that there has already been a small waterfall originally, which has been substantially artificially elevated, both by building a dam and by deepening the bed. In the absence of any historical evidence of Alekšupīte in the area prior to its transformation, it is virtually impossible and pointless to detail the extent of the changes at this time.

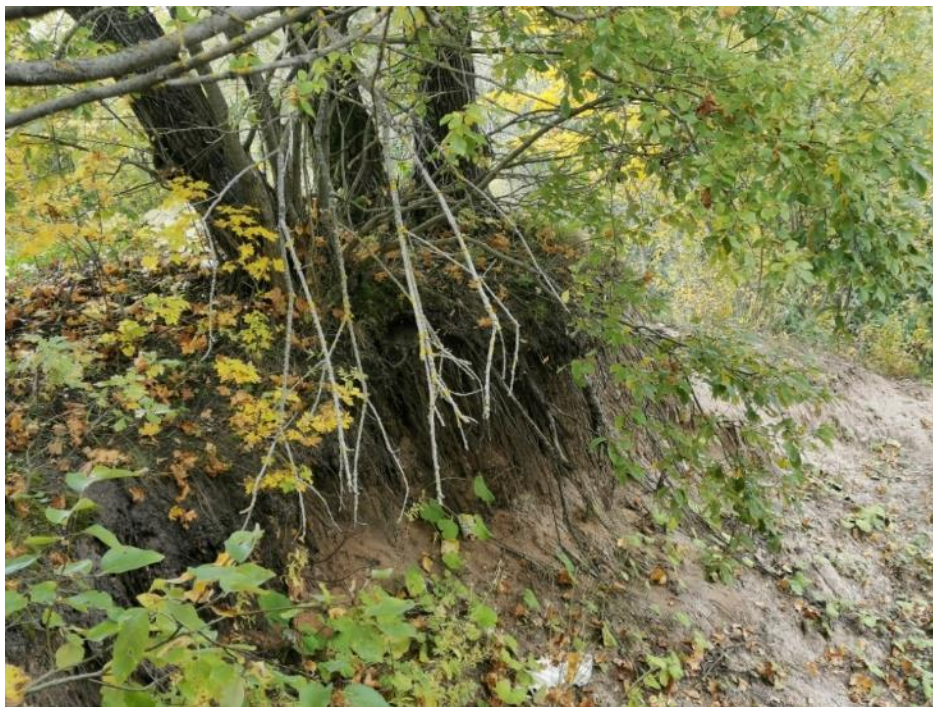
*Figure 27 Sand material collapses Venta's left bank, Black Kolka (Photo I. Gavena, 2019)*

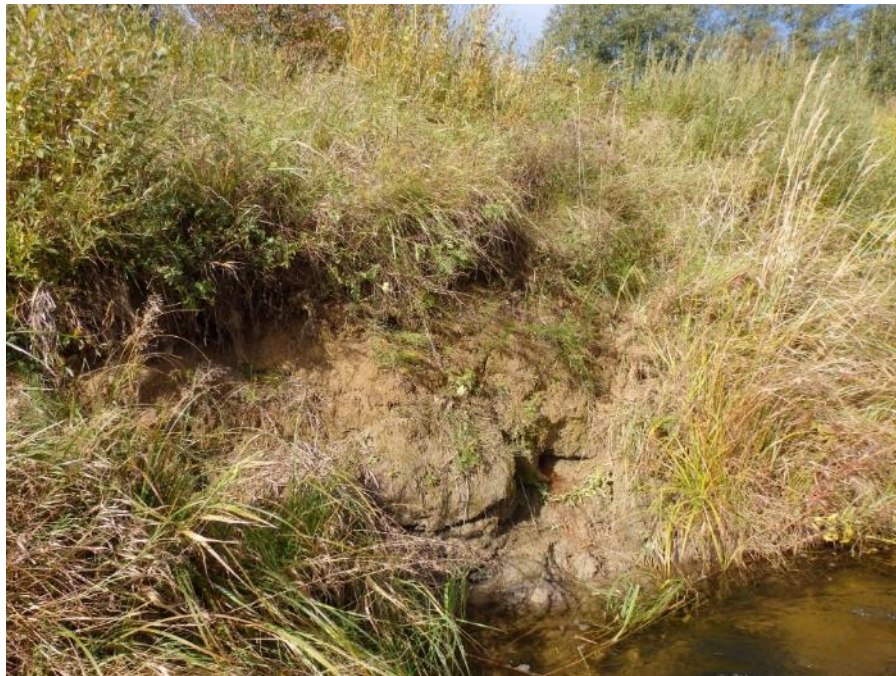
*Figure 28 River eroding activity, signs of sufusion (Photo L. Gr̃nberga, 2019)*

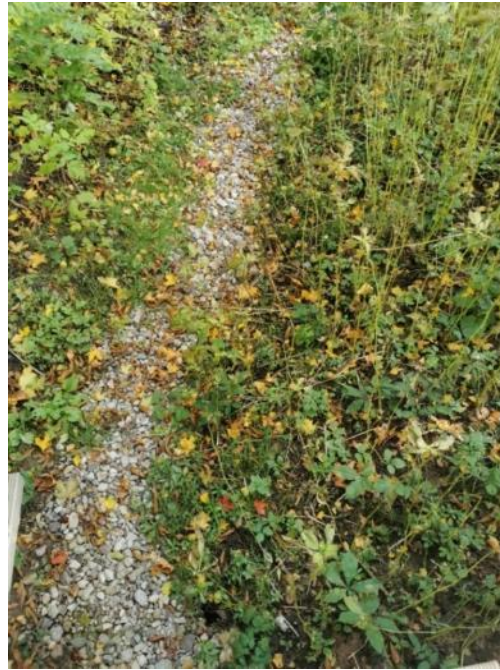
*Figure 29 A ravine, the base of which is protected from deepening by the burial of pebbles – rubble, on the right bank of the Venta in the section between Ventas Street and Vidus Street (photo I. Gavēna, 2019)*

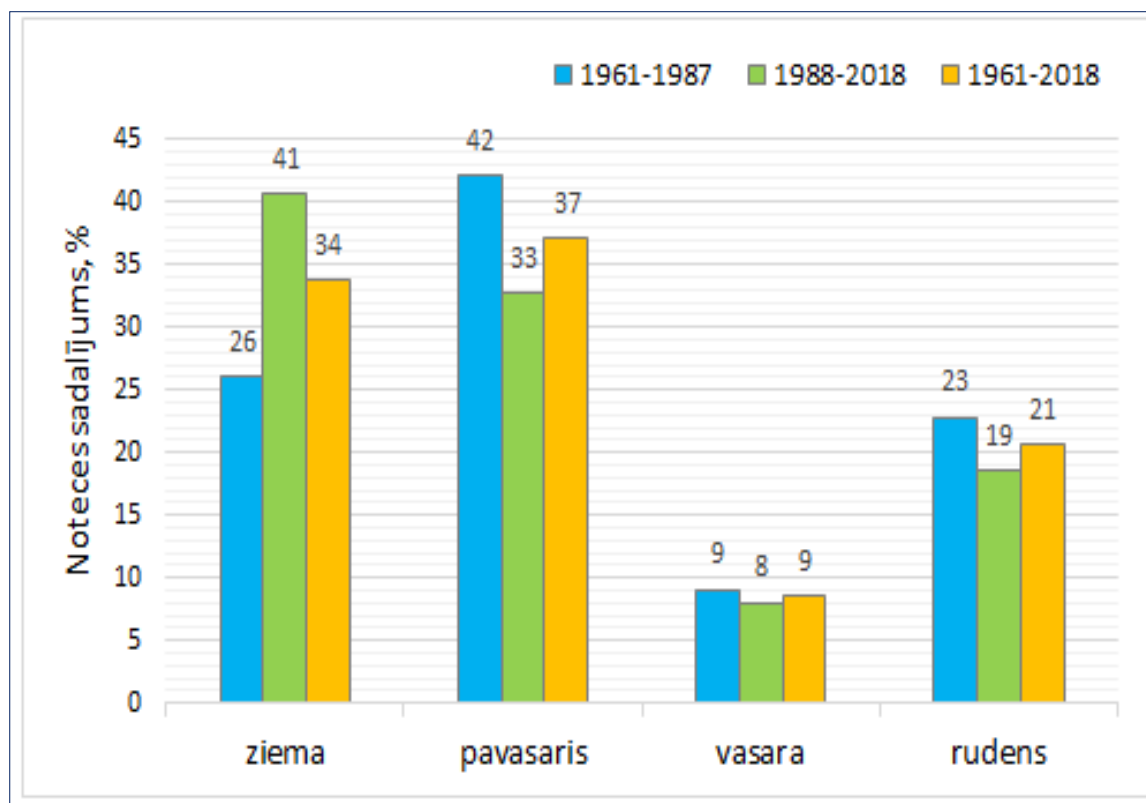
Figure 32 Season change in runaway in Ventas by periods

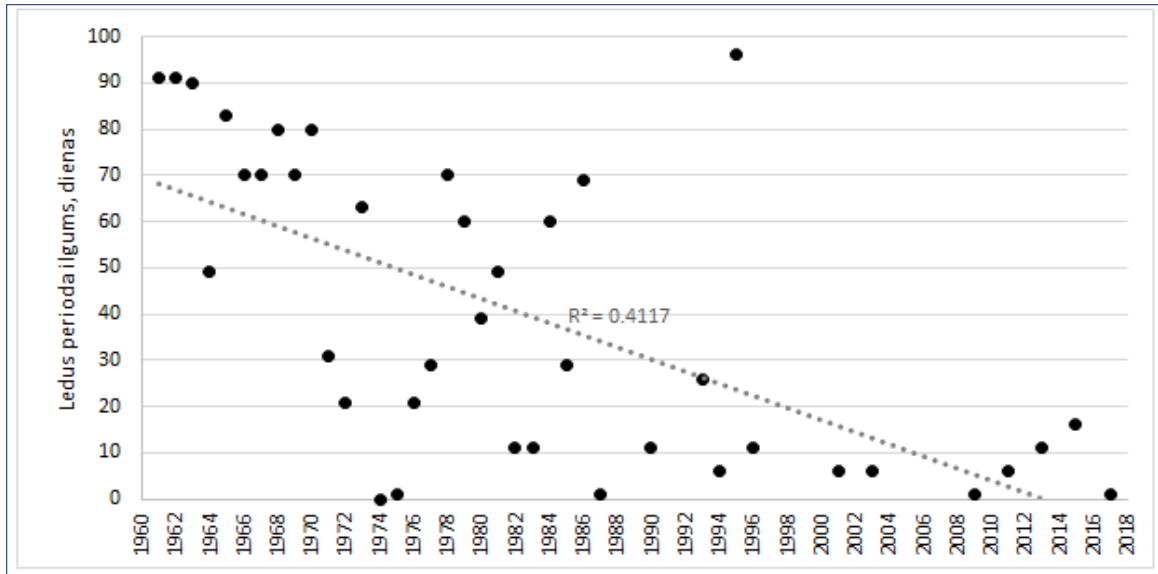
Figure 33 The duration of the ice period 1961-2018

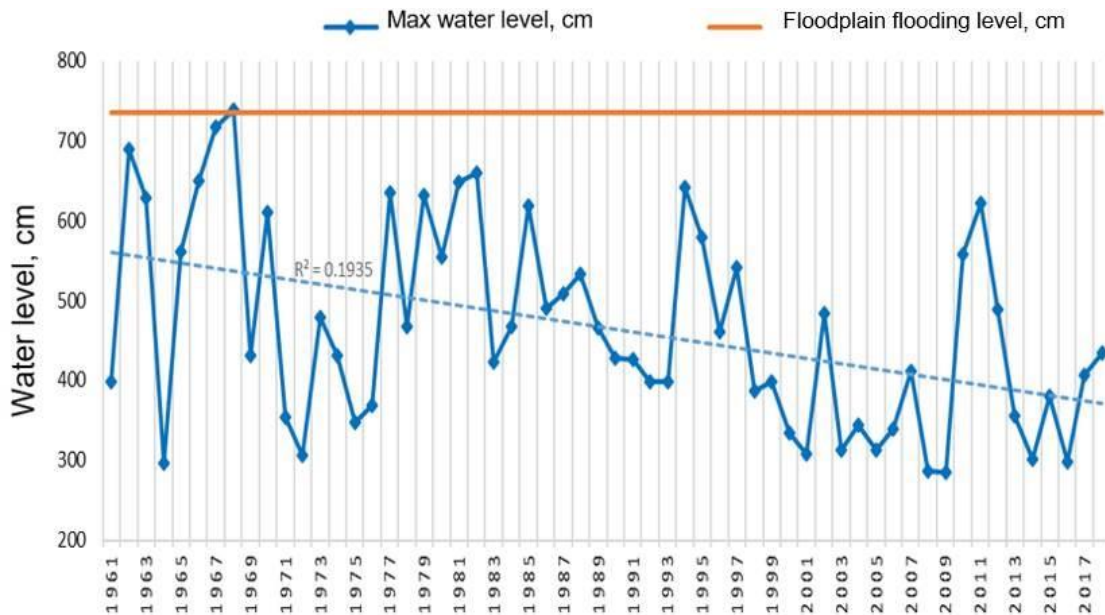
Figure 35 Maximum water levels in Venta - Kuldīga 1961-2018

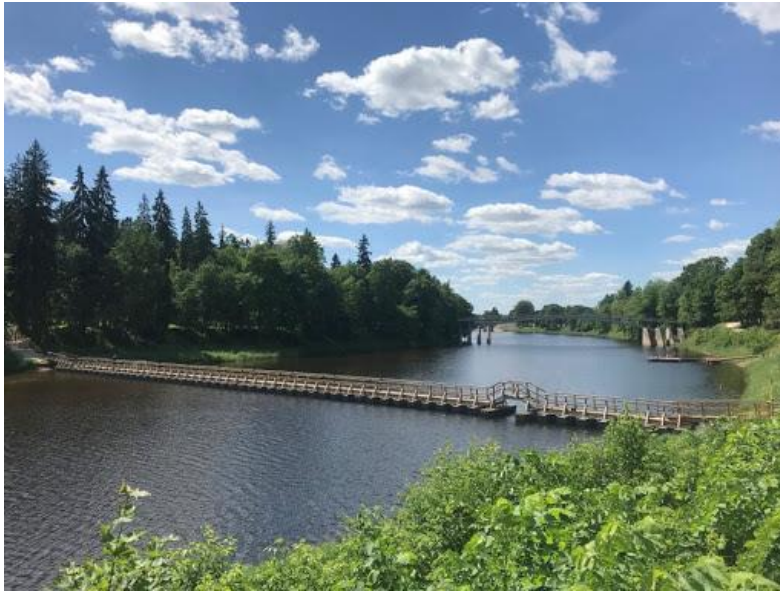
*Figure 60 Example of a pontoon footbridge, Latvia (Ogre city):*  
[http://www.ogresnovads.lv/lat/pasvaldiba/projekti/zinas\\_\\_jaunumi/?page=0&doc=33797](http://www.ogresnovads.lv/lat/pasvaldiba/projekti/zinas__jaunumi/?page=0&doc=33797)
