Ports Energy and Carbon Savings

Deliverable 3.8.2

Report of the Installation, pre-testing and Certification of PECS supported (PP8) Link-span for Portsmouth City Council

Project No. 2S03-009

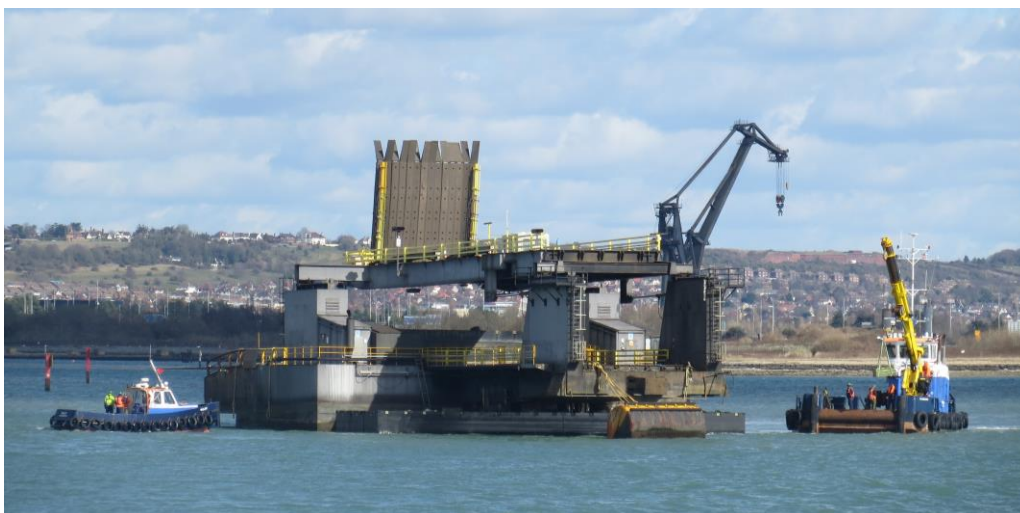
Photograph showing Old Linkspan at moorings following successful removal

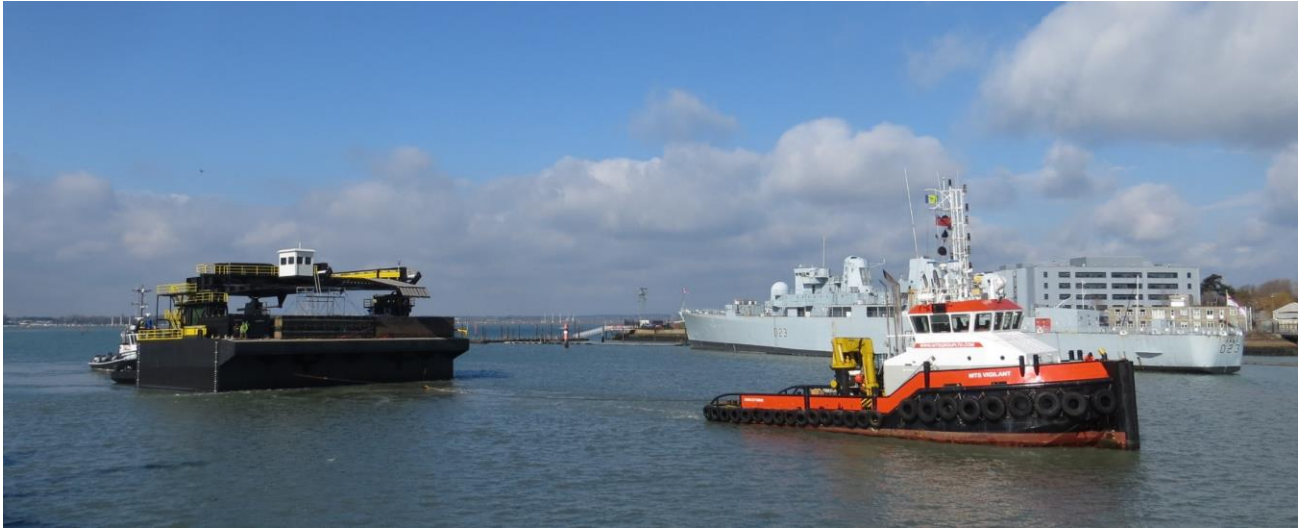
In with the New

With the Old Linkspan now removed from the bank-seat the new linkspan was on its way from Rotterdam having sailed on 3rd March. The New Linkspan arrived in Portsmouth towed by MTS Vigilant on 7th March when it was delivered (towed) direct to No 4 berth and secured further down from the linkspan position to the East of the berth.

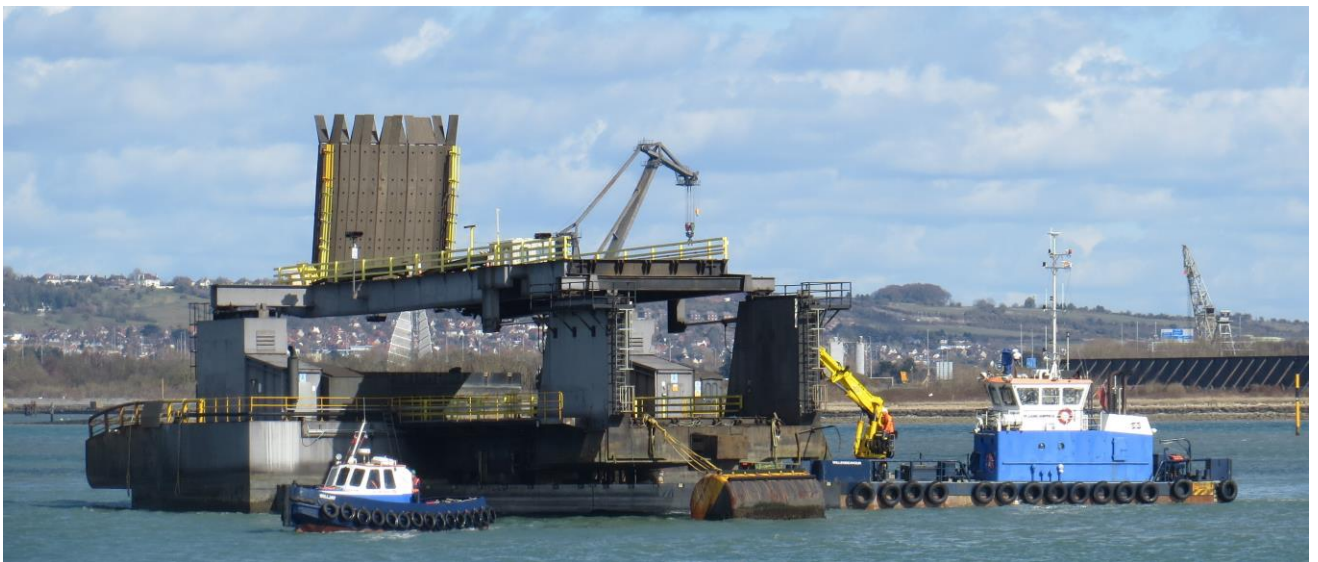
Out with the Old

With the new Linkspan safely alongside berth 4, the old linkspan was prepared for departure on the 8th and towed to a mooring in Portchester Creek prior to her being re-used/disposed of.

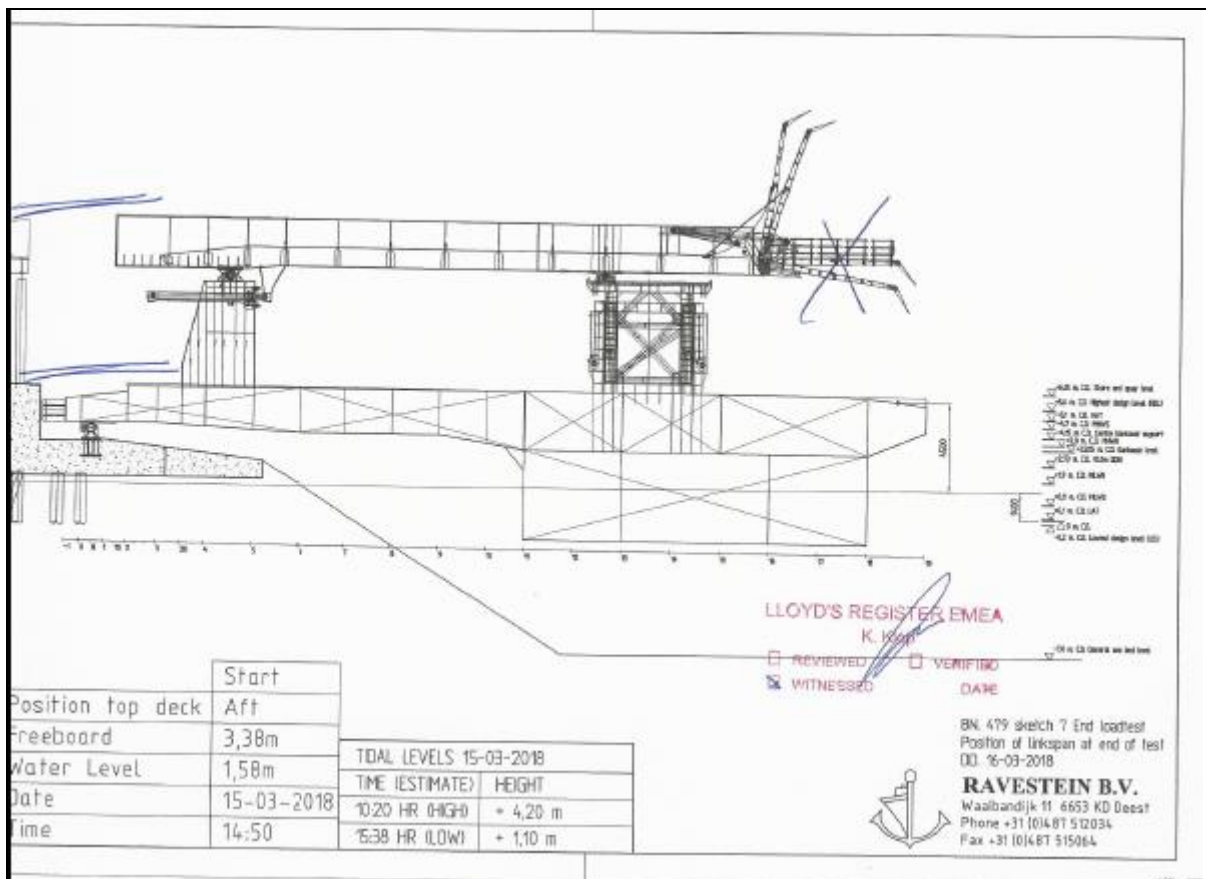
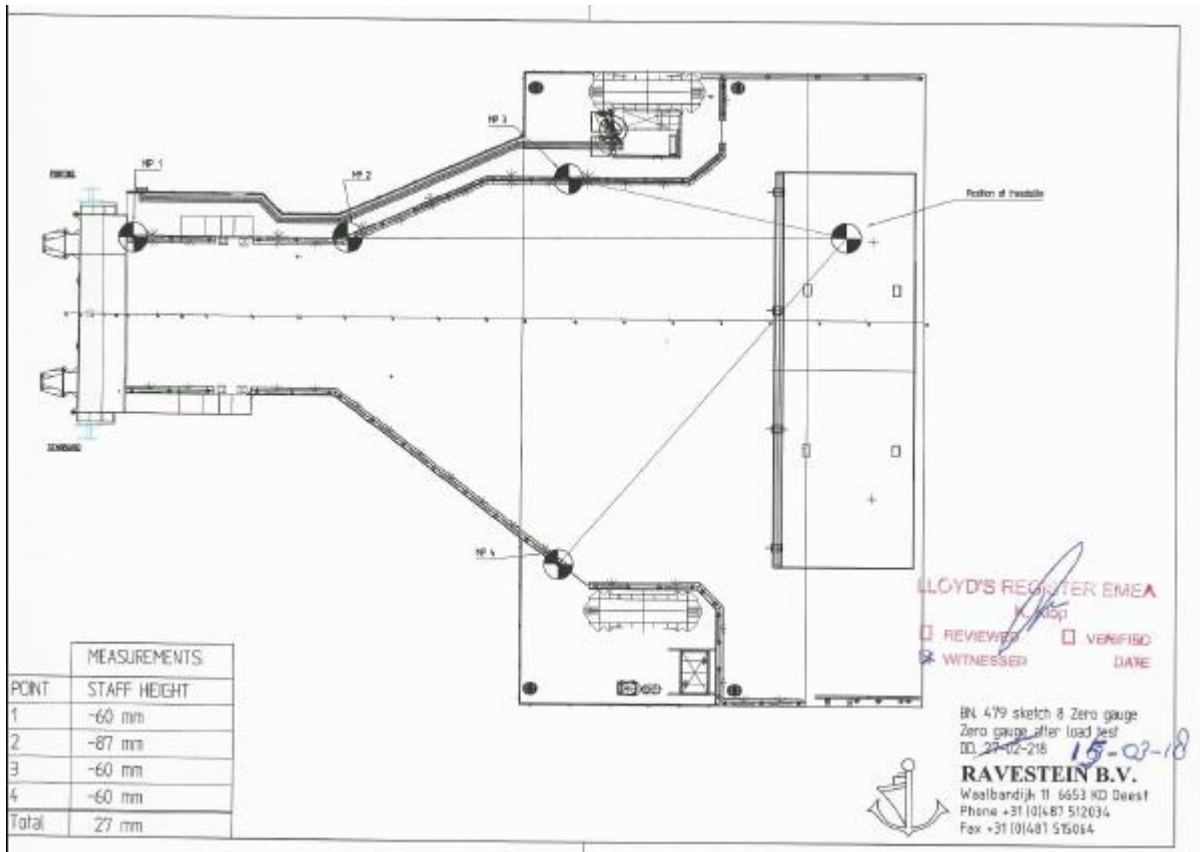
The diagrams reproduced below are the 'as built' diagrams initialled by the attending Lloyds Surveyor shown with the Lloyds stamp certifying the Linkspan as meeting their requirements for Lloyd's Register classification ✕AT Passenger and Vehicle Linkspan.

The linkspan was designed and constructed in accordance with, and classified as, a Lloyd's Register classification ✕AT Passenger and Vehicle Linkspan.

The testing of the new linkspan was specified as being to 1.1 times the worst case scenario over a full tidal cycle. In this case the full tidal cycle was taken to mean from HW to HW rather than a 24hr cycle of tides.

The sinkage of the linkspan under full load was to be no more than 350mm.

The testing took place on 27th March with water loads using the modular units previously used for floating the linkspans placed upon the upper and lower decks of the linkspan simulating the 110% loading stipulated in the initial tender documentation.

The testing was completed after the full tidal cycle and the Certification completed by Lloyds.
