# WP 1 Living Lab Climate Adaptive Flood Defences Survey Overview Report

Version: 1.0 2022-12-15

The present document constitutes the Survey Overview Report within the framework of Work Package 1 "Living Lab Climate Adaptive Flood Defences" of the Interreg Polder2C's project (**Deliverable 1-1-2** and **Deliverable 1-5-1**).

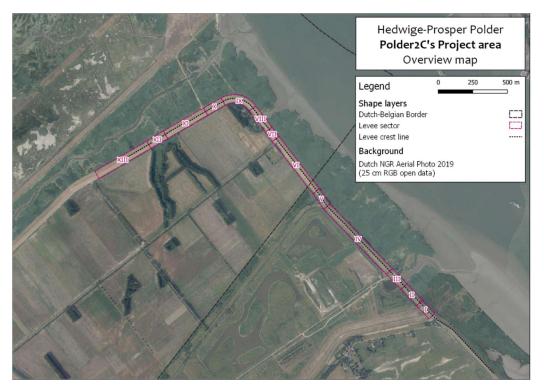
Figure 1: Overview map of the Polder2C's project area in the Hedwige-Prosper polder.

The study area for the Polder2C's project comprises the levee that protects the polder from the Scheldt river. The study area has been divided in 13 levee stretches (Figure 1) as an internal reference system. Sectors I to V are situated in Belgium; sectors VI (except the southernmost part) to XIII are situated in the Netherlands.

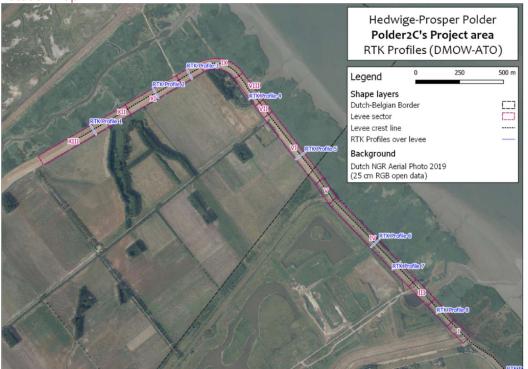
Figure 2: Location of the T0 topographic profiles.

Description In July 2020, DMOW-ATO has produced a set of 8 perpendicular profiles acquired with high ((sub)centimeter) accuracy using Real-Time Kinematic (RTK) GPS equipment over the levee in HPP and one profile outside the HPP area ("Profiel 9" on Doeldijk).

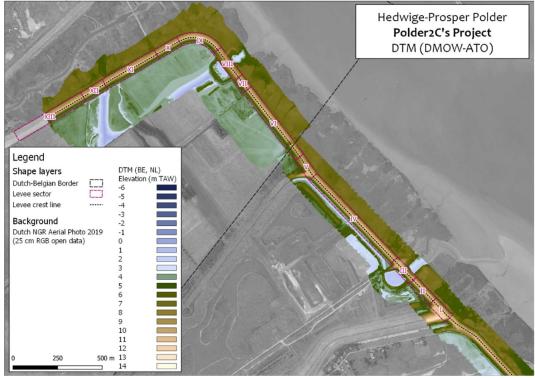
Figure 4: Overview map showing the Digital Terrain Model.

Description In June 2020, a **drone flight** was carried out by DMOW-ATO for aerial imagery. Through stereo-imagery, a detailed Digital Surface Model (including object heights) and Digital Terrain Model (ground surface height) could be generated.

Result The images below shows a rendering of this DTM as an overview, as well as a detailed image. The pixel size of the data is 4.8 cm in X and Y direction. Dataformats: GeoTIFF; PointCloud; 2D, 2.5D and 3D mesh objects.

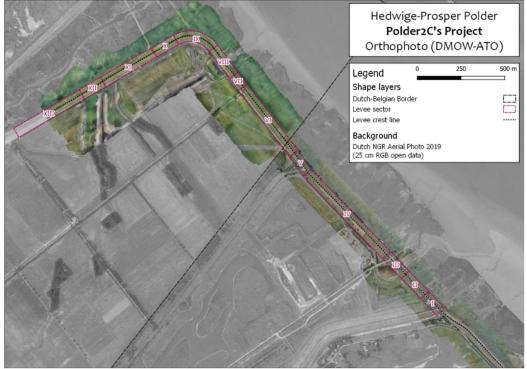
Figure 6: Overview map showing the T0 Orthophoto.

Description Aerial imagery acquired by drone flight over the levee acquired in June 2020. The images are corrected to be georeferenced (orthorectified) to yield a spatially correct high resolution image of the surface of the levee and its surroundings.

Result The image is available as GeoTIFF data. The Pountcloid data of the DTM (see previous paragraph) also contains RGB data. The images below portray the coverage of the orthophoto and a second image is shown as impression of the data quality and resolution.

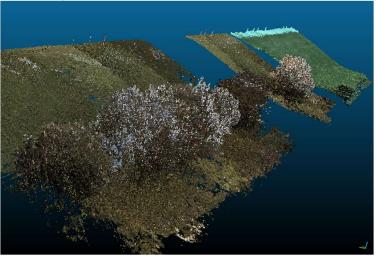
Figure 8: 3D view of T0 state 3D laser scans of Belgian test sections.

Description Laser scanning technique employed to create a 3D point cloud of the environment, yielding detailed and extensive digital terrain models. Optionally, color data is acquired in each scanning point to enable a photorealistic digital representation of the environment. Result Spatial (and coloured) point cloud data (Pointcloud E57 format; ascii pts file) State T0, T1, T2, T3, T4 surveys

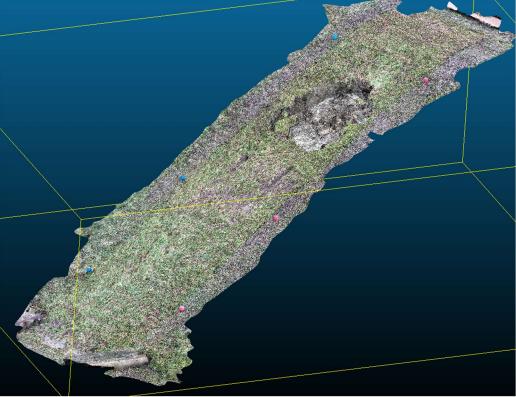
Figure 10: 3D view of the Handheld Lidar point cloud data of a damaged section.

Description Laser scanning technique created by using a smartphone and/or tablet with an integrated Lidar sensor. Results in a 3D point cloud of the environment, yielding detailed and extensive digital terrain models. Optionally, color data is acquired in each scanning point to enable a photorealistic digital representation of the environment.

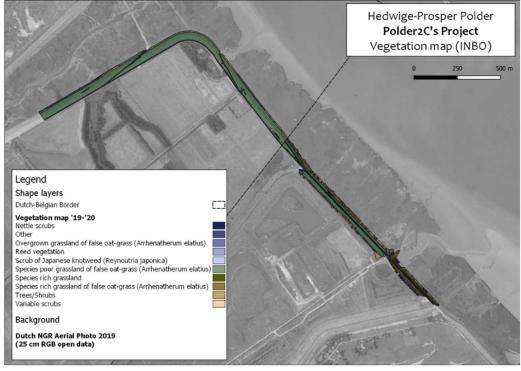
Figure 12: Polder2C's T0 vegetation map example of detail

Description During spring 2019 and spring 2020, a vegetation map of the levees in the study aread has been created by the Research Institute Nature and Forest (RINF; Instituut voor Natuur en Bos Onderzoek, INBO). The methodology is described in Vandevoorde et al., 2019. State T0 survey

Result A GIS shapefile has been supplied with polygons of 11 vegetation types and additional information in the feature comments.

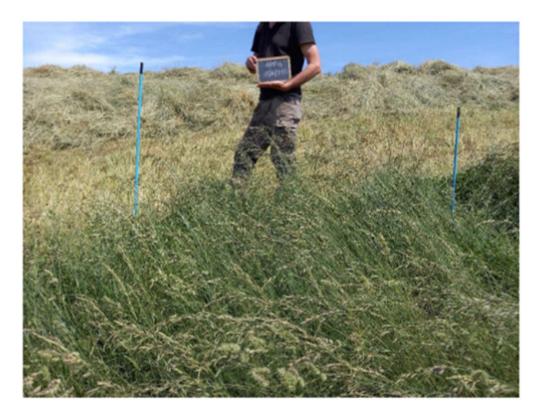
LamX (punt a)	139938.360	Vegetatietype	Type 3 Soortenarm
			glanshavergrasland
LamY (punt a)	226852.927	Aantal soorten	6
Z mTAW (punt a)	8.442	Shannon-diversiteit	1.35
LamX (punt b)	139940.358	Ellenberg nutriënten	5.3
LamY (punt b)	226850.981	Biomassa (ton DS/ha)	7.8
Z mTAW (punt b)	7.819	Bedekking (%)	75.0
Helling (*)	18.1	Worteldichtheid	matig
Helling (%)	32.8		
Expositie	Z		
Afstand kruin (m)	15 (land)

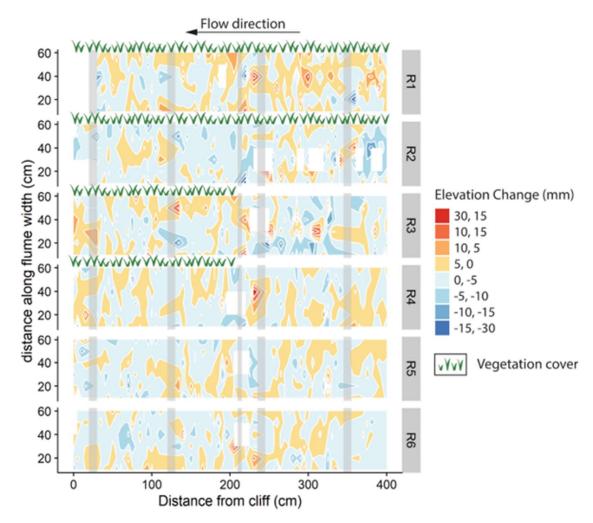
Figure 13: Elevation change measured during the experimental runs (R1, R2, ..., R6)

Description In collaboration with NWO HPP erosion resistance experiments of the tidal marsh are foreseen. University of Antwerp will perform lab tests on marsh soil samples related to erosion resistance.

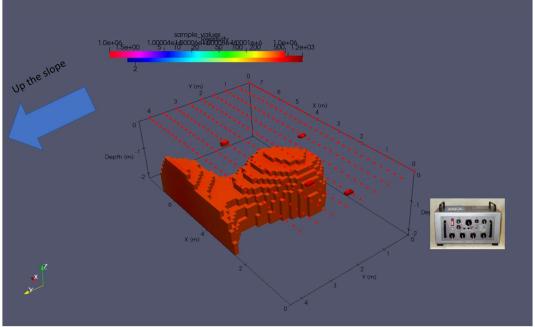
Figure 15: 3D ERT inversion image of the void created by burrow inside a levee (draft result).

Description In collaboration with Deltares, the spatial dimensions of animal burrows will be assessed via intrusive and non-intrusive methods)

Result Spatial extent of animal burrows on site based on ERT measurements, and result of other inspection and investigation activities.

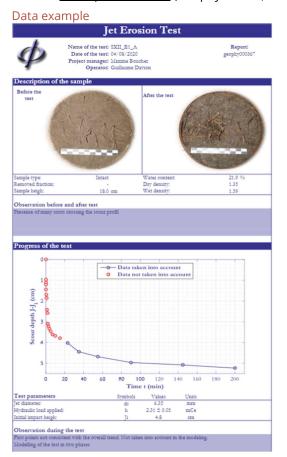
Figure 17: Example of a JET erosion test data sheet.

Description The Jet Erosion Test is a technique in which the erosion of soil by a small, highpressure water jet, is measured under controlled conditions. After modelling the properties of the jet vs the advancing of the erosion, soil strength parameters can be deducted. State T0 survey

Result The jet erosion test has been performed on 20 soil samples of the levee cover, distributed over the levee study area. The locations of the JET test samples is shown in the figure with the soil sample locations. The report is attached to this report. References

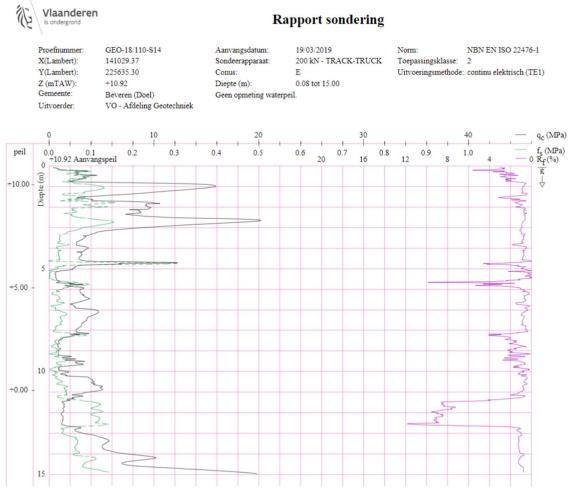
Description The classical cone penetration test consists of measuring cone resistance and cone sleeve friction while pushing a rod into the soil at a speed of 2 cm per second. Measurements with a resolution of 2 to 5 cm yield insight in the strength properties of the layers. The CPT depth goes up to 20 m.

Result Vertical profile of cone resistance, sleeve friction and derived geotechnical parameters. Layer model and properties interpretation.

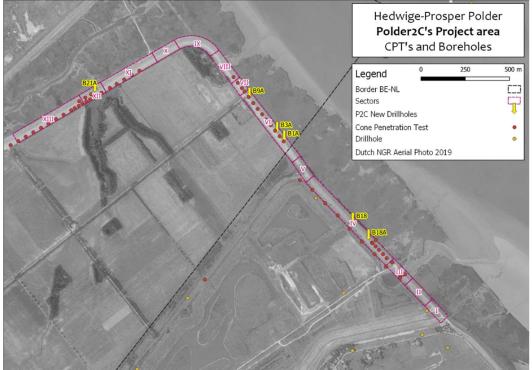
Figure 19: Drillhole map State **T0** References

Description Soil samples derived from hand or deep drilling will are subject to geotechnical tests in the laboratory.

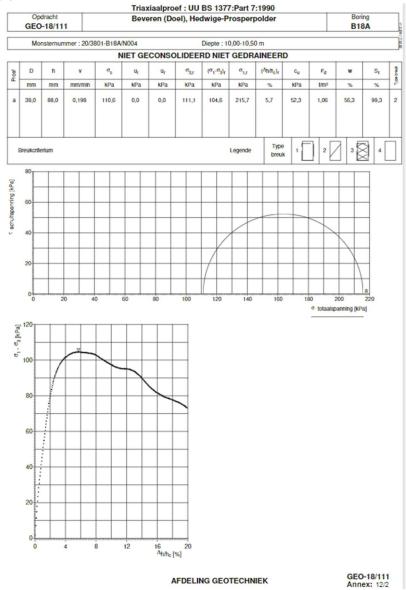
Figure 20: Example of a triaxial test data sheet.

- Shear resistance by Triaxial tests/(simple shear tests)
- Deformation characteristics by compression tests
- Permeability tests (constant & variable head)

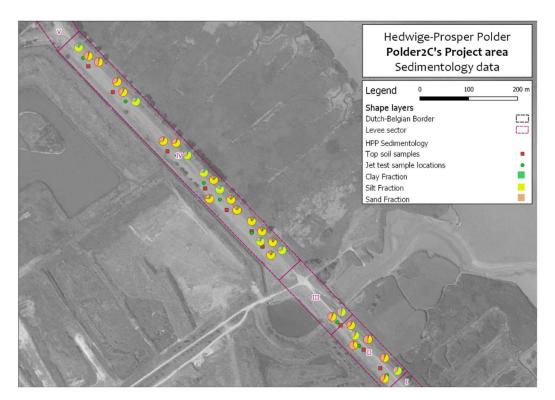
Result The soil samples are being analyzed with methods depending on the data need (granulometry, sedimentology, geotechnical parameters). The image shows the distribution of samples and the fractions of sand, silt and clay for a spread of samples. Reference

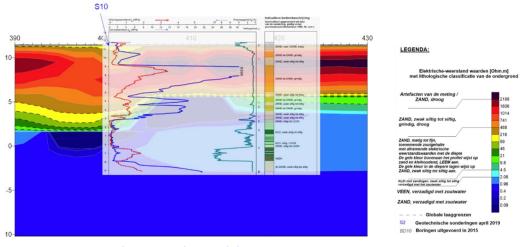
Figure 21: 2019 ERT data example (Dutch levee)

Description The ERT method uses an array of electrodes inserted in the soil to inject a small current between 2 electrodes, and measure resulting potential values between couples of electrodes. By varying the distances between injecting and measuring electrodes, the pseudo-volume or pseudo-depth of the measurement can be varied. Numerical inversion techniques are then used to calculate a resistivity model of the subsurface, which gives insight in sedimentology and conductivity parameters. ERT is carried along longitudinal and transversal transects.

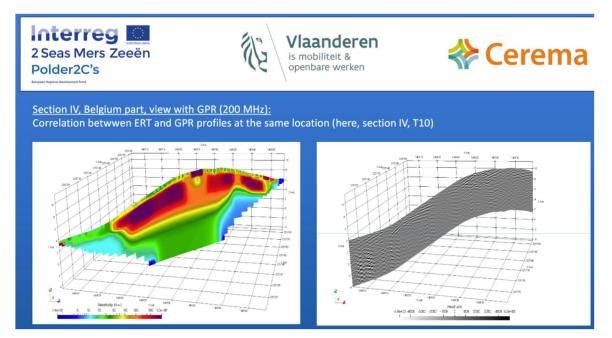
Figure 23: Example view on levee transect with ERT and GPR.

Description The ground penetrating radar is a technique that uses antennas to transmit high frequency pulses in to the soil and capture reflections on interfaces with changes in dielectric permittivity. Frequencies used are 200 and 400 MHz. GPR profiles require elaborate processing but if successful, the image can indicate layering structures below the structures. Limitations for the technique include the presence of strongly conductive elements (e.g. clays, saline water, ...).

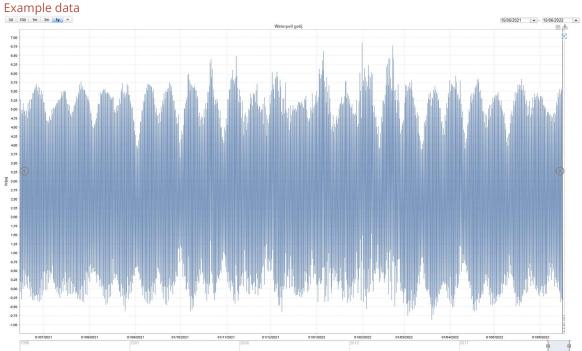
Figure 24: Screenshot of the interface to visualize and download continuous timeseries data.

Description The water level of the Scheldt River is being monitored in many stations. In front of the marsh, the Prosper tidal monitoring station, provides continuous monitoring data of water level.

Result Water level time series through <u>www.waterinfo.be</u> and available through the DDSC as a WMS service.

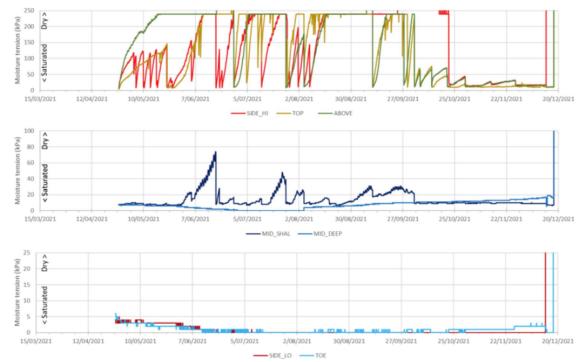
Figure 25: Soil moisture evolution in 7 measurement points at N-OF10 test site.

Description The installation of soil tensiometers (Watermark) on two sites (Dutch and Belgian location) allows to monitor the soil moisture or pore pressure in or below the levee cover layer. Result Pore pressure or soil moisture timeseries are reported in the Factual Data reports of the relevant overflow tests (in concept). The data is reproduced below and stored online. References

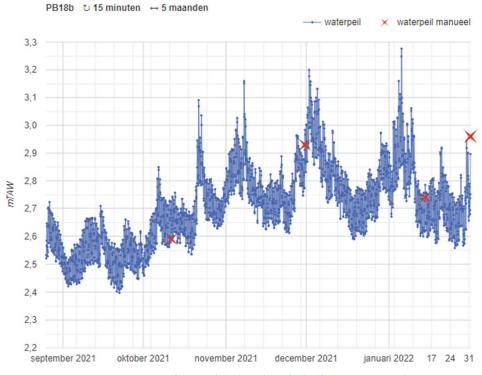
Figure 26: Diver measurement of water levels in borehole during 15 months.

Description The deep boreholes that will be installed by DMOW-GEO, will be equipped with water level divers to monitor the head levels inside the levee.

Result Hydraulic head timeseries in point locations on the dike. Data will be extracted at fixed intervals and provided to the project team (no real-time connection).
