The REDACt project Educational Hub

Earthquake Damage to Structures and Infrastructure

Deliverable No: D.T3.5.1e (EN)

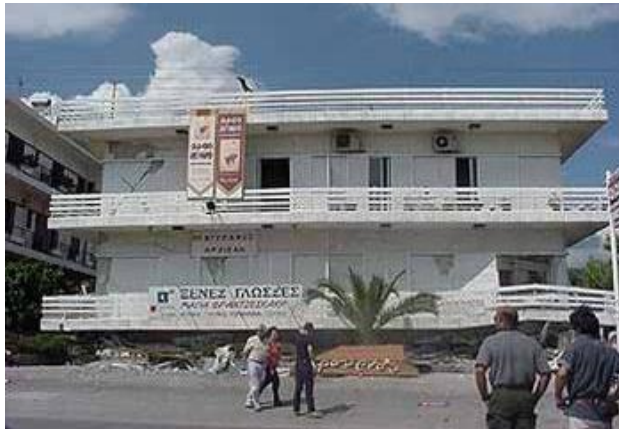
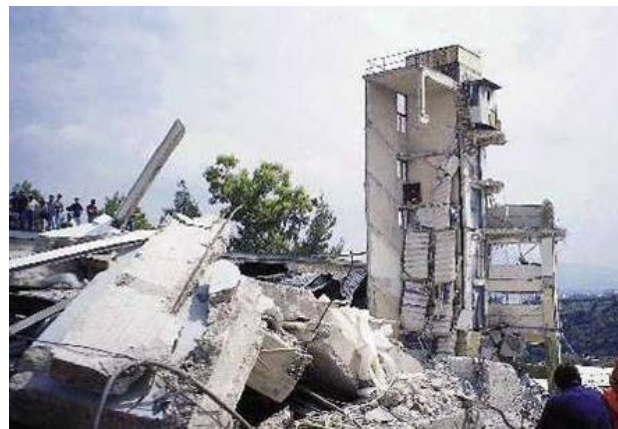
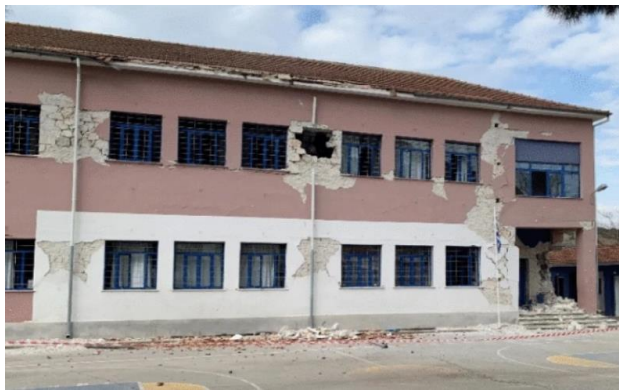
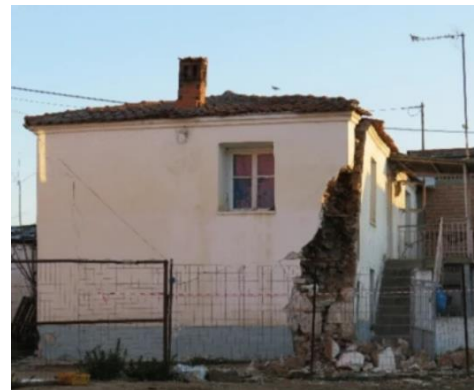
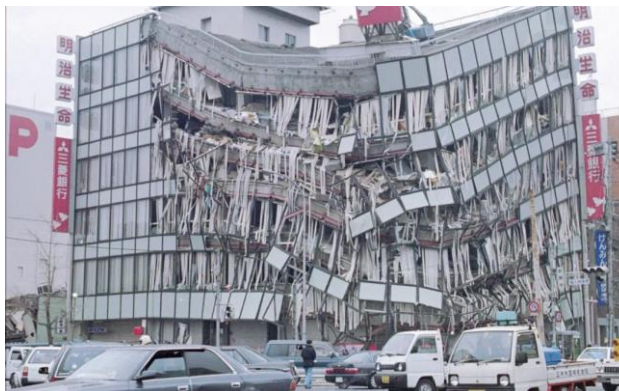
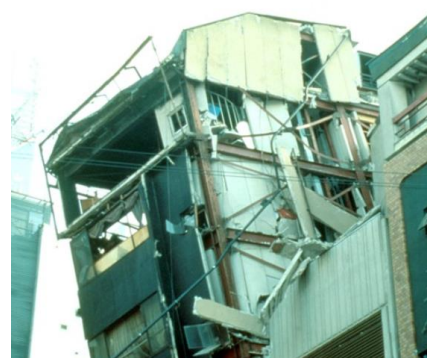
Figure 6. (a) Soft story collapse of a 3-floor reinforced concrete building during the Athens 1999 earthquake, Greece, (b) Collapse of a torsionally flexible building with stiff shear walls only at one corner of the structure, Athens 1999, (c, d) Seismic damage in masonry buildings during the Thessaly 2022 earthquake, Greece (source: Sarhosis et al., 2022), (e, f) Failure of flexible steel structures (source: Katsumi Kasahara/Associated Press, Michael Engelhardt).

A typical example is the soft-story mechanism in multi-story frame buildings, where the absence of wall infills on one floor (usually the ground floor to create parking spaces or shops with large façade windows) results in a significant reduction of its stiffness. As a result, this floor exhibits significantly larger relative displacements compared to the other floors (Figure 6a).

Other forms of irregularity may be associated with inadequate torsional resistance/stiffness in some buildings (Figure 6b), abrupt changes in mass or stiffness, etc.

- **Additional variations in the structural system**, depending on the construction material, which lead to significantly different seismic responses and consequently forms of damage. In reinforced concrete buildings, this may relate to the number, location and form of shear walls, the presence and type of diaphragms and partitions in masonry-bearing buildings (Figure 6c,d), and the placement of lateral bracings in steel buildings (Figure 6e,f).

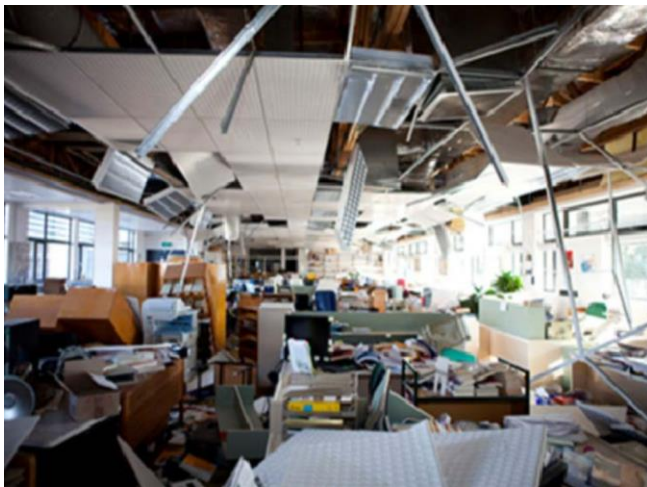
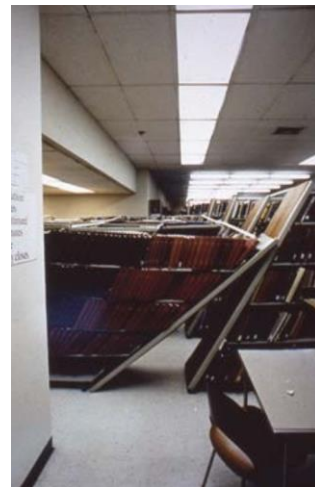
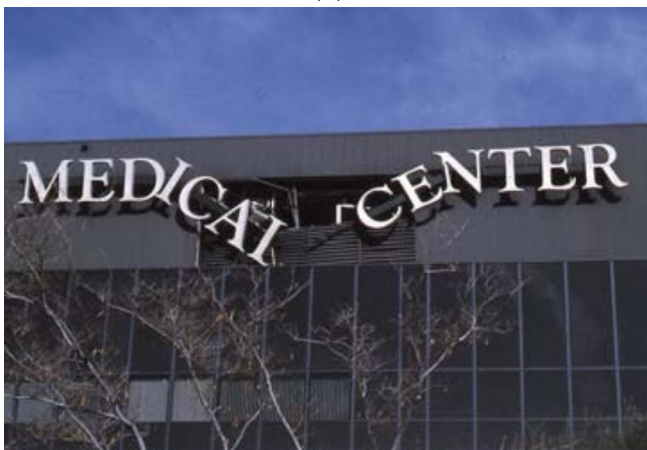
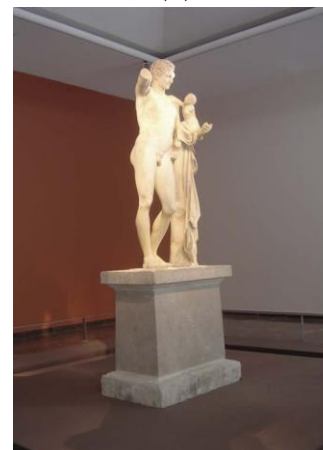
Figure 7. (a) Widespread damage to a ceiling system (source: Ferner et al., 2014), (b) Falling shelves in a library (source: NISEE-PEER), (c) Destruction of a signboard on the exterior of a hospital during the 1994 Northridge earthquake, USA (source: Robert Reitherman), (d) Statue of Hermes by Praxiteles at the Archaeological Museum of Olympia, Greece. Installation of a seismic isolation system for the protection of significant exhibits (source: Michael Constantinou).

Furthermore, it should be noted that damage to building structures are not exclusively related to the load-bearing structure and the infill elements of the building itself, but also to its contents. Thus, damage frequently appears to furniture, machinery, installations (Figure 7a,b), as well as various contents of lesser value (Figure 7c). Serious injuries, or loss of life can occur due to collapsed non-structural components, even if the load-bearing system has not suffered serious damage. To avoid damage to invaluable (e.g. cultural heritage) items, the implementation of appropriate protective measures is essential (Figure 7d).

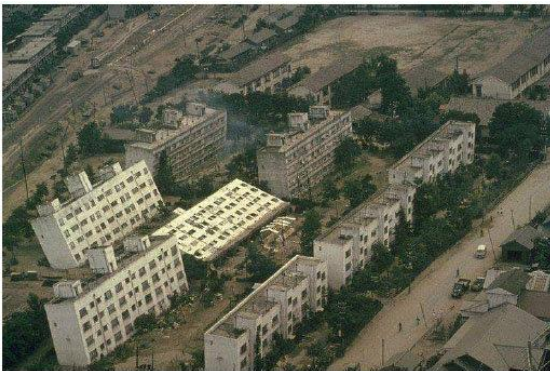
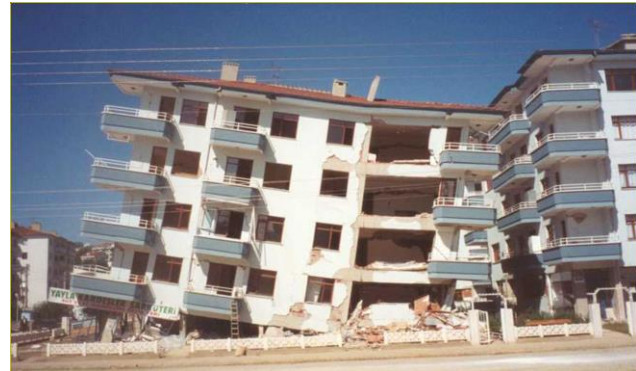
Figure 8. (a) Collapse of buildings due to soil liquefaction during the 1964 Niigata, Japan earthquake (photo: Joseph Penzien), (b) Differential settlement of the foundation of a reinforced concrete building in Türkiye, 1999

Often, damage to buildings from earthquakes are due to the failure of the ground or the foundation of the building (Figure 8). Cases of differential settlement of the foundation can lead to significant damage to the superstructure, while more extensive phenomena, such as soil liquefaction, might result in the global failure of the construction.

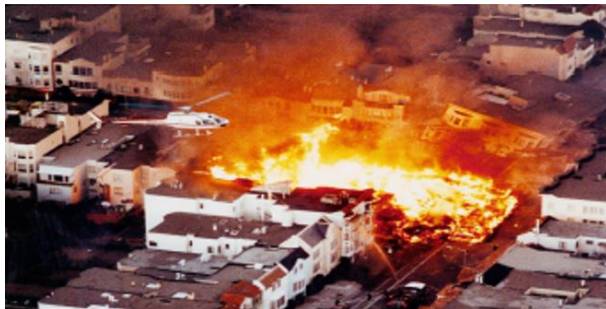
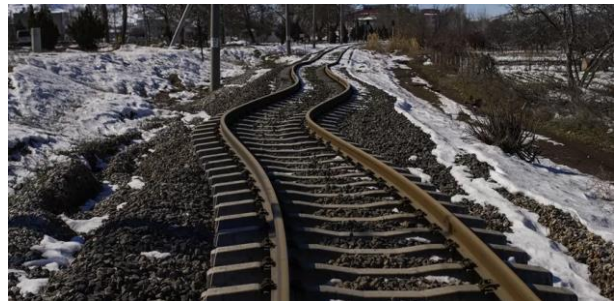
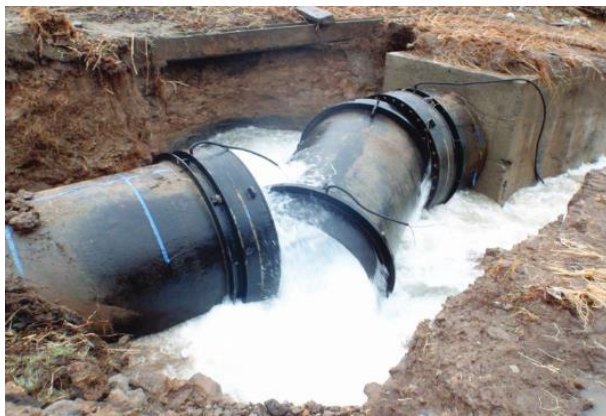
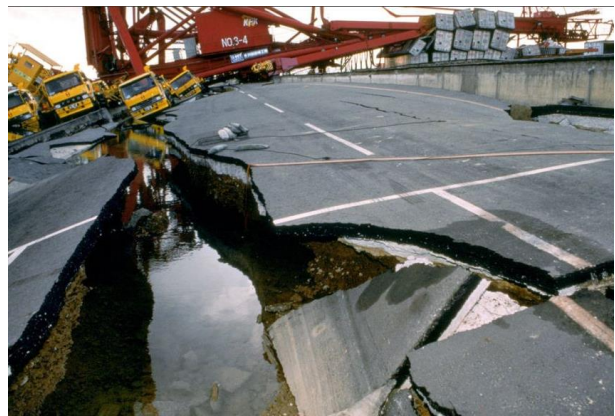
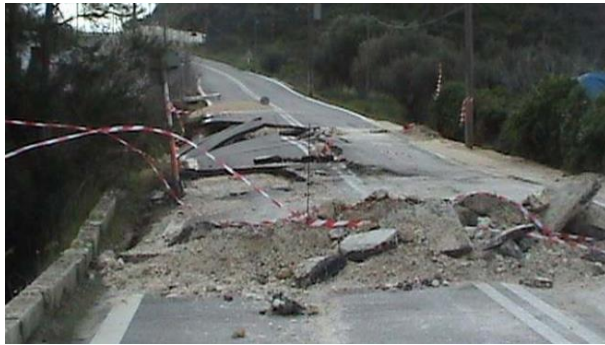
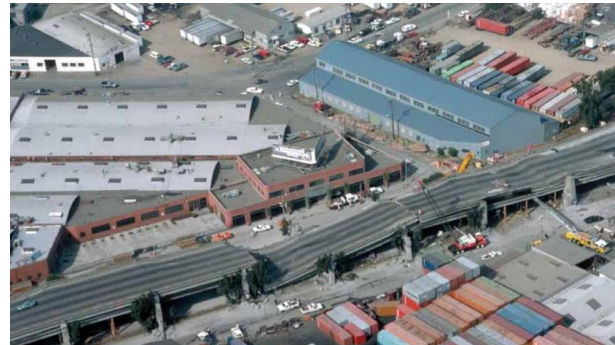
Figure 9. (a) Natural gas network failure in the Loma Prieta earthquake, USA (1989) (photo: Bob Pepping/Contra Costa Times) (b) Failure in the railway line during the earthquake in Turkey (2023) (photo: AP/Francisco Seco), (c) Failure of a water supply network pipe during the Tohoku earthquake, Japan (2011) (photo: Miyajima, 2012), (d) Failure of port facilities during the Kobe earthquake, Japan (1995) (photo: Karen Kasmauski), (e) Failures in the road network during the earthquake of Kefalonia, Greece (2014) (photo: ITSAK), (f) Bridge collapse in the Loma Prieta earthquake, USA (1989) (photo: USGS)

Indicative photos of damage to infrastructure elements following significant earthquakes are shown in Figure 9 for various categories of infrastructure.
