# Evaluation report

Safe bike crossing  
City of Zwolle

Author: Griet Vanwynsberghe, Rebecca Thys and Hans Vermeersch  
Project coordinated by Province of Overijssel

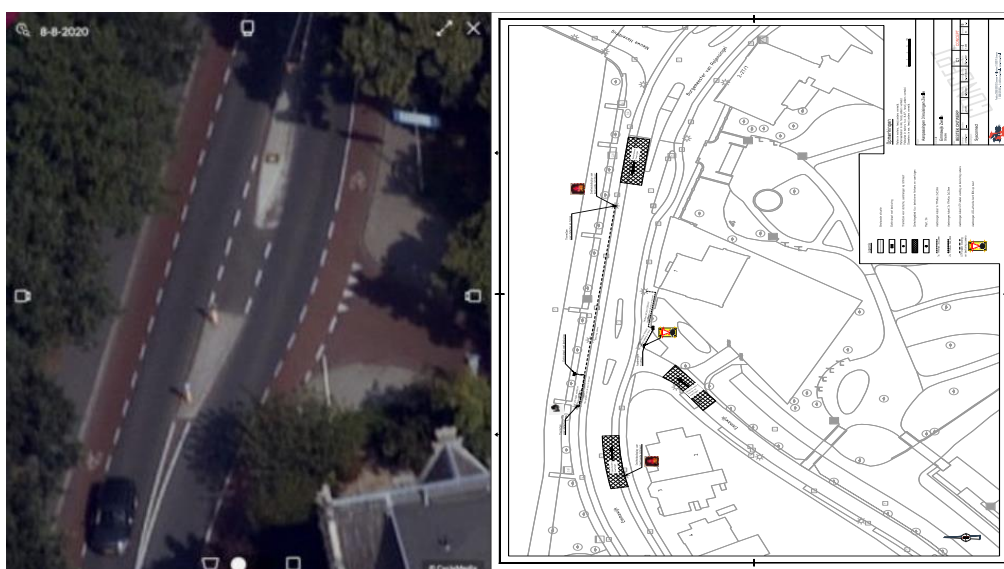
The junction which was subject of this ITS implementation is situated in the centre of Zwolle. It is a crossing of the Burgemeester van Roijensingel, one of the main roads in the city, with the Emmawijk, a smaller street giving access to residential areas and which is also a cycle street (a street in which cyclists have priority).

**FIGURE 1: THE INTERSECTION BETWEEN B. VAN ROIJENSINGEL AND THE EMMAWIJK**

In the pre-measurement, Mobycon first analysed the intersection on standards following the guidelines of the Dutch government. These guidelines are no legal obligations, but the government stipulates that decent arguments are needed not to follow the guidelines. The analysis by Mobycon showed that this intersection met almost all criteria of ‘a priority intersection within the city centre’ except for two. Firstly, no crossing for pedestrians is foreseen, however due to a limited amount of pedestrians crossing here and another pedestrian crossing rather close by, this is not necessary. Secondly, due to a bend in the Burgemeester van Roijensingel, the visibility on the intersection for passengers and cyclists coming from the east is limited.

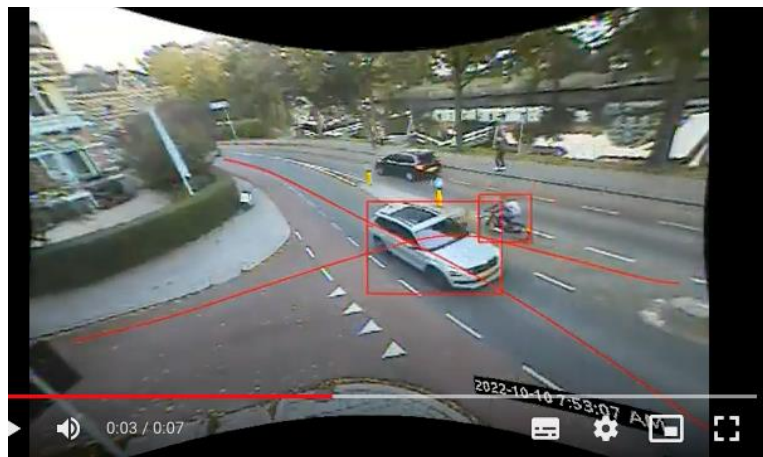
The main conflicting situation on this cross road is between vehicles driving on the Burgemeester van Roijensingel with cyclists that are cycling on the Burgermeester van Roijensingel and are turning left to the Emmawijk (as shown in the pictures beneath). The trough car traffic on the Burgemeester van Roijensingel has priority in this situation.

**FIGURE 2: TRAFFIC SITUATION CAUSING HIGHEST AMOUNT OF (NEAR) CONFLICTS**

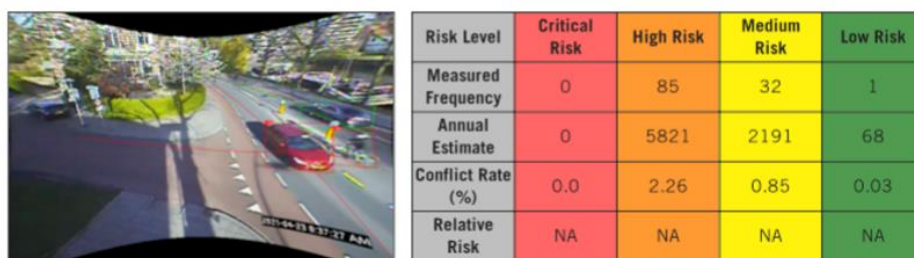
In the case of this intersection 118 conflict situations were detected during the 96 hours of measurement, of which one with a low risk, 32 with a medium risk, 85 with a high risk and zero with a critical risk. The conflict rate for a high risk is 2,26%, which means that for 2,26% of all cases of passing traffic crossing left turning cyclists on this junction we have a near accident with a high risk. Most conflict situations are registered during morning and evening rush hours. The risk on a high risk near accidents increases during evening hours.

FIGURE 3: TOTAL AMOUNT OF CONFLICT TRAFFIC SITUATION BICYCLE TURNING LEFT TO EMMAWIJK

**East-Through Vehicle vs Cyclist on East Crossing (East-through far-side)**

@ Emmawijk, 2021-Apr-20 to 2021-Apr-26

In the total number of conflicts, all conflict situations are included in the analysis. The conflicts are also included in situations where the driving trajectory of the car traffic is beyond the driving route of the turning bicycle traffic (see picture above). In these situations, the cyclist continues to cycle slowly and anticipates until the car has passed and then turns off. This situation is common and is counted as a possible conflict.

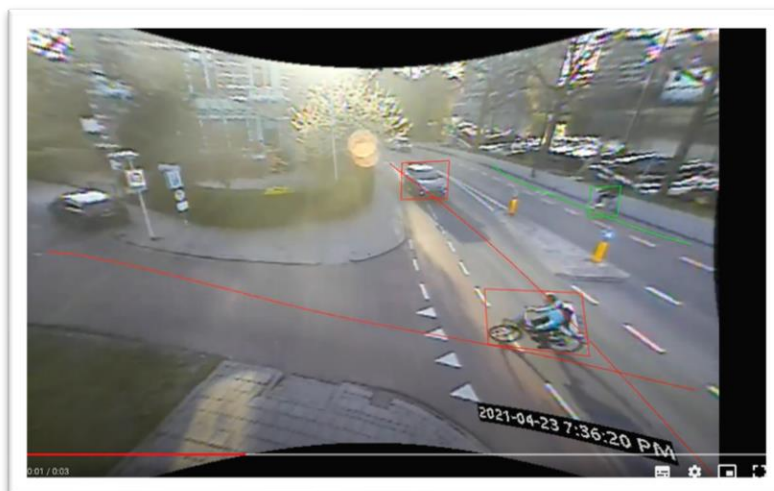
When leaving out this situation (that is not really a conflict situation), the number of conflicts is a lot lower

FIGURE 5: REAL CONFLICT SITUATIONS FOR CYCLISTS TURNING LEFT TOWARDS EMMAWIJK

and in the 0 measurement we see 12 conflicts of which 7 with a high risk and 5 as a medium risk.

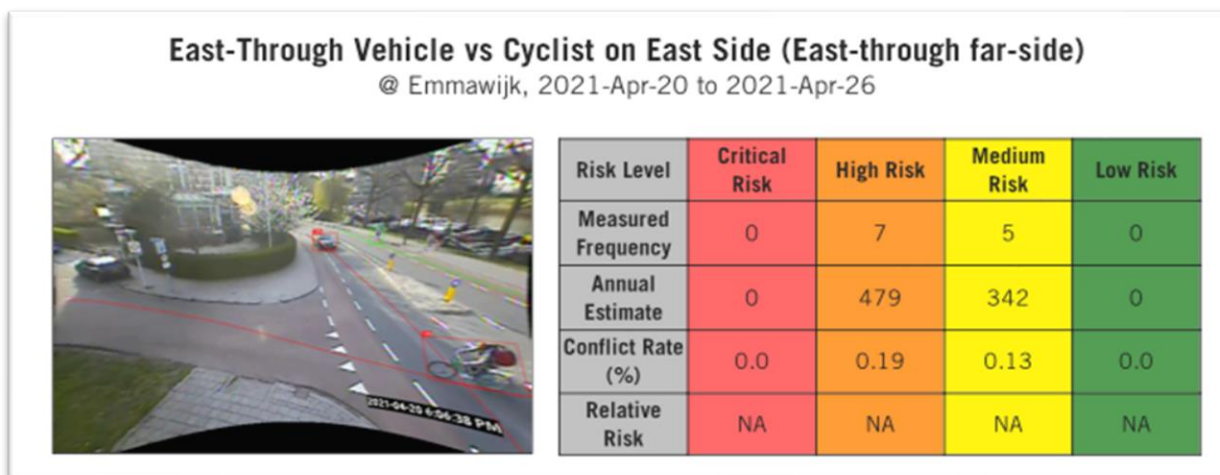
FIGURE 6: CONFLICT ANALYSIS FILTERED FOR FALSE CONFLICT SITUATION

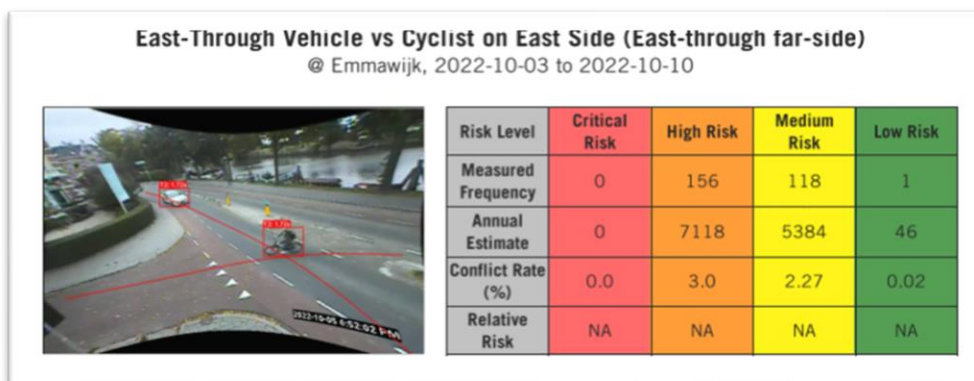
In the table beneath, we note an increase in high-risk situation. The post-measurement indicated 156 high risk situations whereas in the pre-measurement we found 85 such cases. The conflict rate is now at 3%. The frequency of medium risk situations equally increased. The conflict rate more than doubled (2,27) as compared to the pre-measurement (0,85). The frequency of the low-risk situations remains the same: only

1 situation has been registered. The conflict rate in this case is lower for the post-measurement (0,02% as compared to 0,03).

FIGURE 9: CONFLICT ANALYSIS AFTER INTERVENTION CYCLIST TURNING LEFT TO EMMAWIJK

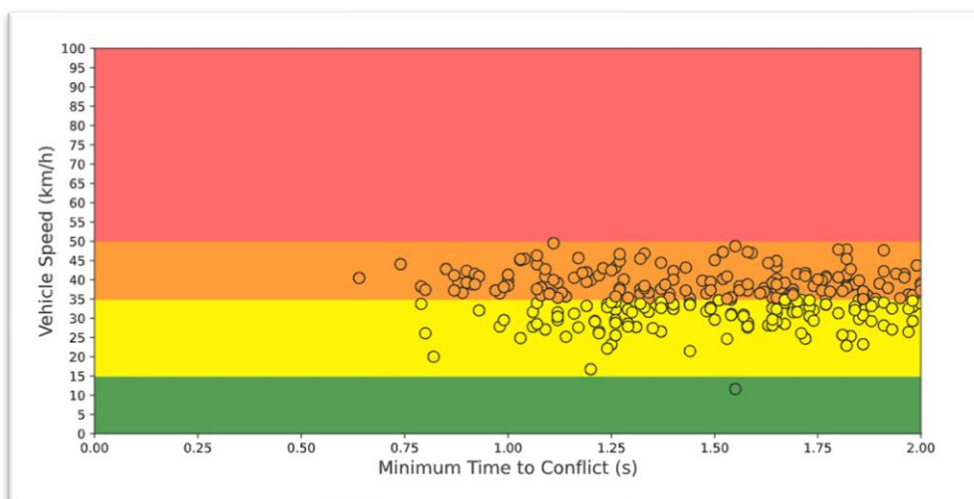
FIGURE 10: RELATION SPEED AND MINIMUM TIME TO CONFLICT

The second reason not to conclude that the intersection became less safe after the interventions has to do with the speed of the vehicles. Between both measurement periods, the average speed decreased from 36 km/hour to 33 km/hour indicating a positive evolution toward a safer intersection. A majority of the vehicles (59%) adapted their speed to less than 35 km/hour. In 2021, before the intervention it concerned only 40% of the vehicles.
