NuReDrain

**FILTER SYSTEMS FOR A
SUSTAINABLE AGRICULTURE**

FIELD CASE DESCRIPTION

Phosphorus filter box
for drainage water

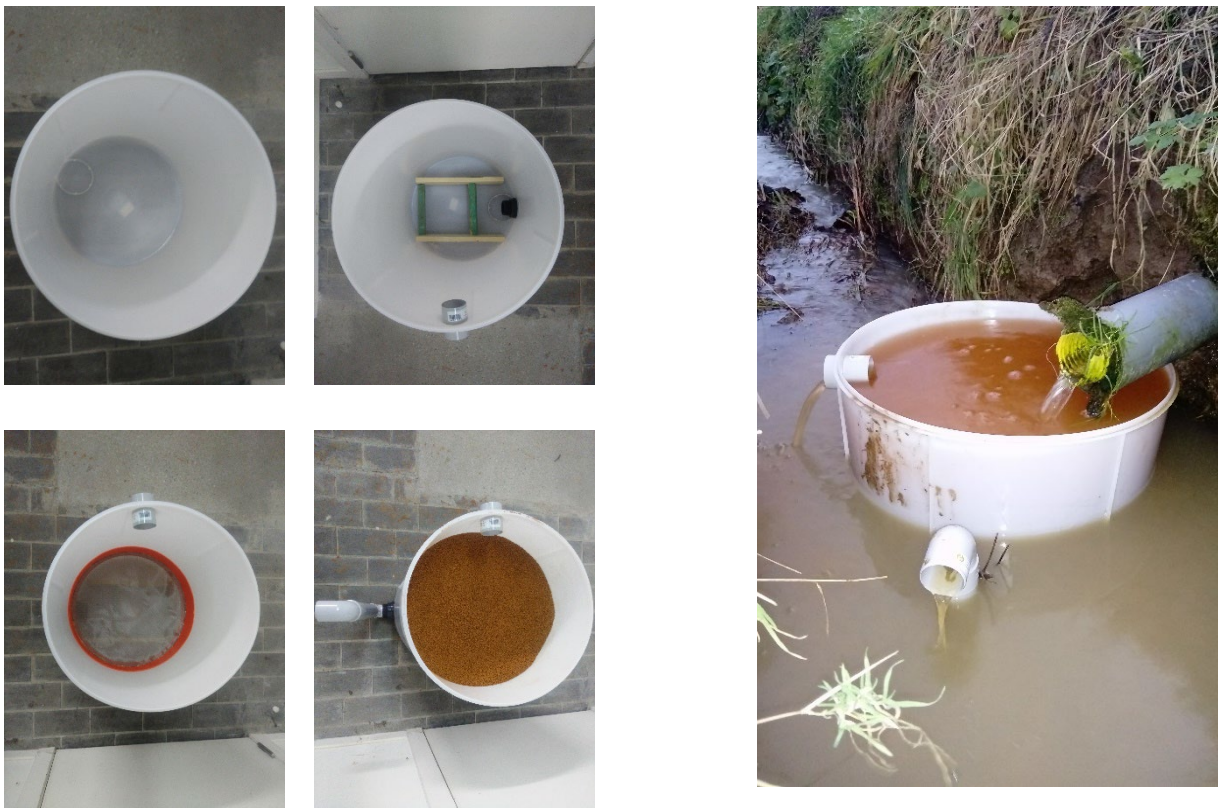
Figure 3 custom-made filters in the season of 2017-2018

Two custom-made bucket filters (100 L, Figure 3) were filled with iron coated sand (marked as **ICS_Ton** in Figure 6) and Diapure (marked as **Diapure_Ton** in Figure 6). Filter materials were filled a layer of no more than 20 cm, approximately 32 L. Two layers of wire mesh of 0.75mm were placed at the bottom and top of filter materials to stop big particles. The height difference between inlet and outlet tube was 5 cm.

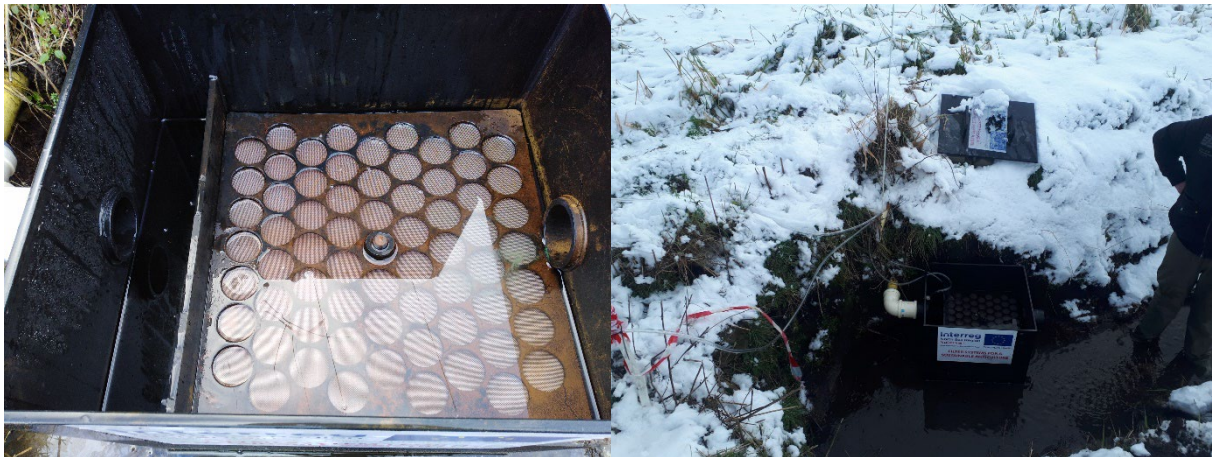
Figure 4 Prototype installed in the season of 2018-2019

Two filters installed from 2017 were kept in the field and the filter materials, i.e. ICS and Diapure were replaced with fresh ones. One prototype filter from CGK (600 mm*480 mm*590 mm, Figure 4) was installed in winter 2018 with 40 L of ICS (no more than 20 cm). This filter was marked as **ICS_Prototype_2018** in Figure 7.

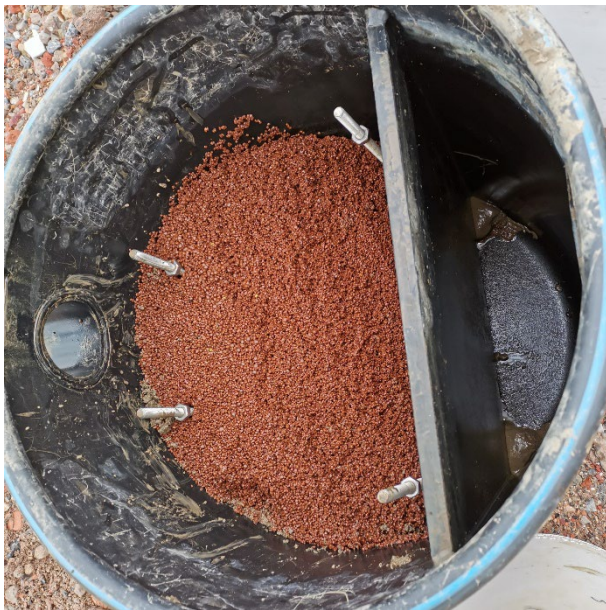
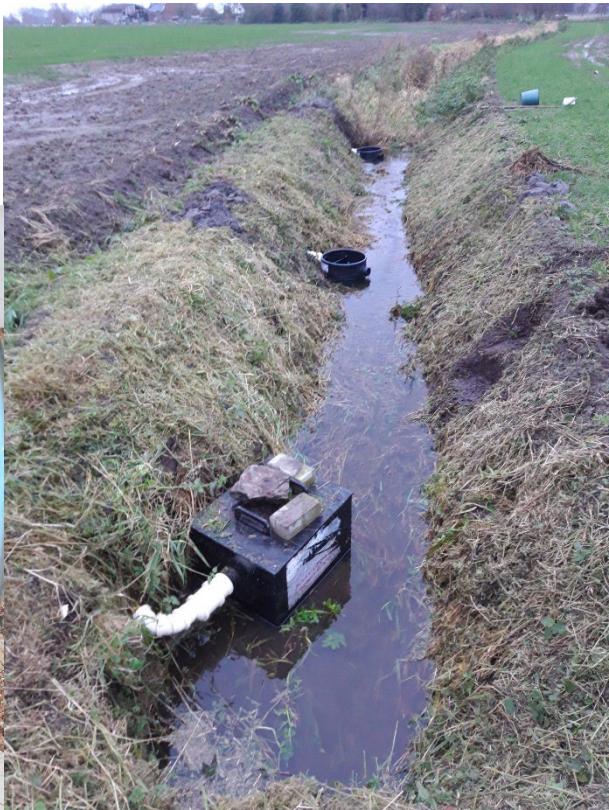
Figure 5 Prototype installed in the season of 2019-2021

The rectangle prototype filter from 2018 stayed in the field to check the long-term performance of the filter. Two new prototype filters (cylindric shape, Figure 5) were installed in Dec 2019 with different particle size materials (ICS>2mm and ICS>1mm marked as **Prototype_ICS>2mm** and **Prototype_ICS>1mm** in Figure 8, respectively). A layer of 24 cm with approximately 35 L of ICS was filled in the filters.

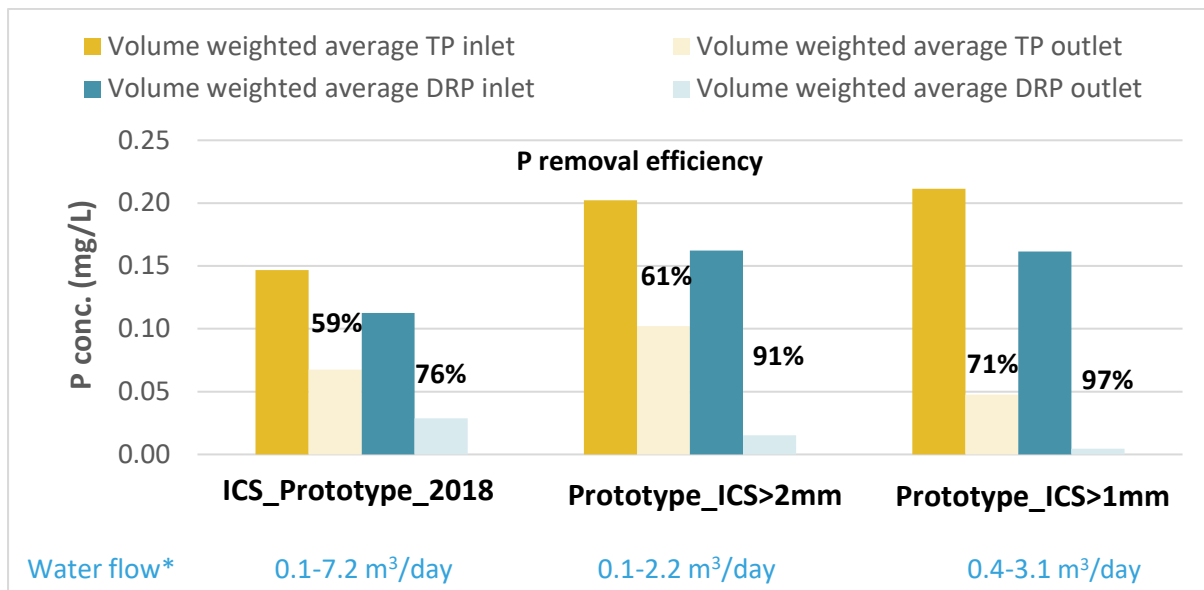
Figure 8. P removal efficiency of ICS_Prototype_2018, ICS_Ton and Diapure_Ton during the season of 2018-2019.

*water flow was measured every week and this range represented the water flow on the measuring days.

The filter performance of three prototypes was evaluated during this season to check the long-term performance of **ICS_Prototype_2018** and the effect of the ICS particle size. In the second drainage season of ICS_Prototype_2018, 59% of TP and 76% of DRP was removed even at the low P level during the period of 10/1/2020 – 23/3/2020. The long-term performance of the filter is better than we expected and the field monitoring in the following drain season would continue to see when the filter materials get saturated. Different particle sizes of filter materials were used in filters. As we expected, filter with smaller particles of ICS (**Prototype_ICS>1mm**) showed higher P removal efficiency, 97% of DRP and 71% of TP than one with bigger particles (**Prototype_ICS>2mm**, 91% of DRP and 61% TP) due to the longer reaction time.

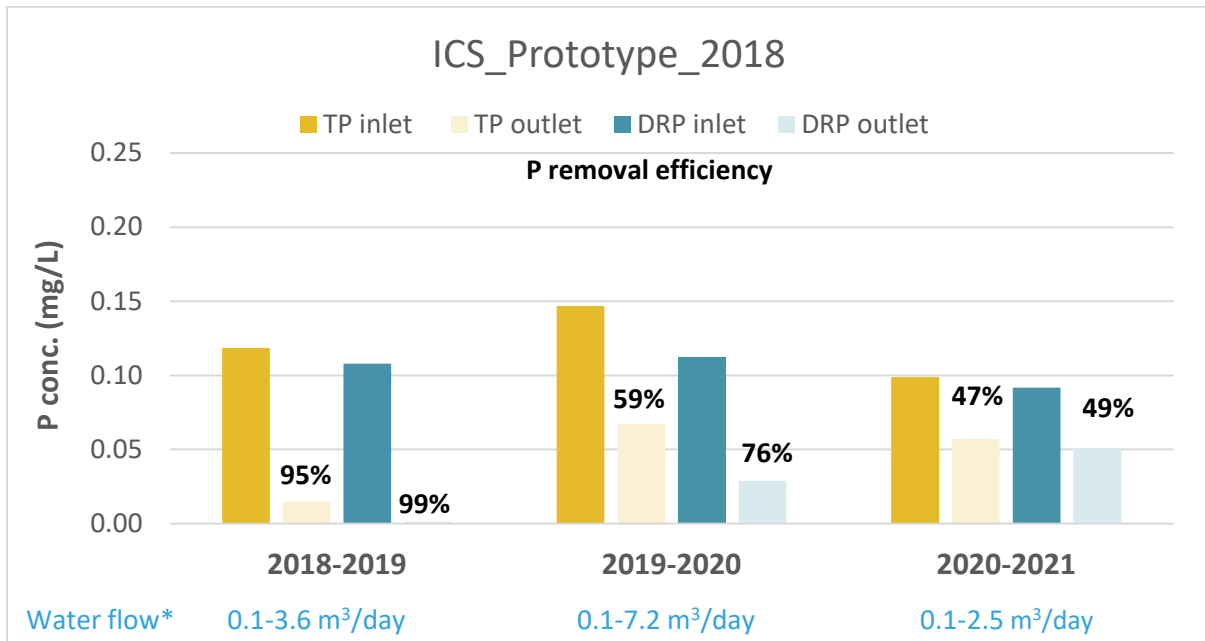
Figure 9. Long-term performance of ICS_Prototype_2018 over three drainage seasons

After three drainage seasons, the P removal efficiency of **ICS_Prototype_2018** decreased gradually: on average 94%, 59% and 47% of total P (TP) meanwhile 99%, 76%, 49% of dissolve reactive P (DRP) was removed in the first, second and third season, respectively (Figure 9). Two different particle sizes of filter materials were used to check filter performance since winter 2019. The filter with fine filter materials, **Prototype_ICS>1mm**, could remove on average 71% and 64% of TP meanwhile 97% and 66% of DRP in the first and second season, respectively (Figure 10). Unfortunately, we could not take samples properly in the second season from the filter with coarse particles, **Prototype_ICS>2mm**, because either the outlet tube was under water level of the ditch or the drainage water was limited. In the first season, we observed a better performance of filter with fine particles due to the longer reaction time, however, we could not make comparison in the second season.
