## Cloncrow Bog Restoration Case Study

## REPORT

May 2023

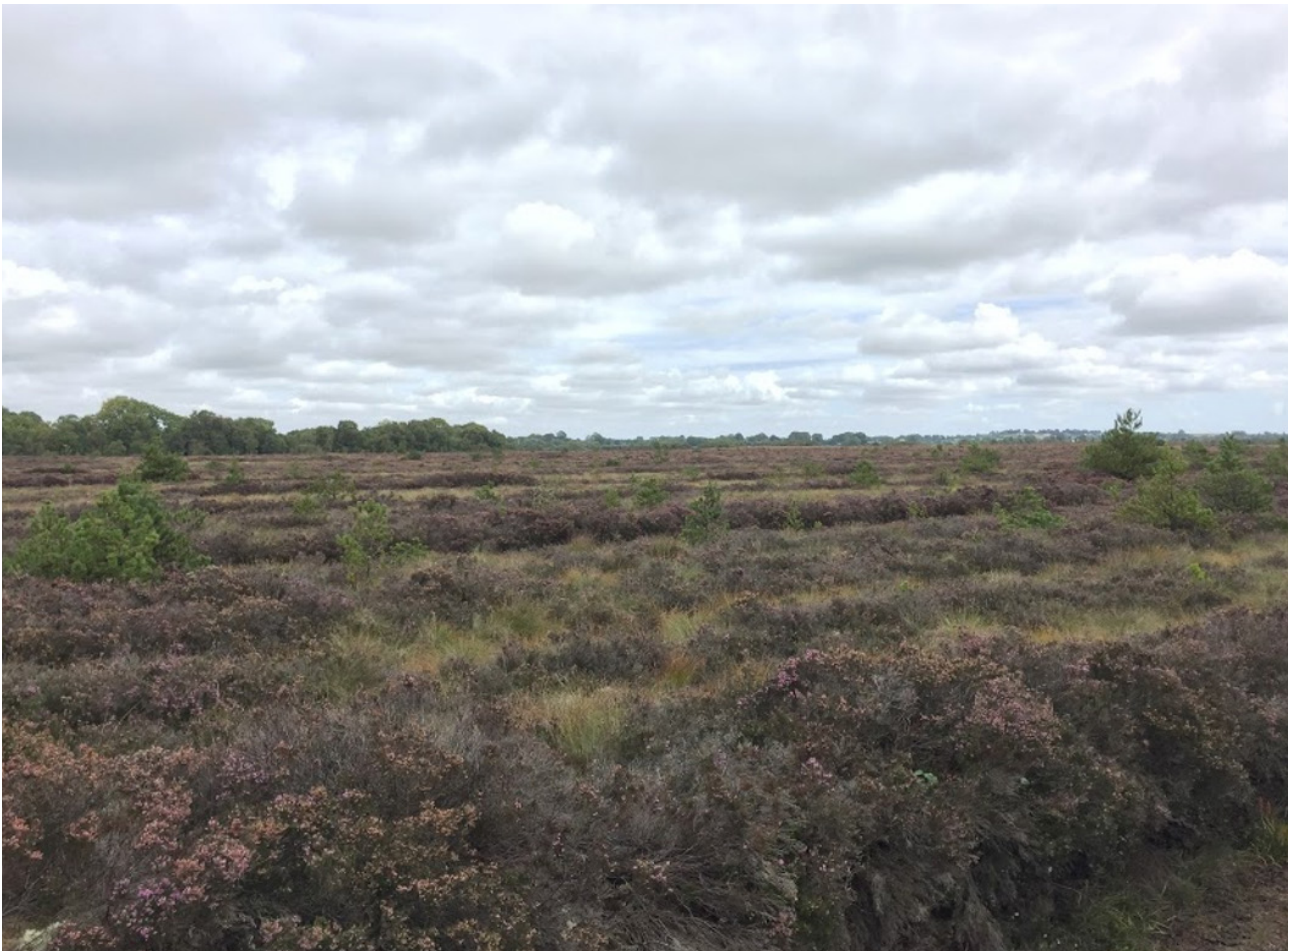
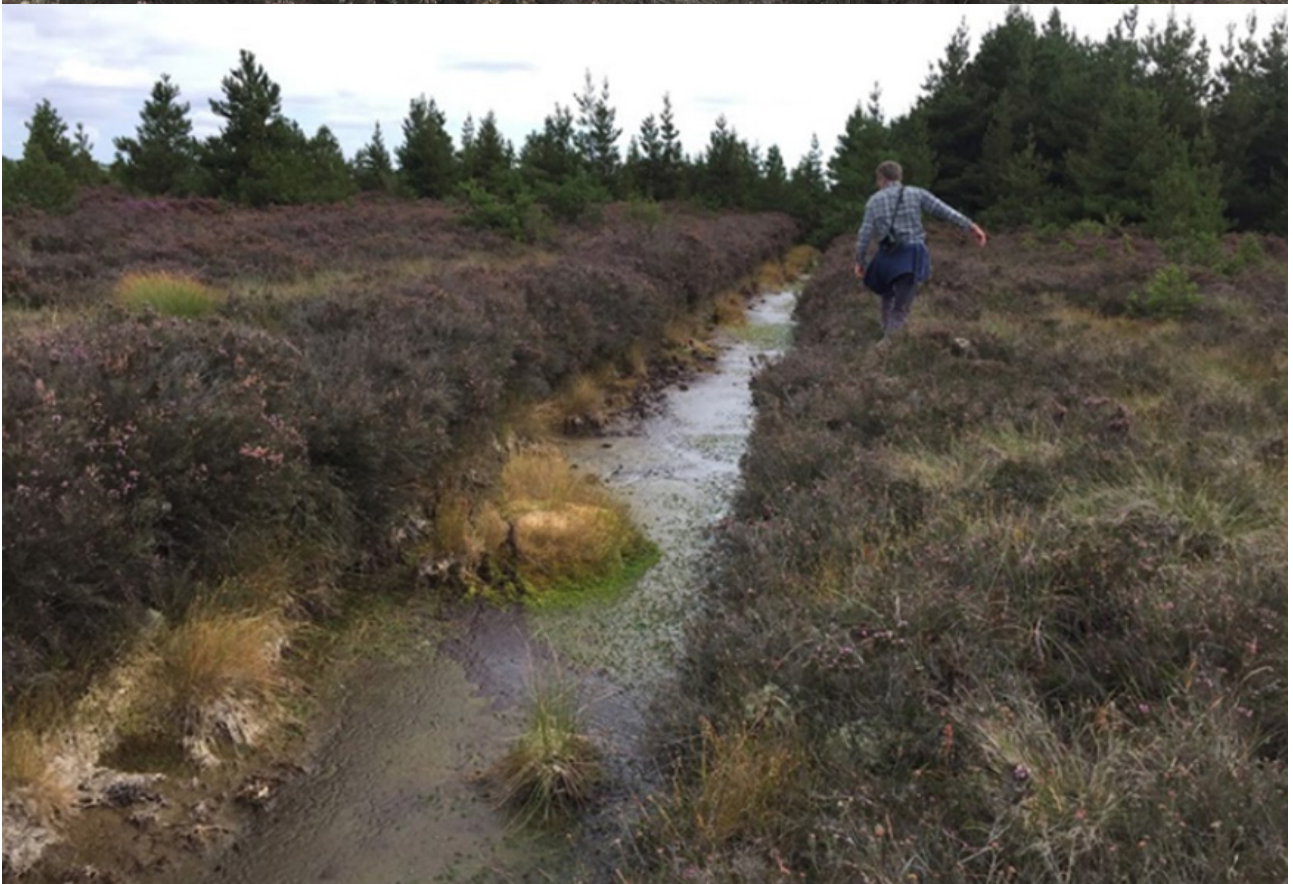
Figure 4: General state of pilot site before restoration (Source: Dr. Terry Morley)

The peat within the project area is relatively intact but has suffered drainage and drying as a result of the ditches. Heather (*Calluna vulgaris*) has taken over in the drained areas of the bog and *Sphagnum* development is impeded due to the impaired eco-hydrological status of the project area.

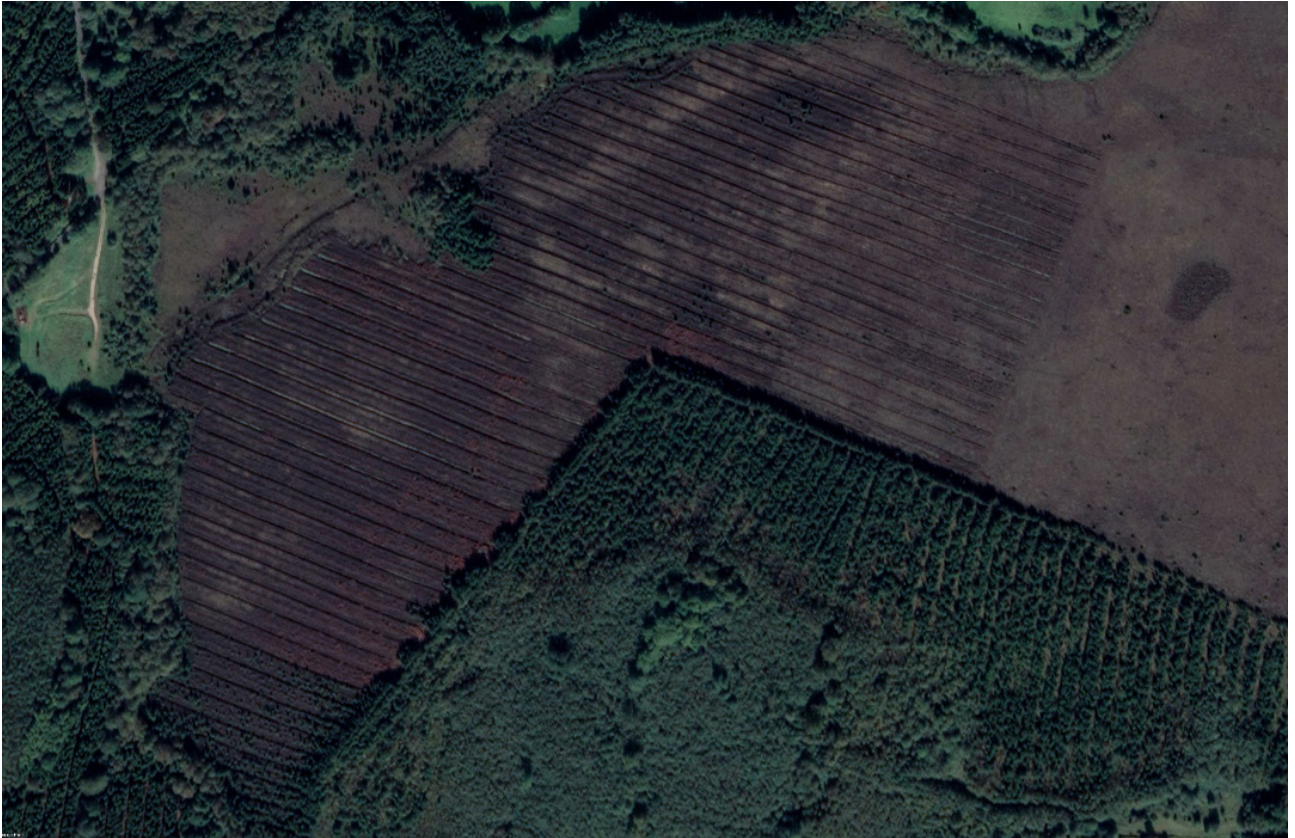
Figure 5: Initial aerial image of degraded bog (Source: Google Imagery)

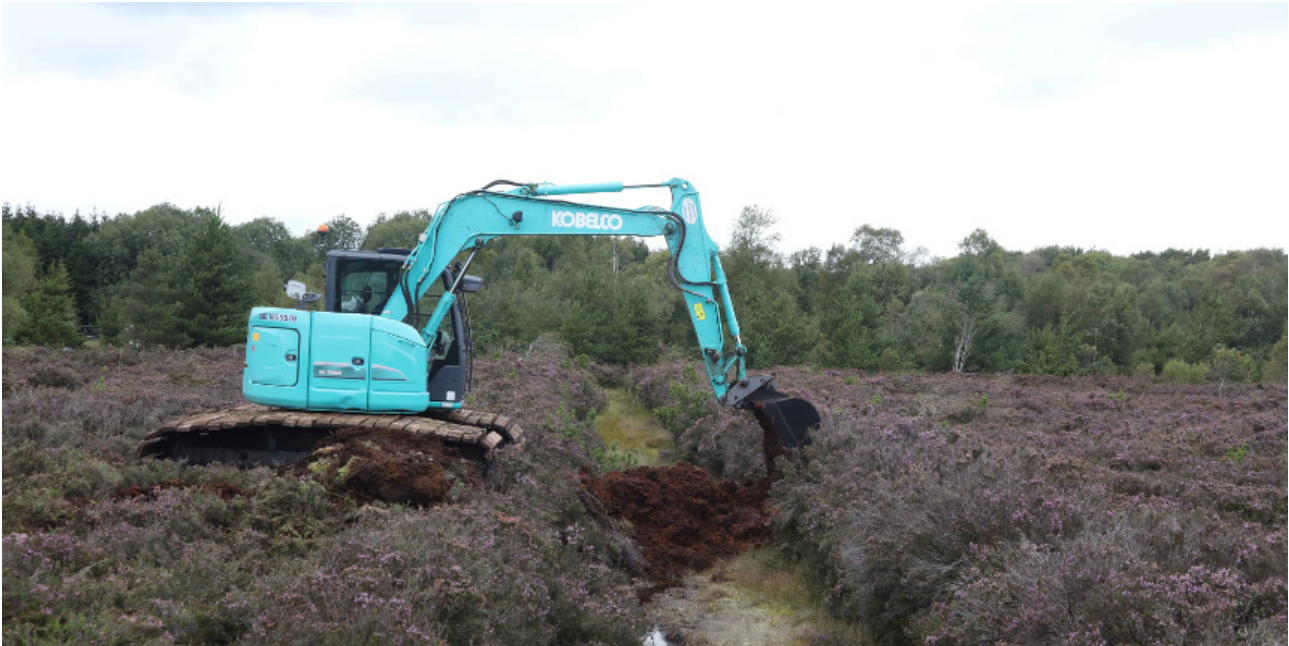
Figure 9: Drain blocking at pilot site (Photo: Eugene Dunbar)

The restoration works implemented at Cloncrow bog (from September to October 2020) consisted of blocking drains using 991 peat dams and 8 plastic dams consistent with best practice guidance from Mackin et al. (2017) within the high bog and cutover sections, and 865 m of trench cell bunding in the cutover areas (Figures 4 and 5). Plastic pipes and weirs were also installed to prevent trench bunds failure. The use of trench bunding on cutover areas is one of the first of its kind within the Republic of Ireland and the purpose is creating a shallow layer of water (<30 cm) within the cells to allow the establishment of peat forming vegetation.

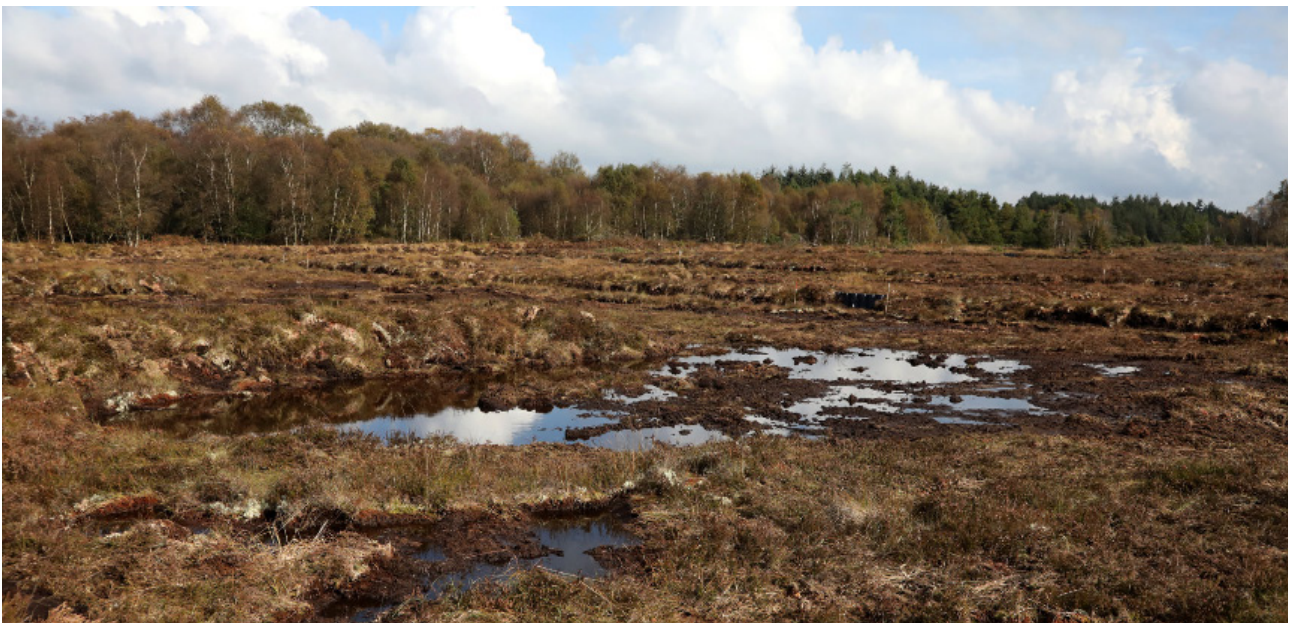
Figure 10: Extensive bunding at pilot site (Photo: Eugene Dunbar)

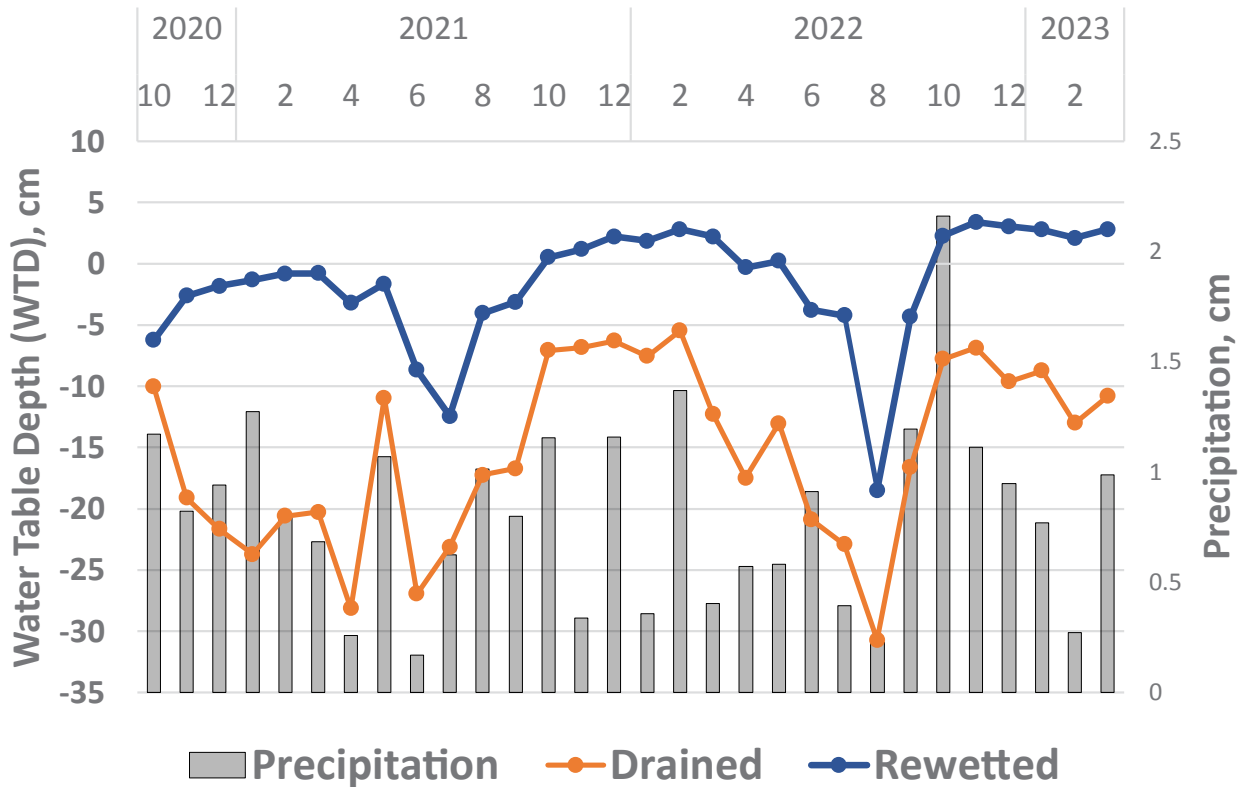
Figure 13: Monthly average watertable depth from Cloncrow Bog pilot site from the onset of rewetting

The main aim of rewetting is to increase and maintain the water level to within 10 cm of the surface throughout the year. To this end, the restoration works on the high bog areas have been very effective. Mean rewetted table depth was -1.6 cm below ground level, almost always within 10 cm of the surface and significantly higher than the control area in an adjacent drained section of the bog (Figure 13).

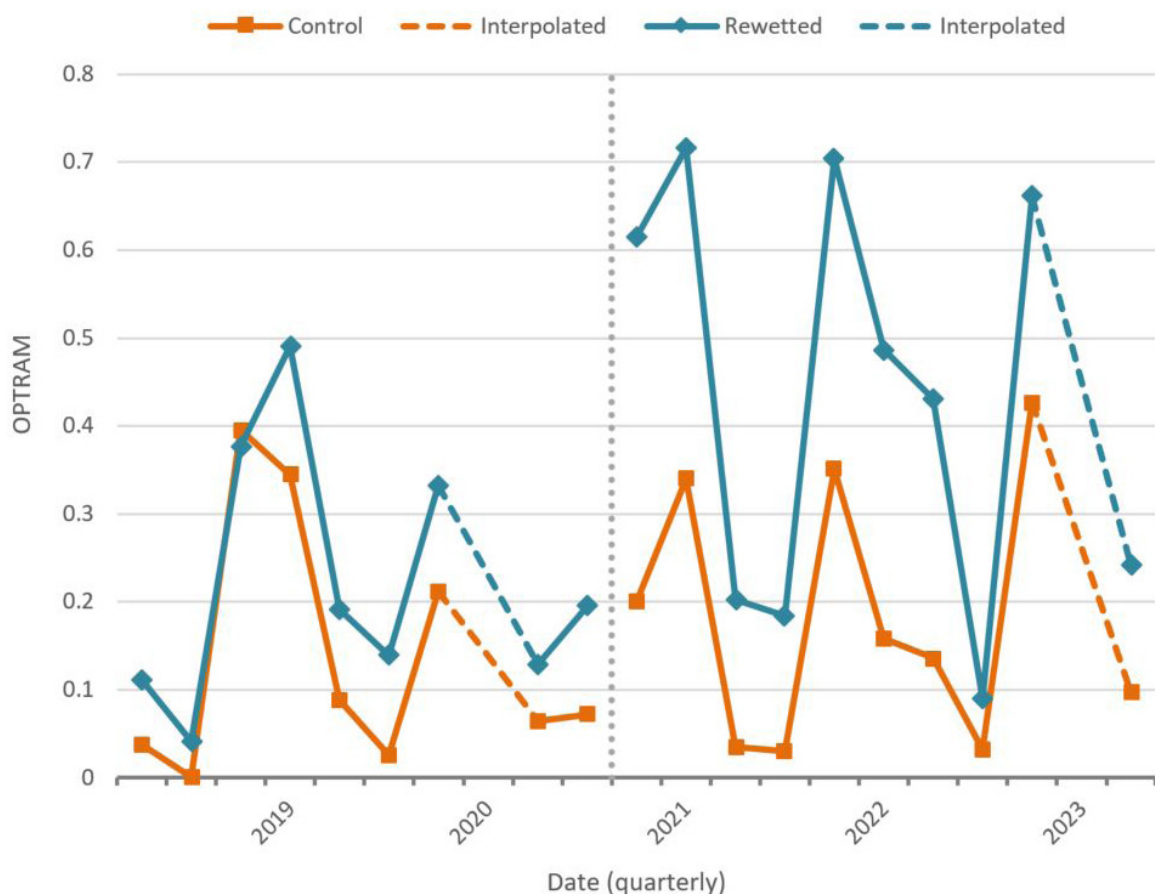
Figure 16: Aggregated average control and restoration OPTRAM for pre and post restoration period.

The Optical Trapezoid Model (OPTRAM; Sadeghi et al. 2017, Remote Sensing of Environment 198) indicates soil moisture as a response between short-wave infrared reflection and vegetation activity (NDVI) and requires a suitably large dataset to project patterns in two-dimensional point cloud space. OPTRAM has been successfully employed in other peatland studies to analyse Water table depth. Averaged OPTRAM values for the re-wetted areas are markedly higher during the post-restoration period (Figure 16), which indicate a general increase in soil moisture content. In contrast, patterns in averaged OPTRAM values for the control area are generally consistent over the monitoring period.

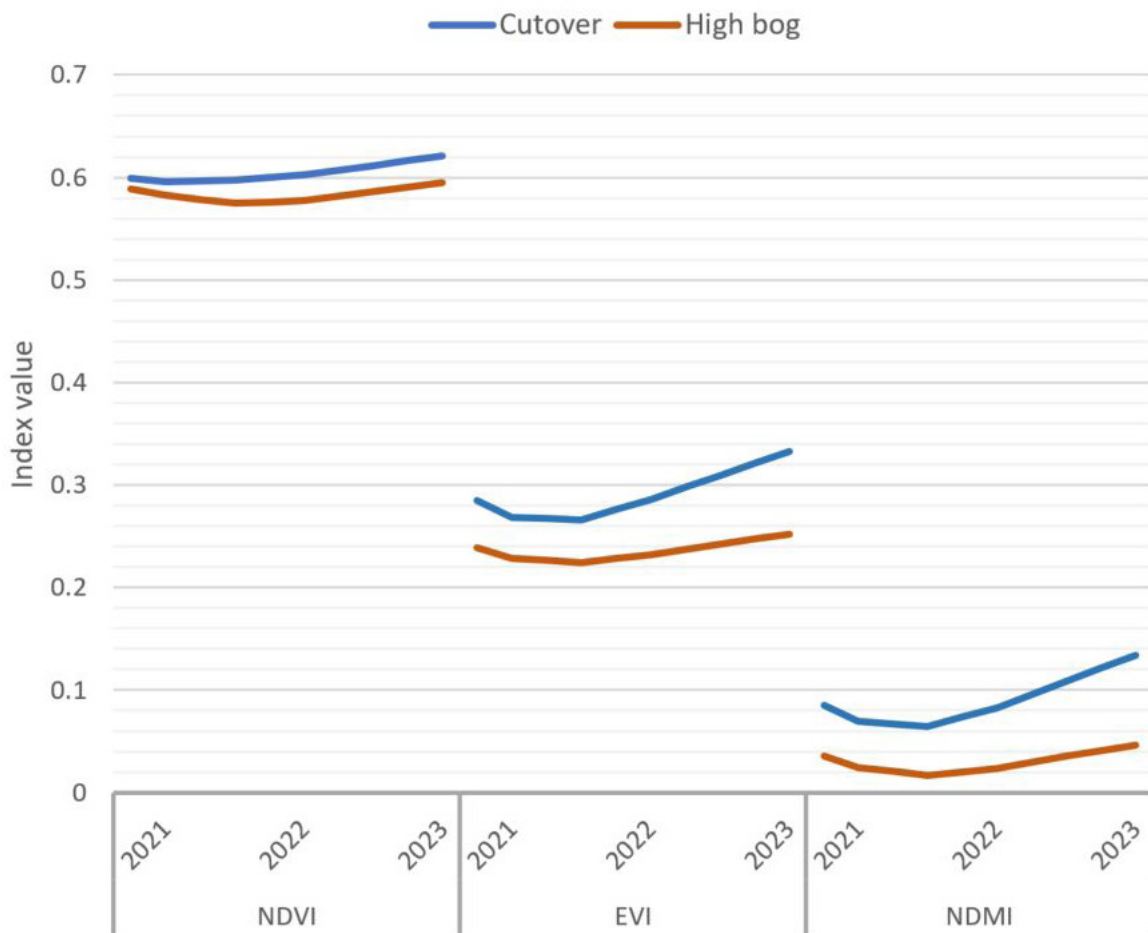
Figure 17: Averaged post-restoration trends decomposed from time series NDVI, EVI and NDMI values for Cutover and High bog areas

While differences in post-restoration OPTRAM values between re-wetted and control areas are similar to patterns observed through on-site monitoring, similar patterns are not observed for other moisture indices, the Normalised difference moisture index (NDMI) and Normalised soil moisture index (NSMI). Patterns here, correlate with patterns for vegetation indices the Normalised difference vegetation index (NDVI) and Enhanced vegetation index (EVI), in that averaged values for re-wetted areas are generally lower during the post-restoration period. A possible explanation is that initial re-wetting may have inundated areas of plant/soil material resulting in an average reduction in infra-red reflectance. Slight upwards trends in the NDVI, EVI and NDMI indices (Figure 17) could be indicative of post-restoration vegetation development in re-wetted areas. Further site investigation will be beneficial to assess whether these trends continue and if they represent change in cover of beneficial plant species. While all earth observation outputs are currently indicative and require further cross-validation to site conditions to provide more robust information on pilot site developments, positive correspondence to site measurements indicate benefits in earth observation analysis to monitor peatland restoration.

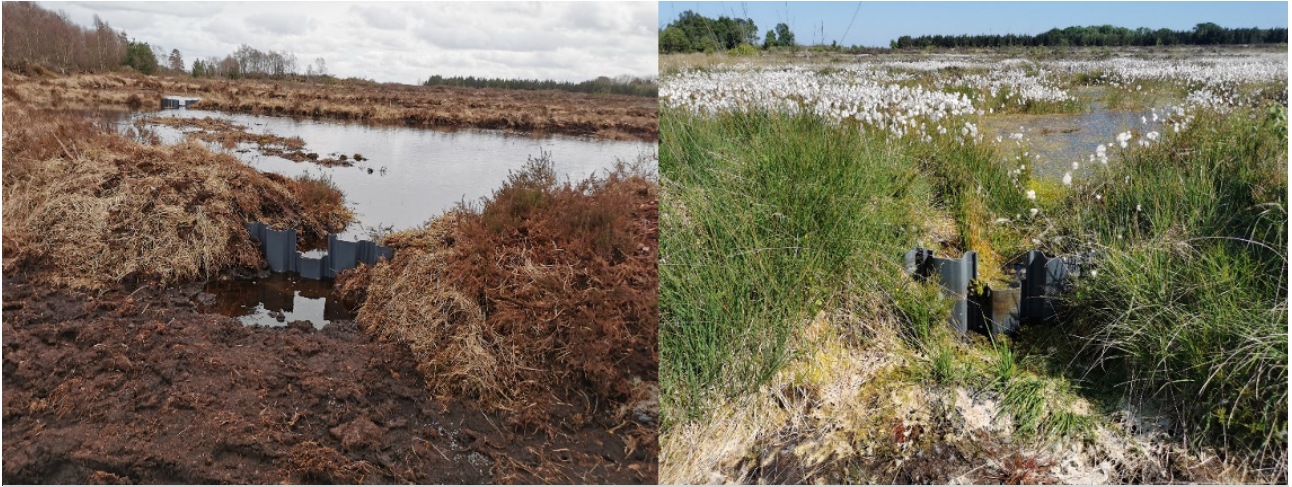
Figure 19: Cell bunding and plastic weir shortly after restoration (left, 2020) and after restoration (right, 2023)

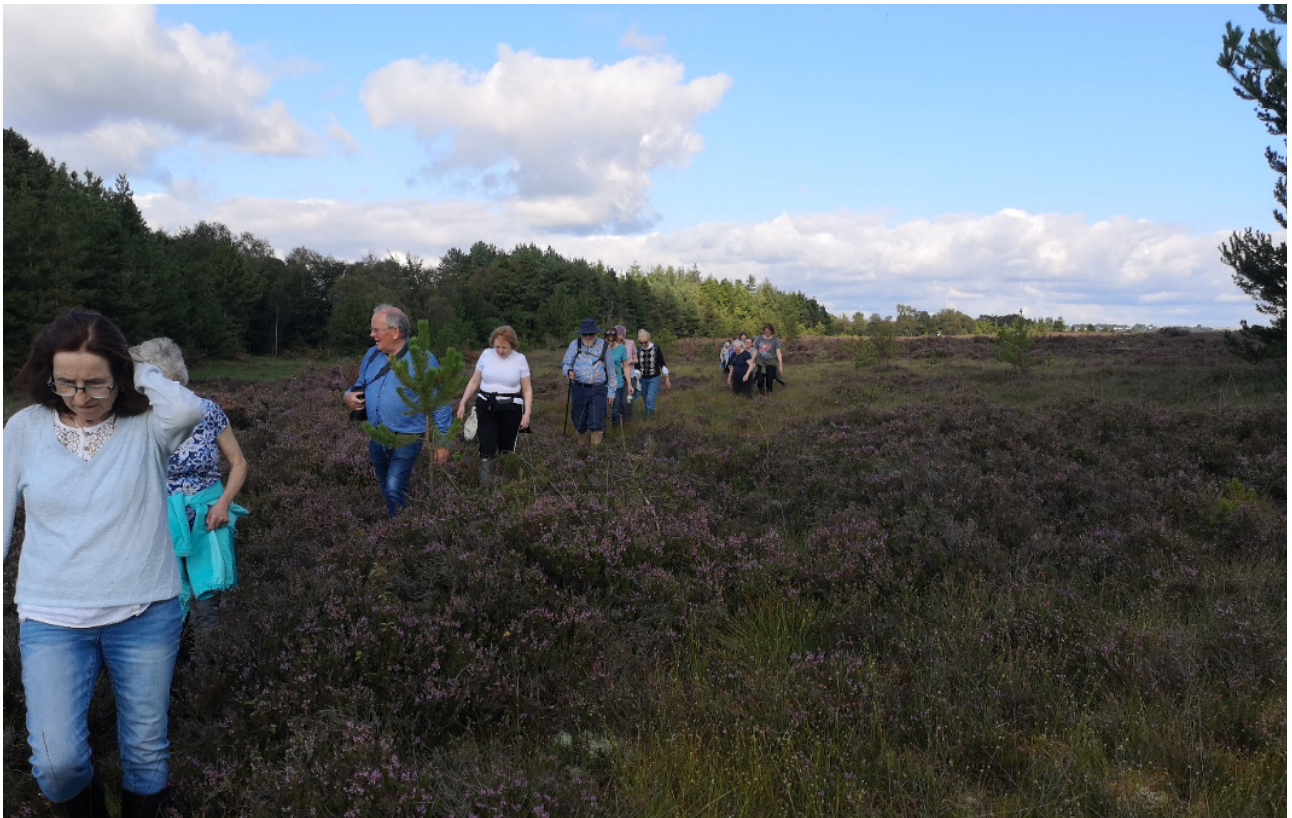
Figure 20: Local demonstration of rewetting successes at the pilot site  
(Source: Dr. Terry Morley)

COVID delayed several of our initial field workshops thus several information sessions were completed online. However, by summer of 2021, we were able to host one public landowner workshop at the pilot site on 22 August 2021. This was attended by 21 local (and regional) members of the public and several local landowners and demonstrated the effect of rewetting at the pilot site. We took the public on a tour of the pilot site, and discussed the different techniques used to rewet peatlands and how these techniques can be applied at local scale areas. Of particular note, one of the main aims of the workshop was to discuss the common misconception that rewetting will inundate adjacent lands.

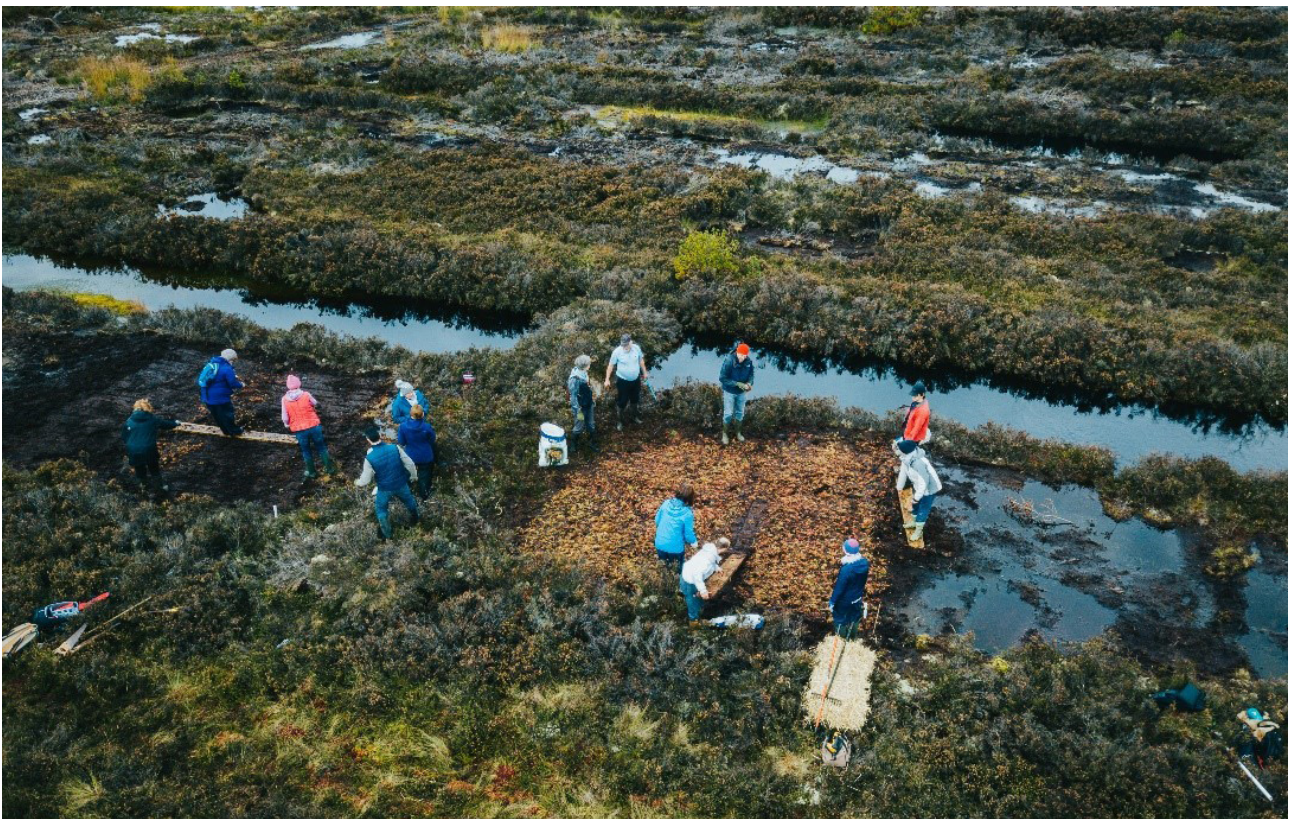
Figure 22: Aerial photo of public transfer event. The square to the left is a bare plot, while the square to the right as been seeded with *Sphagnum* (Photo: Elena Aitova)

This consisted of two events led by sub-partner IPCC and the University of Galway to demonstrate the utility using a Canadian *Sphagnum* transfer technique at the pilot site. On the 12th October 2021, we had approximately 12 transition year students at the pilot site to establish *Sphagnum* trial transfers. Then on the 16th October, 2021 we had 14 members from the public to establish additional transfers. Both events were highly successful and the adult public meeting expressed interest in sharing their knowledge to additional local groups for trial this technique at other locations.

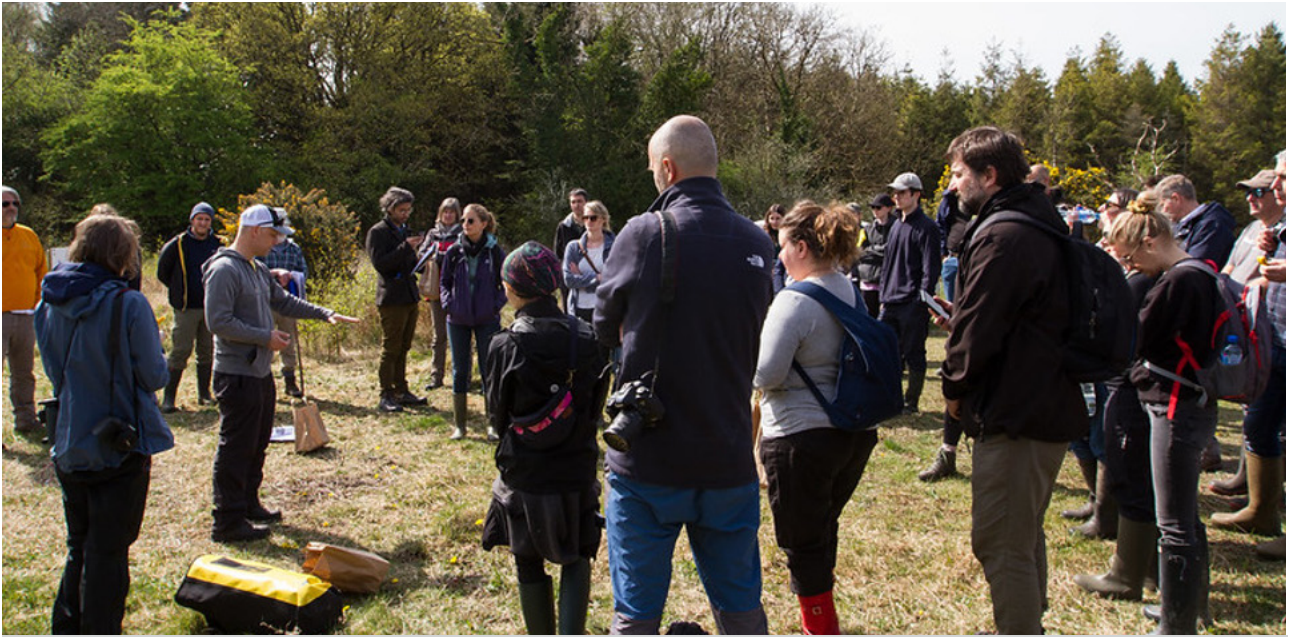
Figure 23: International demonstration of restoration works at the pilot site (Photo: Robin Verachtert).

On the 28th and 29th of April 2022, the University of Galway hosted an international Peatland Conference as part of the Care-Peat project. The first day was focused on scientific dissemination and knowledge exchange while the second day consisted of two international demonstrations. This demonstration was attended by over 45 participants from across Europe.

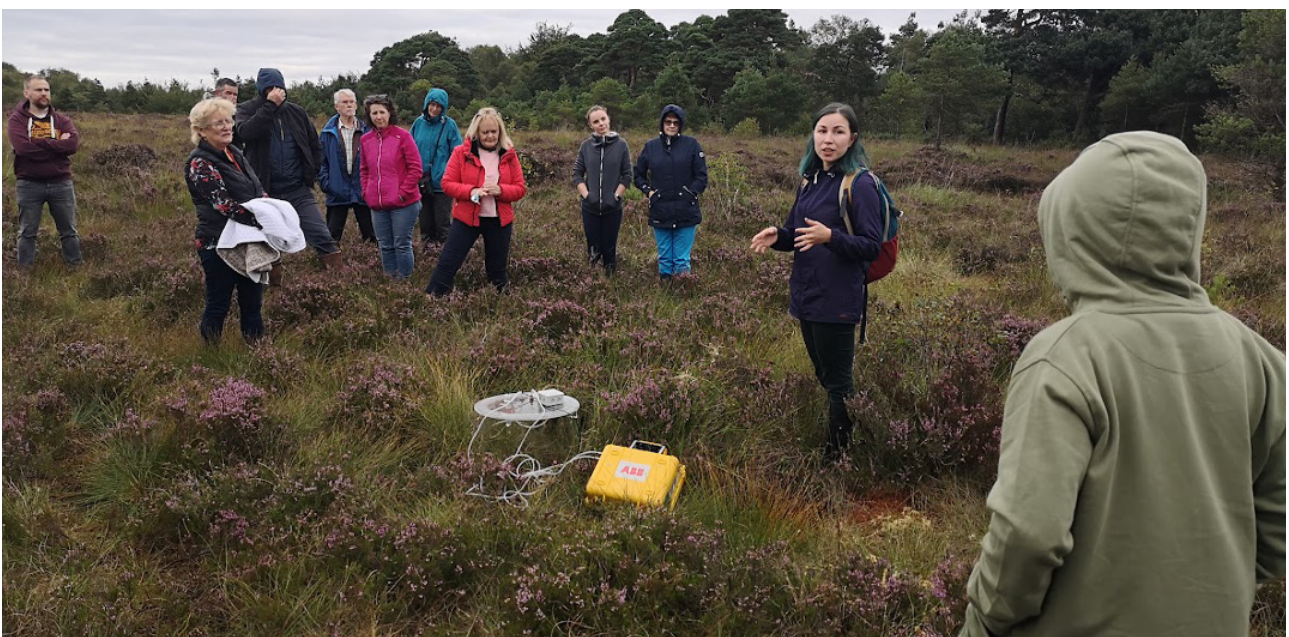
Figure 24: Public demonstration of Greenhouse gas monitoring at the pilot site. August 2021 (Photo: Dr. Terry Morley)
