Slurry acidification

Micro-structural analysis of concrete after exposure to acidified and non-acidified slurry

Lena Rodhe, Mariusz Kalinowski, Leticia Pizzul, Johnny Ascue, Marianne Tersmeden

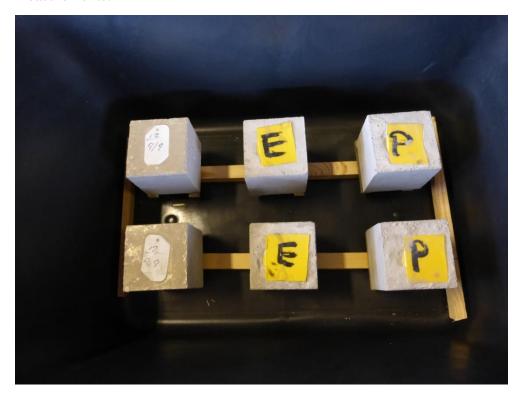
Figure 1. Concrete samples, Sweden. Left: Long lasting concrete; P, concrete in basic platform; E, concrete in wall elements. The samples are placed on a wooden frame made of 20 mm x 20 mm strips at the bottom of a plastic container. During exposure the labels were on the bottom. Samples were placed randomly in each box.

The samples were placed at least 0.1 m apart, on strips of wood in two containers, one for each slurry type, to expose the samples from all sides (Figure 1). The two types of slurry were added to the containers, respectively, to a depth of about 0.17 m, ensuring the samples were covered with a layer of slurry about 0.03 m thick. The boxes were placed in a ventilated room at 20 °C, where the concrete samples were exposed for almost two years (Figure 2).

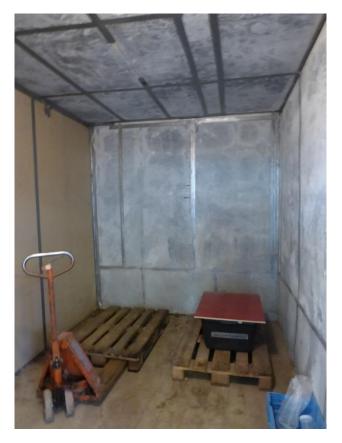
Figure 2. Room with constant temperature 20 °C for exposure of concrete samples to acidified and non-acidified cattle slurry. In the figure the container with acidified slurry and concrete samples is placed in the room and fitted with a non-airtight cover.

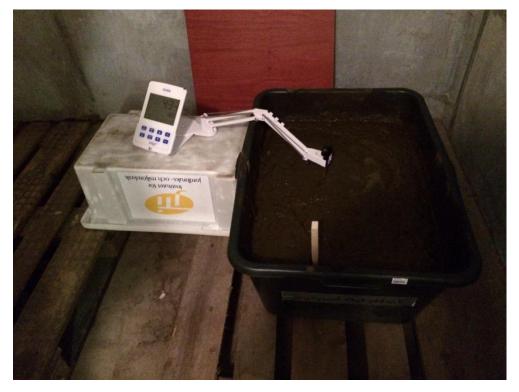
Figure 3. Measuring pH in container with acidified slurry to follow buffering before starting exposure of concrete samples at pH<5.5.
