MORPHOLOGICAL DEVELOPMENT OF SECONDARY CHANNELS

BUILDING WITH NATURE – EXPLORATORY RESEARCH OF MORPHOLOGICAL DEVELOPMENT OF SECONDARY CHANNELS

Client: Rijkswaterstaat
Project number: RWS188
Report number: 2.0
Status: Definitive version
Date: 17 april 2020

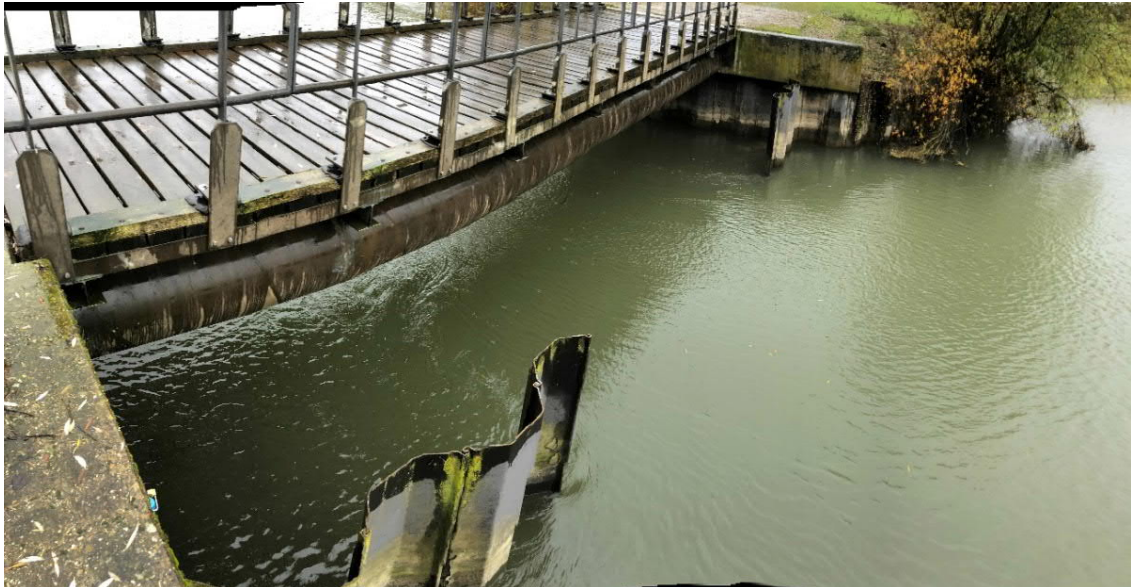
Gameren has a similar phenomenon in the southern channel, as described earlier in Passewaaij. Behind the relatively narrow bridge (see Figure 3.26) there is an erosion pit that appears to have been created by the concentration of the flow, see appendix B2-5 (bottom figure), Figure 3.27 and Figure 3.28. The erosion pit is more than 10 m deep, and has arisen because the entire decline of the southern channel is concentrated on the bridge.

Figure 3.26 Gamerensche Waard: bridge over inlet construction with narrowing of the flow.

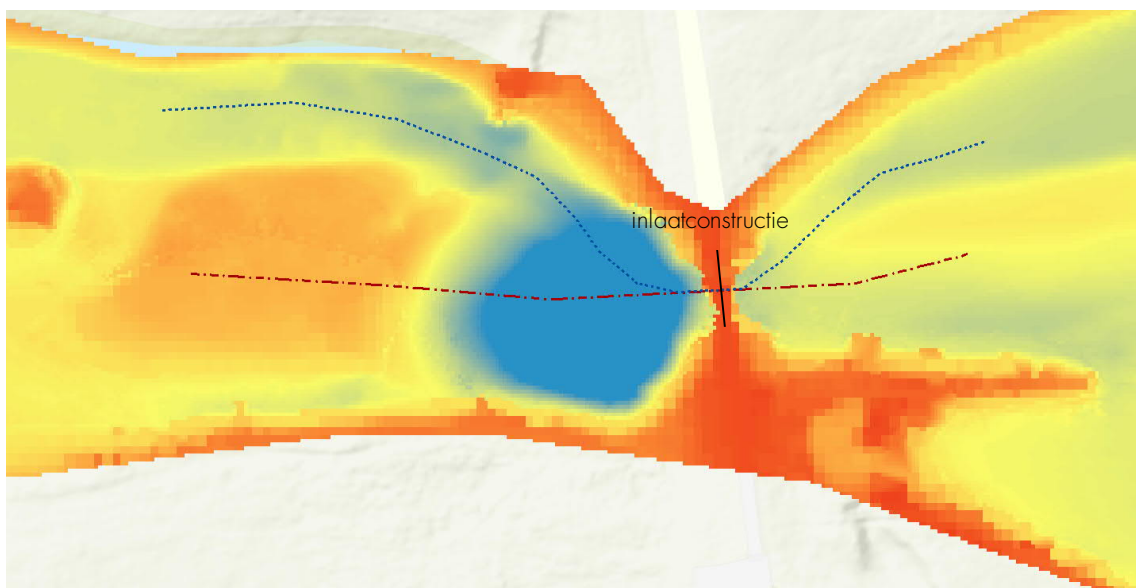
Figuur 3.27 Detail bottom height south channel Gameren near bridge with two longitudinal profiles.

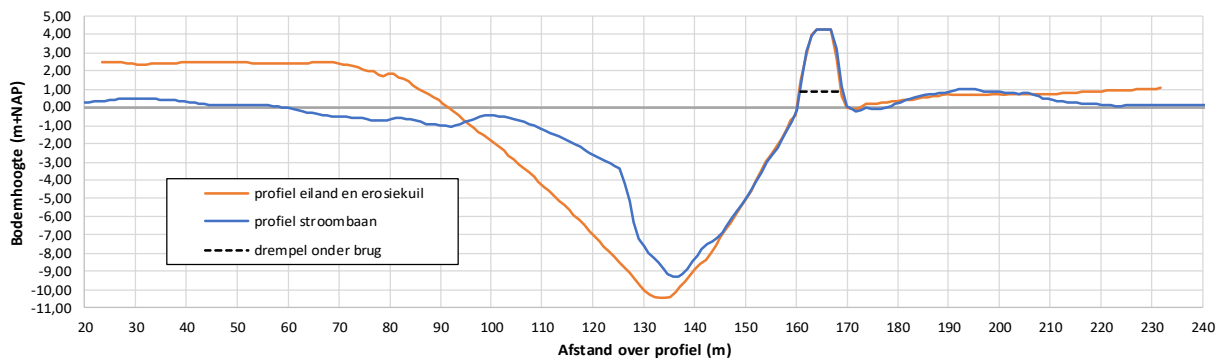
Figure 3.28 Bottom heights in the two longitudinal profiles through the bridge of the southern channel Gameren.

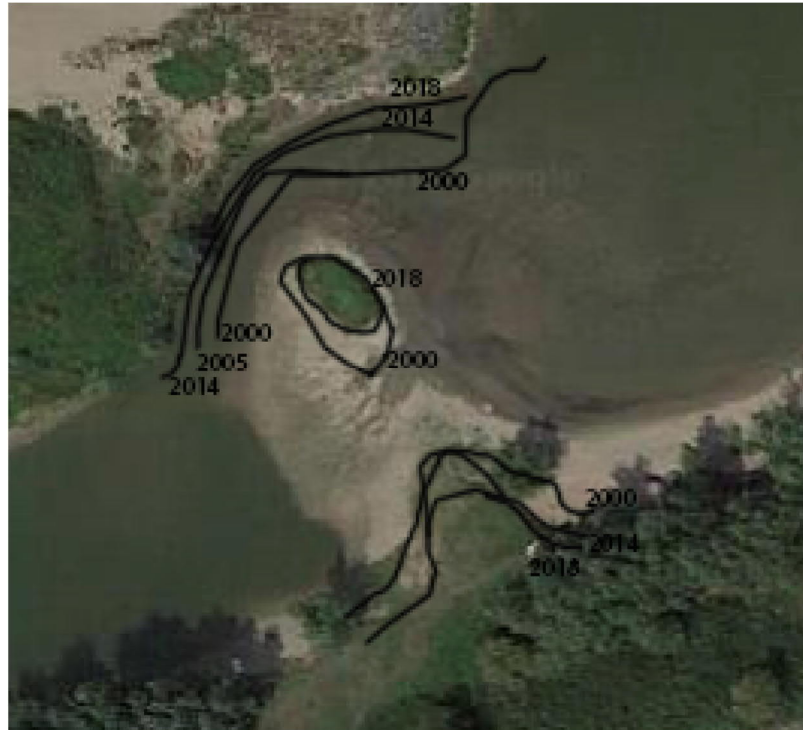
Shortly after the construction of the channel in 1997, a small channel formed along the north side of the inlet. This breakthrough was already visible in the aerial photo of 2000. In the years that follow, this inflow channel slowly grew (see Figure 3.35), but major developments did not occur. The remaining part of the threshold remained intact, but here the boundary of the vegetation has changed, from which it can be concluded that parts have become lower.

Figure 3.35 Contours of the bank line on the north side of the channel, which flows along the north side of the threshold and of the vegetation line and on the south bank in 2000, 2014 and 2019.

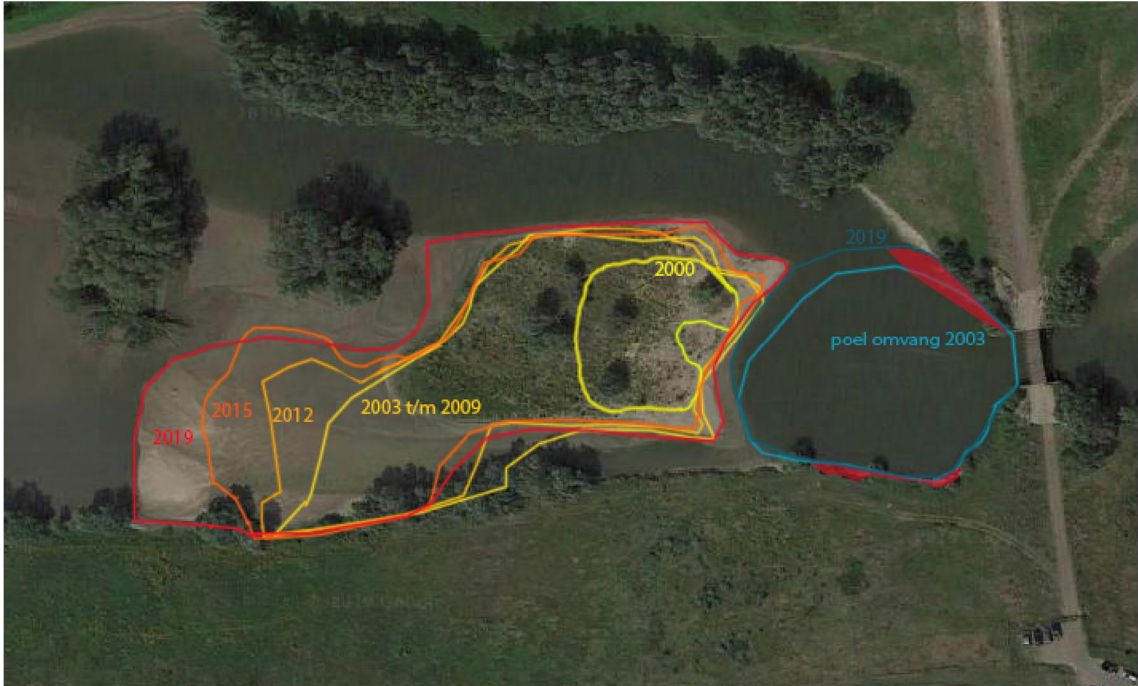
Immediately after the inlet under the bridge, in the years following the construction of the secondary channel, an erosion pit formed with a sandy island immediately downstream of it. The height difference maps (see figure 3.26) show that the erosion pit has deepened to 10 m and the island behind it is approx. 2 m higher than the bottom height during construction. The island was already visible in the photo of 2000, then it was still small. In 2003 the island grew strongly and was on the south side on the bank. The island changed little in shape in the years that followed; however, a photo from 2007 shows that the southern part of the plate was somewhat lower than the center and that water flowed over its lower discharge levels. The situation changed in 2012, the channel that ran along the south side became longer and at the same time, the extension of the island's shore quickly expanded to the west. The elevation difference maps also show that the southern part of the island decreased during this period. This depression attracted more water and more sediment, which extended the sandbank on the downstream side. This process continued in the years that followed. The east and north banks of the sandbank changed little in shape during this time, except for slow growth on the northeast side of the sandbank.

Figure 3.36 Changes in the contour of the erosion pit downstream of the inlet works (in blue) and of the sand island (yellow - red lines) downstream thereof, over the period 2000 to 2019. The red areas are parts where bank erosion has occurred.

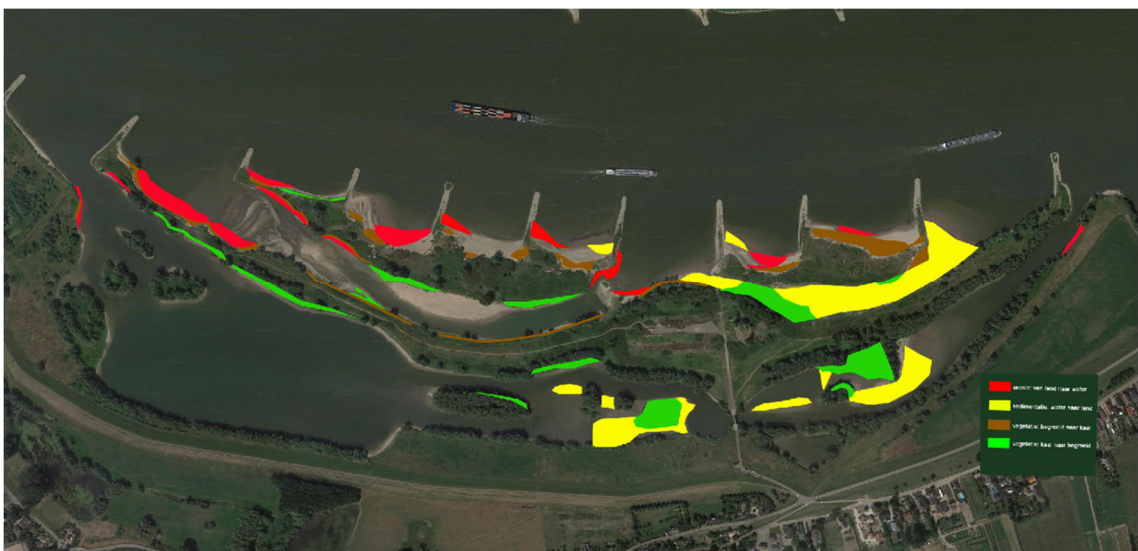
The changes are most evident in the northwestern channel. Bank erosion is visible along the south bank, but the horizontal changes are not significant, often no more than a few meters (narrow brown line in Figure 3.37). The base where the bank erosion occurs, vegetates over time and the erosion activity does not take place annually. Along the northern edge of the northwestern channel, but also along the northern edge of the southern channel, there are sections where vegetation on the bank extends towards the channel (green areas). These are sandbanks, which eventually become so high that they have become overgrown. The erosion in the inlet of the northwestern channel is described in 3.3.4.4.

Figure 3.37 Changes between 2000 and 2019 in the riparian zones as a result of erosion (red), sedimentation (yellow) and the degree of growth (green = expansion, brown = decline).

In the southern channel, sedimentation has taken place at several locations and in recent photos, taken at the lower discharge levels, increasingly larger areas with land are visible (yellow areas in Figure 3.37). The vegetation also spreads over a part of these areas (green areas in Figure 3.37), which shows that the height of the areas is increasing. This is also evident from the bottom height difference maps where each subsequent measurement shows an increase and extension of the sedimentation surface.

Figure 3.37 shows that quite a lot of erosion also occurs along the river bank. In most groyne sections, the sandy beach is smaller in 2019 than in 2000. Higher on the bank, the boundary between overgrown and bare has retreated. The large area of bare sand in the groyne sections directly after the outflow of the northeastern secondary channel, is a location that was covered with lowland riparian forest. After this forest was cut down in 2006, no vegetation has returned.

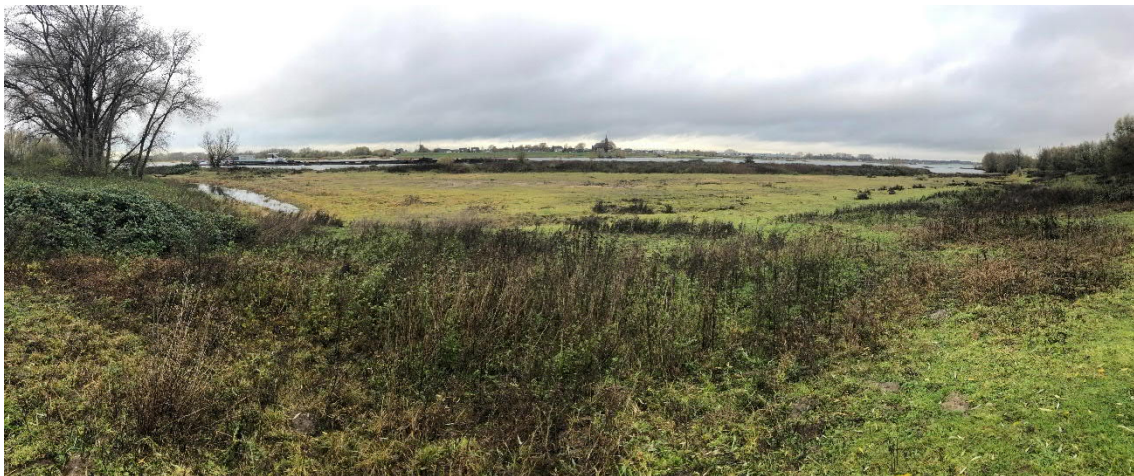
According to the bottom height difference maps (see appendix B2), a lot of sedimentation occurred in this secondary channel in the first years after construction (>1 m). This claim is supported by aerial photographs showing a large sandbank along the north bank as early as 2000. Half channel was already filled with sedimentation. After 2003, the channel was filled in almost completely. Only on the downstream side on the south bank, in the years thereafter, an elongated, approximately 2 to 3 m deep pool remained. After the initial rapid silting between 1996 and 2003, the elevation decreased according to the bottom height difference maps. This is also evident from the aerial photos, because the bottom of the channel was only sparsely overgrown, which shows that co-flow occurred around the median water level in the river. From 2005, some trees were present in the central part of the channel. These grew into a small grove, which was cut down after 2012. From the summer of 2012, the central part of the channel was also covered with grassy vegetation. This vegetation gradually expanded, covering about 65% of the secondary channel in 2017. After the high water of 2018, the vegetation was largely covered by a sand deposit. In 2019, vegetation has only recovered to a limited extent.

Figure 3.40 Impression of the northeastern secondary channel (November 2019)

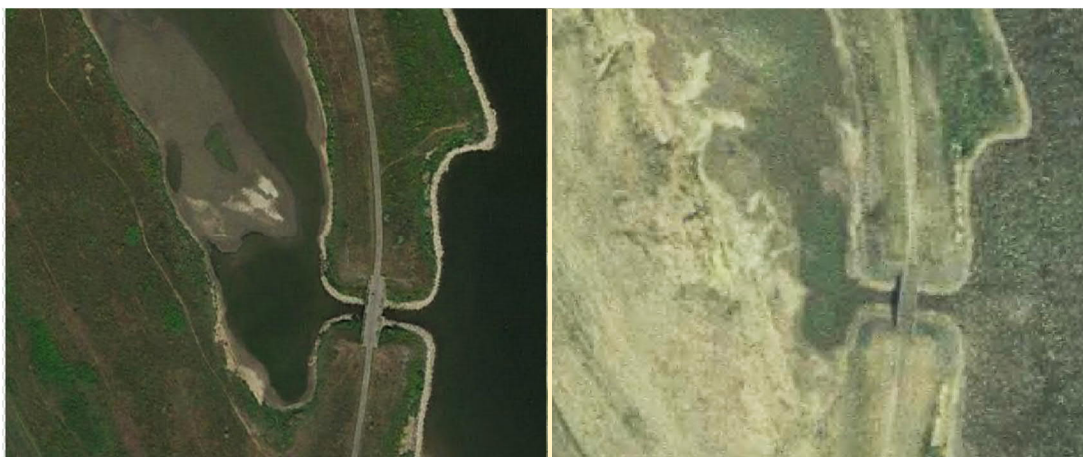
In 2003, there was an elongated erosion pit directly downstream from the inlet; however, it is not clear whether this was the remnant of the channel, which was filled further downstream, or a newly created deeper part. In 2011, the depression had a more round shape and the bank on the west side had retreated. This process continued in 2015 and 2016. In 2019, the eastern bank also became an eroded bank over a distance of approx. 10 m. The sand released from the erosion pit was deposited directly downstream (see Figure 3.45). Despite the poor quality of the bottom height measurements, this pattern of erosion and sedimentation downstream of the erosion pit is visible on the bottom height difference maps (see appendix B2).

Figure 3.45 Aerial photo 2019 (left) compared to 2003 (right) in which the increasing size of the erosion pit is visible. NB In 2003, there was still a lot of sand on the bank around the secondary channel that was deposited there during the high water of 2003.

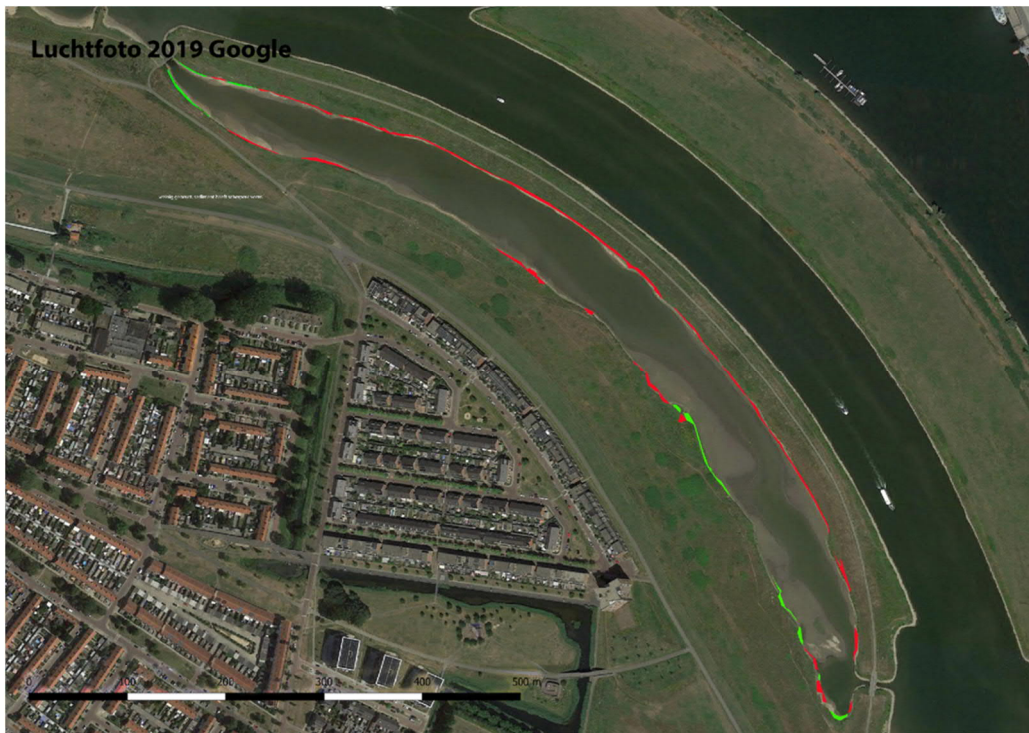
A comparison of several years also shows that the changes on the bank mainly occurred between 2005 and 2011, after which virtually no changes have been visible. Compared to the first photos, the vegetation shifts downwards. In 2003, the sand on the west bank reached high above the waterline. This was already overgrown in 2005. Afterwards, the vegetation boundary has shifted back, because many banks have eroded.

Figure 3.47 Changes in the bank line between 2005 and 2019 (NB The photo from 2003 was too unclear to deduce the bank line).
