**D.T1.3.3 – Estimation of heating losses from
thermal data / PA6**

A.T1.3 Estimation of PV potential and heating losses

Building #1 – Primary school Braca Radic – 2018/19

Building #2 – Kindergarten Loptica – 2018/19

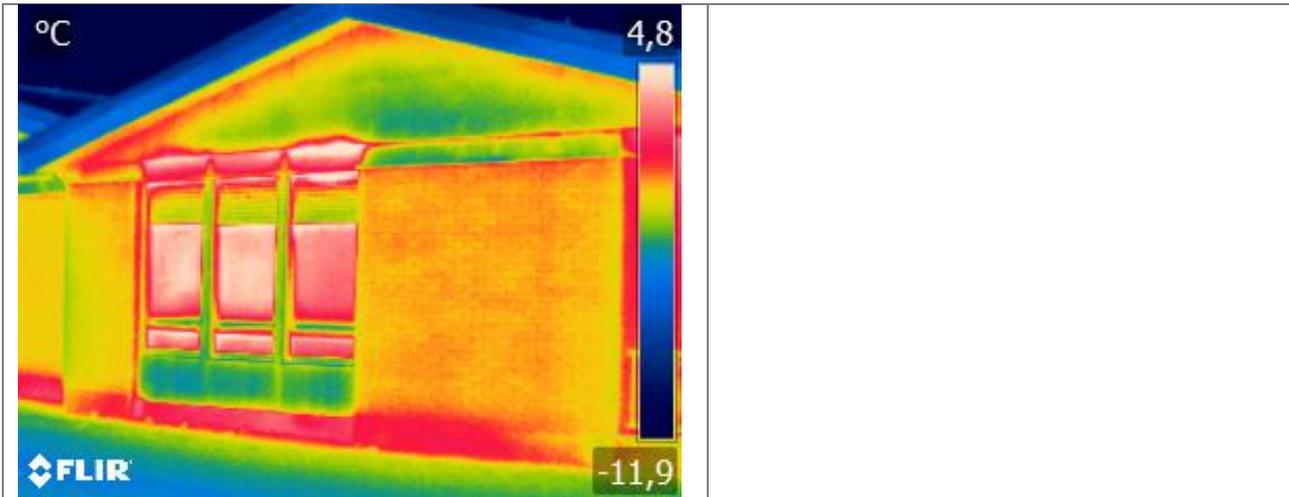
On both images you can see heat losses through windows and through outer walls due to poor quality windows and uninsulated facade.
