NANO-REGION

PROOF-OF-CONCEPT EXPERIMENT REPORT

ANALYSIS OF ANOMALIES IN ENAMEL INSULATION ON COPPER WIRE

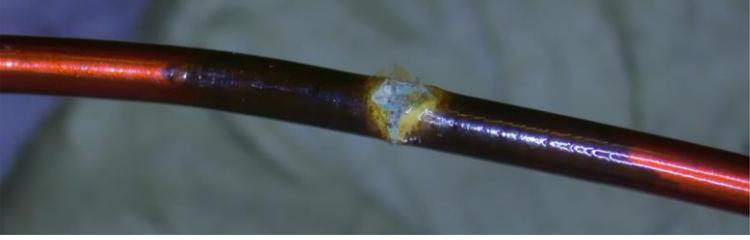
<p style="text-align: center;">Sample 4 Delivery date: October 14th 2020</p>

Three copper wires (diameter of ~ 1 mm) insulated by several THEIC-PEI (polyesterimide) layers in thickness of ~10-15 μm and ~10 μm topcoat PAI (polyamide-imide) layer. The wires were sampled from different part of motor stator pack which was subjected to lifetime test. Digital image of the delivered samples with given names are listed in Table 1.

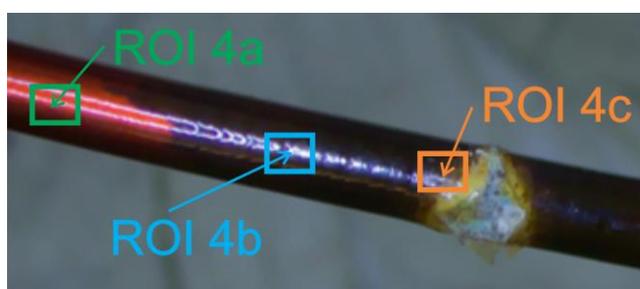
Figure 1: Sample 4 with selected ROI locations and corresponding names

SEM analysis shown that the surface morphology and topography of enamel protection was very similar at healthy (ROI 4a) and blue colored region (ROI 4b) of insulated wire (Figure 2-3). At this locations cracking, degradation or any foreign contaminant on enamel surface was not detected. The later was confirmed also with EDX analysis (Table 2) which shown very similar elemental compositions on both locations (EDX 4a and EDX 4b). Contrary, at the ROI 4c, heavily enamel degradation was found which resulted in enamel layer cracking and insulation peeling of the Cu wire as shown in Figure 4. Moreover, phase contrast images shown in Figure 5 revealed presence of additional phases on top of unprotected Cu wire (at cracked part) as well as on enamel surface near the cracked region. These phases include potassium as well as traces of sodium and chlorine elements, which were not seen at healthy or blue colored enamel surfaces (Table 2). According to elemental analysis in Table 2 (EDX 4c-2 to EDX 4c-4), the content of potassium increases from the cracked enamel edge toward “peeled off” Cu wire region. This indicates that the potassium/sodium contamination was most likely present locally at the Cu wire surface, where the corrosion/degradation effect was most intense, and from there degradation process advanced in the near surrounding which caused defects in enamel insulation layers.

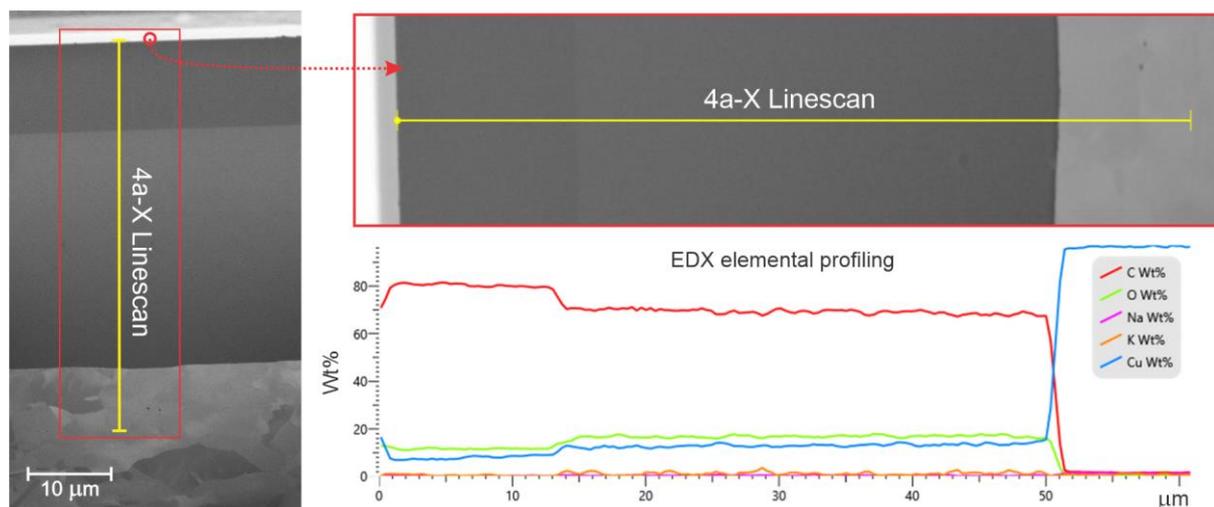
Figure 7: EDX linescan analysis along cross-section of healthy region (ROI 4a) with enlarged linescan acquisition detail and corresponding EDX elemental profiles

FIB-SEM cross-sectional analysis of healthy region (ROI 4a) shown that total thickness of enamel insulation on top of Cu wire was 49.5 μm. Phase contrast images in Figure 6 revealed two different types of enamel layers which were firmly sandwiched together without any traces of foreign contaminations between them. According to the company description, the first enamel protection part

on top of Cu wire should be composed of 2-3 polyesterimide (THEIC-PEI) layers with individual thickness of ~ 10-15 μm. However, (THEIC-PEI) layers cannot be individually distinguished by phase contrast imaging (same material) and therefore are shown on phase contrast image (Figure 6) as one combined layer with total thickness of 32.9 μm. By the contrast, the topcoat polyamide-imide (PAI) layer was clearly distinguished from the initial layers and shown its uniform thickness of 13.6 μm. The difference between two different types of enamel layers was also confirmed by EDX elemental composition shown in Table 3. The interface between Cu and enamel protection presented in enlarged image in Figure 6 shown flawless adhesion of first protection layer without any cracks or defects. The wire composition near the interface shown practically pure copper with some traces of carbon which is related to Cu X-ray secondary fluorescence with enamel layers (Table 3). At the Cu/enamel interface there were not found any traces of foreign contaminants or Cu surface degradation. In addition, EDX linescan (4a-X) shown in Figure 7 confirms uniform elemental profile along both types of enamel layers (in terms of C and O) and stepwise change of C, O and Cu signals at the Cu interface without any traces of foreign contamination elements. Related to EDX linescan analysis it is also important to note that Cu signals in enamel layers could be effect of two contributions: Cu diffusion toward enamel layers and/or beam scattering effect from supporting copper due to large depth of FIB cross-sectional geometry.

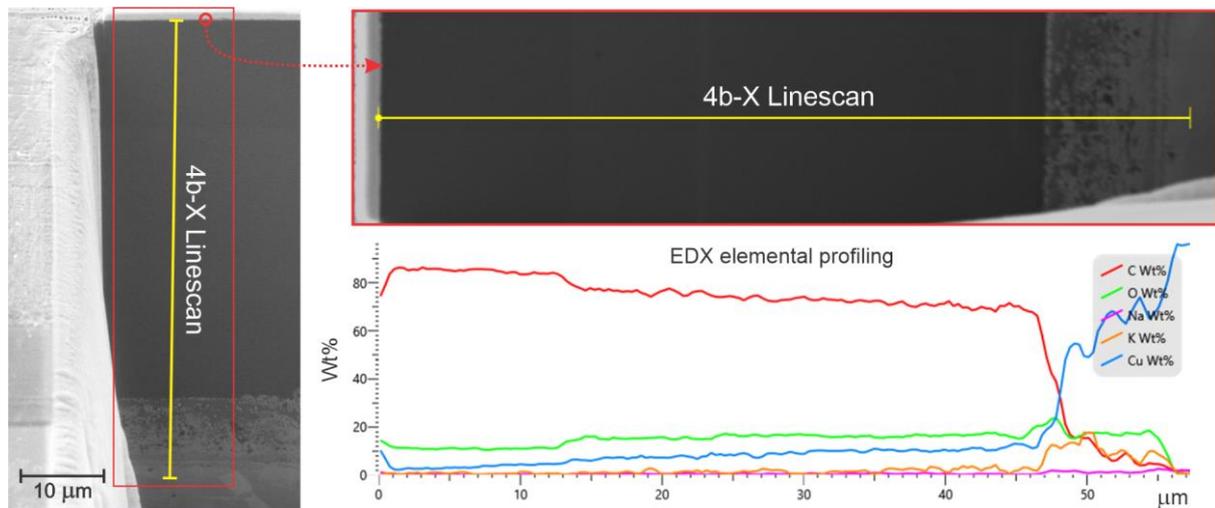
Figure 9: EDX linescan analysis along blue colored region (ROI 4b) with enlarged linescan acquisition detail and corresponding EDX elemental profiles

FIB-SEM cross-sectional analysis of blue colored region (ROI 4b) shown that total thickness of enamel insulation on top of Cu wire was 46.1 μm (Figure 8). Enamel layered insulation was found very similar to healthy region (ROI 4a), composed of two different enamel types with the thickness of 32.9 μm and 31.2 μm for the combined THEIC-PEI layer pack and topcoat PAI layer, respectively. All enamel layers were firmly sandwiched together and there were not found any traces of foreign contaminants between them. However, Phase contrast image in Figure 8 clearly shown corrosion/degradation of the Cu wire surface at the Cu/enamel interface. The corroded Cu surface layer at ROI 4b location was found to be 7.4 μm thick. EDX elemental analysis shown in Table 4 revealed presence of potassium (up to 27.5 Wt%) and sodium (up to 2.2 Wt%) in the Cu degraded layer. EDX linescan (4b-X) presented in Figure 9 shown uniform elemental profile along both types of enamel layers (in terms of C and O) similar as in healthy region. At the enamel/Cu wire interface K and Na elemental signals appeared and were present, together with O element, throughout entire Cu degraded surface layer (7.4 mm) until healthy Cu wire was reached at the depth of 56 μm. This indicates that the traces of K and Na contaminants were present at the Cu/enamel interface within the blue colored wire region and caused surface degradation processes of the Cu wire.

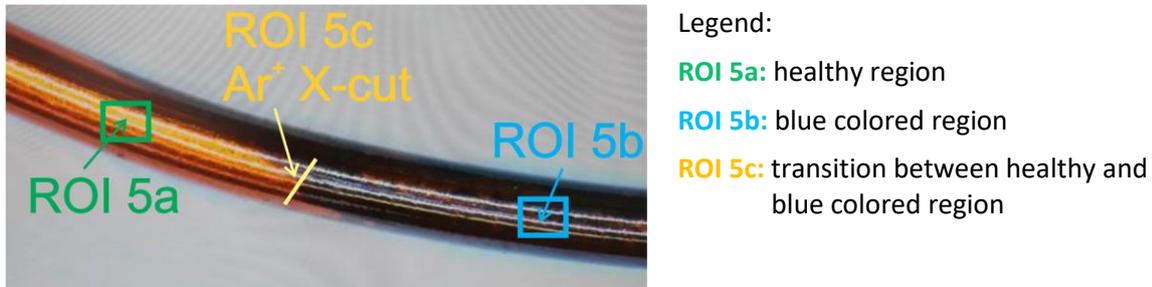
Figure 12: Sample 5 with selected ROI locations and corresponding names

Sample 5 was taken from the motor stator wire pack, where the initial stage of enamel degradation was visually observed. Prior surface SEM-EDX analysis, region of interest (ROI) was coordinated with the company. Target ROI locations with corresponding names are shown in Figure 12.

Surface SEM analysis (Figure 13) of insulated copper wire 5 shown that the surface morphology and topography of enamel protection was very similar at healthy (ROI 5a) and blue colored region (ROI 5b). Cracking, degradation, or foreign contaminant elements were not detected at any of those locations. The later was confirmed also with EDX analysis (Table 6) which shown very similar elemental compositions on both locations (EDX 5a and EDX 5b).
