Caen Hill Pumping Station

PHASE 2 SITE TEST SUMMARY REPORT

Report No: 10031024-00536

Work Package: Trialling Emerging Technologies (Canal & River Trust) I1

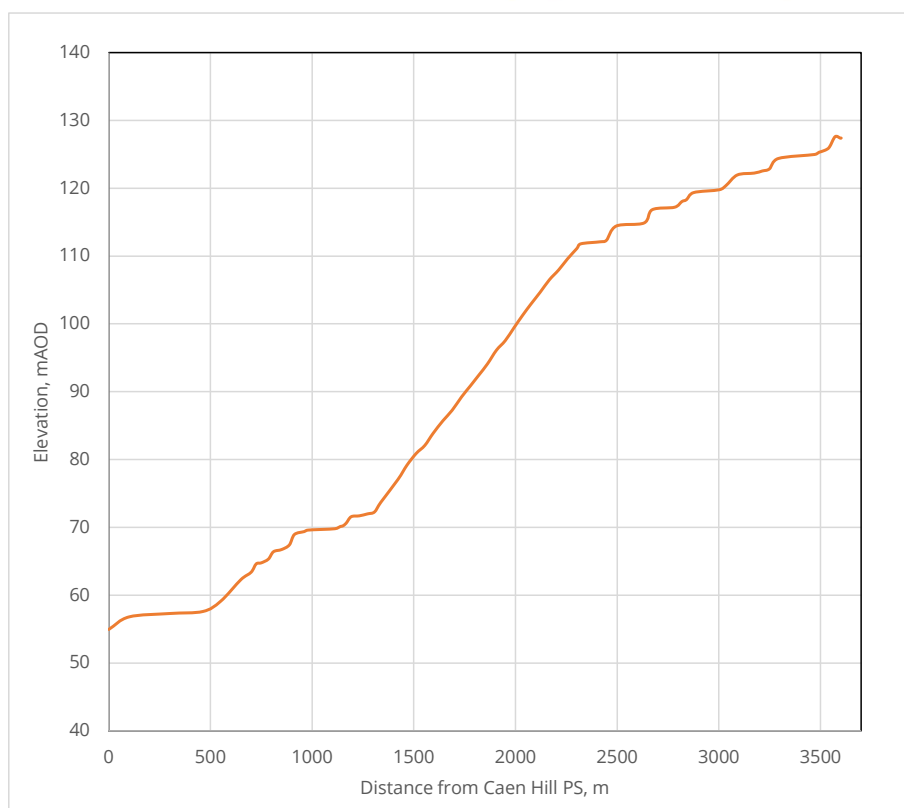
Figure no. 2: Caen Hill PS Elevation Profile

Parameter	Description
Length	3602 m
Elevation rise	72 m
Pipe diameter	600 mm
Discharge level	127.6 mAOD
Pipe material	Ductile Iron
Removed intermediate NRV #1	1270 m from Caen Hill PS
Removed intermediate NRV #2	2410 m from Caen Hill PS

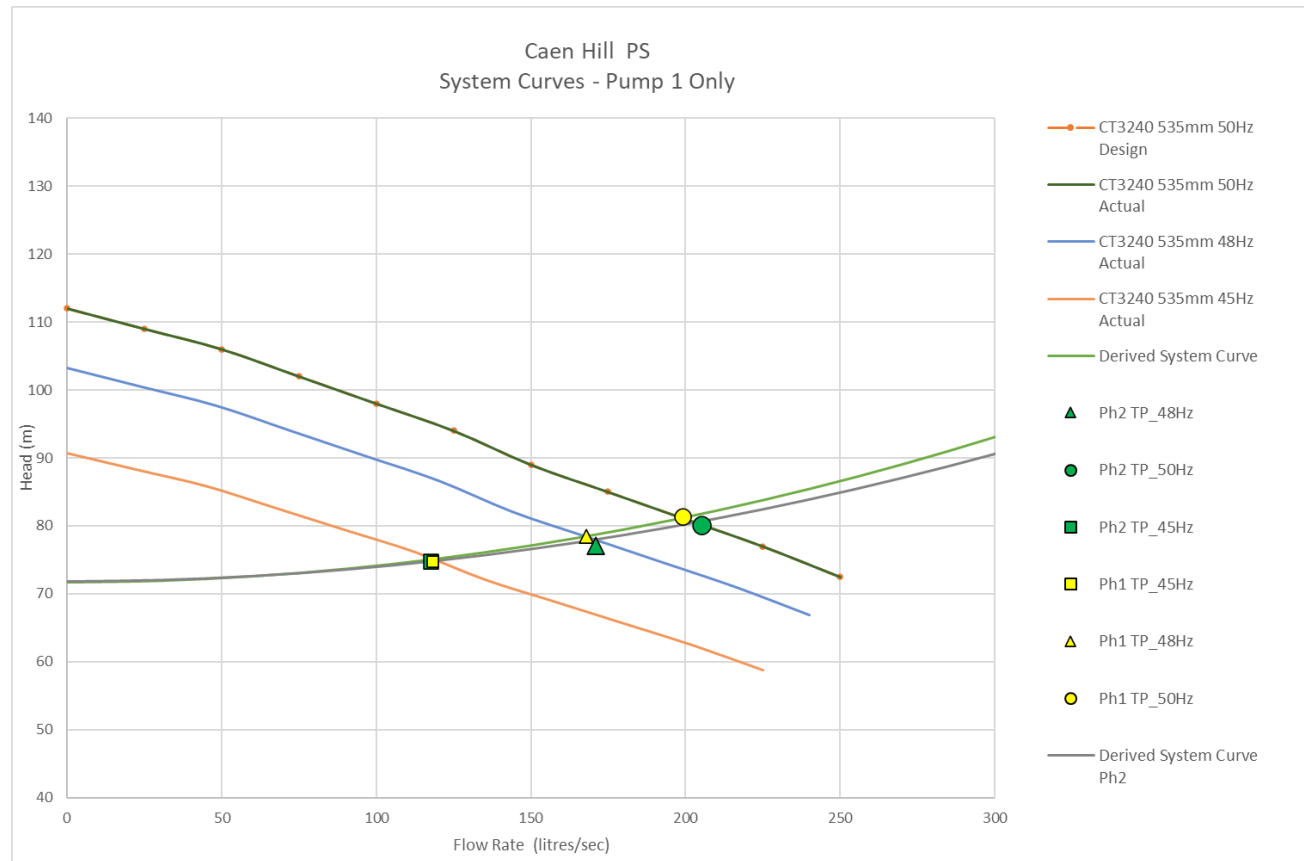
Figure no. 4: Derived System for Pump 1 Only Operation

- The site test results backed up by the SCADA data indicate a marginal improvement on rising main head losses. A reduction of approximately 2m to 3m at 300 l/s between Phase 1 and Phase 2 and removal of the intermediate NRVs was found. However, the rising main dynamic losses are still 3m to 4m higher than expected at 300l/s as indicated by the dashed “design system curve” in Figure no. 3.
