# FRAMES pilot A58 and national highways in Zeeland

Final report

Rijkswaterstaat Zee en Delta

4 juli 2019

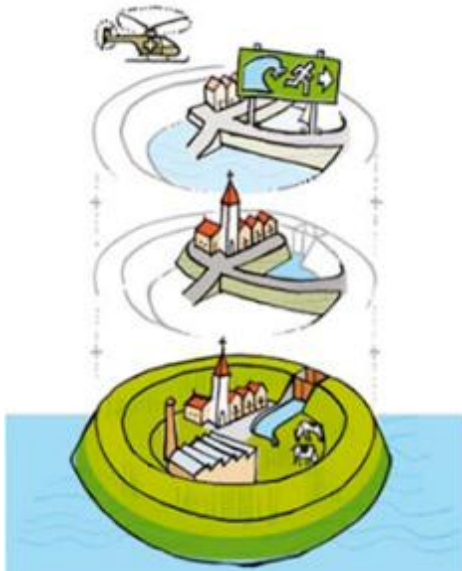
Figure 1.1 Visualisation layer 1 up to and including 3 multilayer safety

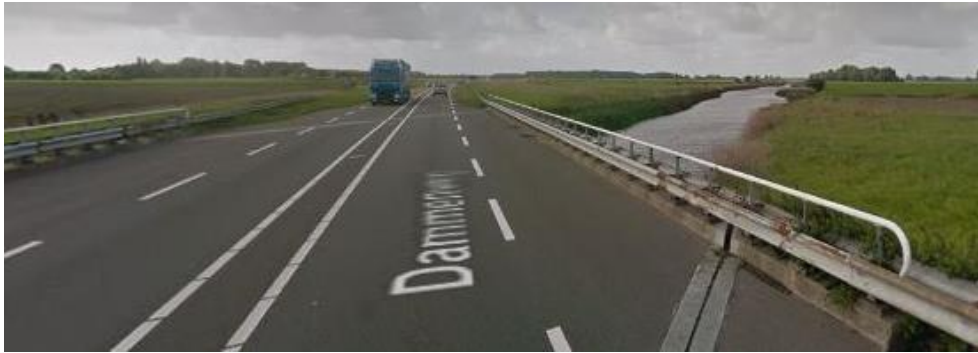
Figure 2.2 Viaduct

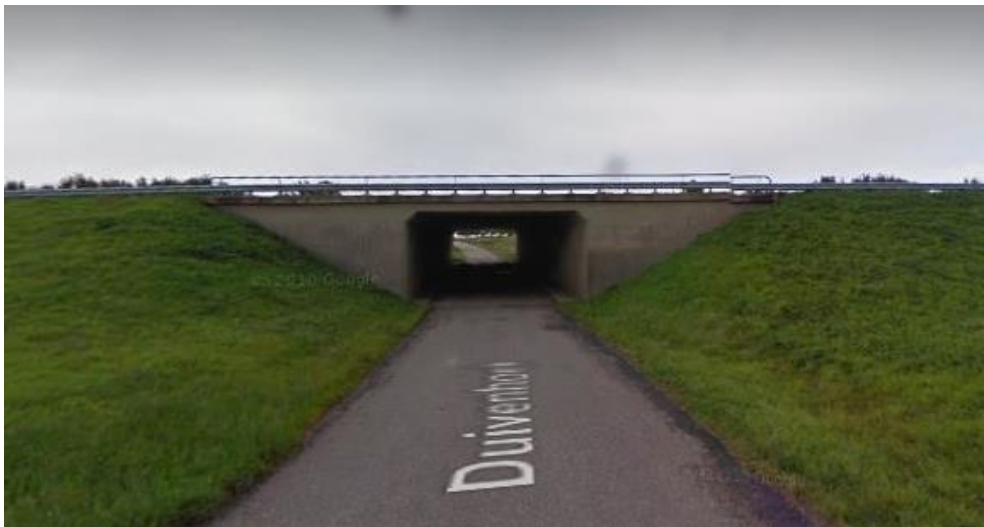
Figure 2.3 Underpass

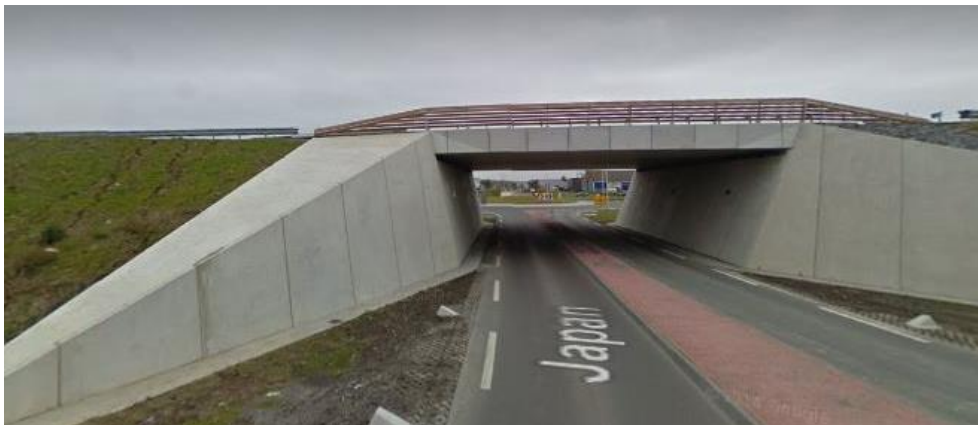
Figure 2.4 Underpass

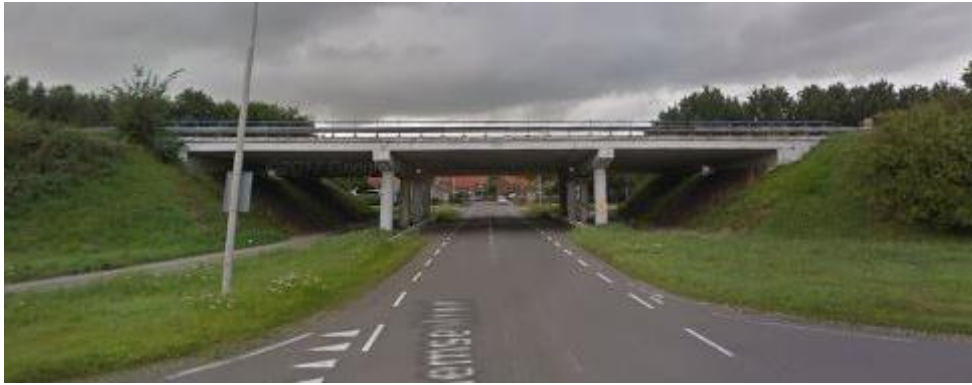
Figure 2.5 Viaduct

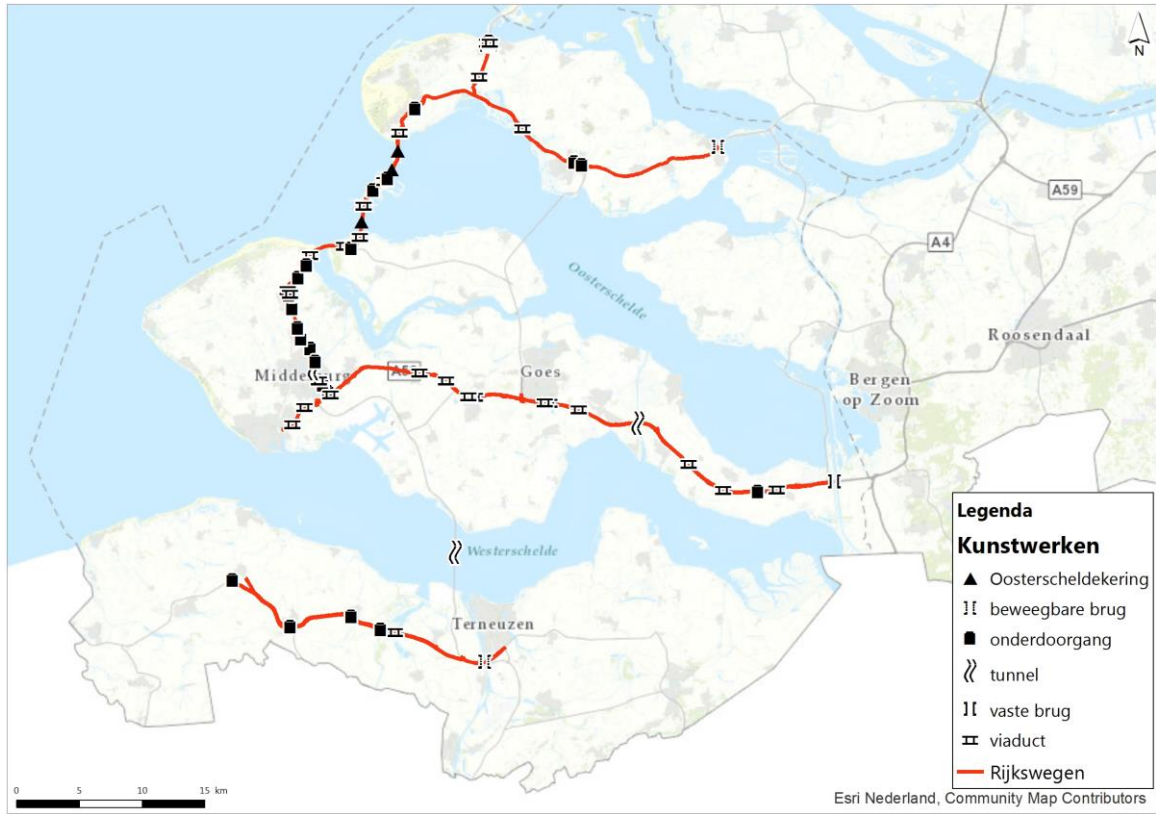
Figure 2.6 Overview of the national highways in the province of Zeeland

The focus of this study is on the A58 within the municipality of Reimerswaal, but the other national highways within Zeeland are also considered. Figure 2.6 on the following page shows the national highways in the province of Zeeland consisting of:

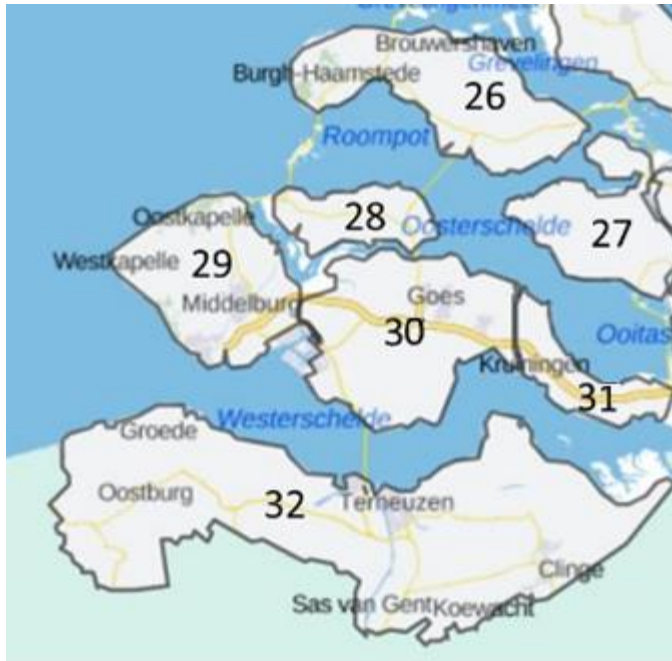
Figure 3.1 Dike rings in the province of Zeeland

Figure 3.1 shows the different dyke rings in the province of Zeeland, these are:

- Dyke ring 26 Schouwen-Duiveland.
- Dyke ring 27 Tholen and Sint-Philipsland.
- Dyke ring 28 Noord-Beveland.
- Dyke ring 29 Walcheren.
- Dyke ring 30 Zuid-Beveland West.
- Dyke ring 31 Zuid-Beveland East.
- Dyke ring 32 Zeeuws-Vlaanderen.

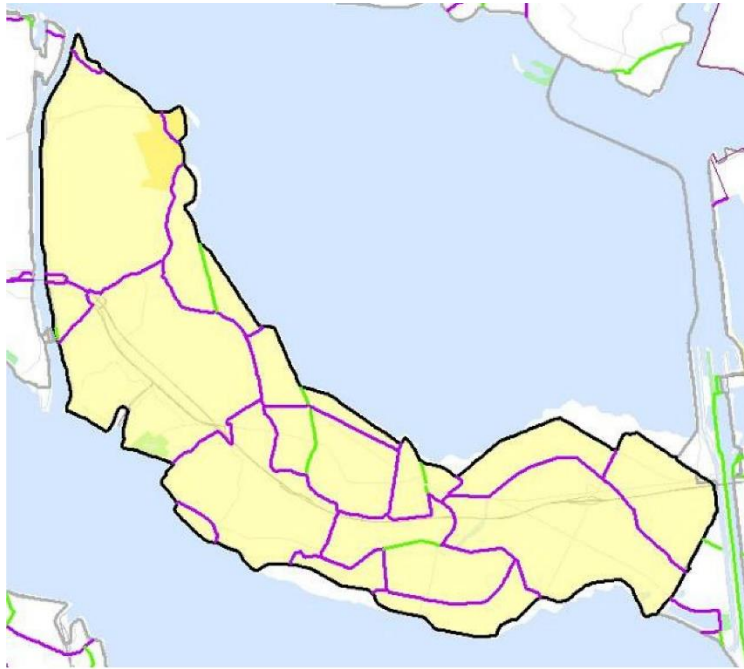
Figure 3.2 Inner dykes within dyke ring 31. Purple: inner dyke with water management function, green: inner dyke without water management function (source: VNK2 report 'Flood risk Dike ring 31 Zuid-Beveland', December 2011)

The FRAMES pilot project for Reimerswaal focuses on the vulnerability of vital infrastructure within dyke ring 31. Within dyke ring 31 different regional barriers are present, a trace of the phased land reclamation from the past (figure 3.1). During the term of the project it has been recorded that the VNK2 scenarios for dyke ring 31 Reimerswaal have been elaborated with the starting point that the regional barriers are not flood proof. This means that it has been assumed that during a breach of the primary flood defence all regional barriers also fail. This is not consistent with the agreed national systematics for VNK2. For those reasons new scenarios have been calculated by the province of Zeeland for Reimerswaal, but then with flood proof barriers as the starting point. In this project the analysis for the A58 within Reimerswaal has been carried out for both non-flood proof (calculation 1) and flood proof regional barriers (calculation 2).

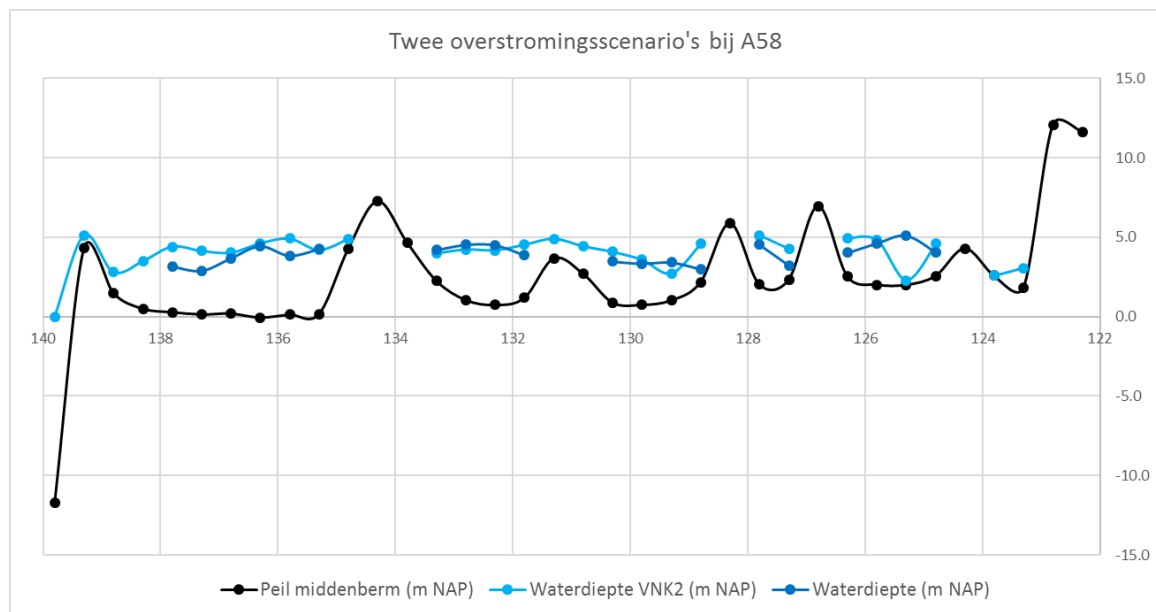
Figure 4.2 Cross section of A58 and the flood maps. Light-blue non-flood proof regional barrier (VNK), dark-blue flood proof regional barrier (province of Zeeland)

The summary of the analysis of the profiles with the VNK2 scenarios can be found in figure 4.2. The water level at a profile is determined on the basis of the water depth (comes from VNK2 scenario) and the ground level height (digital height model AHN). Because the VNK2 scenarios are available at a detail level of 100 x 100 m and water depths shows measured in m relative to ground level and not in water levels in m NAP) and the AHN at 50x50 cm (measured in m NAP), there is considerable uncertainty in the water levels for the profiles. The uncertainty is smaller with the flood maps of the province of Zeeland since here modelled water levels are also available.

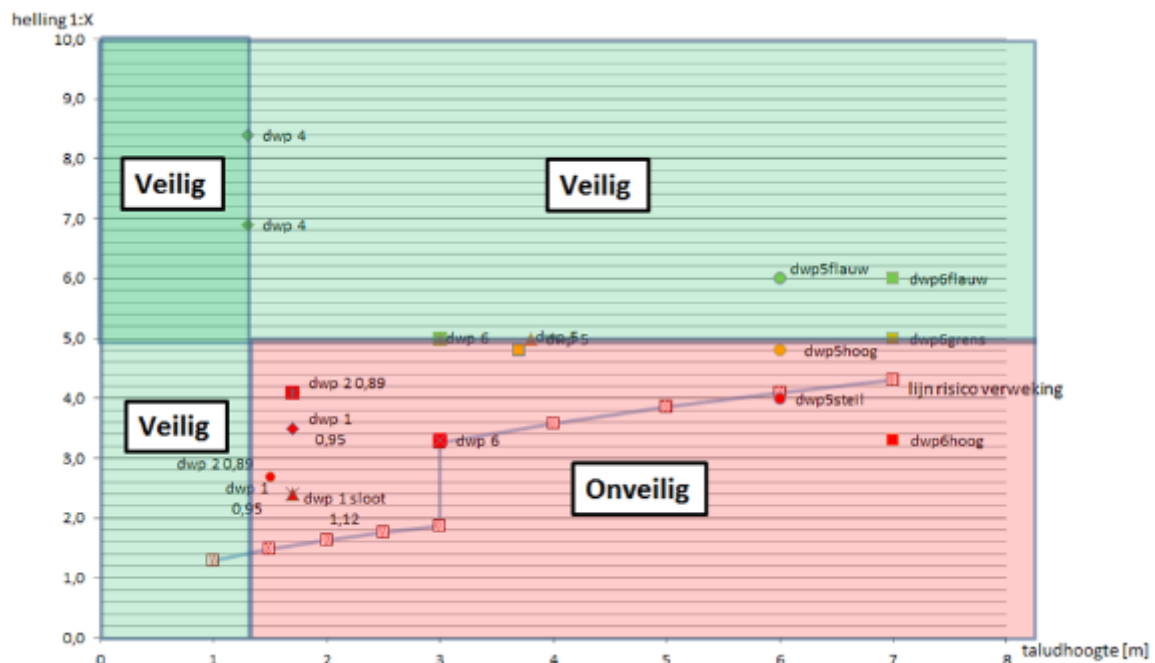
Figure 4.3 Results of Deltares study (taken over from Deltares report, 2014)

In figure 4.3 the embankment height has been plotted relative to the slope. For strain softening the grey line is normative. If the characteristics of a road bed are plotted under the line, there is - according to the Deltares research - an unsafe situation. A road bed with a slope of 1:5 and an embankment height of 5 m is,

for example, safe as regards strain softening. Above the line there is a safe situation. For shear stability this has been indicated with the red plane and the green planes. A road bed with a slope of 1:3 and an embankment height of 5 m is, for example, unsafe as regards shear stability.

The results of the analysis can be seen in figure 4.3.

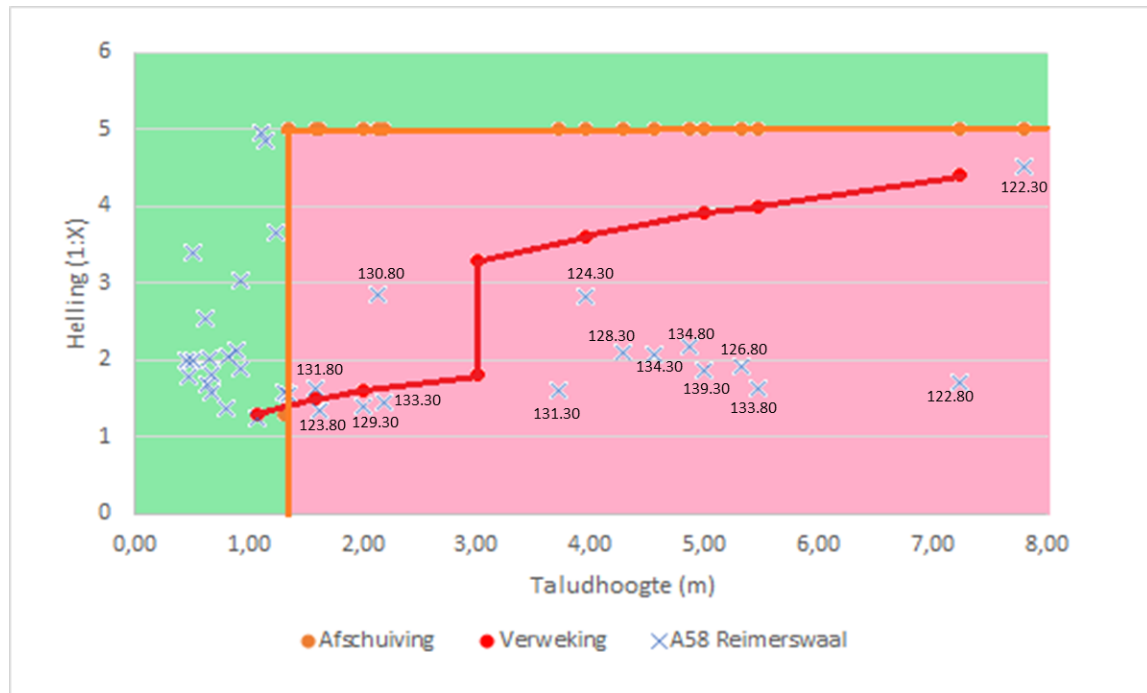
The results can be seen in figure 4.4. In this figure the two lines of the Deltares study can be seen: shear stability in orange and strain softening in red. The profiles are plotted with blue crosses. With this it can be assessed whether a profile is possibly unsafe, with as an important marginal note the fact that the starting points of the analysis of Deltares are too conservative (see the following paragraph). Also it is observed that not all profiles are (completely) under water. Thus the profiles around hectometer poles 122 km (Kreekkrakbrug) and 139 km (Vlaketunnel) do not flood or only do so to a limited extent.

Figure 4.4 Comparison of physical characteristics of A58 with Deltares results (safe in green, not safe in red)

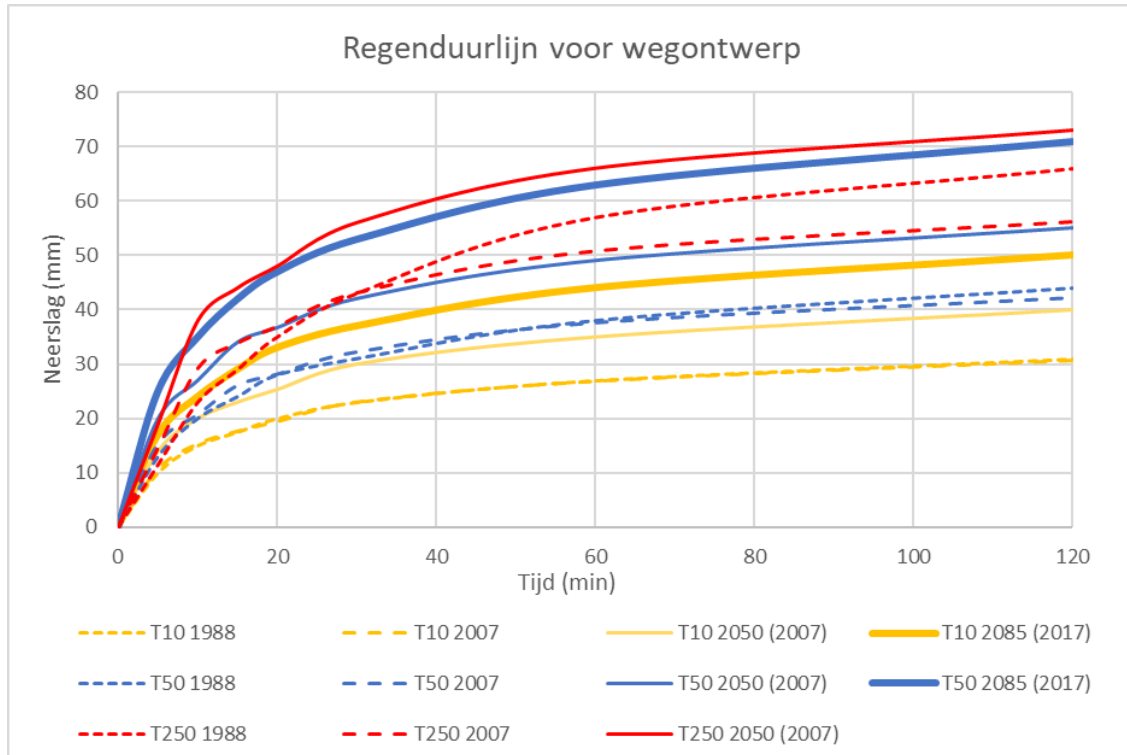
Figure 4.14 Changing insights into rainfall duration line

For the rainfall quantity use is made of a rainfall duration line or rain curve. Figure 4.14 on the following page shows the rainfall duration line of 1988, 2007 and 2050. It is well known that the T250 shower in 1988 for short rainfall durations was less extreme than in 2007. For the T10 and T50 there is a situation where the showers in 1988 and 2007 were around the same. For 1988 the rain curve of Braak is used. For 2012 and 2050 the rainfall duration line of Buishand and Wijngaard is used. An increase of 30 % has been adopted for 2050 in the context of climate change.

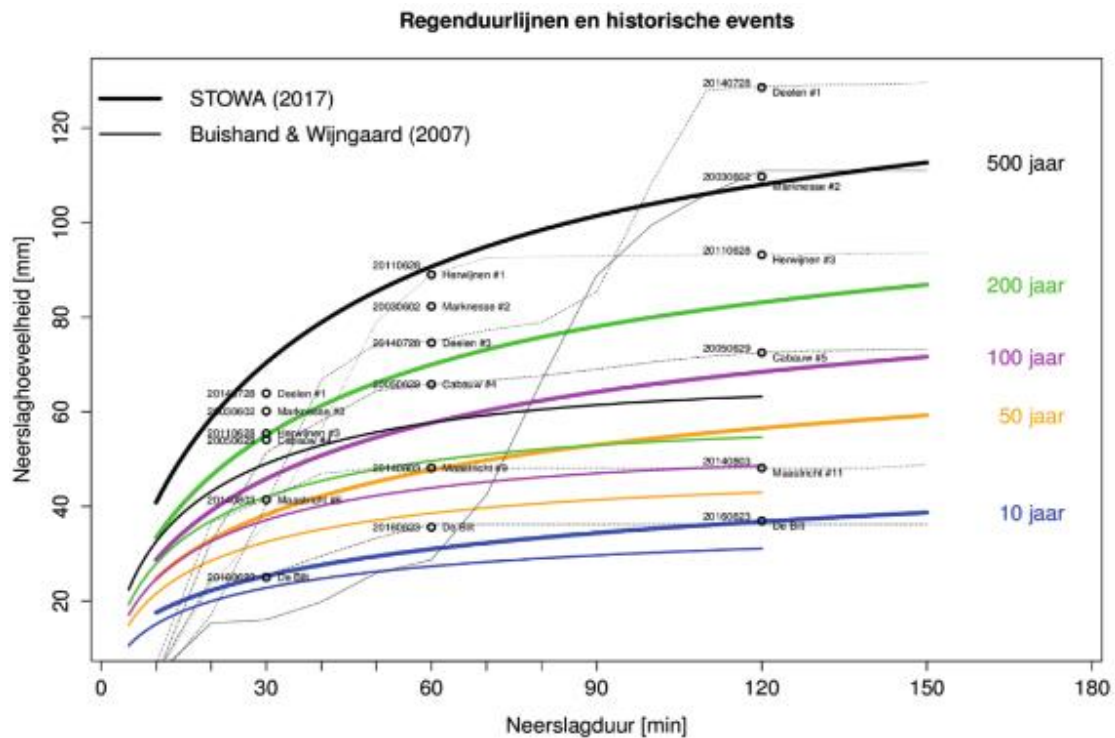
Figure 4.15 Insights in STOWA research study

In 2017, STOWA has carried out a statistical study into recent extreme rainfall in the Netherlands with HKV and the KNMI. The considered period is 2002 to 2016. The conclusions have been summarised in figure 4.15. In short, the observations of the last 15 years show that the extreme rainfall is more frequent than expected 10 years ago and that this is becoming more extreme. The rainfall of 1 x 500 years is approximately 26-71 % larger than previously calculated. With a return time of 1x 100 years this is 17-41 % and at 1x 10 years approximately 15 %. The consequence is that the rainfall duration line of 1x 200 years now agrees with the rainfall duration line of 1x 50 years. Regional differences in extremes will be studied in an addition to the report by STOWA.

Repetition time (year)	Duration	Precipitation quantity (mm)
100	1 hour	70
250	1 hour	90
1,000	2 hours	160

The design rainfall events from the design directive have been visualised in figure 4.15. These are compared with the recent insights of STOWA and the standardisation of the climate stress tests. Insights at the comparison

- STOWA research study:
  - The T10 and T50 with 30 % climate surcharge are comparable with the STOWA results. The essential difference is that the rainfall duration lines relate to recent observations (2002-2016): thus the current climate. The extreme rainfall, which had been expected for 2050 in the 2007 design directive, is now found to be falling already on the basis of the current rainfall data and analysis of STOWA. The 2017 design directive assumes more extreme rainfall for 2085 than the research study of STOWA and better reflects recent insights;
