Interreg  
2 Seas Mers Zeeën
Water Resilient Cities
European Regional Development Fund

Increase Urban resilience to climate change through improved storm water management

Action Plan Middelburg:
City center drainage masterplan

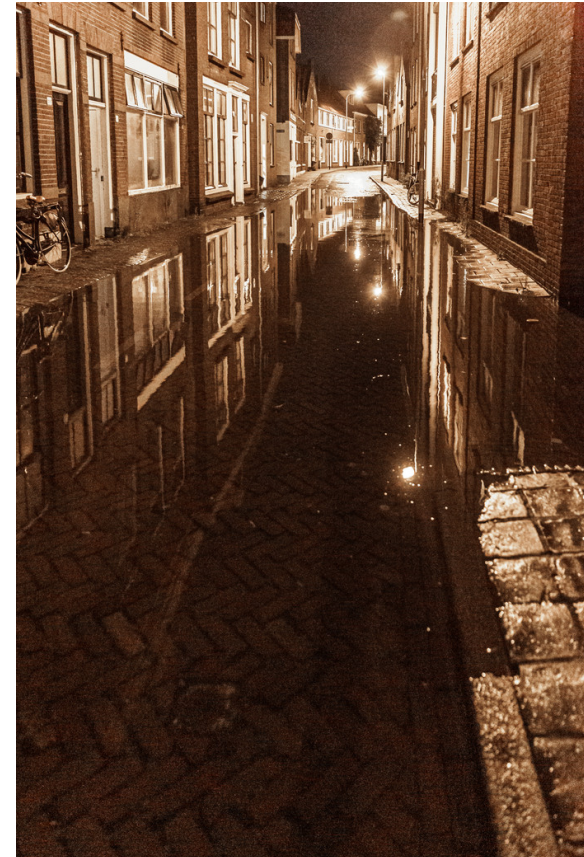
In the night of 30 to 31 August 2015, major flooding occurred in Middelburg. © Loes de Jong

Middelburg was affected as well. During the evening and night of 30 to 31 August 2015, approximately 90 millilitres of rain fall. That is nine buckets of water per square metre. Several sewers in Middelburg were not able to handle this extremely large amount of rain. Some streets were flooded for a while and dozens of houses suffered water damage. The public sewage system could not cope for a while and streets flooded. Homes, shops and businesses suffer from water damage or are temporarily closed down because of the rain.

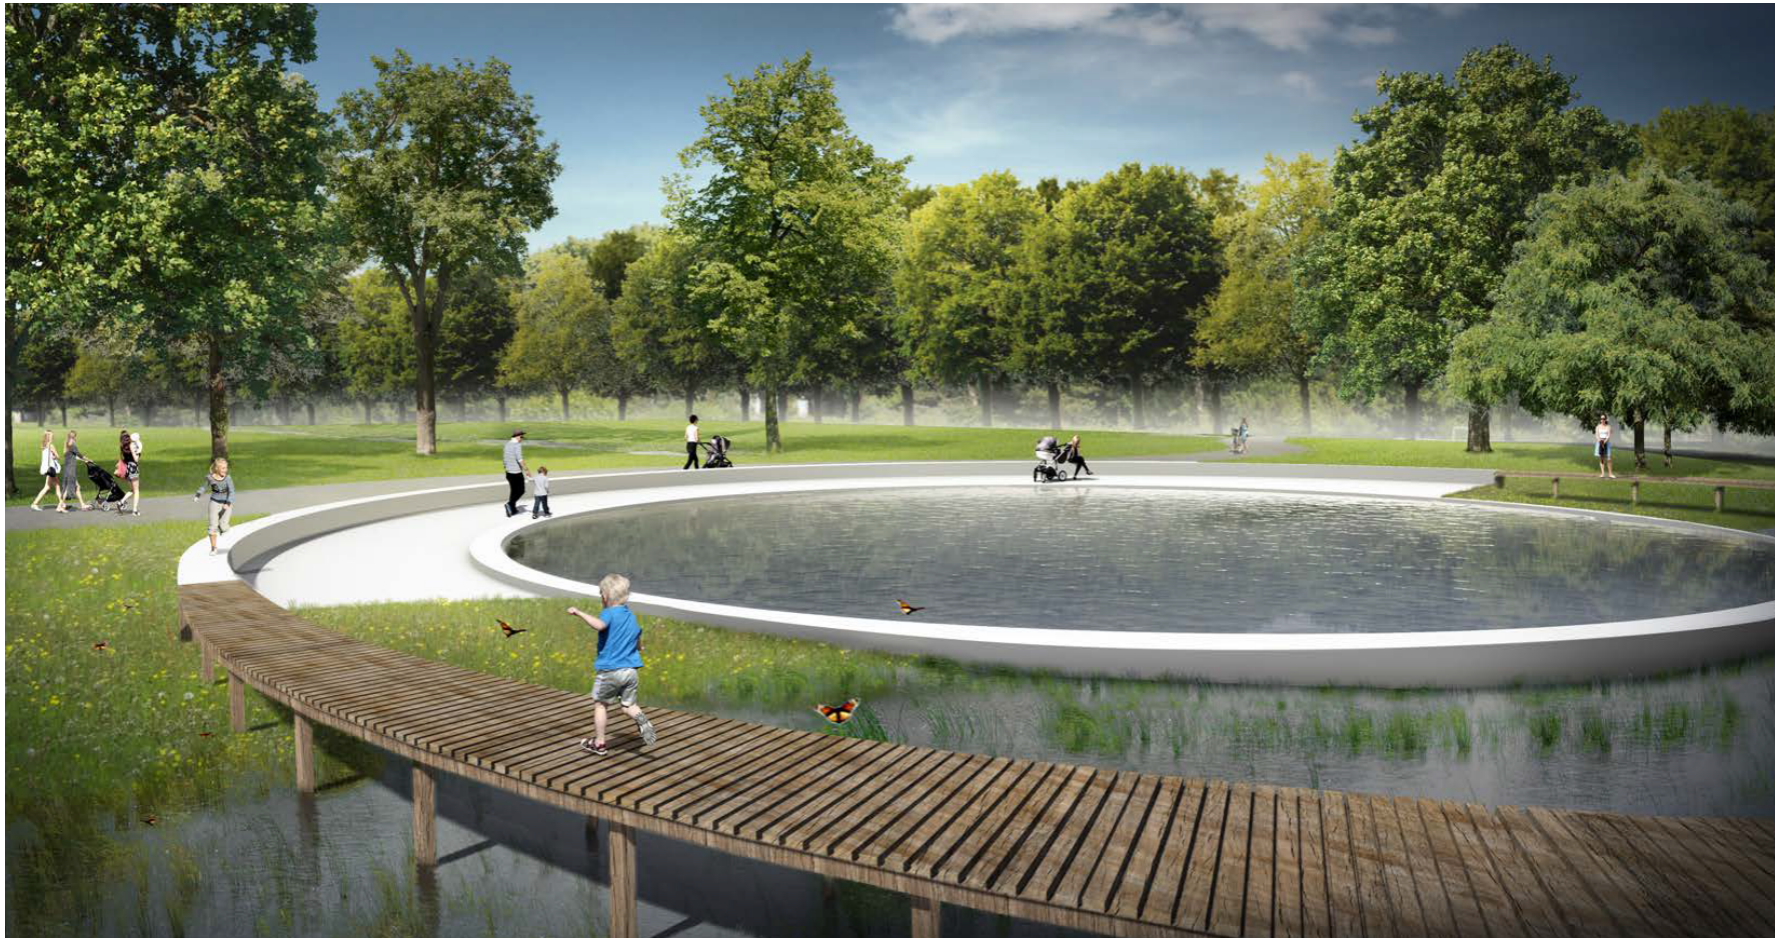
Artist impression Molenwater Park
