Runoff Monitoring pilot site at Churchtown Landfill

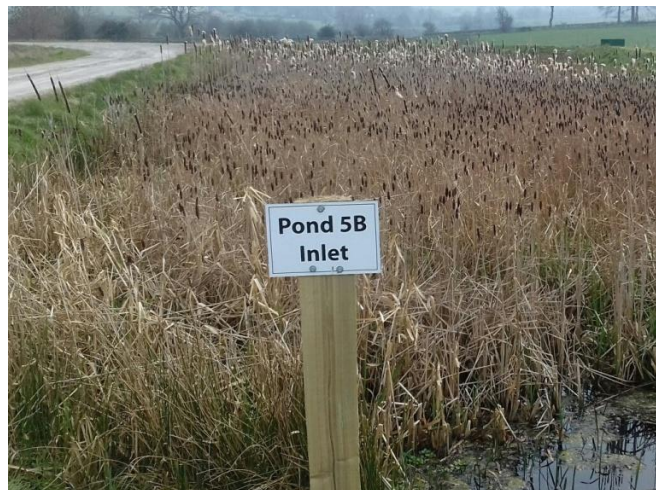
Photos: Fionnuala Bonner

- The monitoring network consists of 2 No. Online ammonia analysers, weather station and 16 monitoring (grab sample) locations, four of which discharge to adjacent drainage channels which lead to the river Finn a designated SAC

- The primary Treatment of Leachate on site is through the over ground irrigation of the willows plantation. The Leachate loading applied is controlled via an irrigation system (Rainbird) which allows the user to control the application for specific timeframes on a daily basis.

- The weather station also prevents irrigation during high rainfall or freezing conditions to prevent over ground flow. Leachate is applied through an over ground distribution pipe network across the four zones within the site.
