# RAWFILL WP I1

## 11.1.1 Archives and inventory report

Date: December, 2020

Prior to the geophysical surveys on the Meerhout landfill site, the amount of waste, the landfill area and the waste types must be estimated. These estimations are based on existing databases and archives from OVAM and the site-operator IOK and will be described in this report.

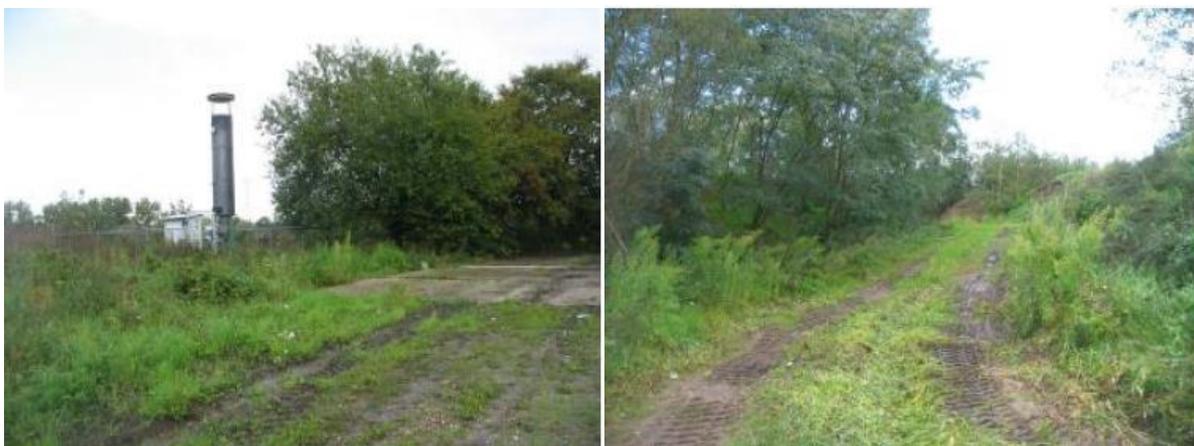
*Figure 3 - pictures with a view on the gas extraction installation from the lower part of the landfill (left) and picture of the path between the lower and higher part of the landfill (right), source: RUP Biezenhoed, IOK (2012).*

The eastern part of the site is now a waste sorting facility. This is the only entrance to the landfill and is only open during working hours (ca. between 8 a.m. and 4 p.m.) and only on demand. **Figure 3** illustrates the different paths by which the landfill is made accessible.
