DELIVERABLE D.T4.1.7

Report on the results from the pilot action 7
- Emergency plans for heritage sites involved
in Poland

**Church of the Exaltation of the Holy Cross in
Stara Wies, ul. Ks. Wojtylki 3, 43-300
Wilamowice**

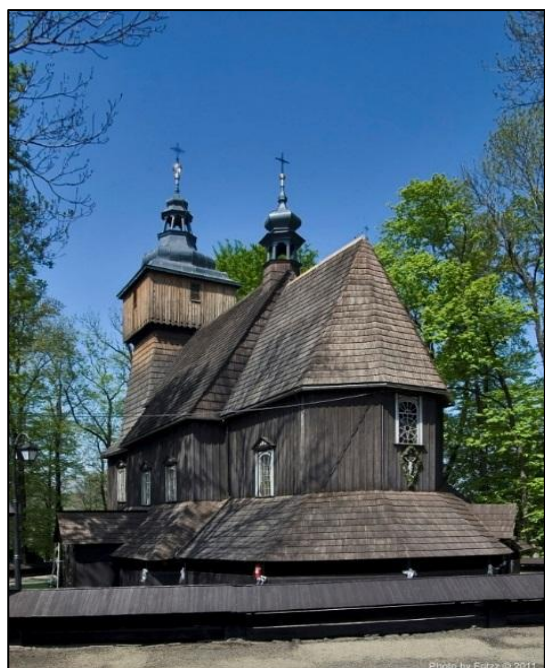
b) number of floors: **1** including underground: **0**

c) number of emergency exits at the facility: **2**

d) access to the facility enabling the use of fire brigade equipment: ~~convenient~~ / **inconvenient**.

e) whether the facility meets the technical requirements of evacuation in the light of applicable regulations: **yes** / ~~no~~

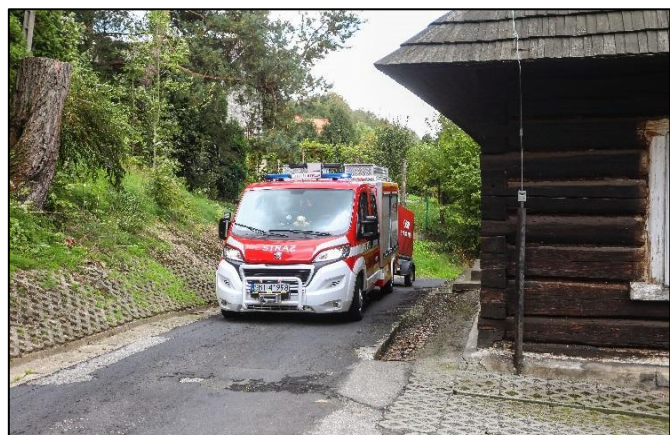
- The road leading over the church to the presbytery is very narrow and steep. In addition, there is a small possibility of returning large vehicles,
- driving to a non-alarm concentration point,

- personal protection equipment of rescuers adapted to perform tasks,
- medical security: KSRG rescuers (equipped with a medical bag PSP R1),
- Focus point: parking at the church in Stara Wies.

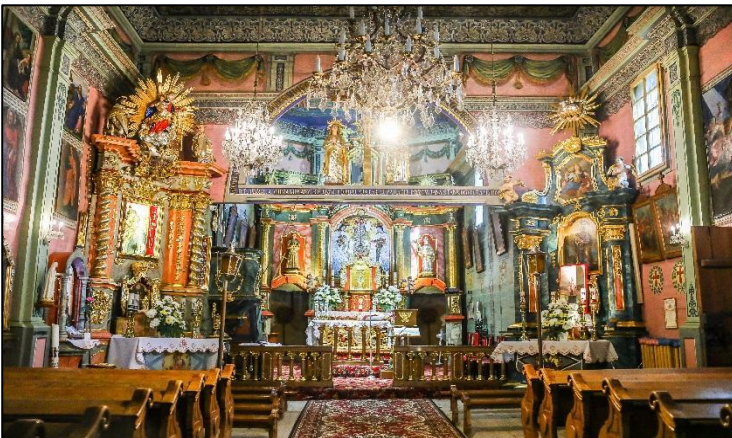
the local Parish Council and representatives of crisis management of local government units, supporting decisions with their knowledge and experience. The decision was made to correctly determine the focus of emergency services on the parking lot under the church and not to send all special vehicles to the access road to the church because of the narrow, steep road and the limited possibility of turning back. Special cars were parked on the main road and, after spreading the flood protection sleeves above the church, it was ordered to pump water to fill them.

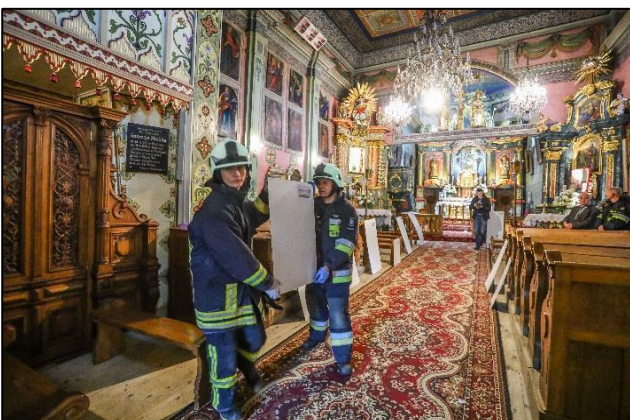
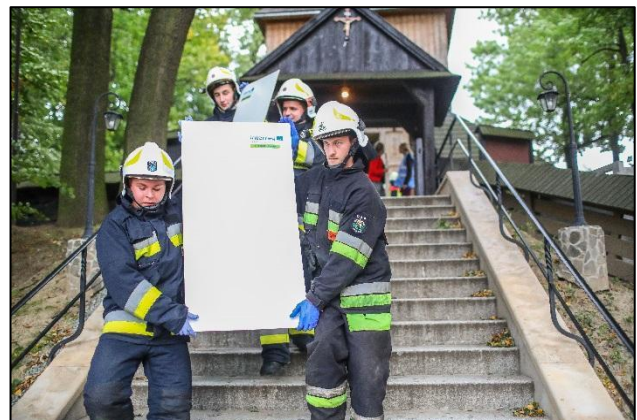
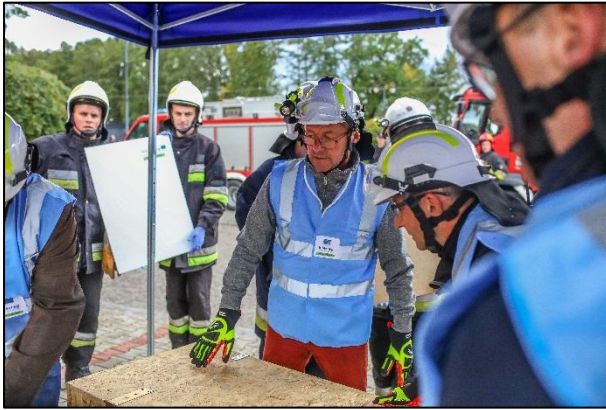
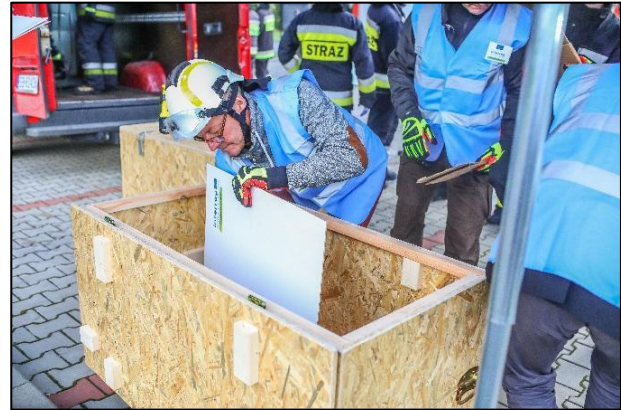
The entire evacuation process of movable cultural heritage was carried out in a coordinated manner involving all collaborating services and representatives of the Parish Council. A special point was created in the parking lot under the church (in a safe place) to secure and write down evacuated property. Due to the dangerous area, only firemen entered the church building, who initially secured the paintings inside and then evacuated them to a special point prepared in the parking lot. There, members of the Parish Council were responsible for securing and preparing evacuated images for transport.

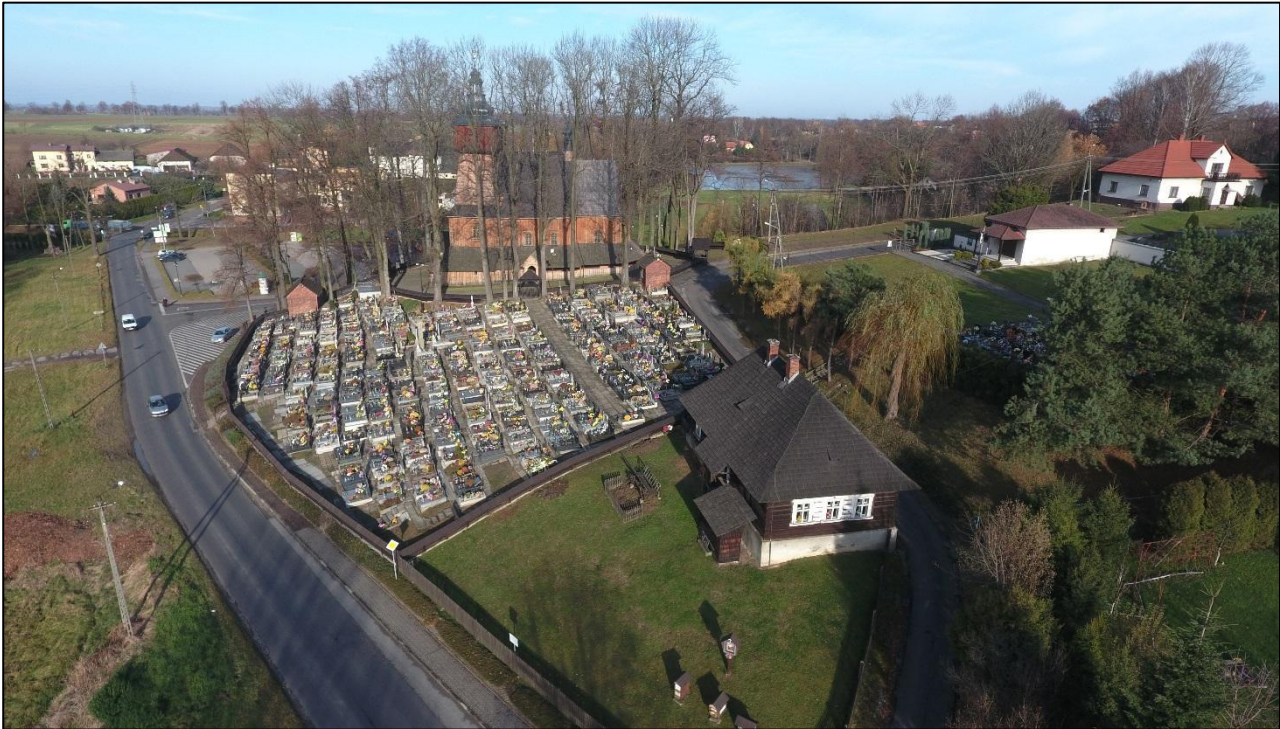
The church is located on a hill surrounded by an old stand, which is a natural monument. It is a tall building, the tower reaches 30 meters, and the nave 20 m. The access road over the church to presbytery is narrow and steep, and it is difficult to turn around larger vehicles. It is possible to enter the building from the other side of the main road, unfortunately there is a steep high staircase due to the natural elevation. In the event of heavy rainfall, the water that flows from the hill above the church (and due to the intensity of the rainfall is not drained) is poured through these stairs making it difficult to reach.

Due to the historic nature of the object and its location, rescue operations must be carried out with increased potential of forces and resources. After receipt of the notification to the Command Post of the Municipal State Fire Service for emergency events (fire or local threat), the nearest rescue and fire-fighting units provided for in the District Rescue Plan are directed. Due to the location in the vicinity of a given facility, these are units of volunteer fire brigades. They can arrive at the scene quickly.

In the event of a threat of negative effects of heavy rainfall, the nearest TSO units were equipped with flood sleeves from the District Flood Warehouse for the Bielsko District. The use of sleeves over the church effectively directs the flowing water next to the church and cemetery, thanks to which it counteracts the flooding of the church and increases the time for evacuation activities of the historic property.
