**OPTIWOOD Project
Summary of Biomass Boiler
Data Logging Activity and
Boiler Operator Training**

OPTIWOOD: Overview of Data Logging Results and Operator Training 5 UK Sites

Stewart Boyle & Paul Spencer
SEWF / Vert Energy Associates

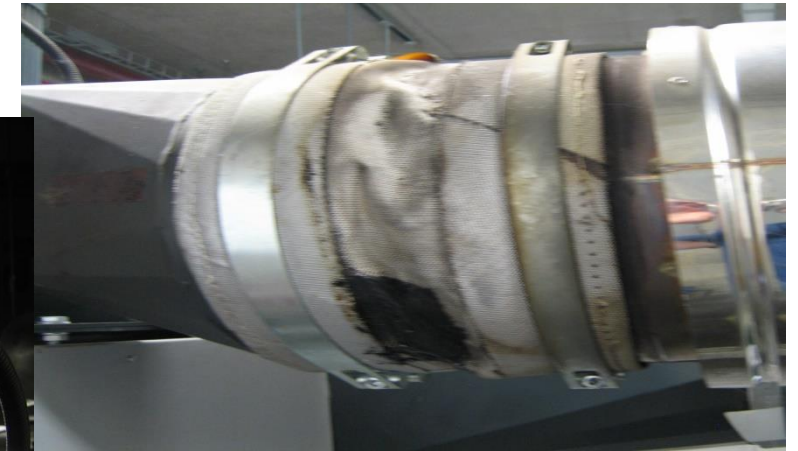
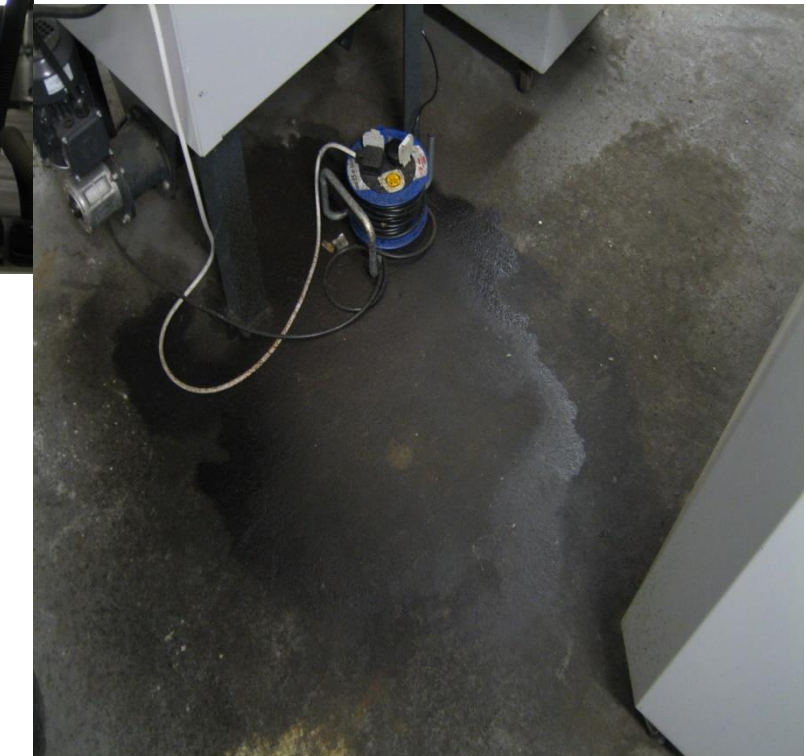
Site 1: 300kW Biomass L.A. Offices – UPDATE Sept 2020

A combination of some simple boiler faults, a power cut, BMS inconsistencies and extended repair response times result in a dirty floor and lost R.H.I. revenue.

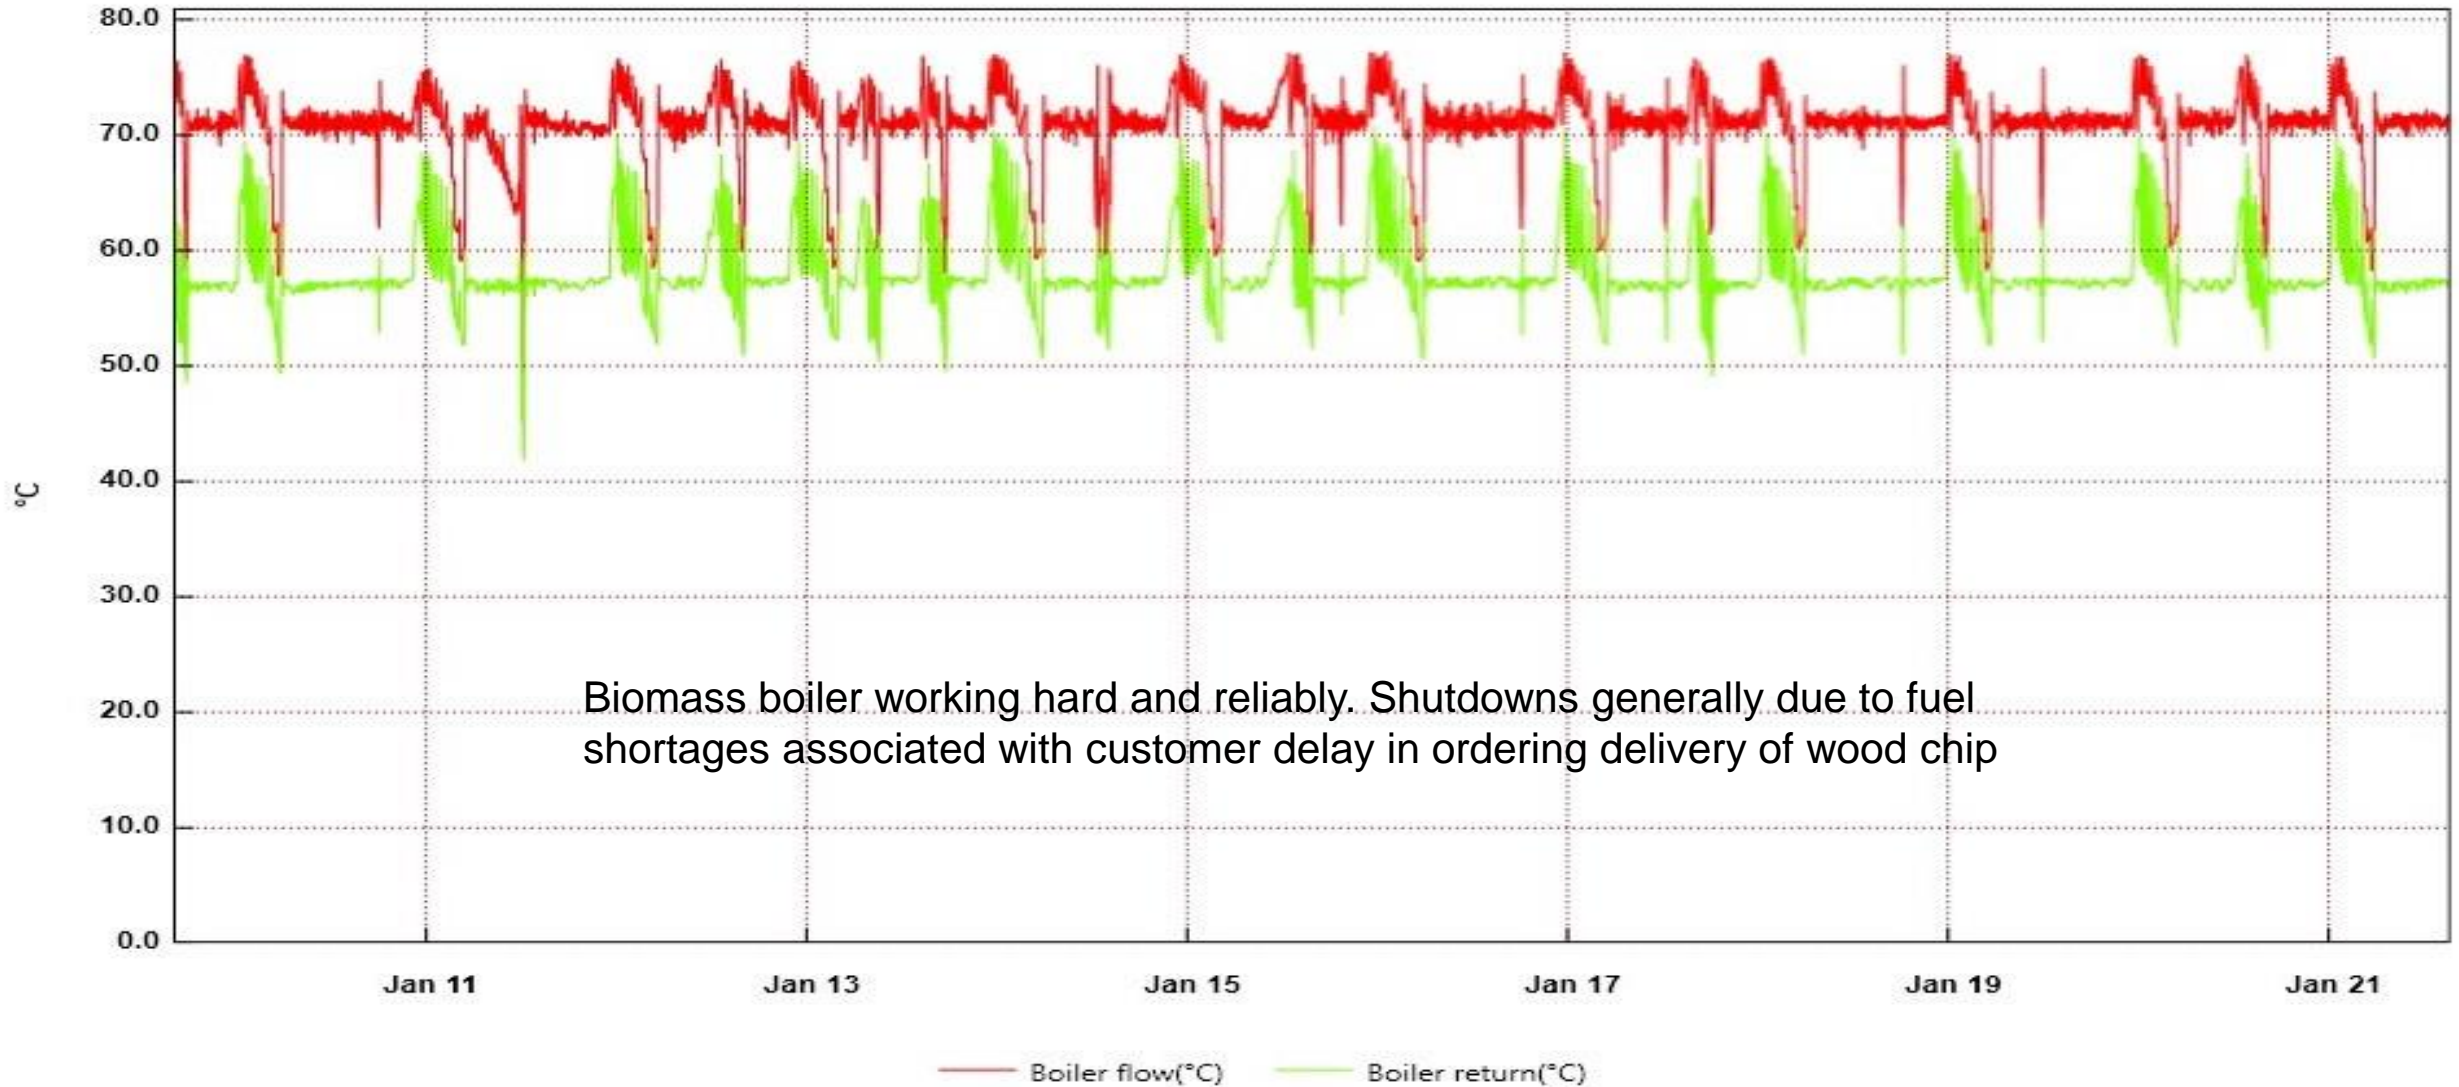
- Boiler Flow and Return

Biomass boiler working hard and reliably. Shutdowns generally due to fuel shortages associated with customer delay in ordering delivery of wood chip

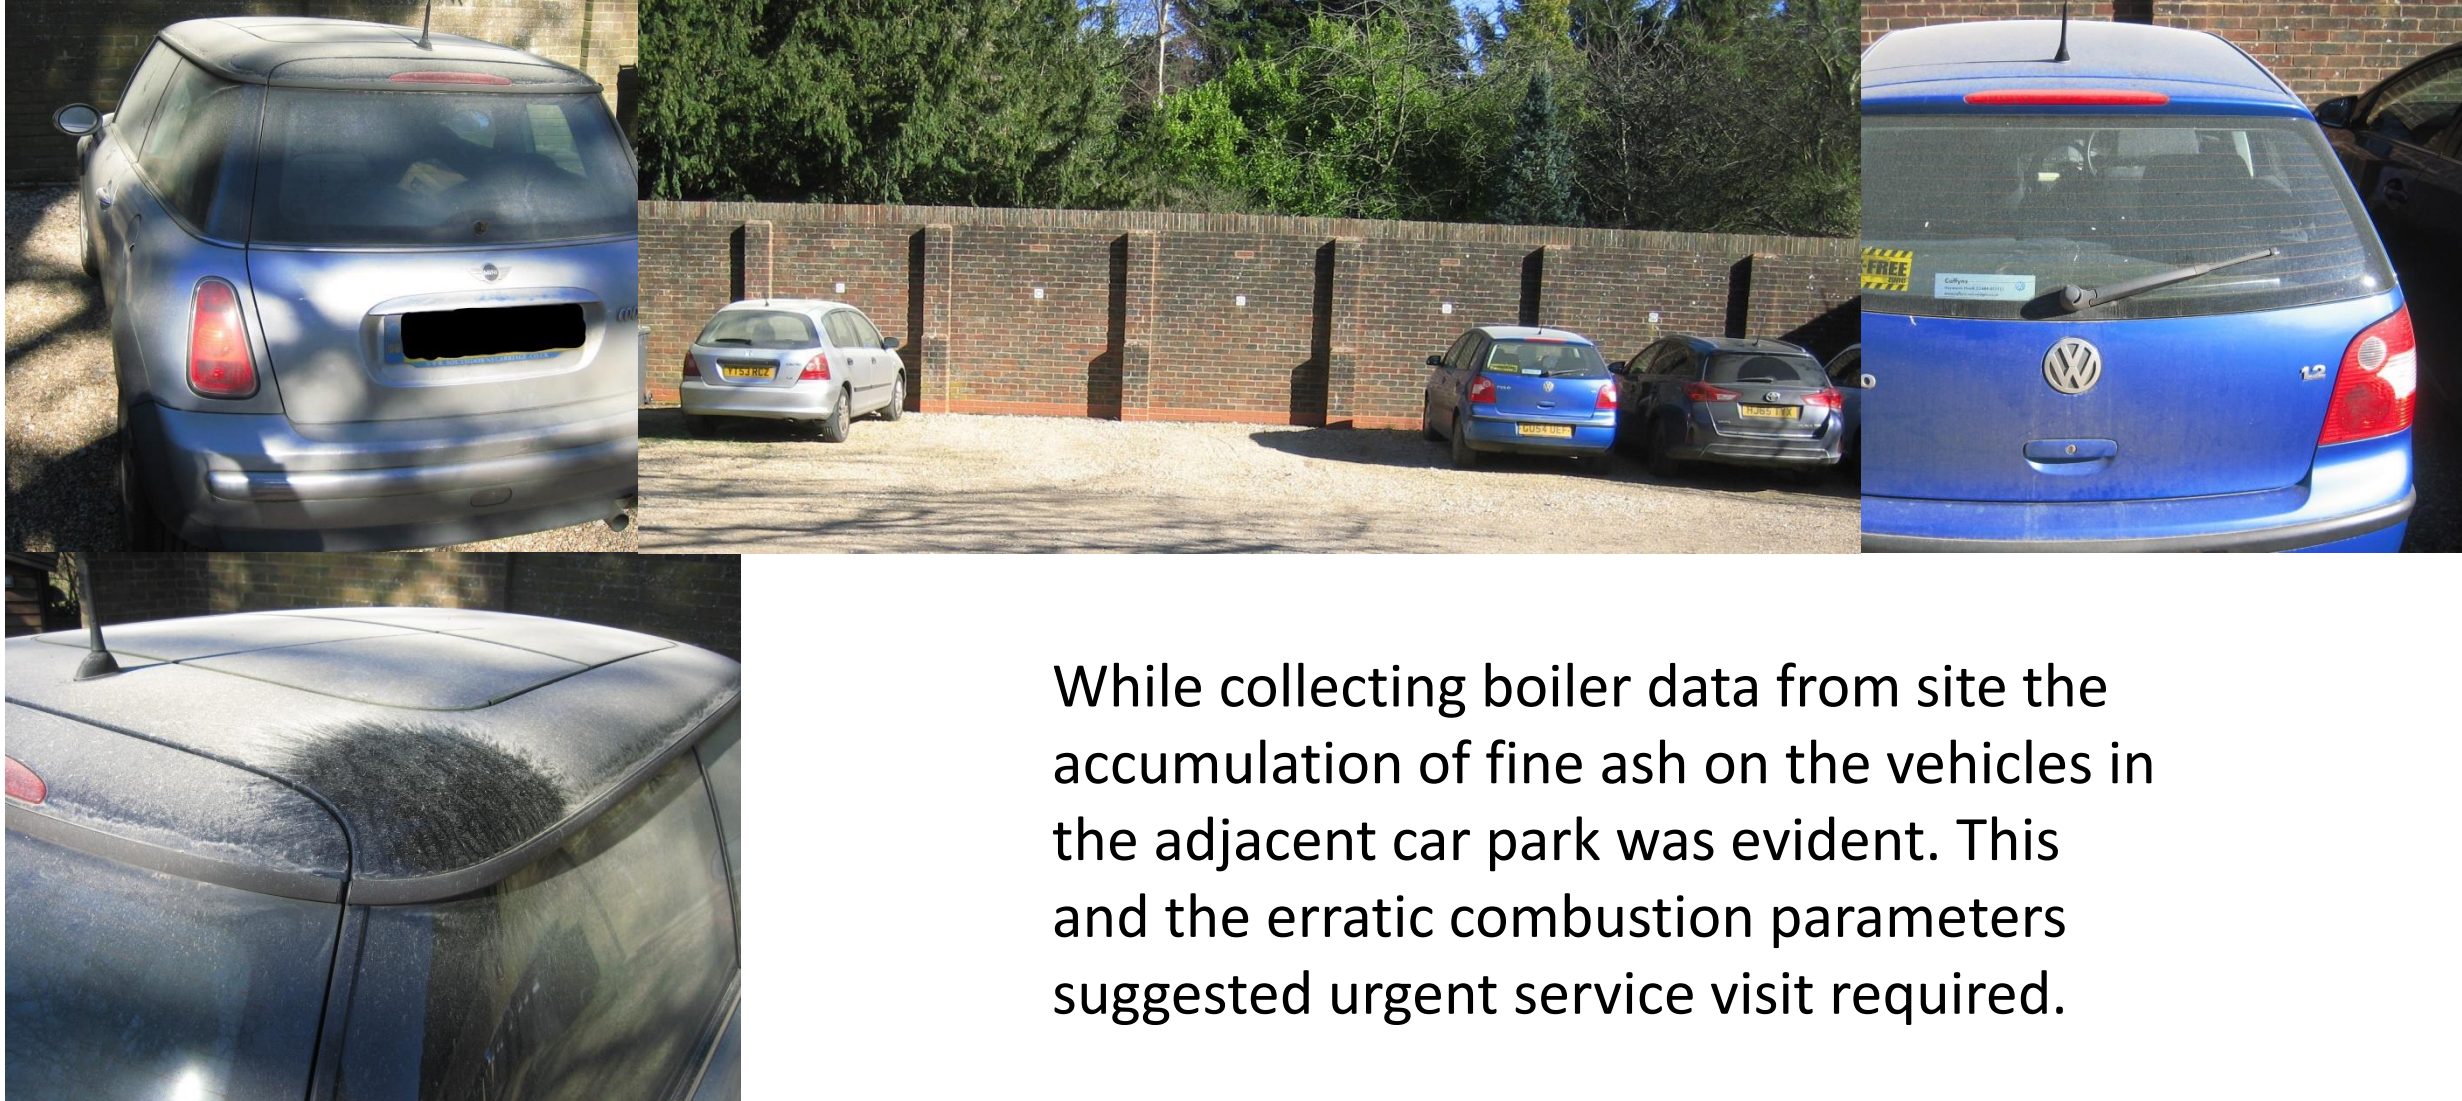
- Boiler combustion condition indication – car park

While collecting boiler data from site the accumulation of fine ash on the vehicles in the adjacent car park was evident. This and the erratic combustion parameters suggested urgent service visit required.

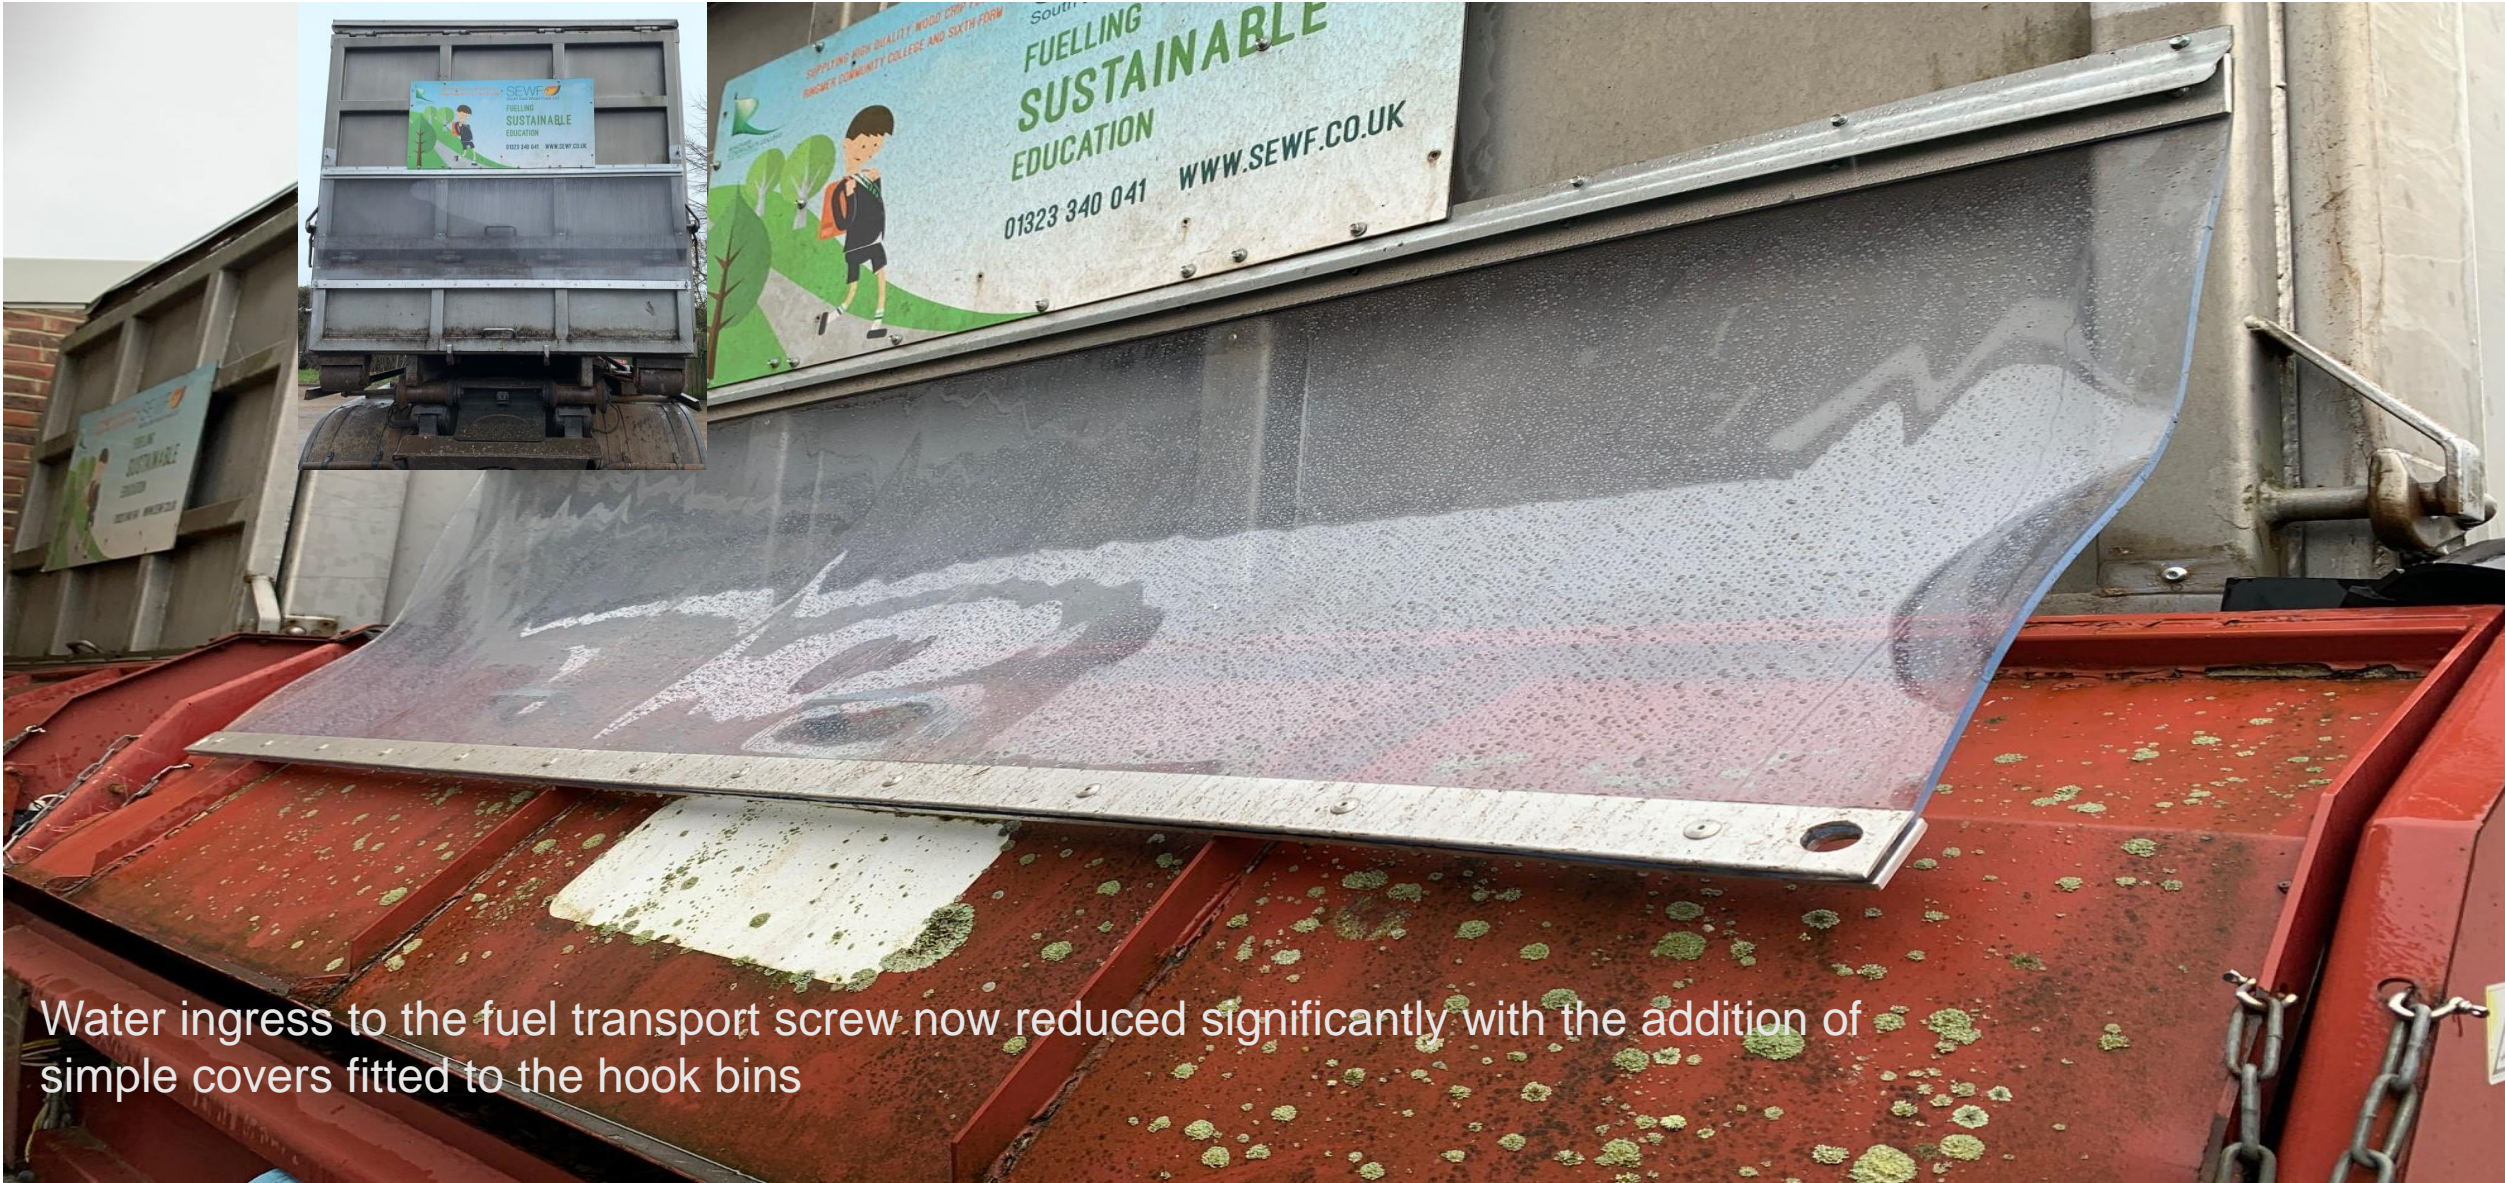
- Low cost weather protection installation on first container – complete with rain.

Water ingress to the fuel transport screw now reduced significantly with the addition of simple covers fitted to the hook bins

- Boiler working efficiently:
 - Motivated and knowledgeable boiler operator resolves issues rapidly
 - Regular servicing regime
 - Maintenance budget made available by interested senior managers
- One main issue:
 - Water ingress to external wood fuel transfer auger
 - Results in fuel clinkering following periods of high rainfall
 - Simple weather protection screen to be fitted during February 2020
