Structural Engineering International

Bio-Based Composite Footbridge: Design, Production and *In Situ* Monitoring

This paper deals with the design, production and monitoring of a bio-composite footbridge with a span of 14 m across the river Dommel in the city of Eindhoven, the Netherlands. The specific bio-composite material that was used for this research is a Natural Fibre Reinforced Bio-Polymer (NFRBP). The goal of the research is to prove that NFRBP can be applied as a load-bearing structure in an outdoor environment. For this purpose, a multidisciplinary team of academic researchers from two universities and from the Centre of Expertise Biobased Economy, together with a manufacturer from the NFRBP industry, have developed a feasible design that could be produced in a short period of time and within a limited budget. The footbridge was designed, built and installed within less than one year. In the two years after the installation of the footbridge, the structural behaviour of the bridge was monitored by means of optical fibre glass strands, integrated within the structure, with the purpose of measuring deformations and change in elasticity that occur over time.

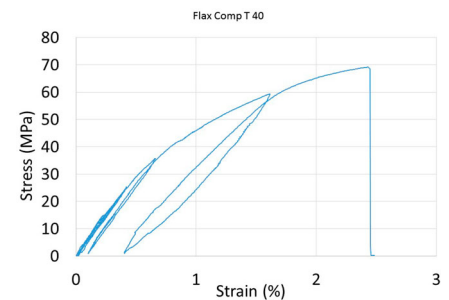
Fig. 6: Typical result of a repeated loading-unloading and reloading tension test in the laboratory on a test specimen of Woven (90 degrees) flax fibre composite showing hysteresis behaviour

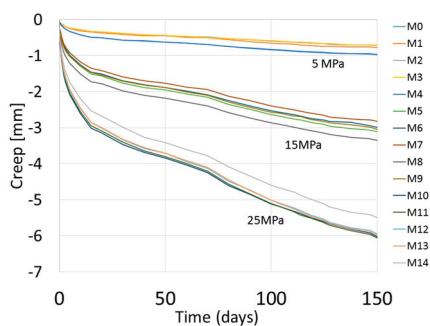
Fig. 8: Creep curves at three stress levels 5, 15 and 25 MPa in three-point bending tests

linear behaviour, creep test have been performed (Fig. 7). Three-point bending material creep tests on three different stress levels (5, 15 and 25 MPa) have been performed at TU/e. Figure 8 shows the results of these tests.

The creep slope of the samples under lower stress levels (indicated with 5 MPa) hardly show a decrease in time. The higher stress level (25 MPa) shows only a very small reduction in the creep slope. Therefore, the long-term deflection of the bridge can be estimated by a reduction in E -modulus approach, using with a reduction factor k_{def} :

Based on the creep curves for the low stress levels of 5 MPa (Fig. 8) and preliminary calculations, a $k_{def}=0.8$ was found and applied in the design calculations.

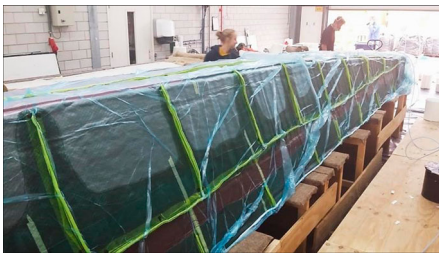
Fig. 14: Bridge beam during vacuum injection

Figure 14 shows the injection of the bridge beam (in top down position). In the dark green coloured areas, between the yellow injection canals, the resin has already penetrated the fibres. After the vacuum injection and the hardening, the bridge beam was turned 180 degrees and then cured at a temperature of approximate 50°C for a 36 h period using electrical air heaters. The bridge rail elements were then mounted and lastly, to prevent moisture accessing the structure over time, a coating system was applied.

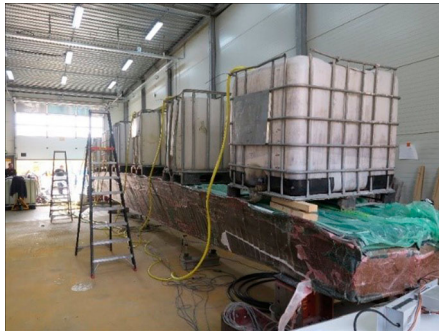
Fig. 15: Impression of the load test using seven water tanks

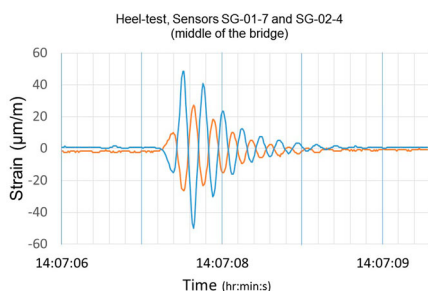
Fig. 20: Strain results versus time of sensors 1-7 and 2-4 showing Eigen frequency and damping

On 15 March 2017 a static load test was performed but also a simple dynamic test was carried out. This was done through a simple heel test in the middle of the bridge. A person, standing on his toes and dropping flat to his feet, generated a vertical impulse load. *Figure 20* shows the measured strains that were invoked in this way versus the time of sensors SG-01-1-7 and SG 01-2-4, both in the middle but at opposite sides, top and bottom, of the bridge.

Based on these measurements the Eigen frequency of the bridge the first (vertical) vibration mode has been calculated at 6 Hz (lying out of the zone of $2.5 \text{ Hz} < f_n < 4.6 \text{ Hz}$ where discomfort due to larger accelerations might occur). Also the logarithmic decrement

$\delta = 0.58$ in a free decay of the vibration and the damping factor $\zeta = 0.093$ was calculated using $\delta = (1/n) \ln(x_0/x_n)$ and $\zeta = \delta/2\pi$ in which ζ is the damping factor, n is the logarithmic decrement, n is the number of cycles, x_0 is the amplitude of the 1st cycle, and x_n is the amplitude of the n th cycle. This relatively high damping compared to for example steel or concrete bridges further contributes to a good dynamic behaviour and pedestrian comfort.

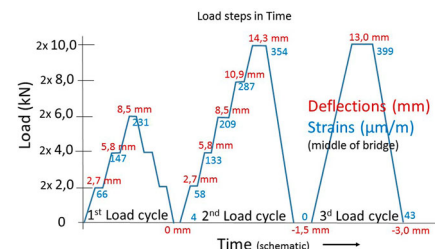
Fig. 22: Three load cycles during the test on 17 August 2018 showing applied load, max strain in middle and maximum measured vertical deflection

the non-woven, randomly oriented hemp fibres was unstable. For this reason, only the tension side results are shown here. During the test, vertical deflection of the bridge was also measured (middle of the bridge) using an optical device (see also *Fig. 22* in the middle).

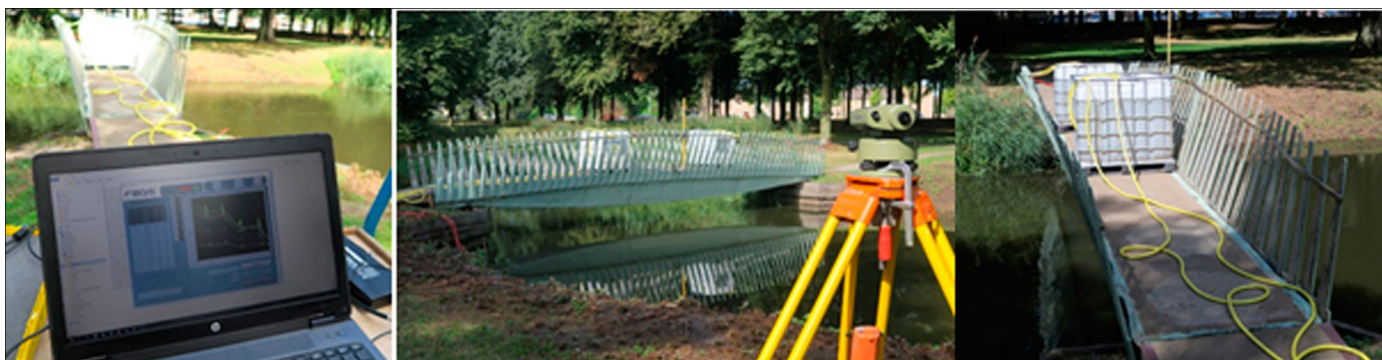
Fig. 21: Cyclic loading test performed one year and ten months after installation

The latest test thus far has been the test performed on 17 August 2018, 22 months after the installation. In this test, two water containers have been used to impose a load of a maximum of $2 \times 10 \text{ kN}$ in a cyclic loading test (*Fig. 21*). Each load cycle step involved loading by filling the water tanks and unloading by releasing the water. The first load cycle has been performed in three steps to $2 \times 6.0 \text{ kN}$. After each load step of 2.0 kN a 5 min break was implemented during which time the load was kept constant in order to see if an increase in strains was measured. *Figure 22* shows the full three loading and unloading cycles versus time. Load cycle 2 was the reloading to $2 \times 10 \text{ kN}$ and the full unloading and cycle 3 was the reloading once more to 10 kN and unloading to 0 kN .
